**Bridge #01779(Routine)**  
**SH 7-10 Log 11.00 over COLEMAN CREEK**  
**Location: 1.00 MI N JCT OF SH 298**

**Team Lead: Shane Byrd Inspection Date: October 19, 2020**

IDENTIFICATION	
(1) State Names	Arkansas
(8) Structure Number	01779
(5) Inventory Route	7
(2) Highway Agency District	06
(3) County Code	51-Garland County, Arkansas

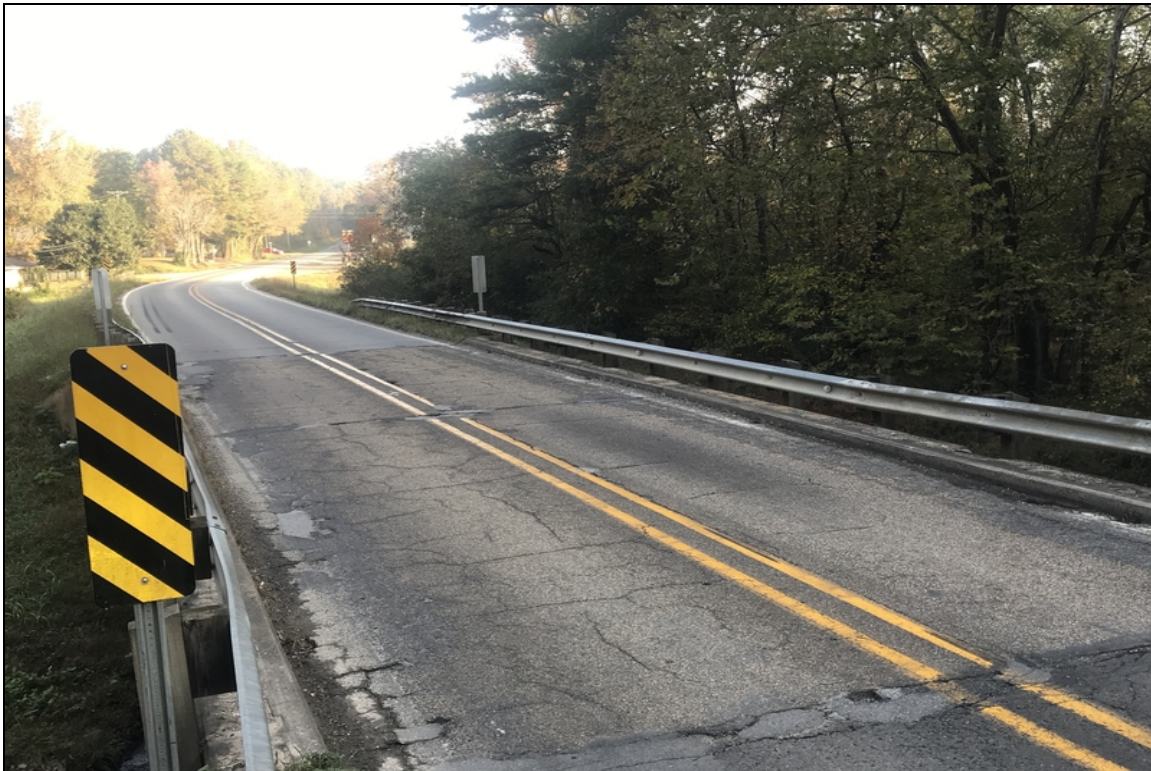
Deck overview.

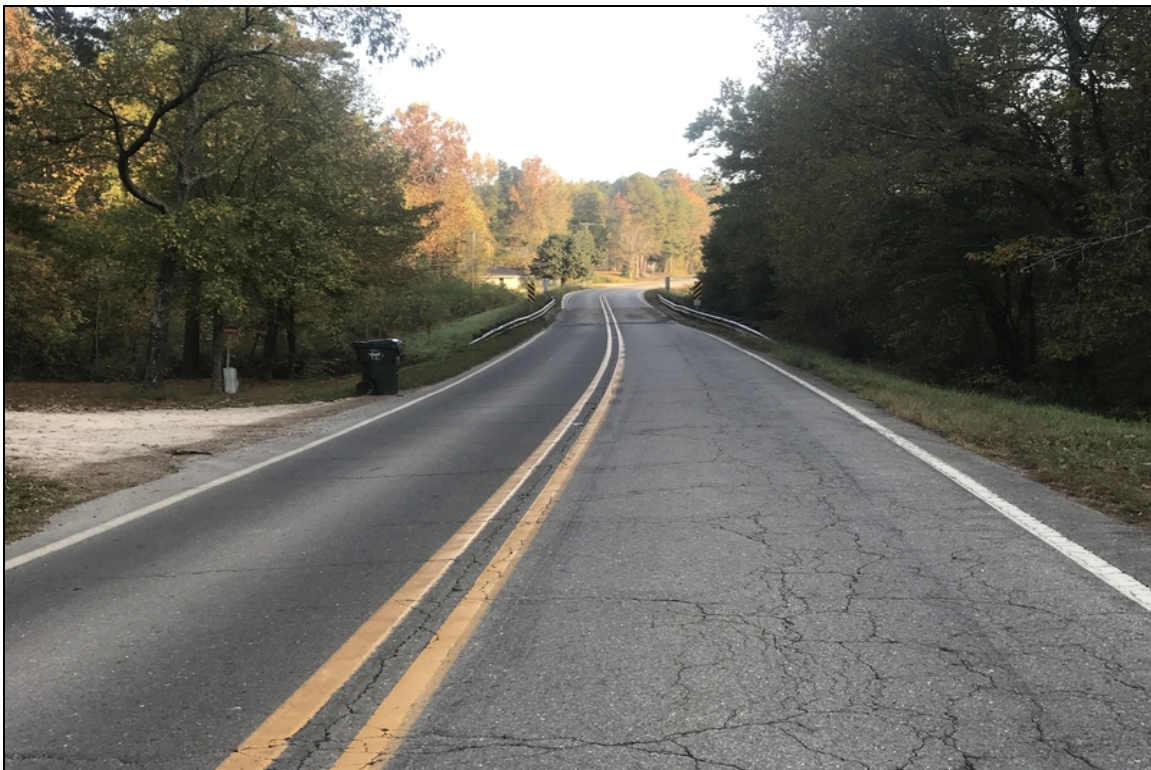
Approach Northbound.

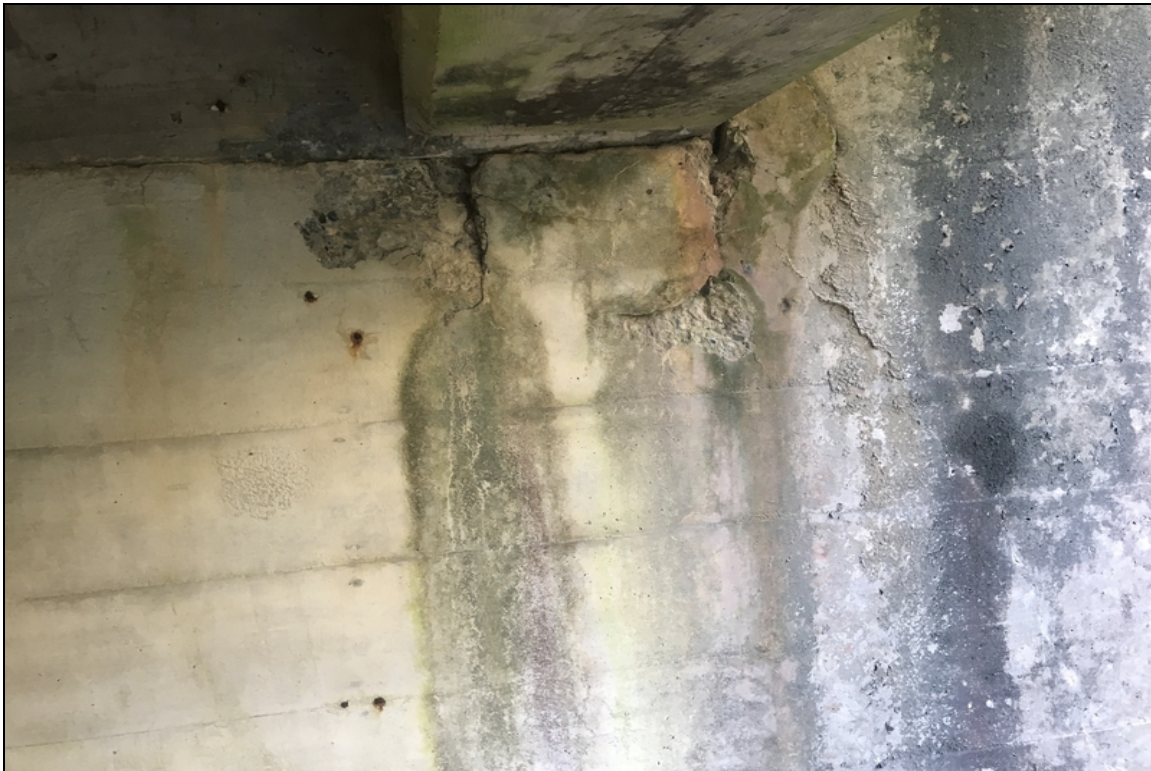
ELEM	DESCRIPTION	UNITS	TOTAL	CS1	CS2	CS3	CS4
(215) Bent 1 has vertical and diagonal cracks and spalls and exposed rebar. Bent 3 has a horizontal crack the with of the abutment, spall with exposed rebar on the left side and spall on the right side.							
234	Reinforced Concrete Pier Cap	LF	19	15	2	2	0
1090	Exposed Rebar	LF	4	0	2	2	0
(234) Spalls with exposed rebar on the right side and ahead side of cap.							
301	Pourable Joint Seal	LF	24	4	0	20	0
2350	Debris Impaction	LF	20	0	0	20	0
(301) Bent 2 joint impacted by overlay.							
311	Movable Bearing	EA	6	6	0	0	0
(311) No notable defects at this inspection.							
330	Metal Bridge Railing	LF	140	140	0	0	0
515	Steel Protective Coating	SF	280	280	0	0	0
3440	Effectiveness (Steel Protective Coatings)	SF	0	0	0	0	0
(330) Rail post have cracks, splits and are hollow on the inside

Bent 1 abutment has delam under beam 1.

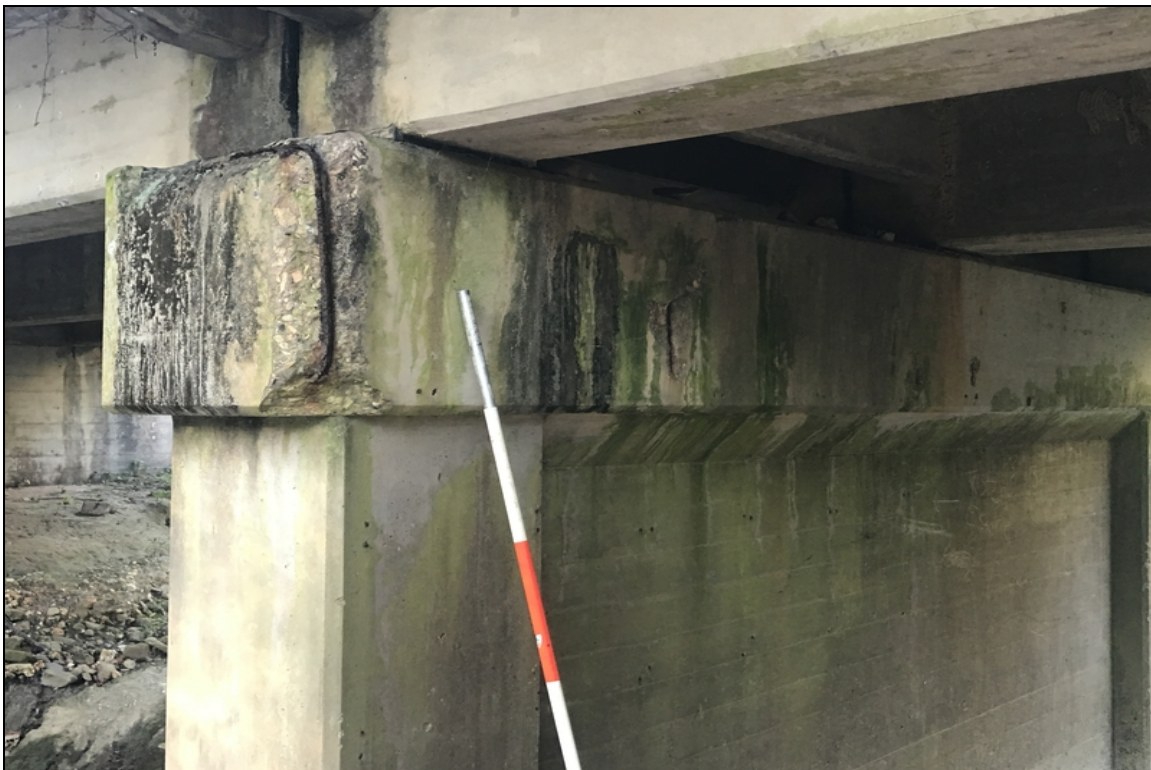
Bent 2 cap has spalls with exposed rebar.

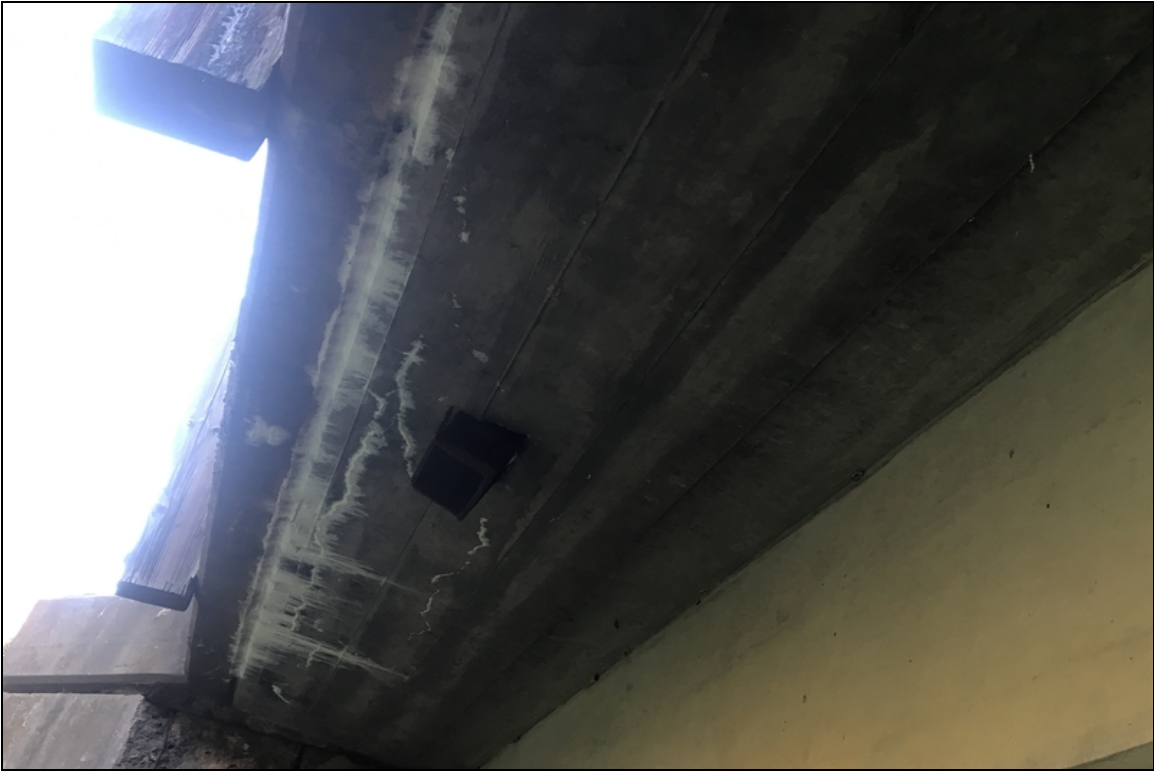
(16)	Wearing surface has large transverse and longitudinal cracks, scattered potholes, patches and abrasion. The soffit has cracks, cracks with efflorescence and exposed rebar in spans 1 and 2.						
110	Reinforced Concrete Open Girder/Beam	LF	210	208	2	0	0
1080	Delamination/Spall/Patched Area	LF	1	0	1	0	0
1090	Exposed Rebar	LF	1	0	1	0	0

Span 2 left side soffit overhang has cracks with efflorescence.

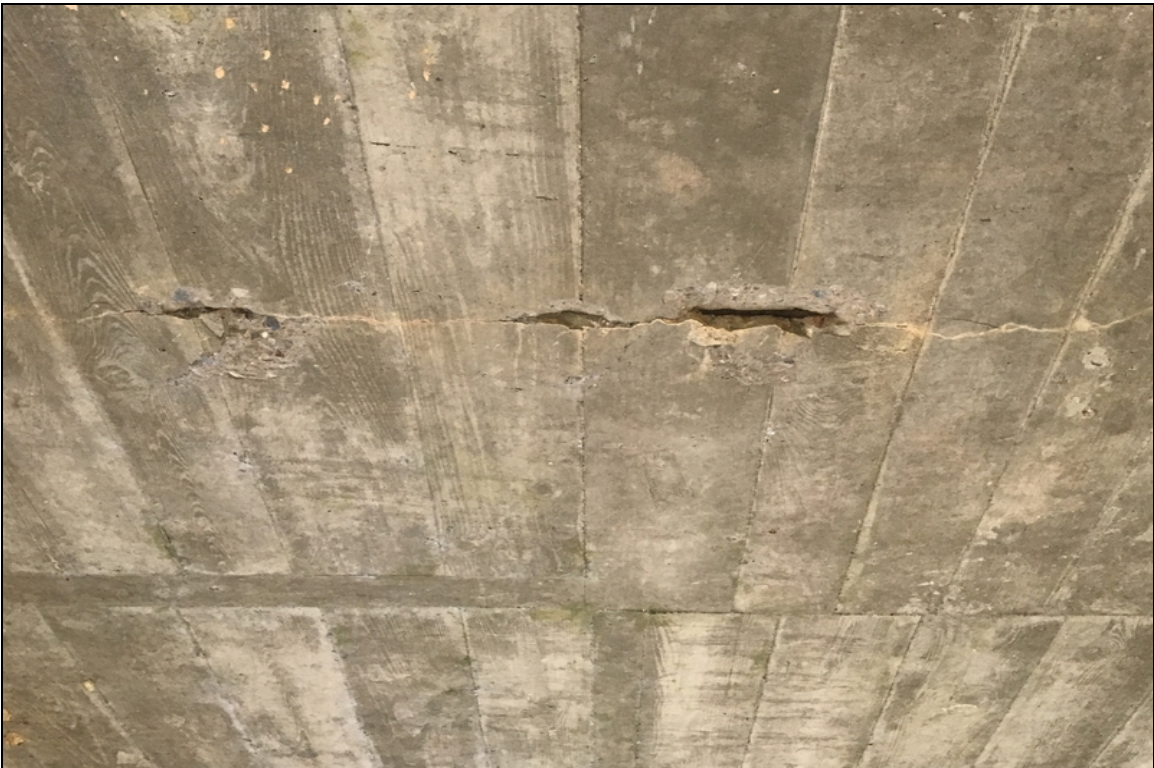
Span 1 soffit left of girder 2 has spall with exposed rebar.

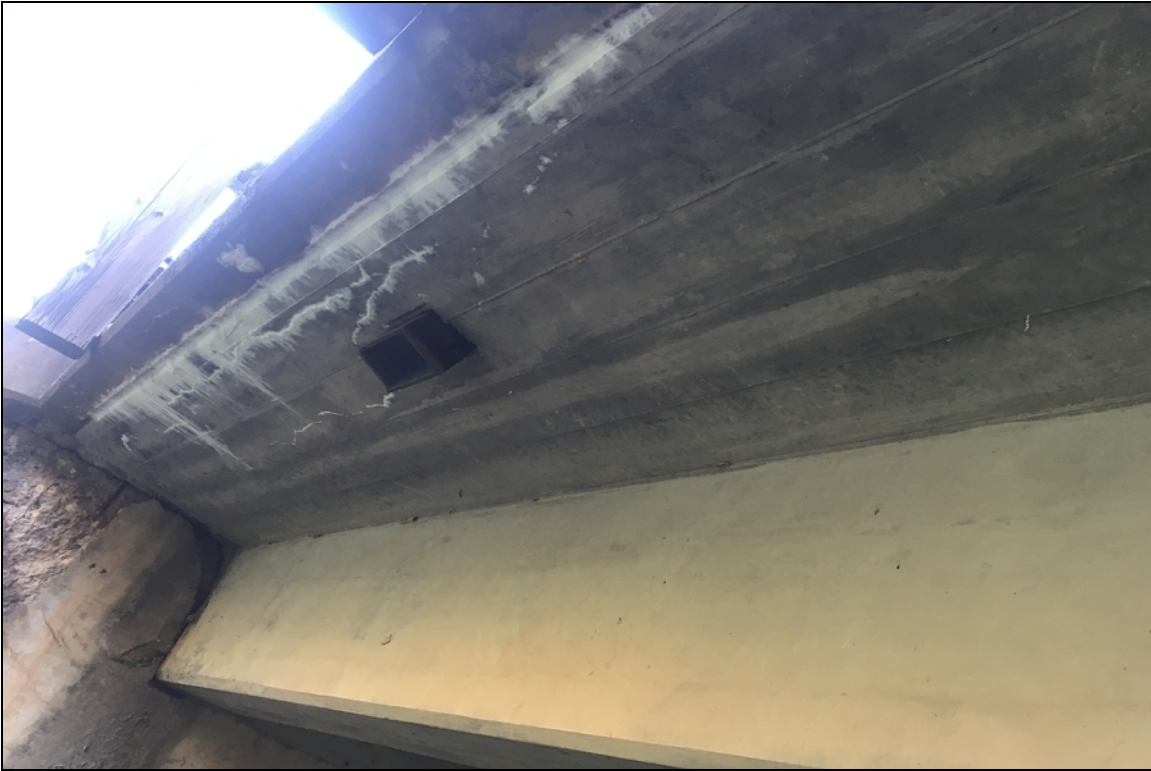
Span 2 left side soffit overhang has cracks with efflorescence.

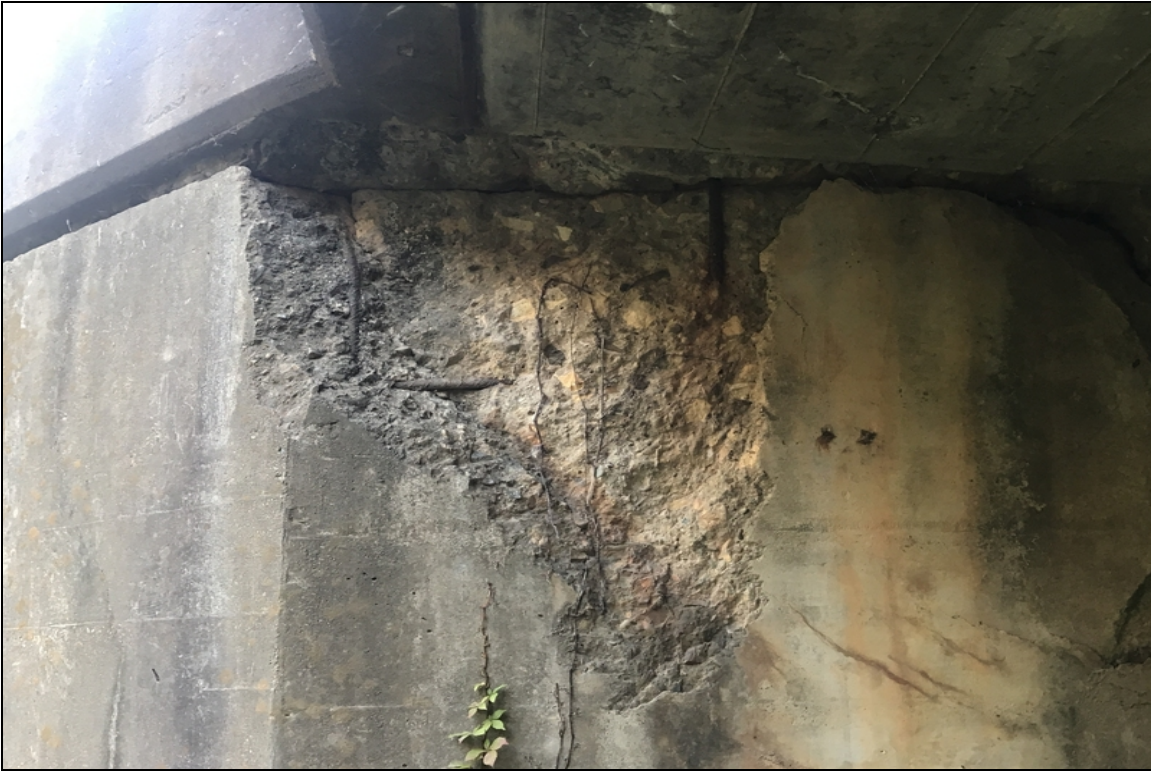
Bent 3 abutment has spall with exposed rebar on left side of girder 1.

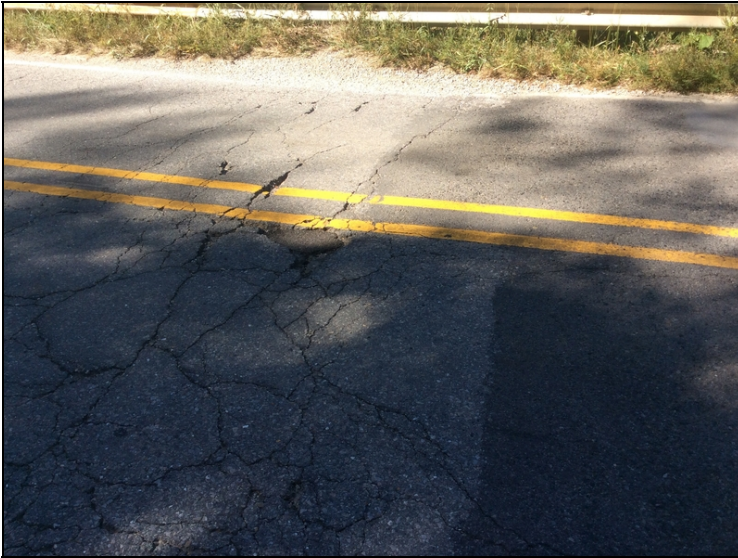
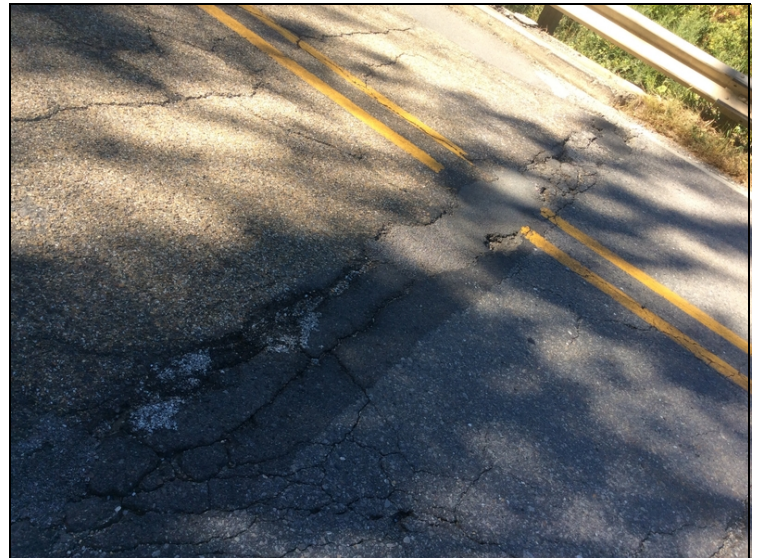
Approach roadway has settled up to 2" and has large potholes at both abutments

Potholes

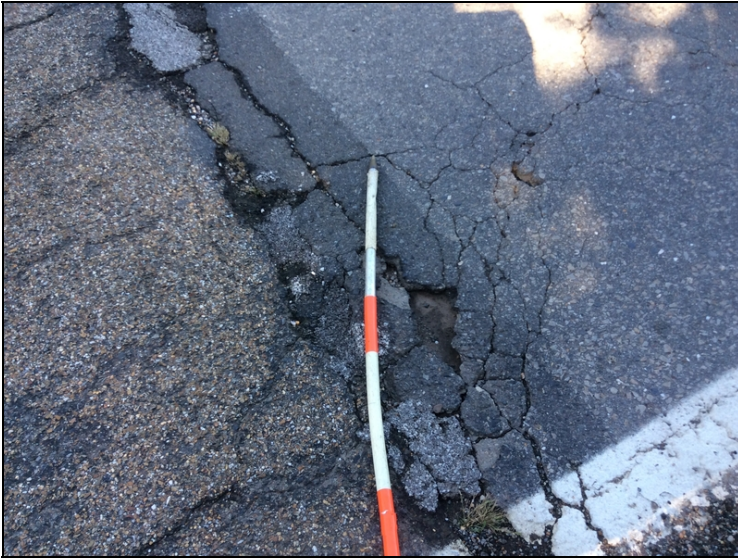
Potholes at the north end of the bridge.

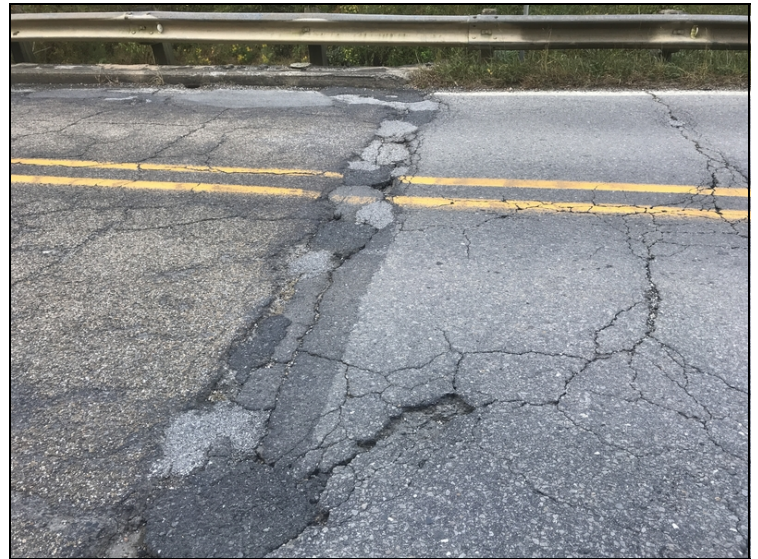
North asphalt approach has settled 2" and has potholes at abutment.

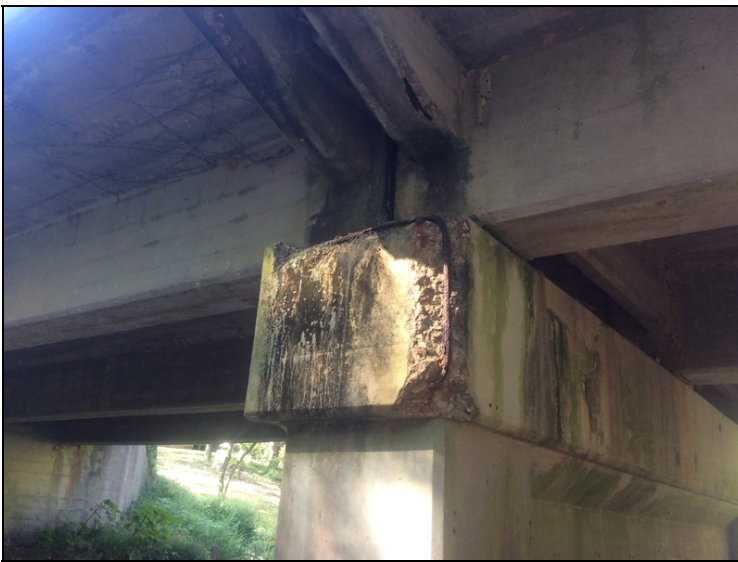
Bent 2 and 3 has large spalls with rebar exposed

Bent 2 right side, spall with exposed rebar.

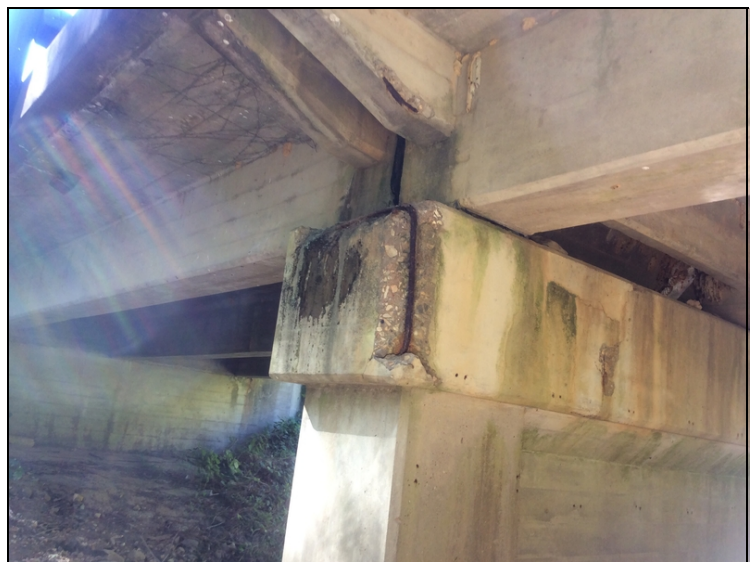
Exposed rebar

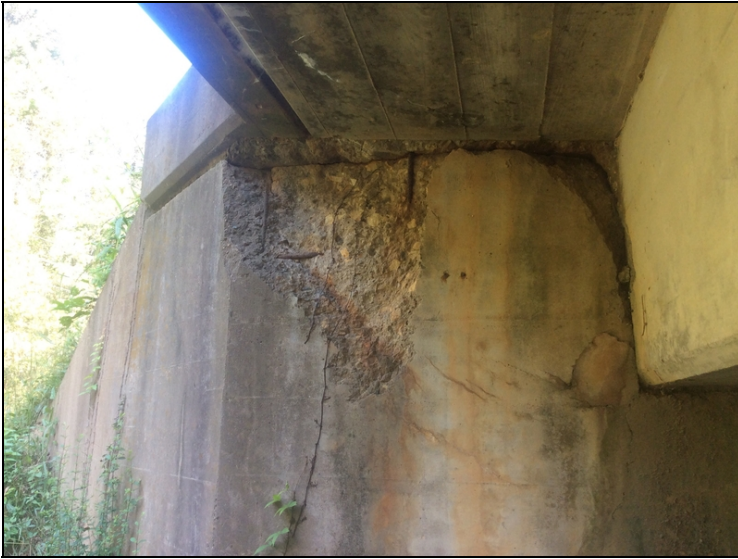
Bent 3 left side, large spall with exposed rebar.

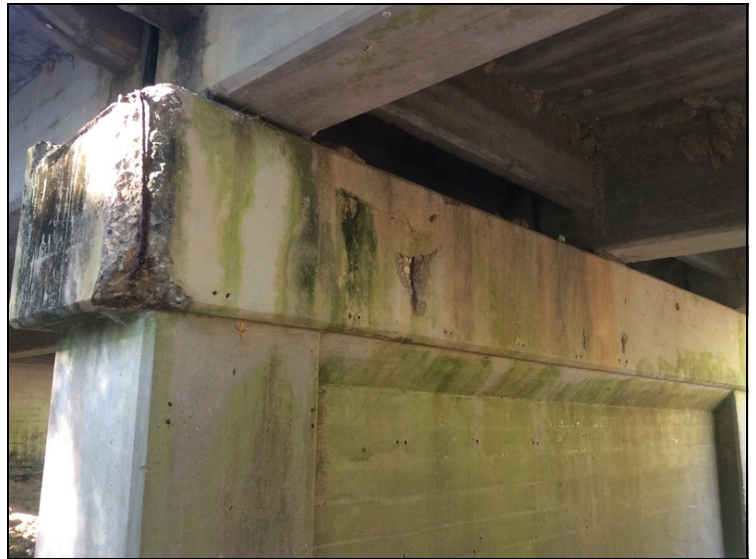
Bt. 2 ahead, right side, exposed rebar.

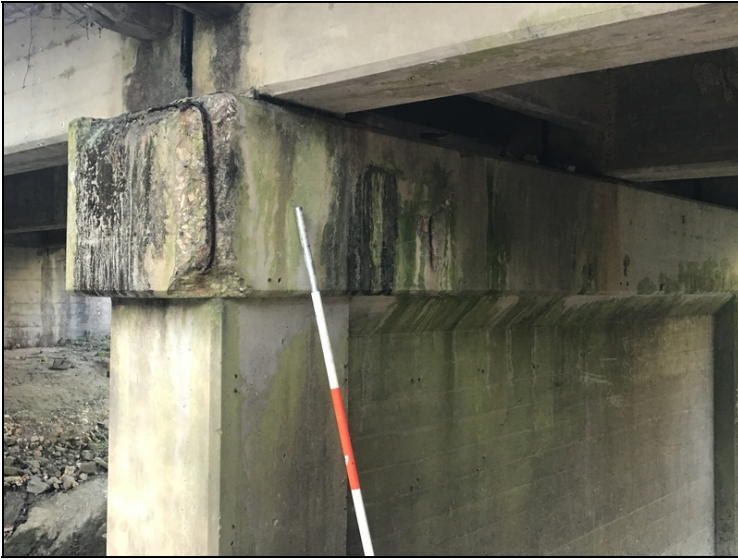
Bent 2 cap has spalls with exposed rebar.
