Bridge #01781(Routine)
SH 7-10 Log 13.27 over MIDDLE FORK SALINE RIVER

Location: 4.22 MI SE OF PERRY CO

Team Lead: Shane Byrd Inspection Date: October 21, 2020

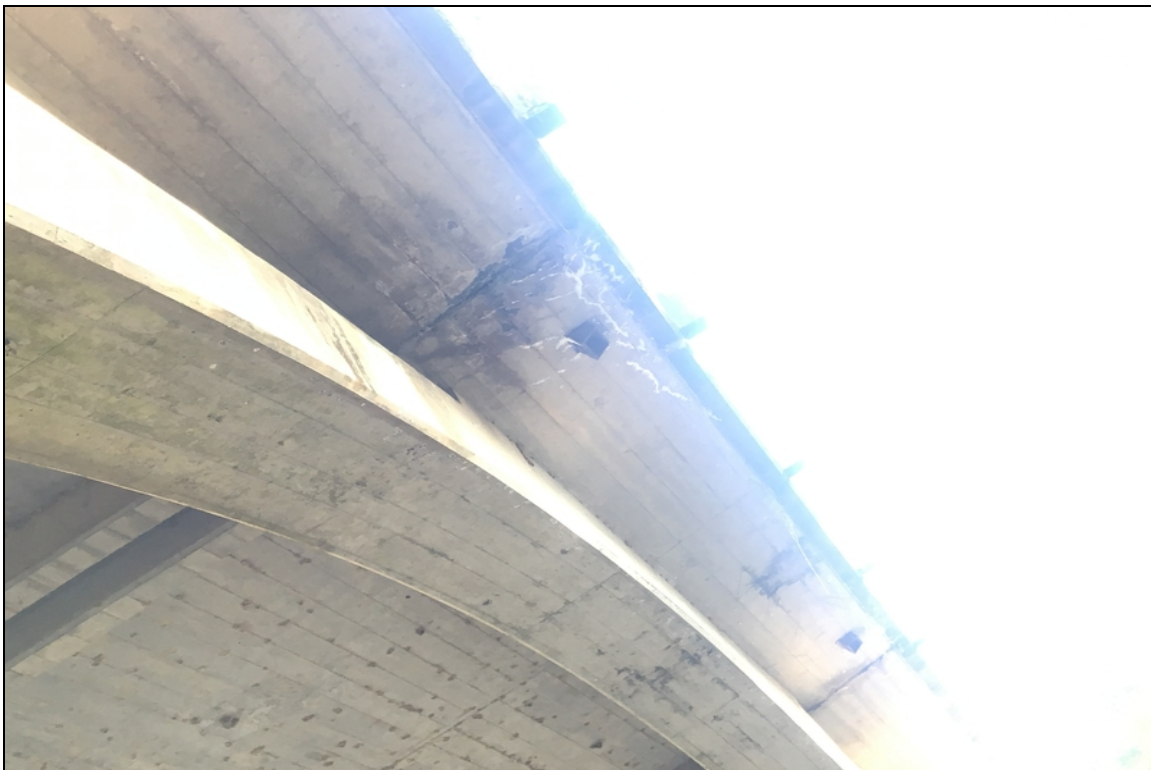
Span 1 right side soffit overhang has cracks with efflorescence.

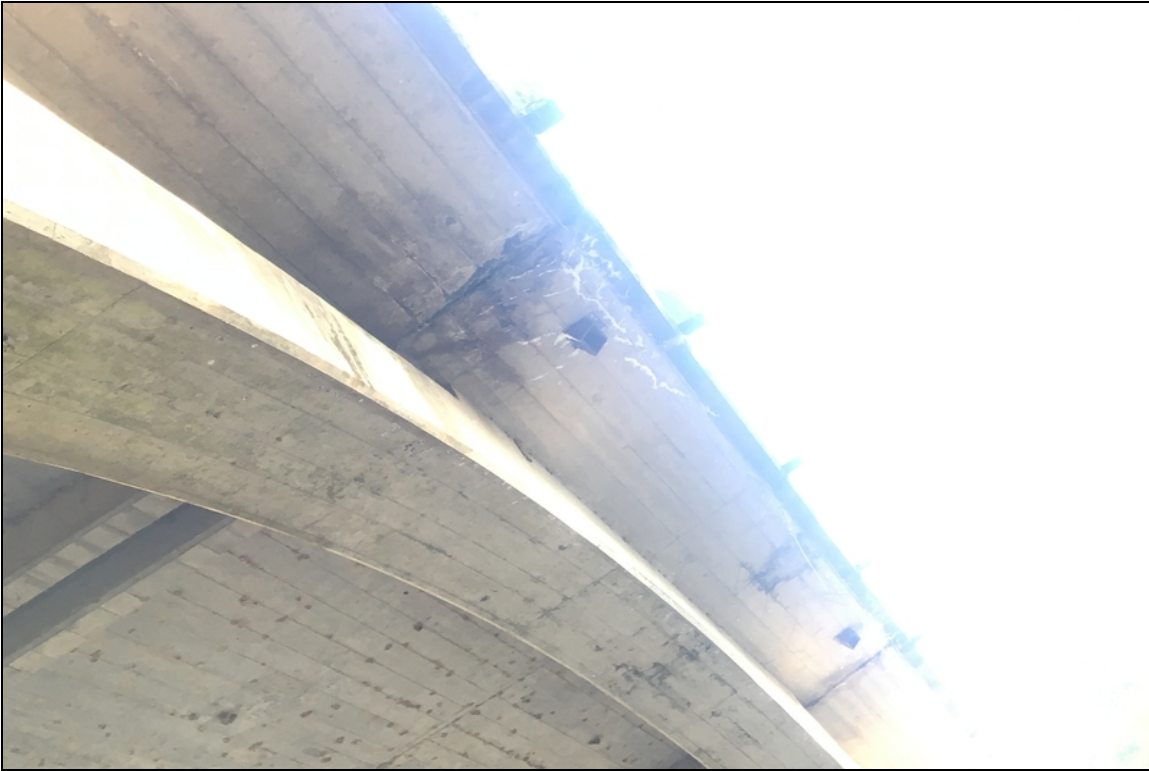
Span 1 right side soffit overhang has cracks with efflorescence.

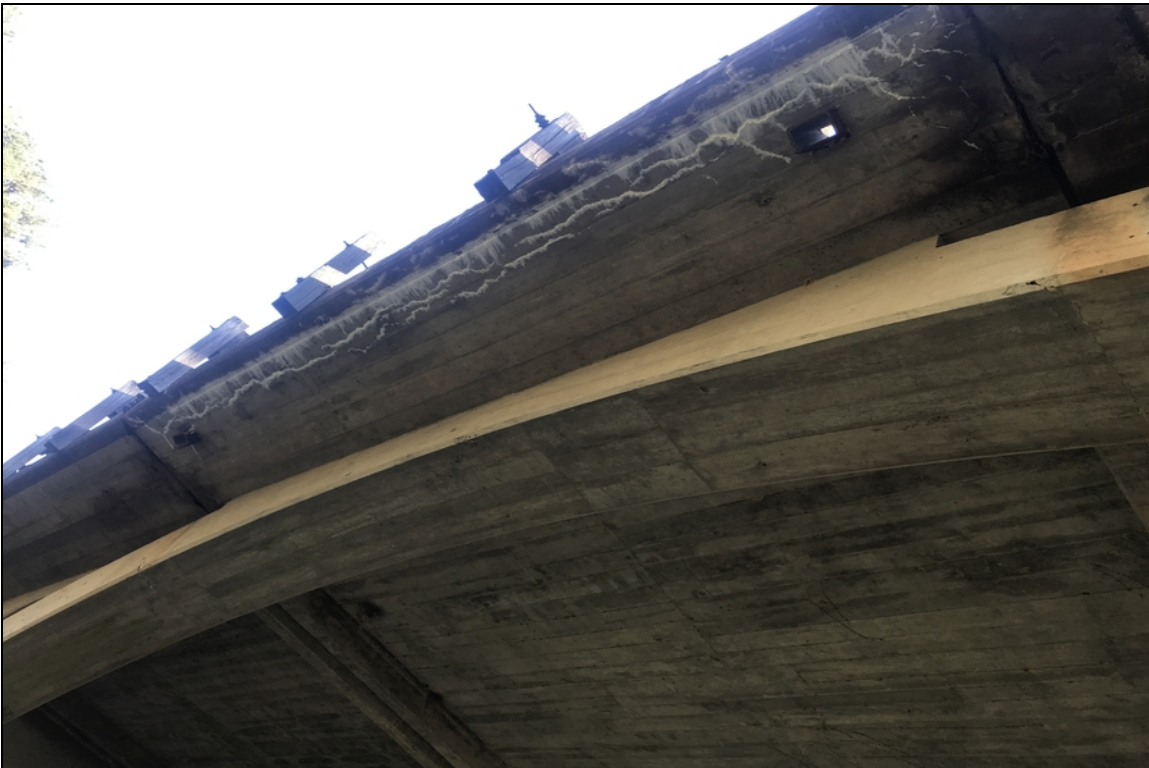
Span 2 left side soffit overhang has cracks with efflorescence.

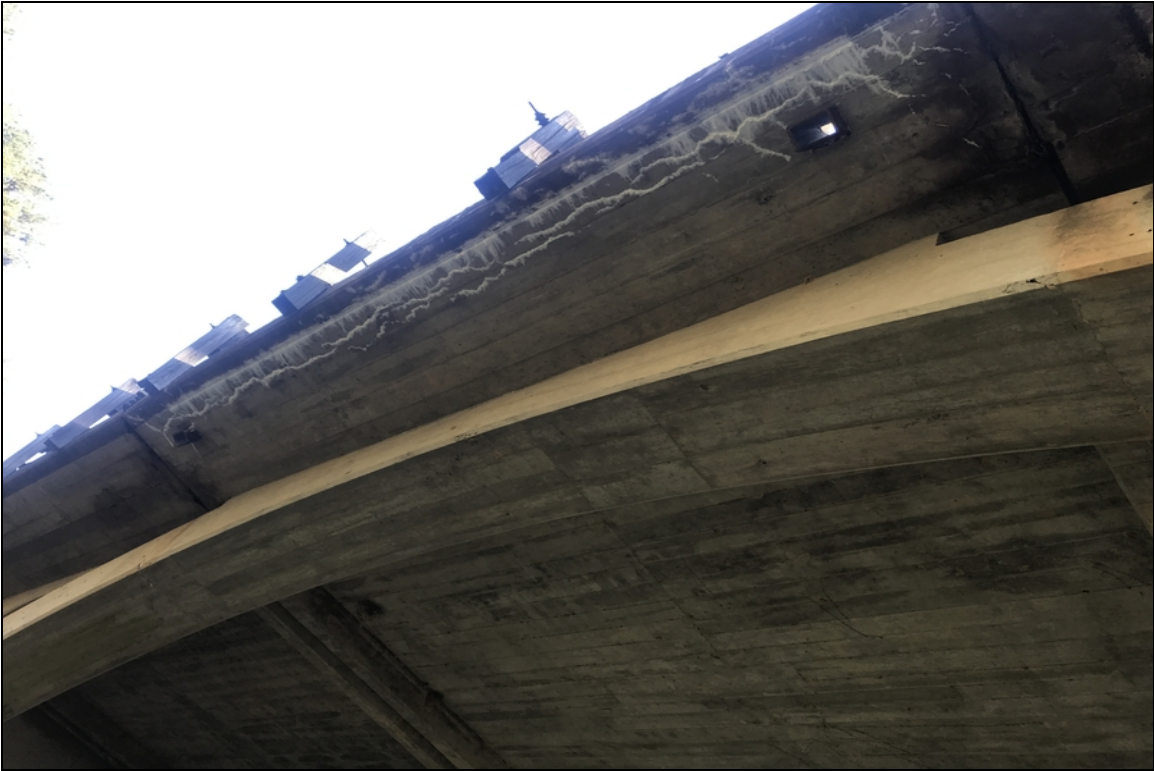
Span 2 left side soffit overhang has cracks with efflorescence.

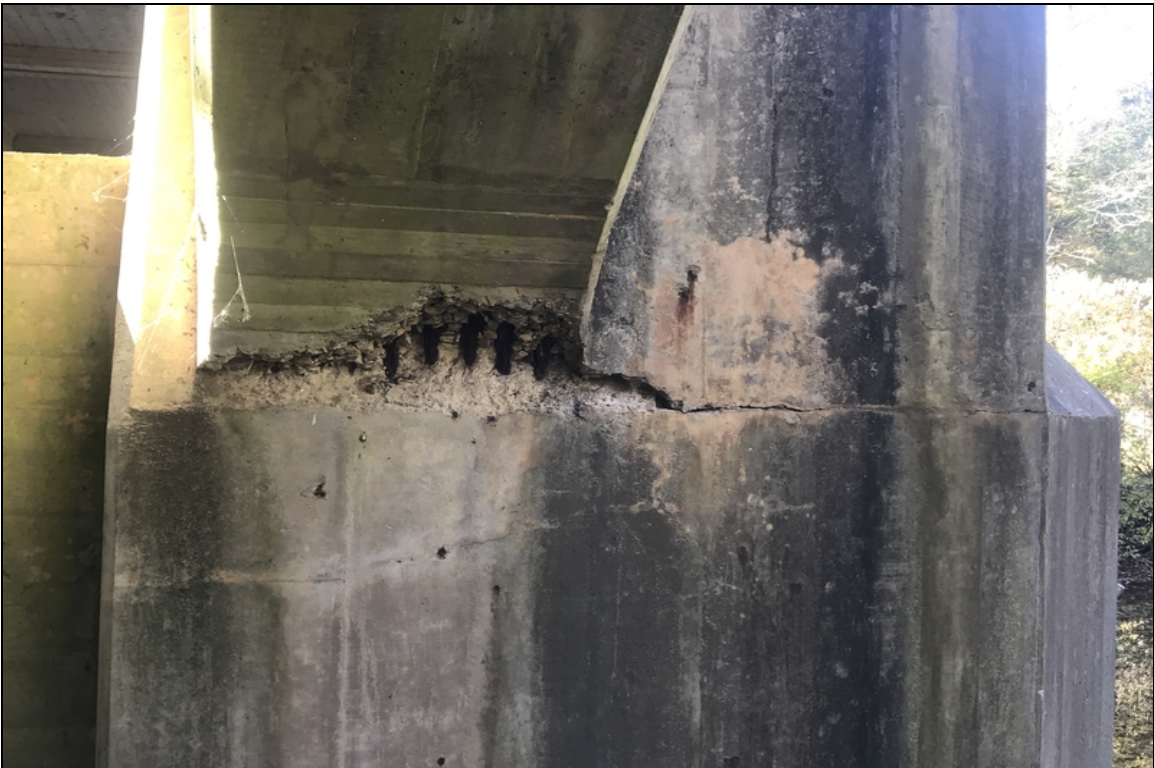
Span 2 bottom of left arch rib has spall with exposed rebar.

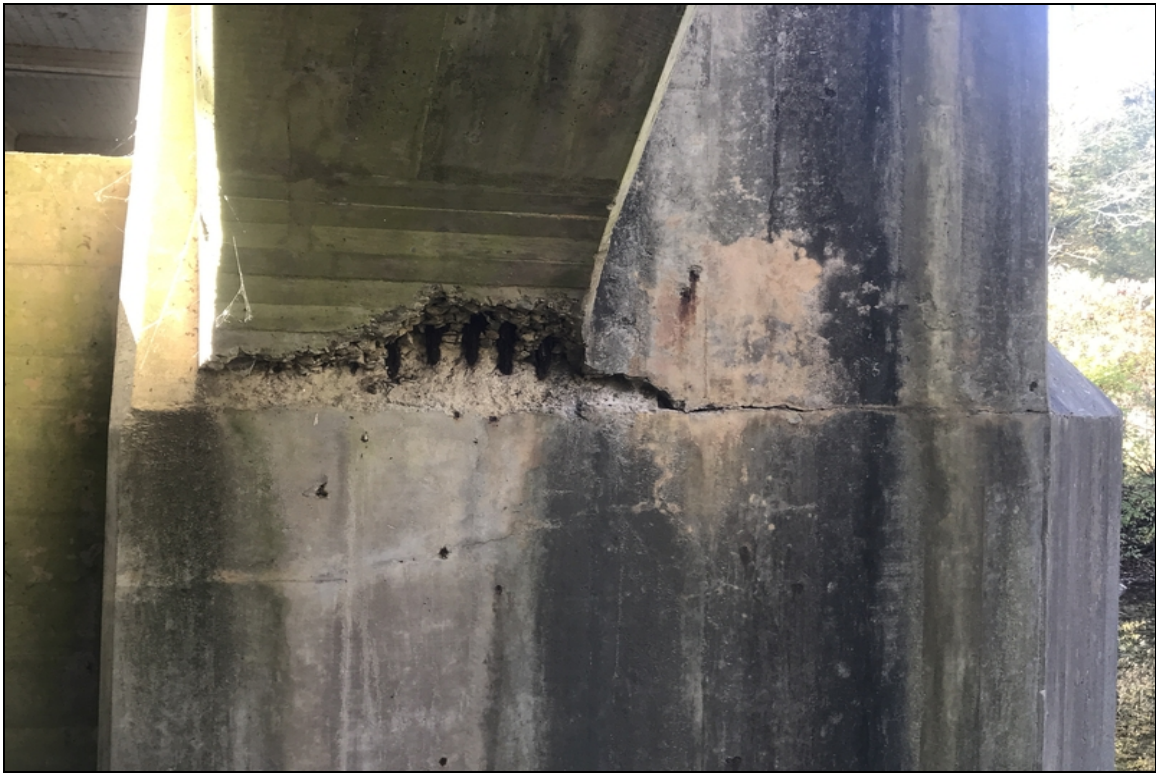
Span 2 bottom of left arch rib has spall with exposed rebar.

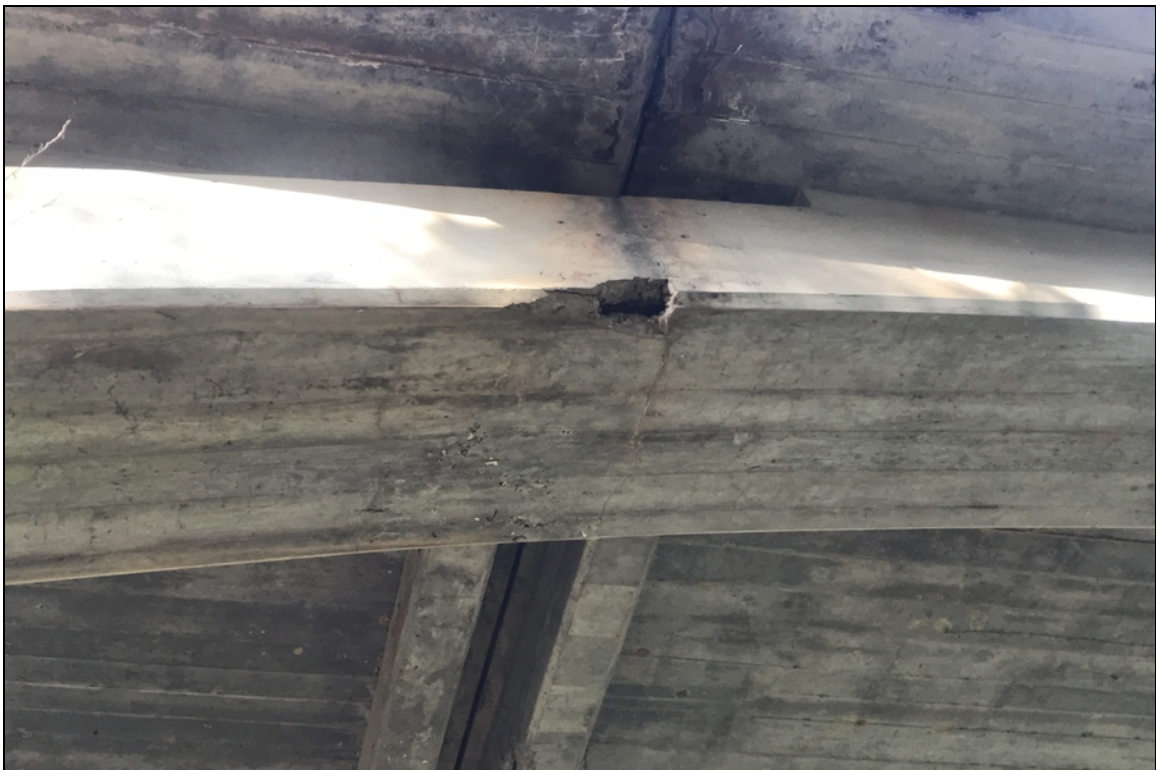
Span 2 right arch rib has spall with exposed rebar near mid span.

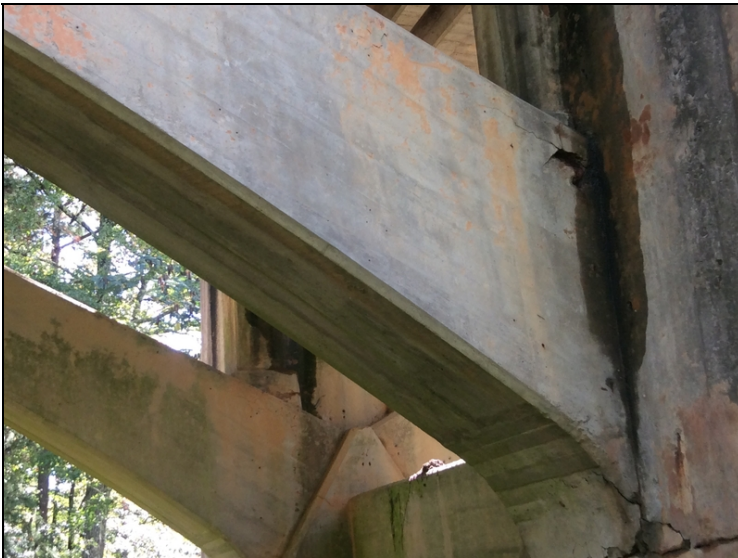
Arches, both spans.
Cracks with rust staining on both arches and both spans, just below deck joints.

Span 2 left arch spall with exposed rebar

Date Reported: 10/04/2010
Priority: D- Routine
Type of Work: Repair
Status: Monitor
Component: Superstructure

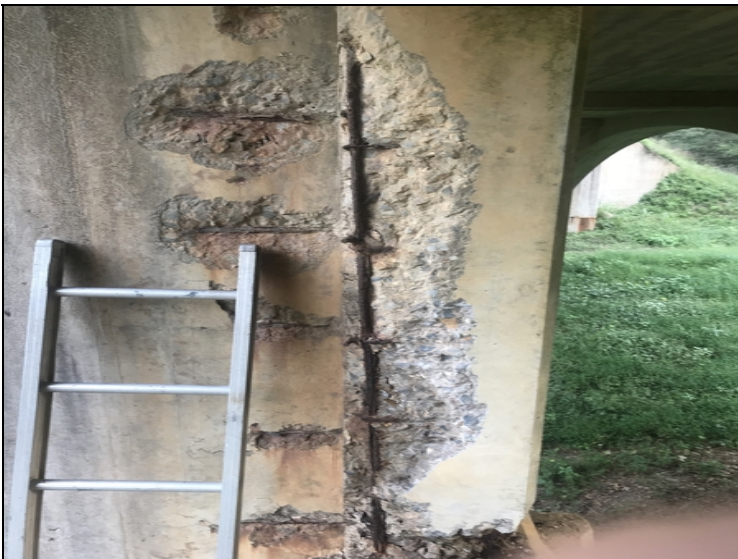
Bent 1 And 2 have spalls with exposed rebar. Added - 10/2/2018 - Spalls with exposed reinforcing steel in the spandrel column at bent 2 both sides and spall at the top of spandrel column at bent 2 right side under bearing. Span 2 arch rib 1 spandrel column 3 spall with reinforcing steel exposed. Changed priority from C to B.

Bent 2 spandrel column left side, spall with exposed reinforcing steel with section loss.

Date Reported: 09/29/2011
Priority: B - Pressing; 6 month completion goal
Type of Work: Repair
Status: Assigned
Component: Superstructure

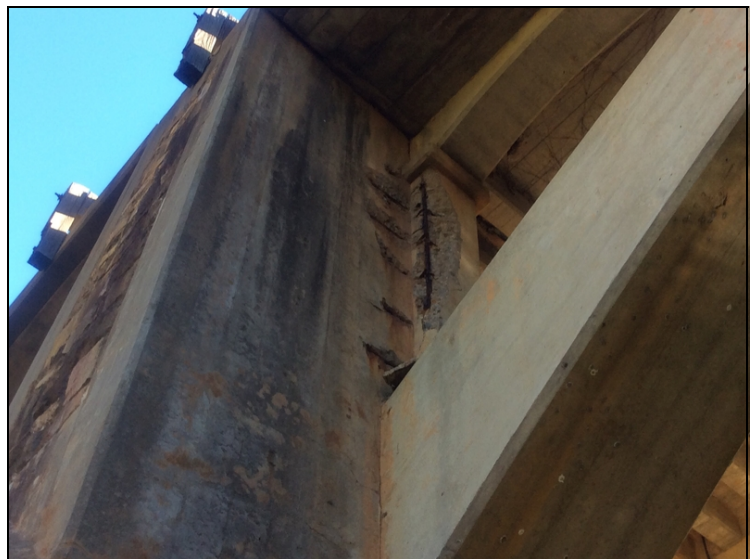
Exposed rebar

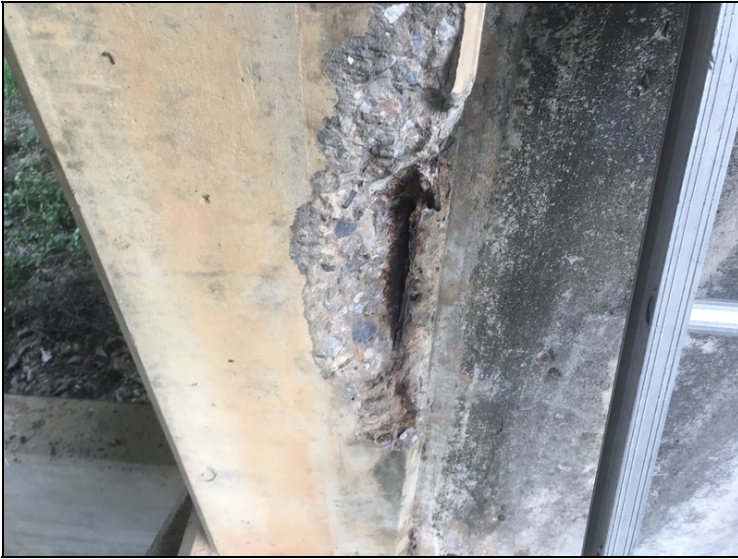
Bent 2 right spandrel column spall with exposed reinforcing steel and section loss.

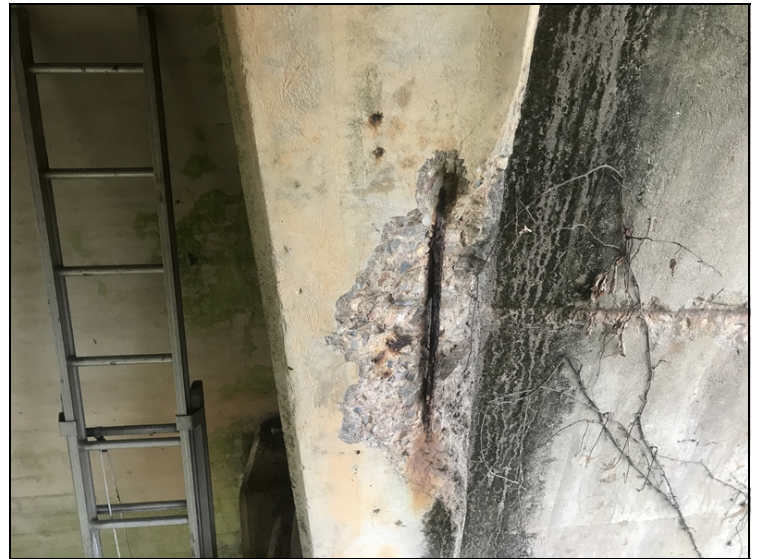
Bent 1 left column exposed reinforcing steel with section loss.

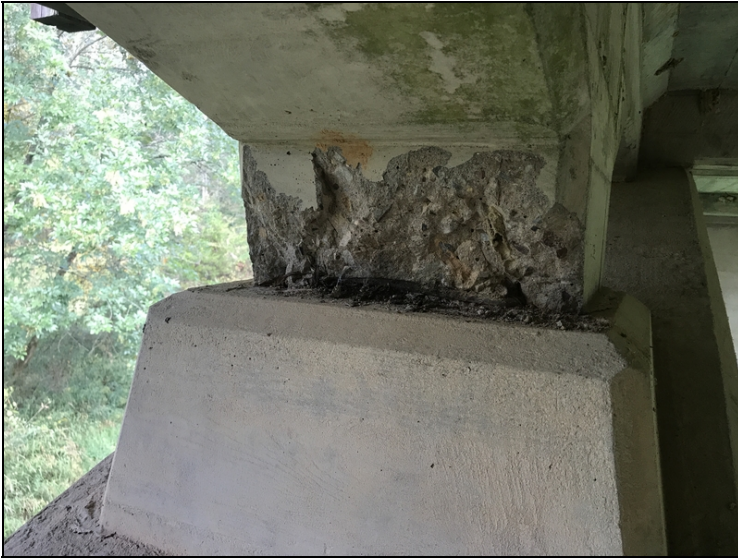
Span 2 spandrel column 2 on rib 1, spall with exposed reinforcing steel.

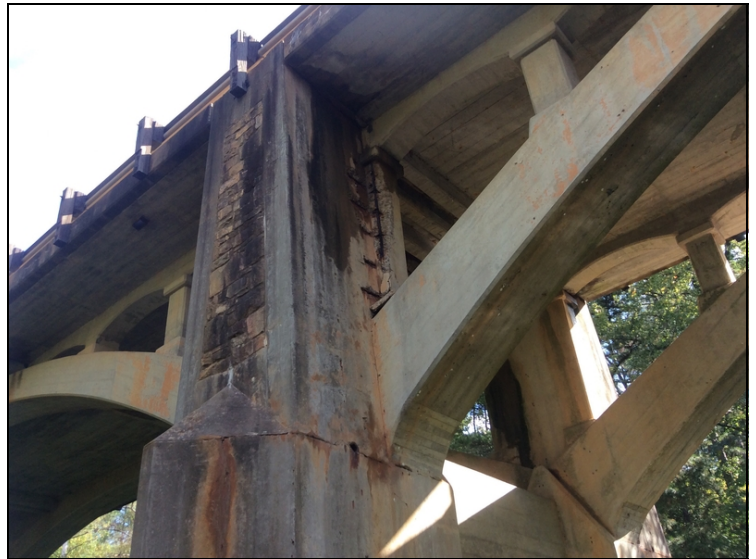
Bent 2 exposed rebar.

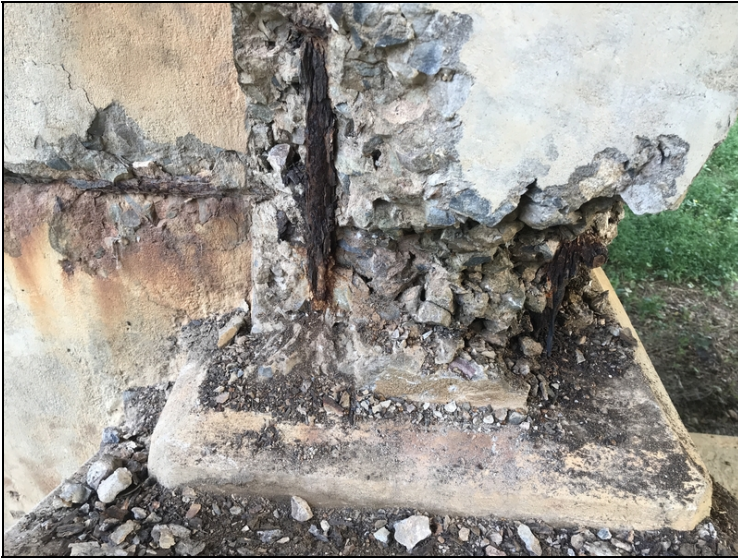
Bent 2 spandrel column left side, spall with exposed reinforcing steel with section loss.

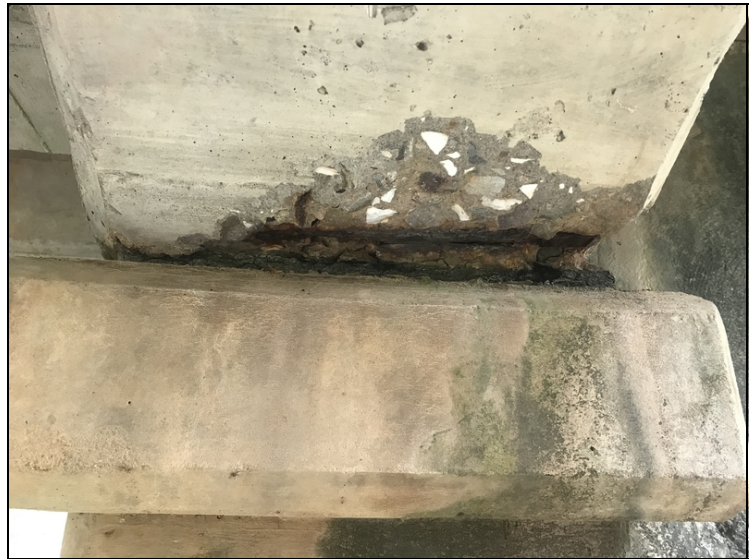
Bent 2 right side spall at bearing area with exposed reinforcing steel.

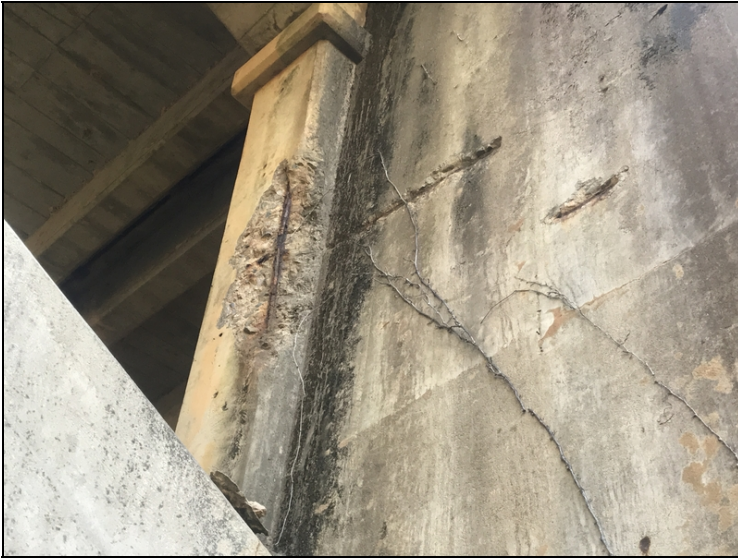
Bent 1 left arch spandrel column 1 has spall with exposed rebar.

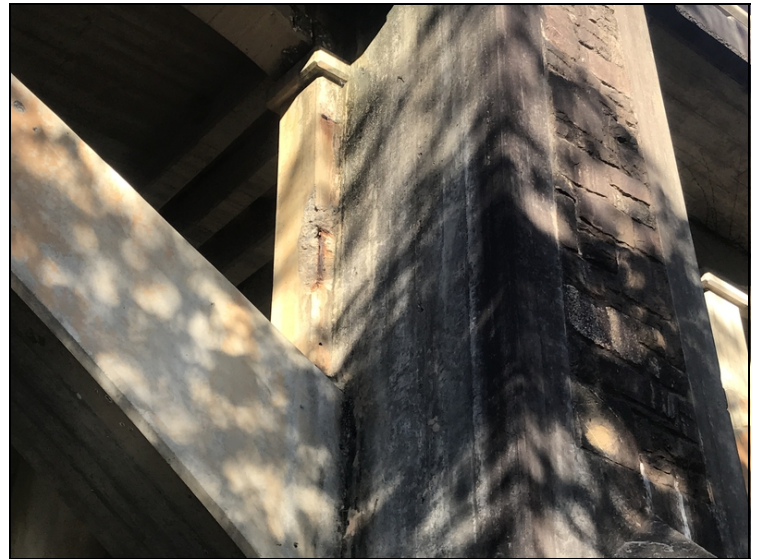
Span 1 right side at bent 2 spandrel column has spall with exposed rebar.

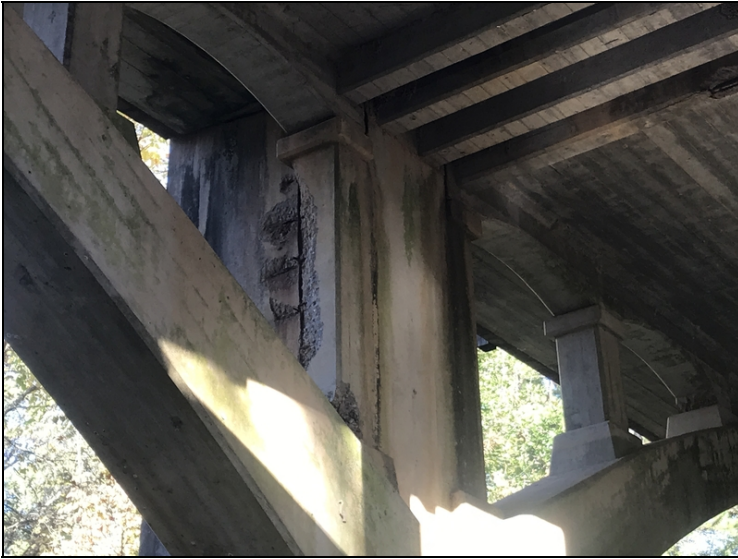
Span 1 Spandrel column left side at bent 2 has
spalls with exposed rebar.
