Bridge #01782(Routine)
SH 7-10 Log 16.70 over MIDDLE FORK SALINE RIVER

Team Lead: Shane Byrd Inspection Date: October 21, 2020

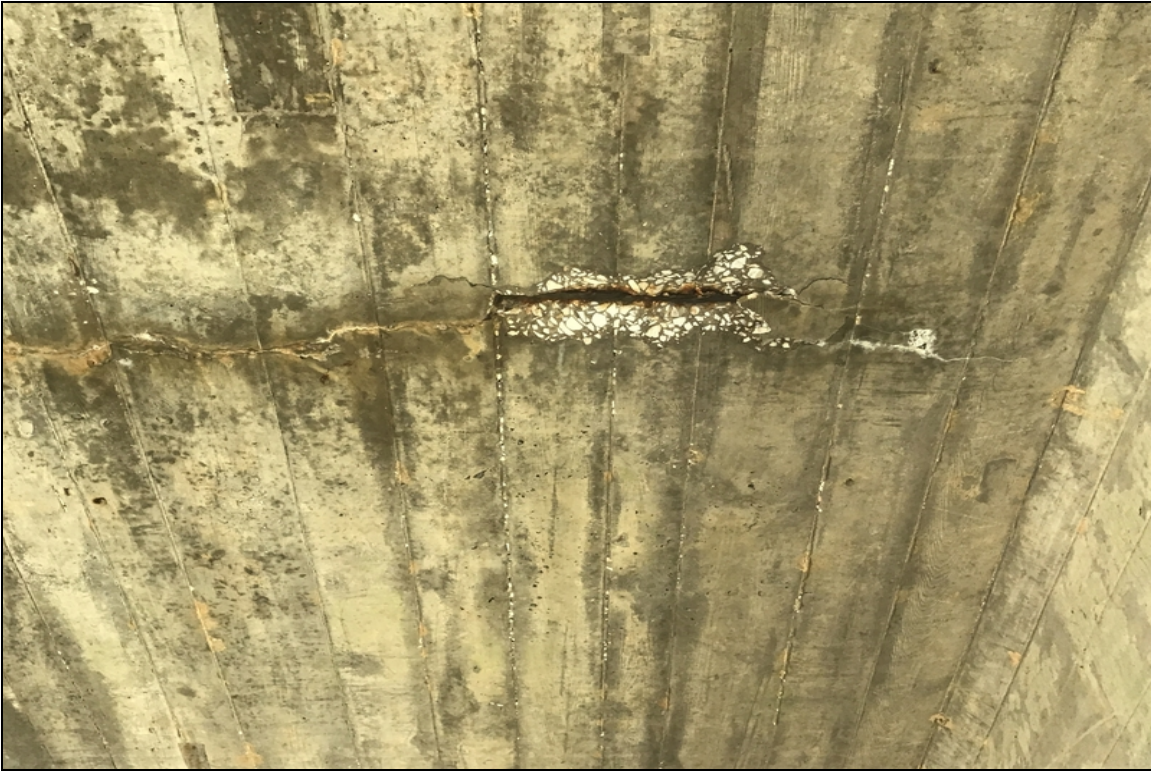
Span 3 soffit has spall with exposed rebar.

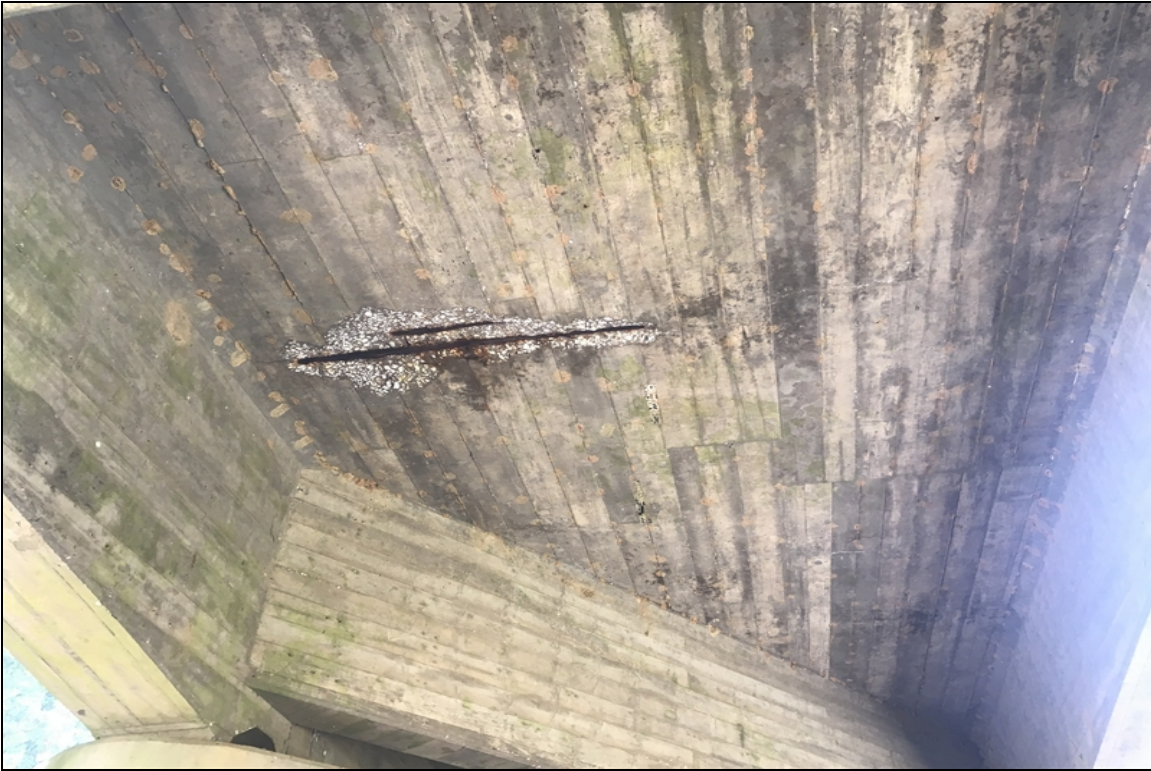
Span 2 soffit has spall with exposed rebar.

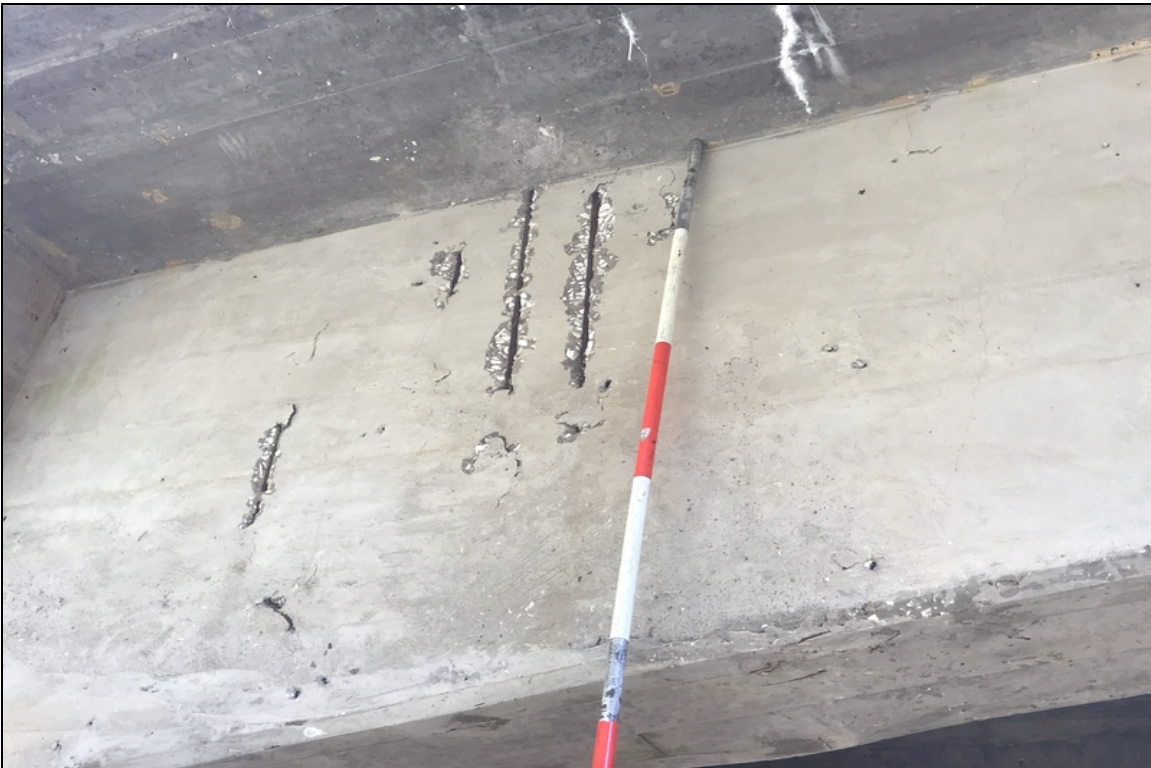
Span 2 girder 1 at bent 3 left side has spalls with exposed rebar.

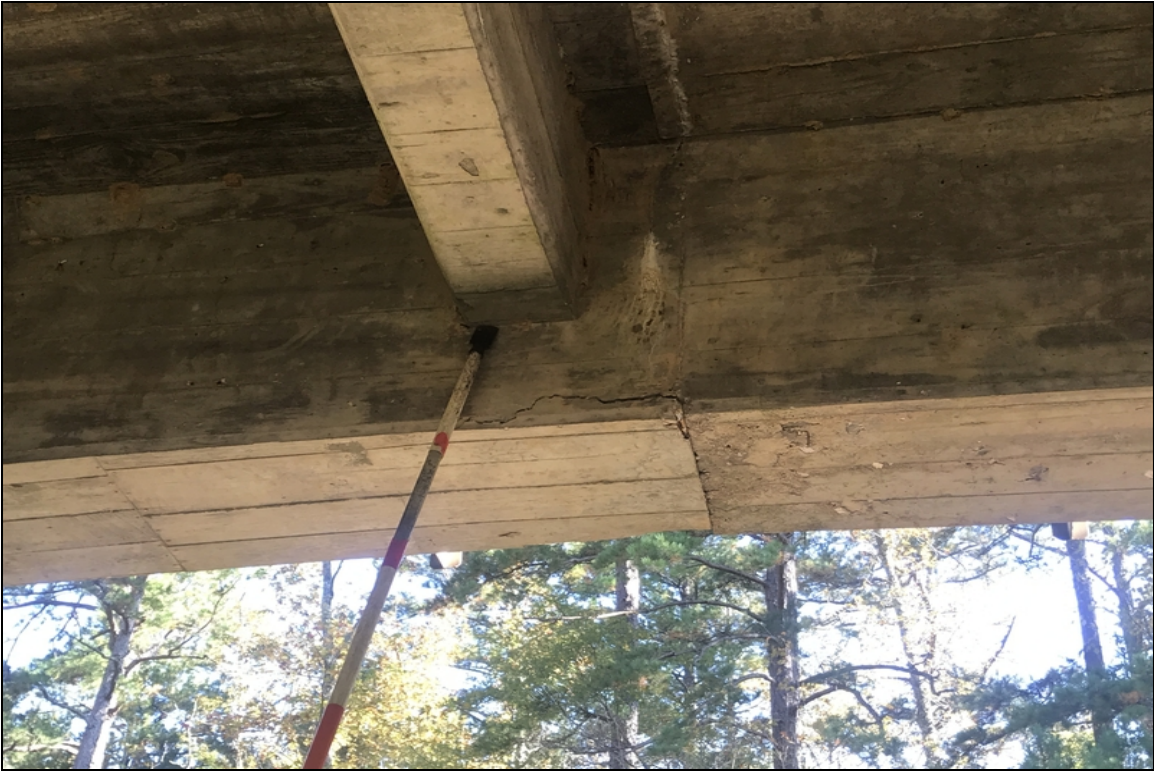
Span 2 girder 2 has delam at mid span.

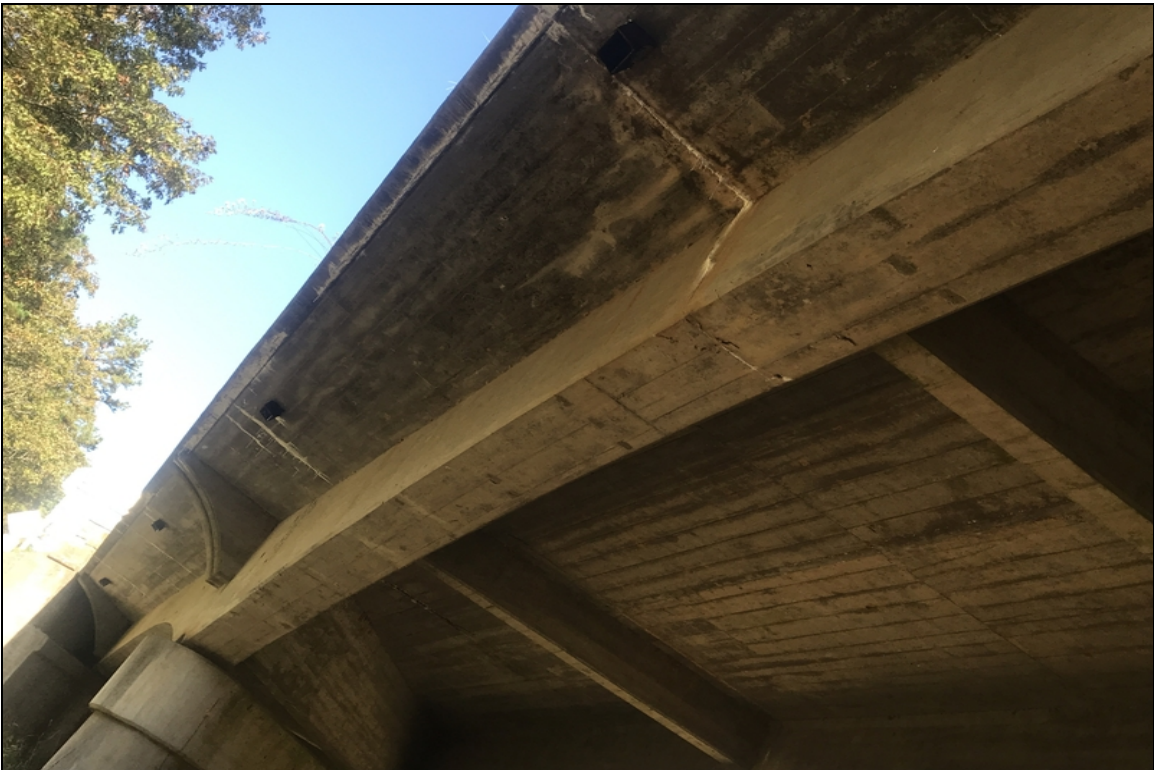
Span 2 left side soffit overhang has cracks with efflorescence.

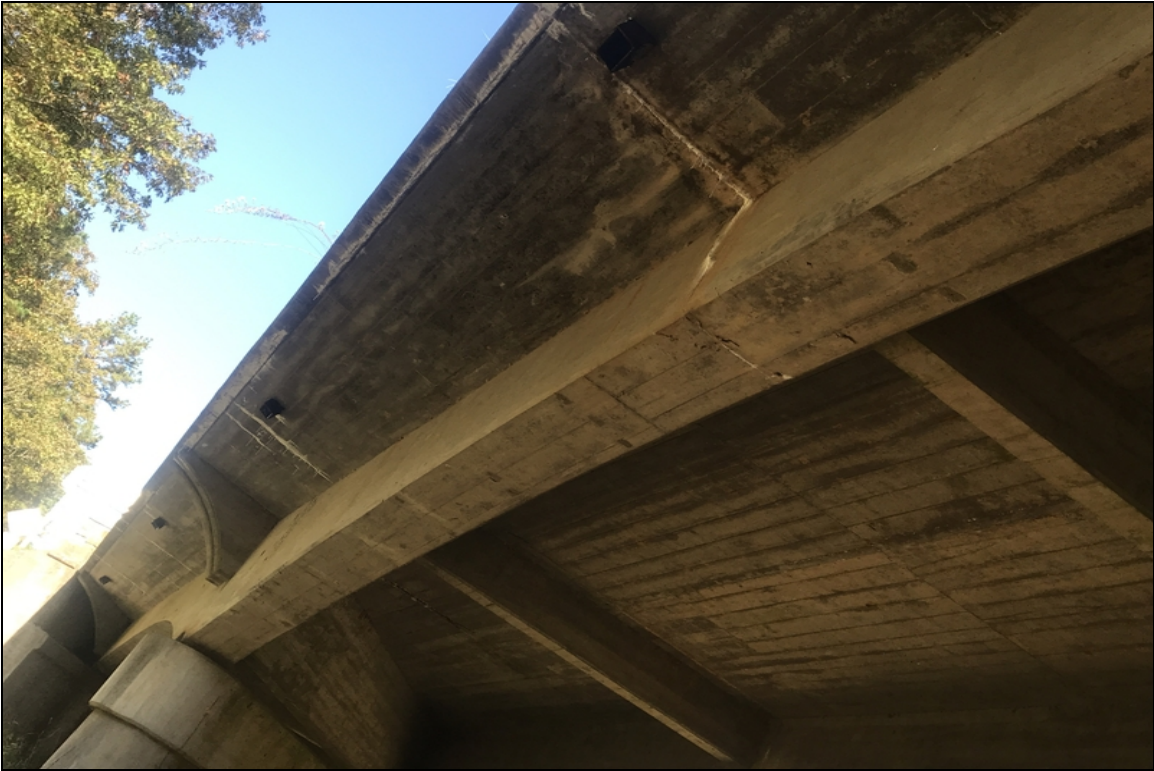
Span 2 left side soffit overhang has cracks with efflorescence.

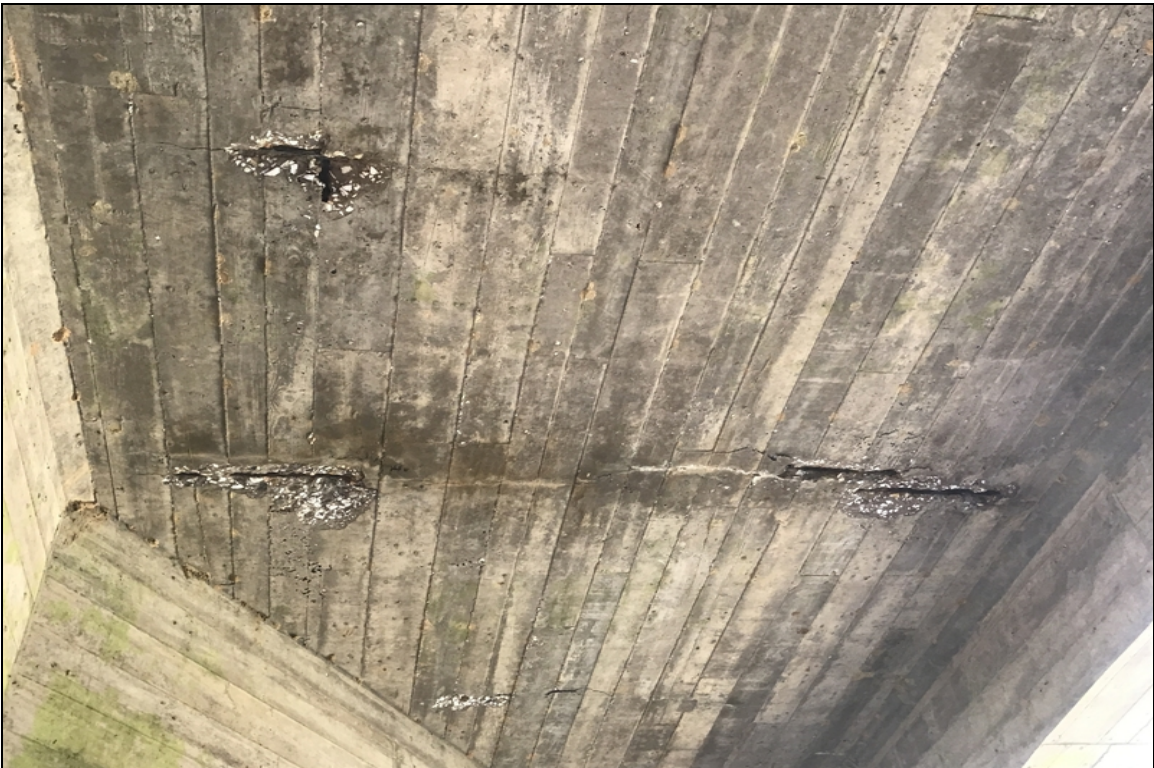
Span 1 soffit has spalls with exposed rebar.

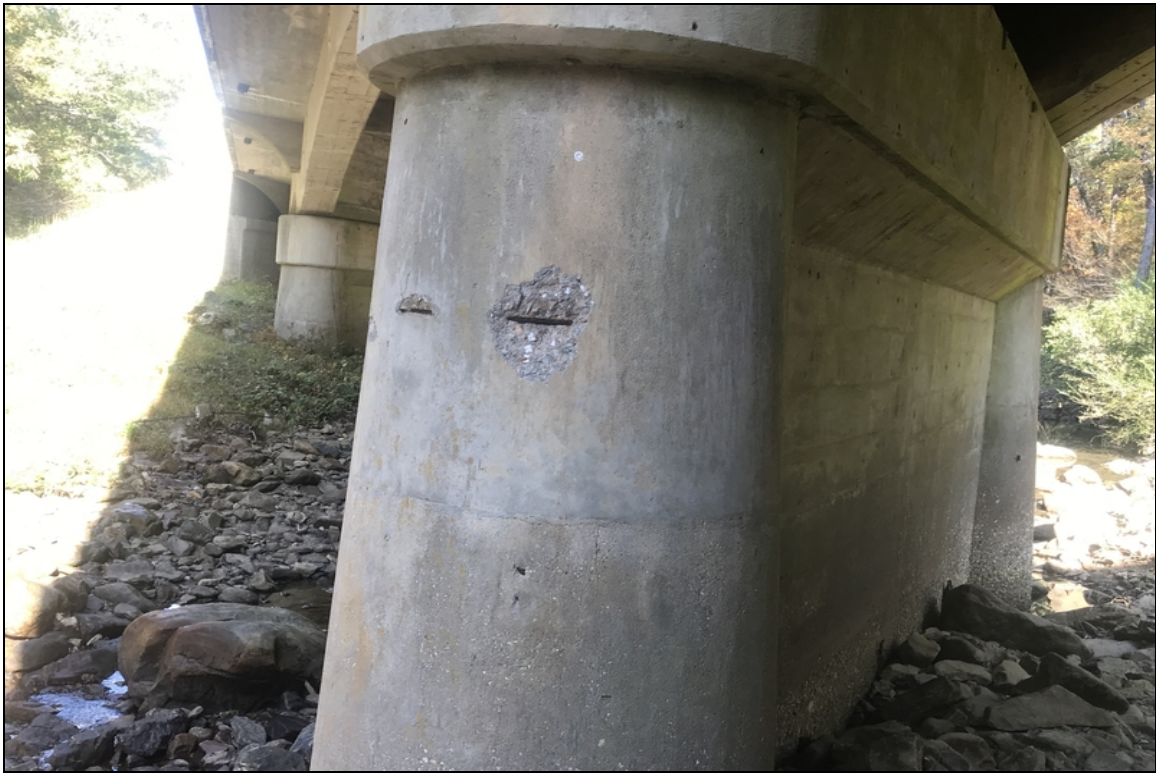
(205)							
Bent 2, columns 1 and 2 have abrasion. Column 1 has spalls with exposed rebar and delam.							
210	Reinforced Concrete Pier Wall	LF	36	13	22	1	0
1080	Delamination/Spall/Patched Area	LF	0	0	0	0	0
1090	Exposed Rebar	LF	2	0	1	1	0
1130	Cracking (RC and Other)	LF	3	0	3	0	0
1190	Abrasion/Wear (PSC/RC)	LF	18	0	18	0	0

Bent 2 column 1 has spall with exposed rebar.

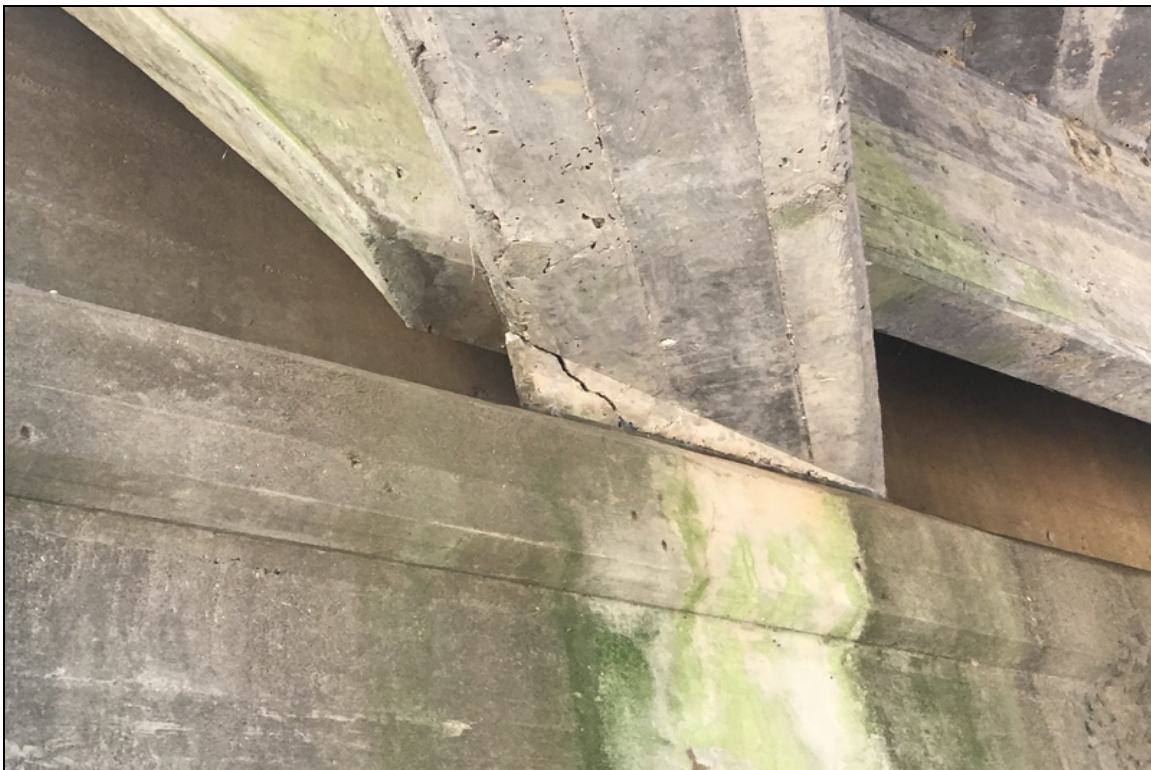
(110)							
Both girders have spalls, spalls with rebar, cracks and cracks with efflorescence. Bent 1 girder 2 has a spall in the bearing area.							
155	Reinforced Concrete Floor Beam	LF	48	48	0	0	0

Girder 2 at bent 1 has delam above bearing

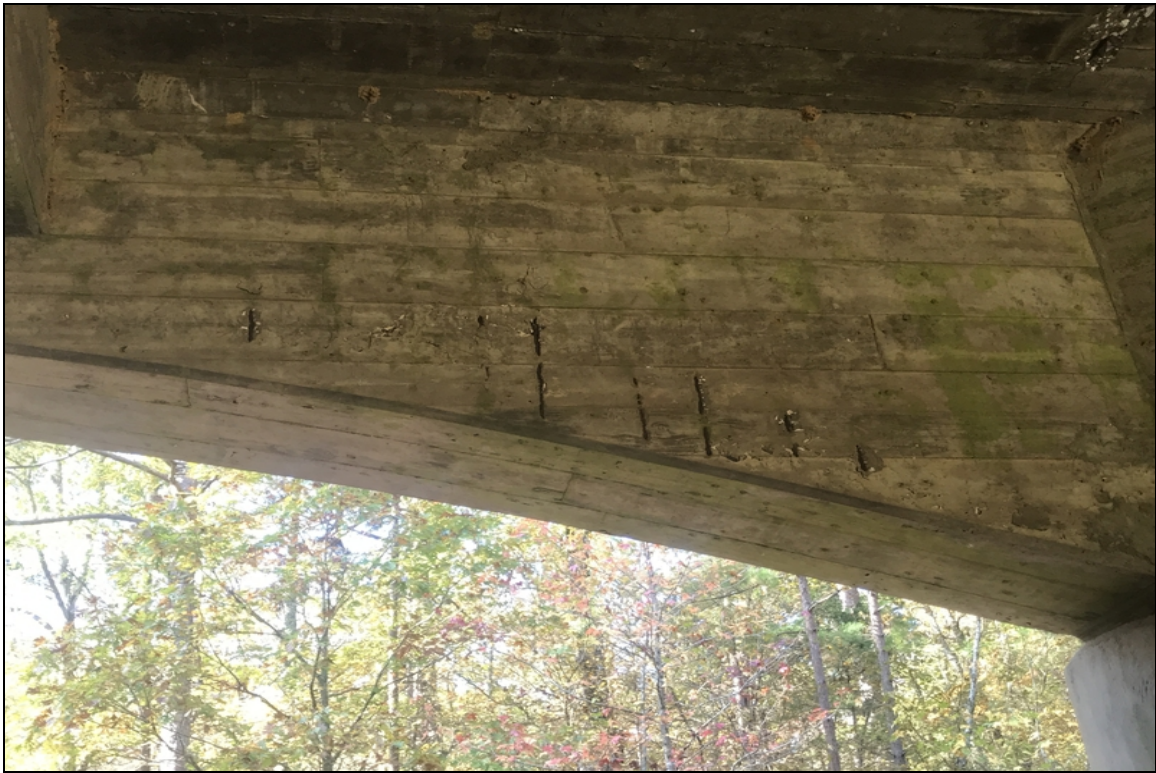
Span 1 girder 1 right side has spalls with exposed rebar.

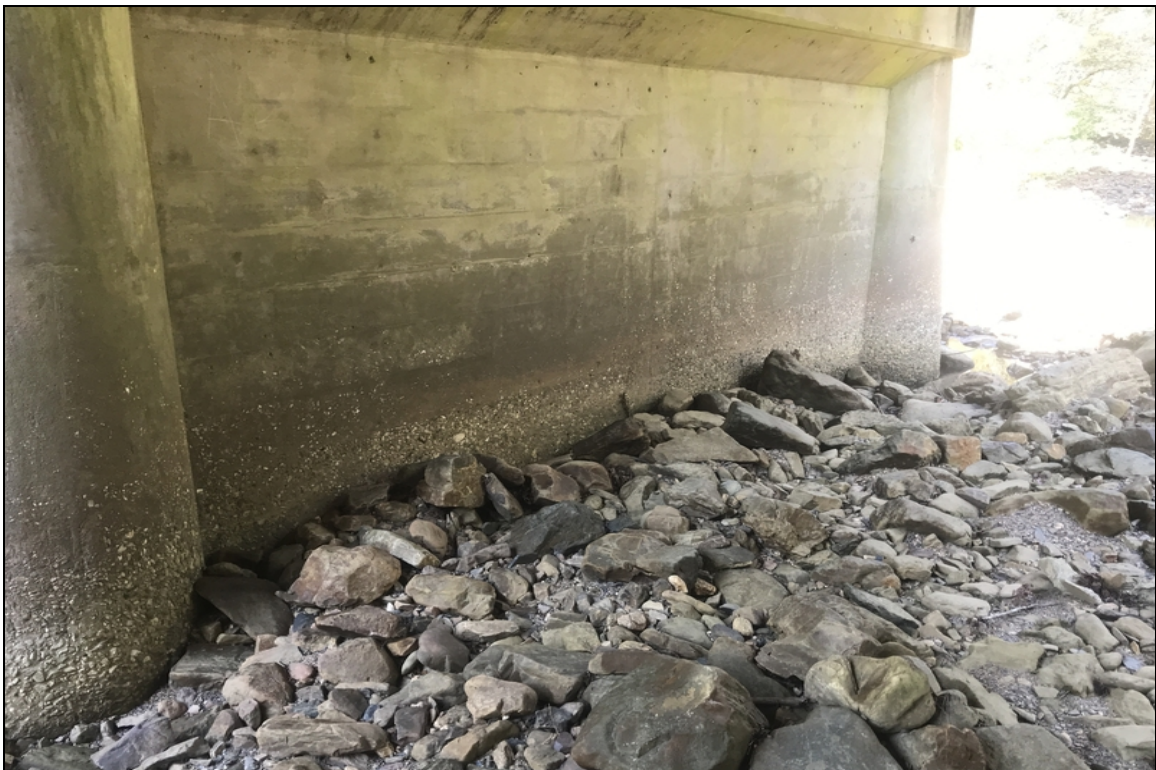
Bent 2 pier wall has abrasion at ground level.

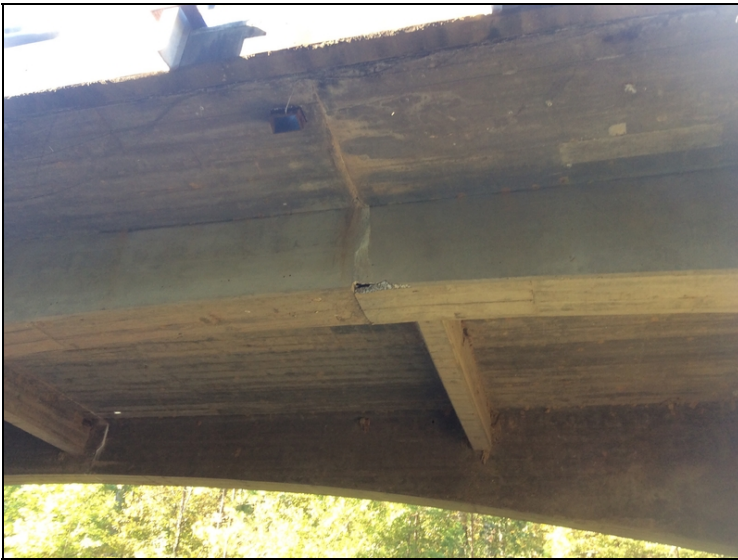
Both girders in all spans have cracks with rust, efflorescence staining and exposed rebar.

Span 2, girder 2. Exposed rebar at mid span.

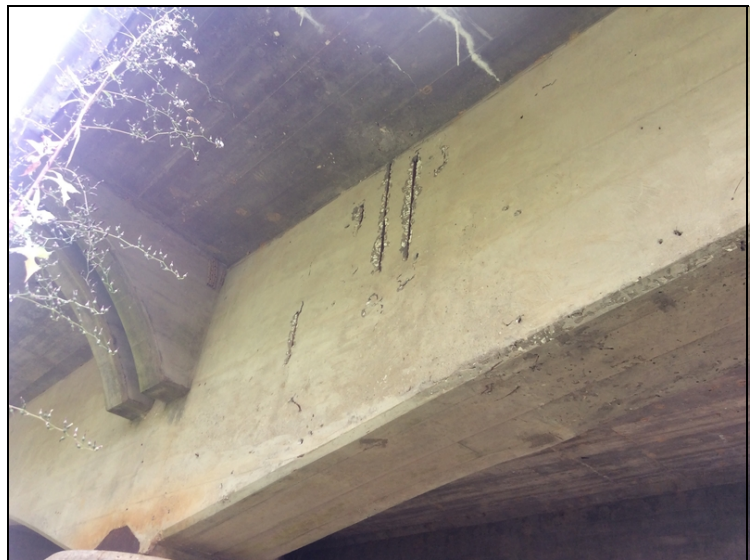
Span 2 Girder 1 left side spalls with exposed rebar.

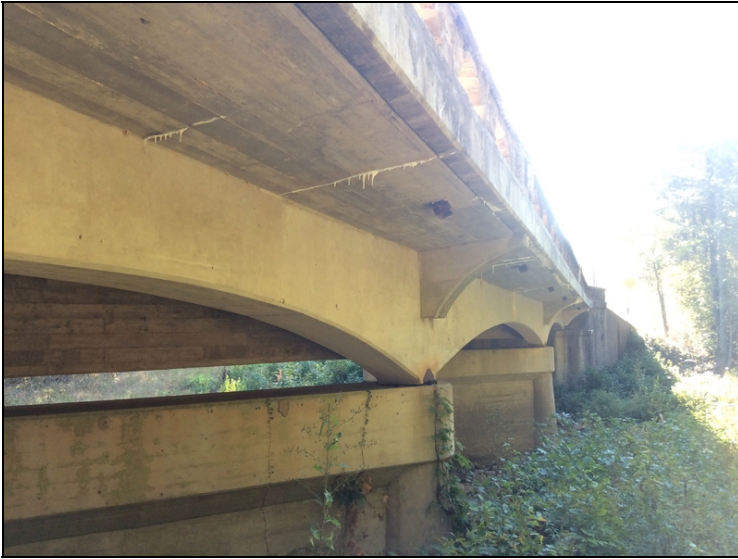
Left side looking back. Efflorescence on all three spans.

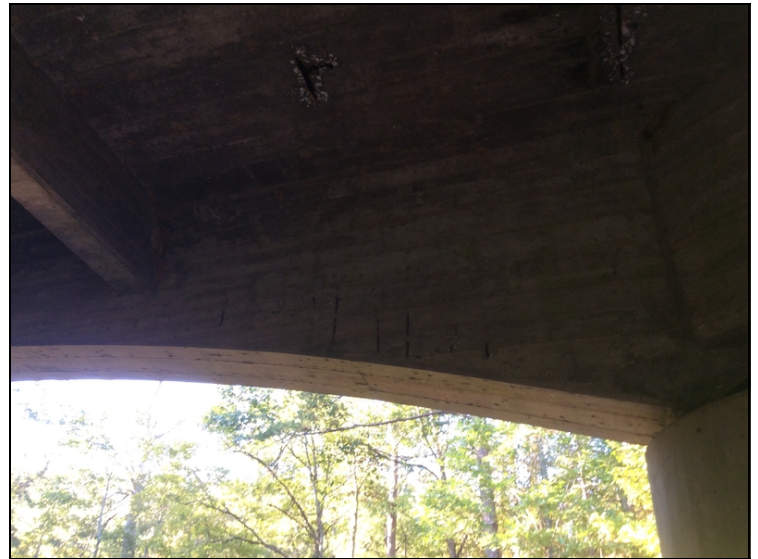
Span 1, girder 1, inside face. Spalls with exposed rebar.

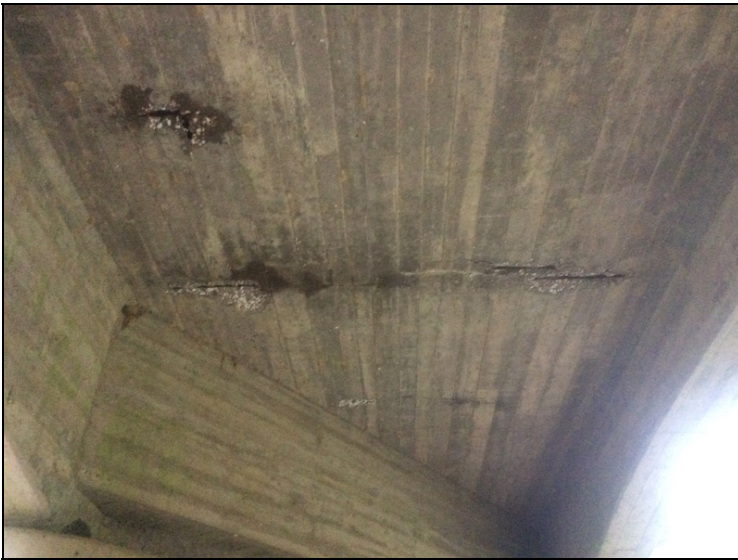
All spans have large spalls and exposed reinforcing steel with section loss in the soffit.

Span 1, spalls with exposed rebar.

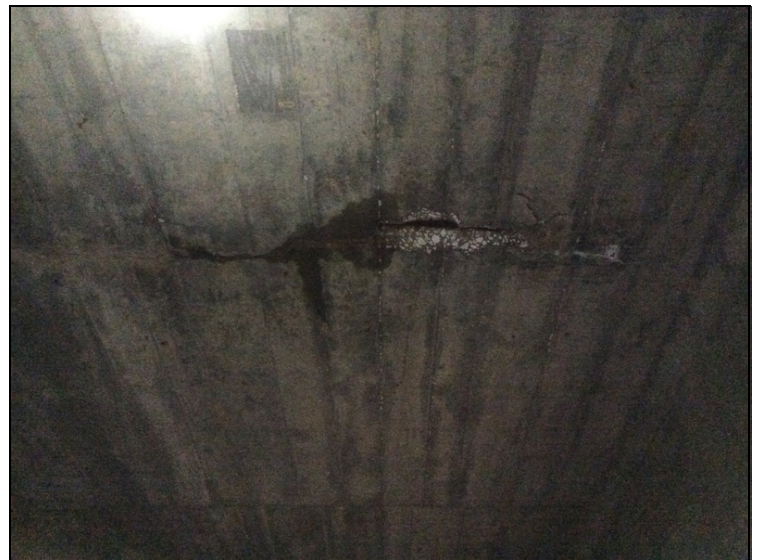
Span 3, spall with exposed rebar in the soffit.

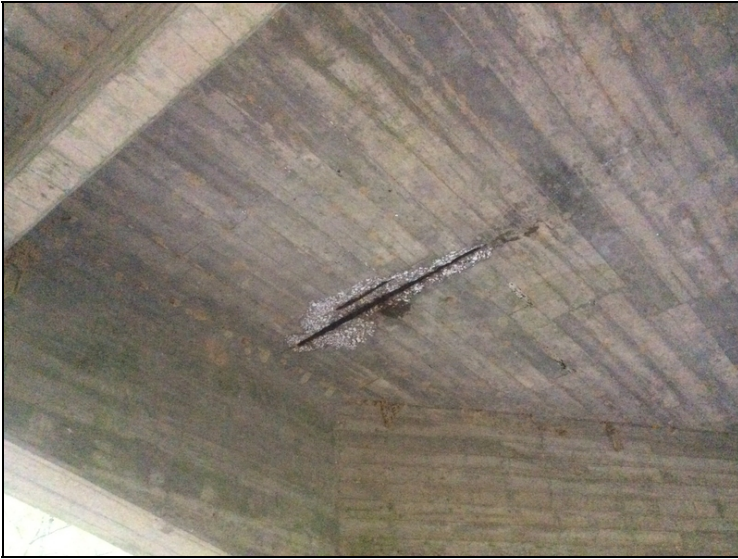
Span 2, large spall with exposed rebar.

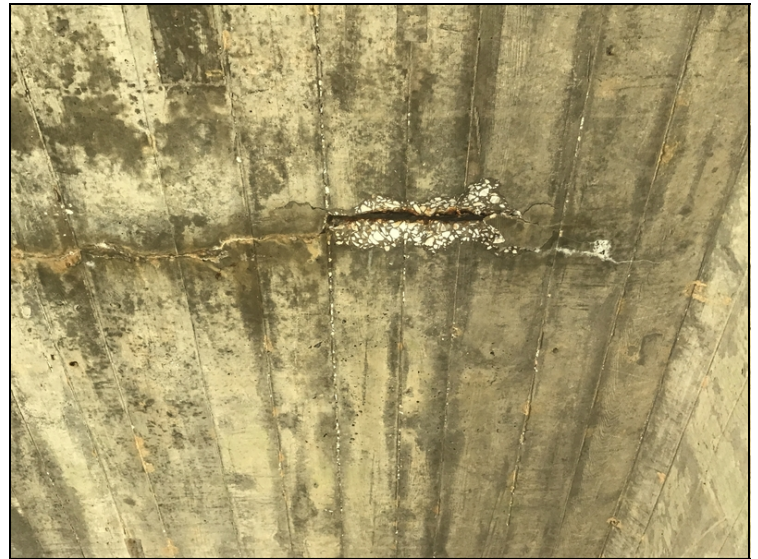
Span 3 soffit has spall with exposed rebar.

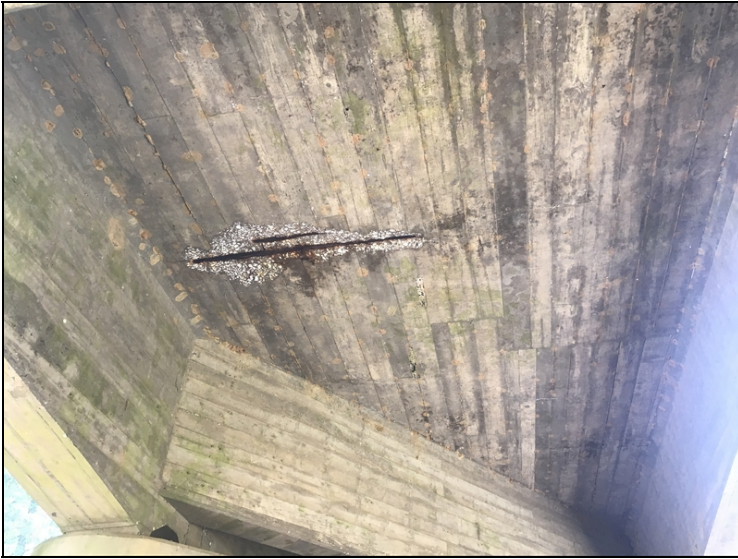
Span 2 soffit has spall with exposed rebar.

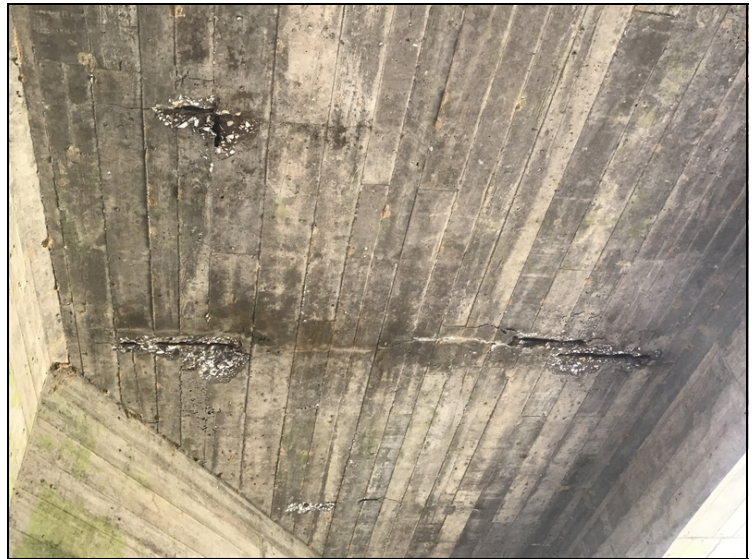
Span 1 soffit has spalls with exposed rebar.

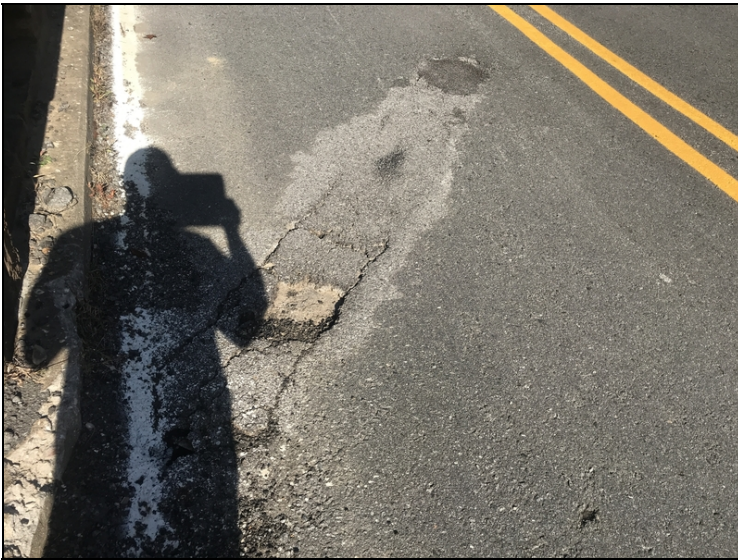
Pothole in asphalt approach at joints of both ends of bridge.

Pothole at joint at bent 1. Common bent 4.
