Bridge #05863(Routine)
US 270 -7 Log 0.55 over TIGRE CREEK
Location: .55 E OF GARLAND CO LN

Team Lead: Bryan Saunders **Inspection Date:** December 09, 2019

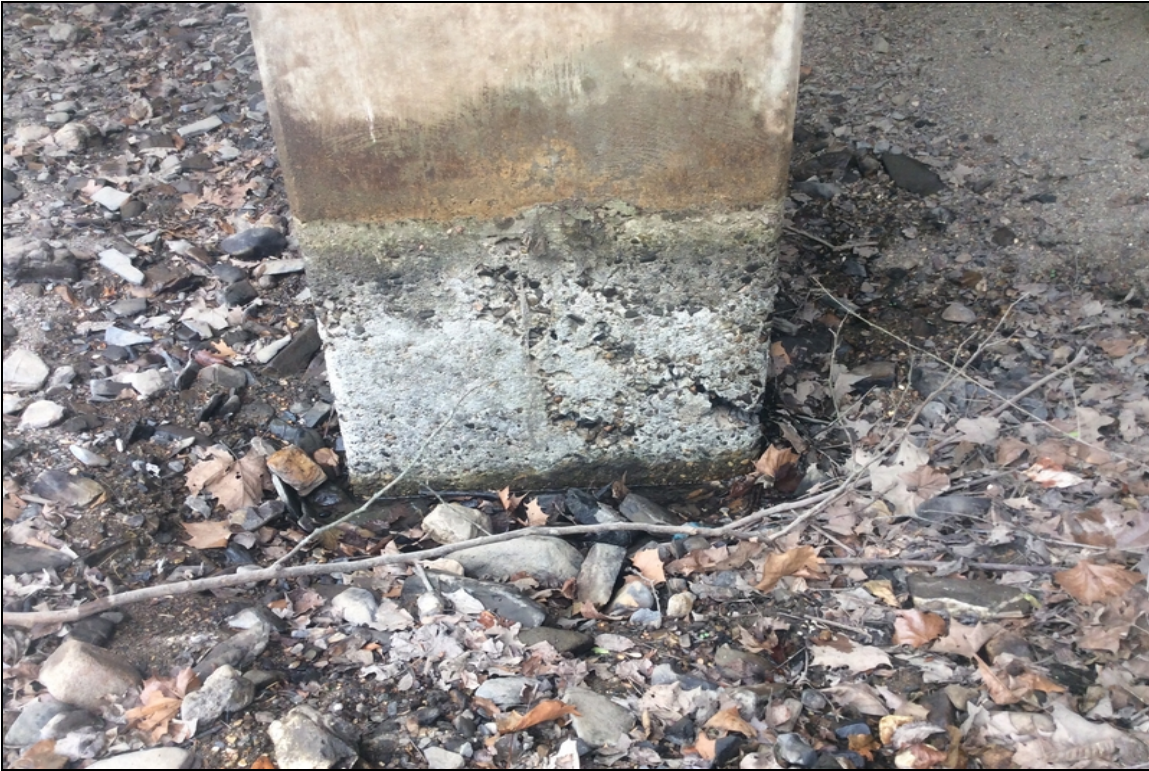
(205)	All eight columns has some abrasion at the bottom due to wave action from the lake. Bt. 2 column 1 has severe abrasion. Bt. 3 column 1 has severe abrasion & exposed rebar.						
215	Reinforced Concrete Abutment	LF	188	169	19	0	0
1120	Efflorescence/Rust Staining	LF	19	0	19	0	0

Bent 3 column 1, severe abrasion.

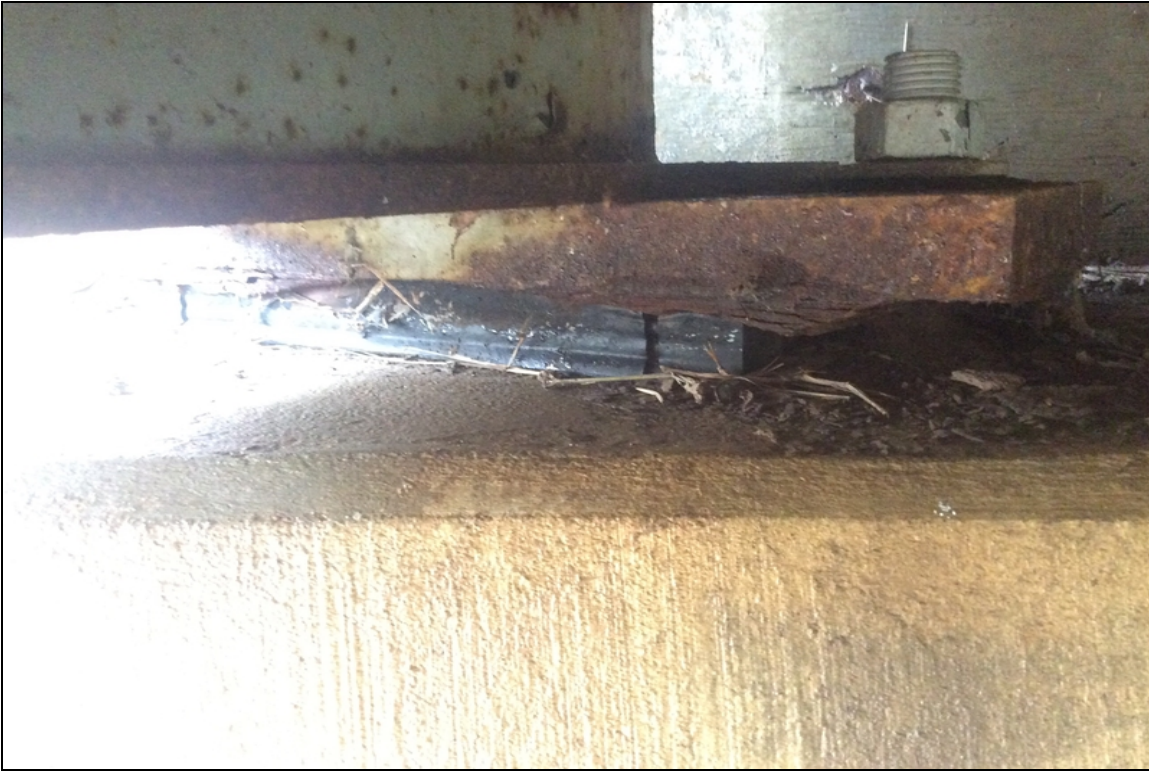
Bent 1 bearing 10, severe corrosion to sole plate.

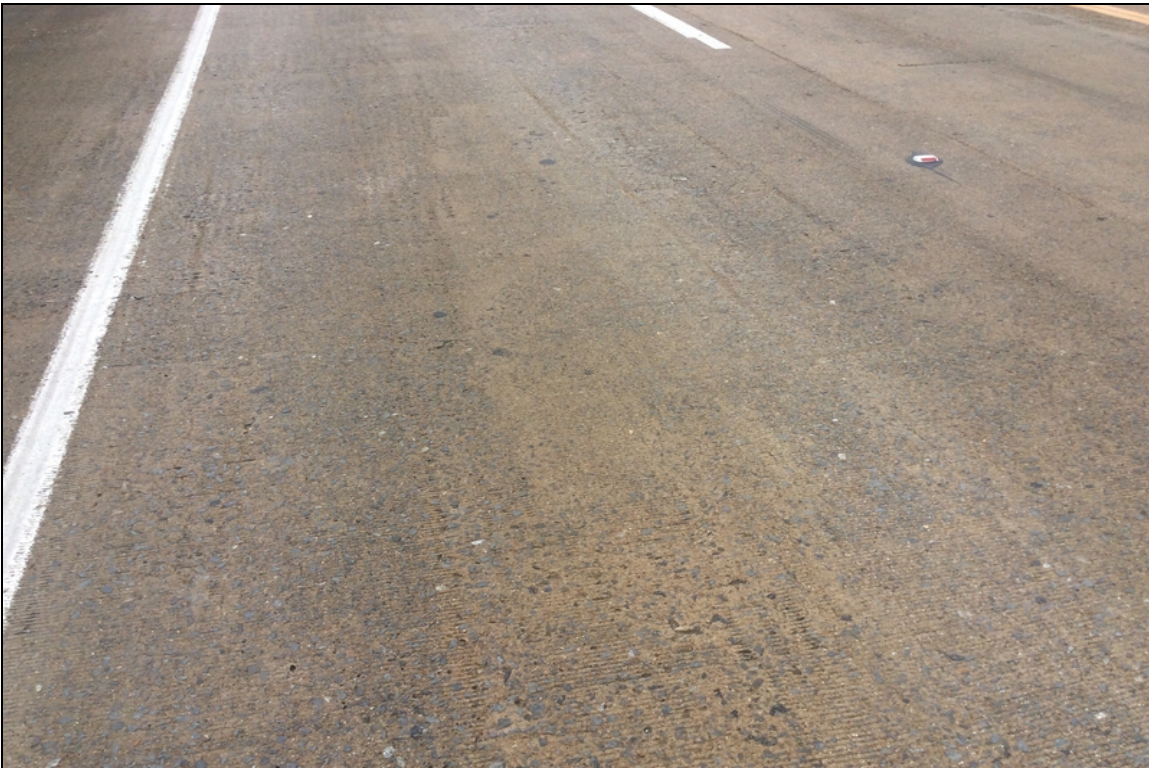
(12)	Longitudinal and transverse cracks in all spans. Soffit of deck between beams 5 and 6 have transverse cracks with efflorescence. Scattered areas of abrasion in span 3.						
107	Steel Open Girder/Beam	LF	1800	1673	120	7	0
1000	Corrosion	LF	127	0	120	7	0
515	Steel Protective Coating	SF	13200	7300	3650	2178	72
3440	Effectiveness (Steel Protective Coatings)	SF	5900	0	3650	2178	72

Span 3, abrasion

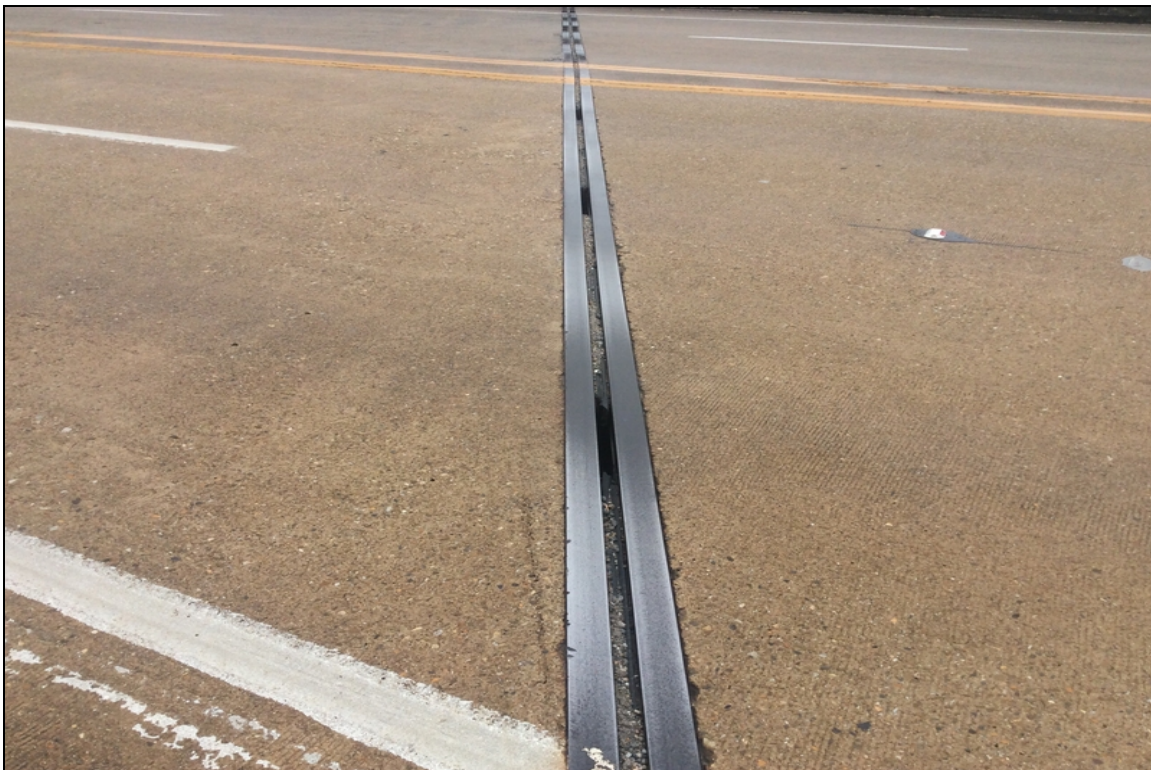
ELEM	DESCRIPTION	UNITS	TOTAL	CS1	CS2	CS3	CS4
2310	Leakage	LF	284	0	278	0	6
2360	Adjacent Deck or Header	LF	30	0	30	0	0
(302)	All of the joints leak. Sections of the seal are missing at bent 3. Some small spalls are present in the deck along the joint armor.						
310	Elastomeric Bearing	EA	60	0	58	2	0
1000	Corrosion	EA	60	0	58	2	0
(310)	Sole plates & anchor bolts of all bearing have active corrosion.						
331	Reinforced Concrete Bridge Railing	LF	360	360	0	0	0

Bent 3, joint is missing in three areas of the westbound lanes.

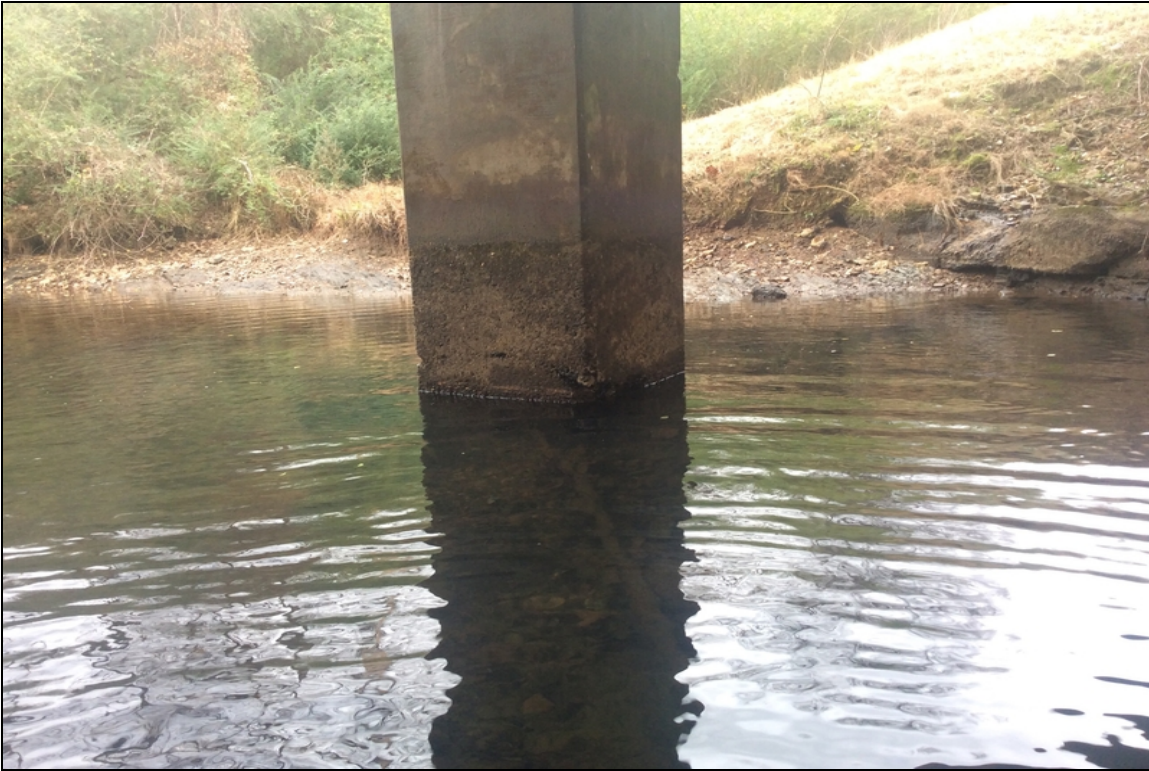
Bent 3 column 1, severe abrasion.

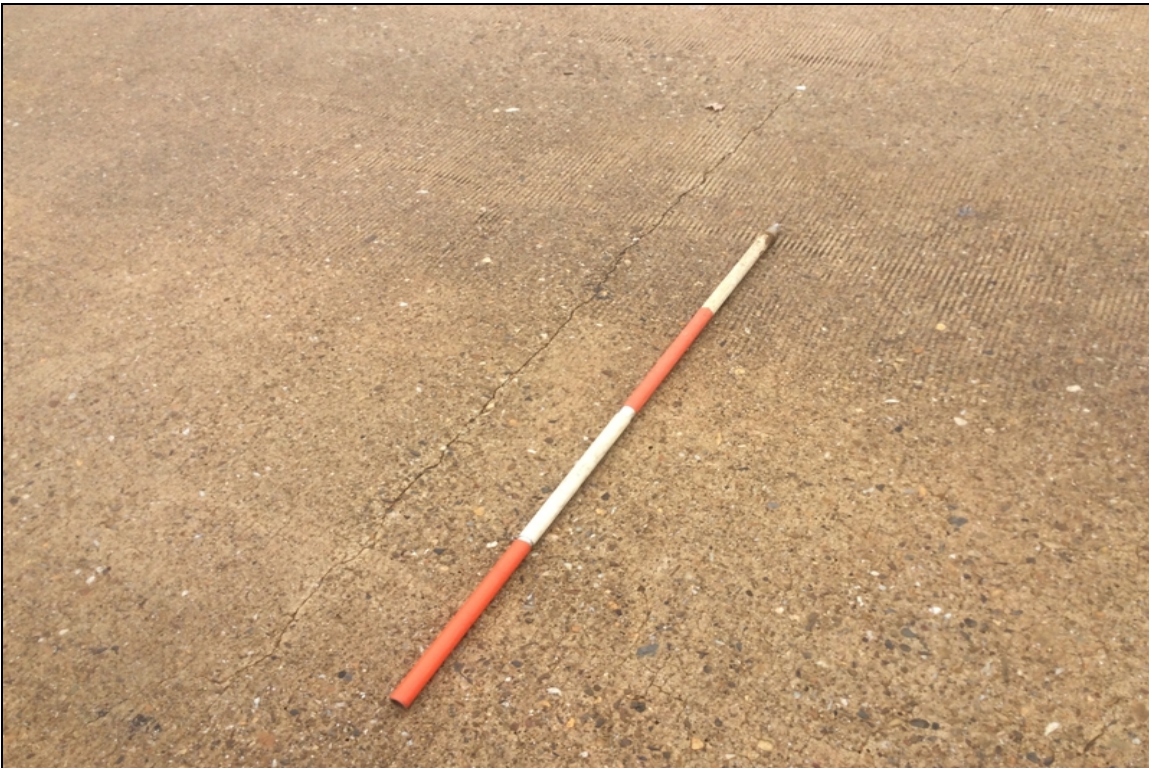
Large transverse crack in Span 3.

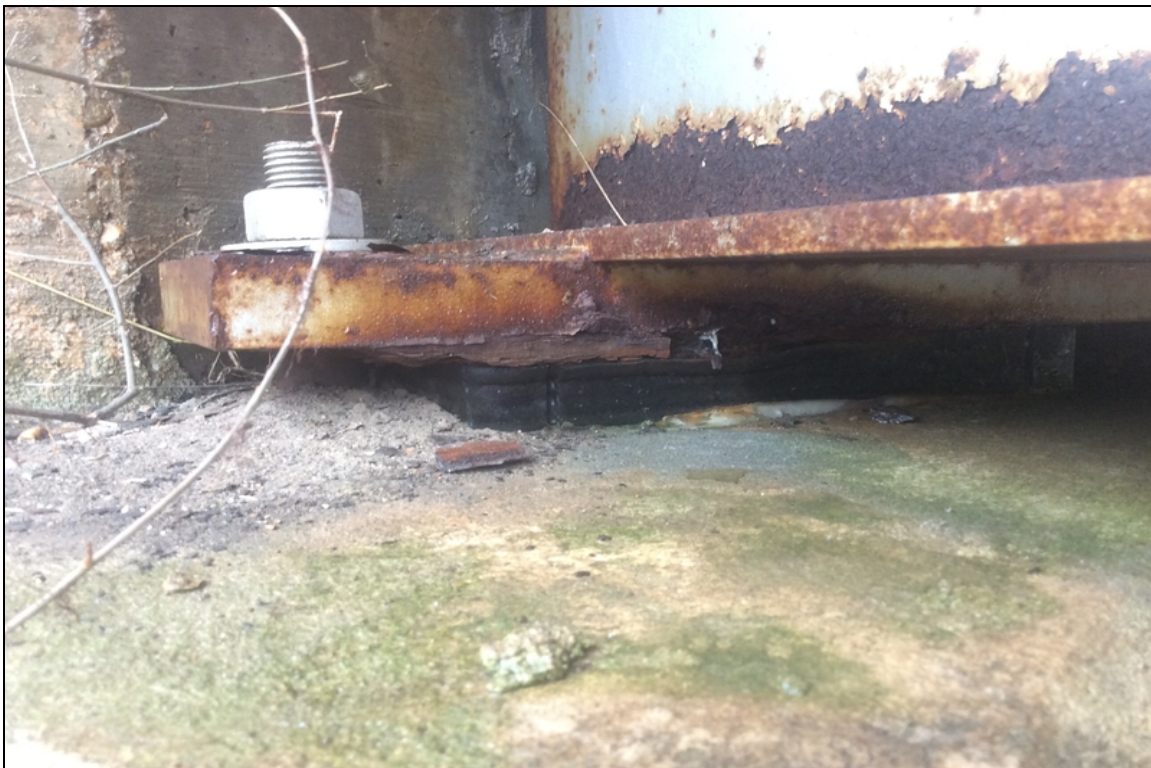
Bent 4 bearing 1, severe corrosion on the sole plate.

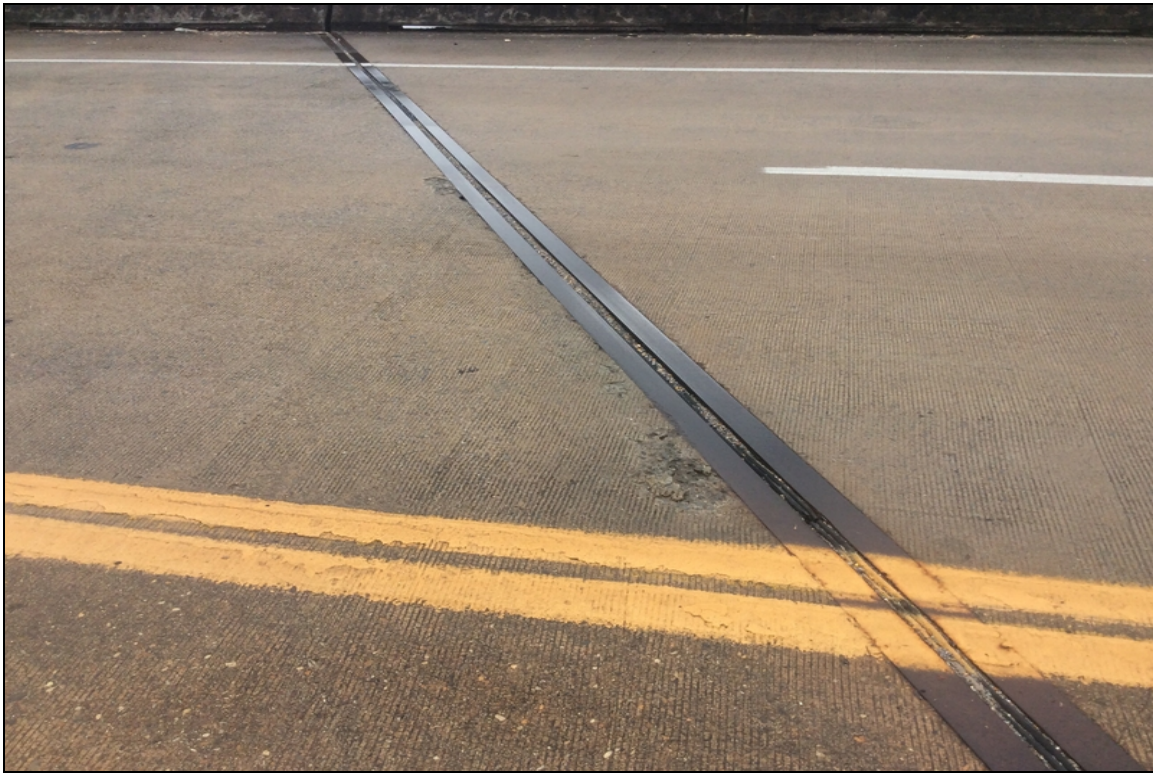
Large spalls in span 3 near bent 3 joint eastbound lanes.

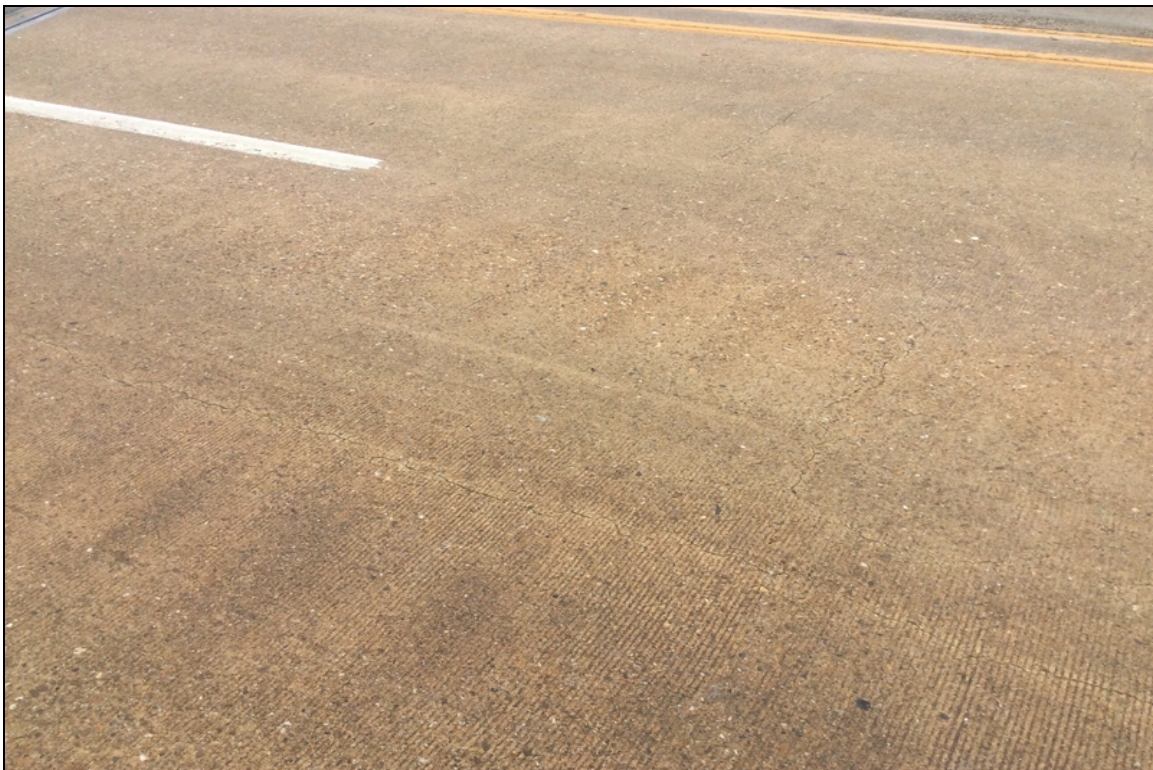
Large cracks in span 3.

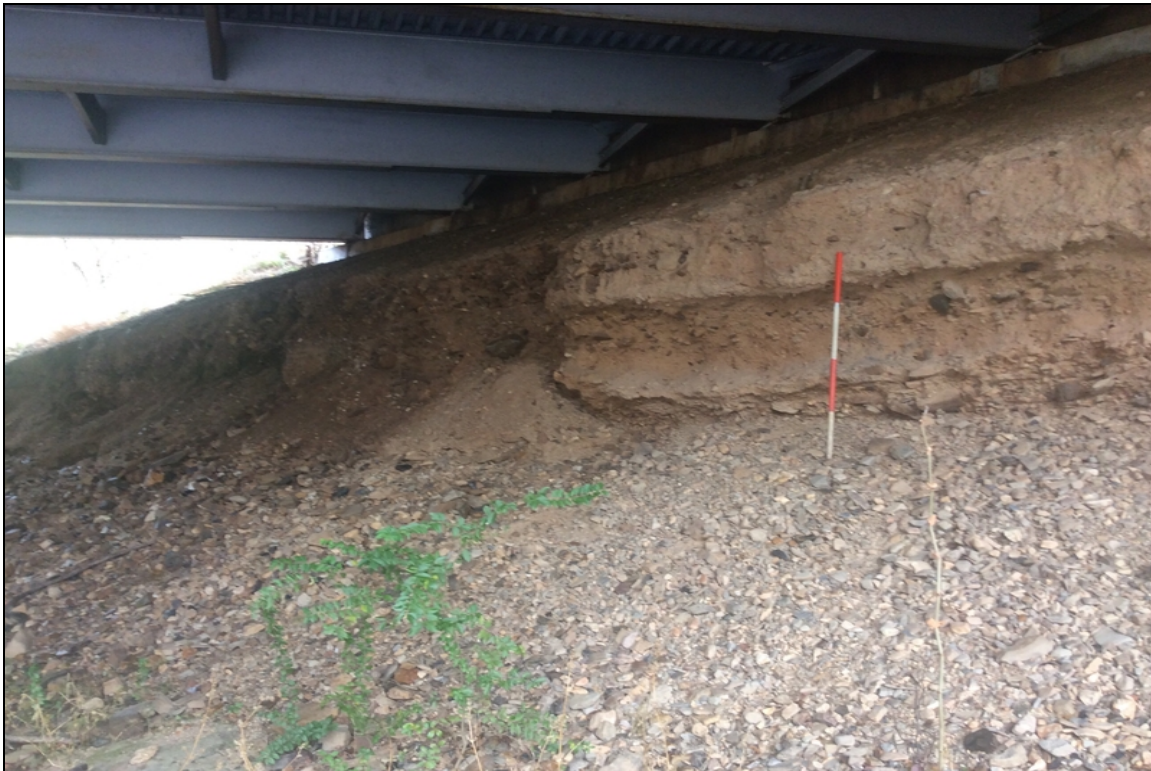
Bent 4 embankment erosion.

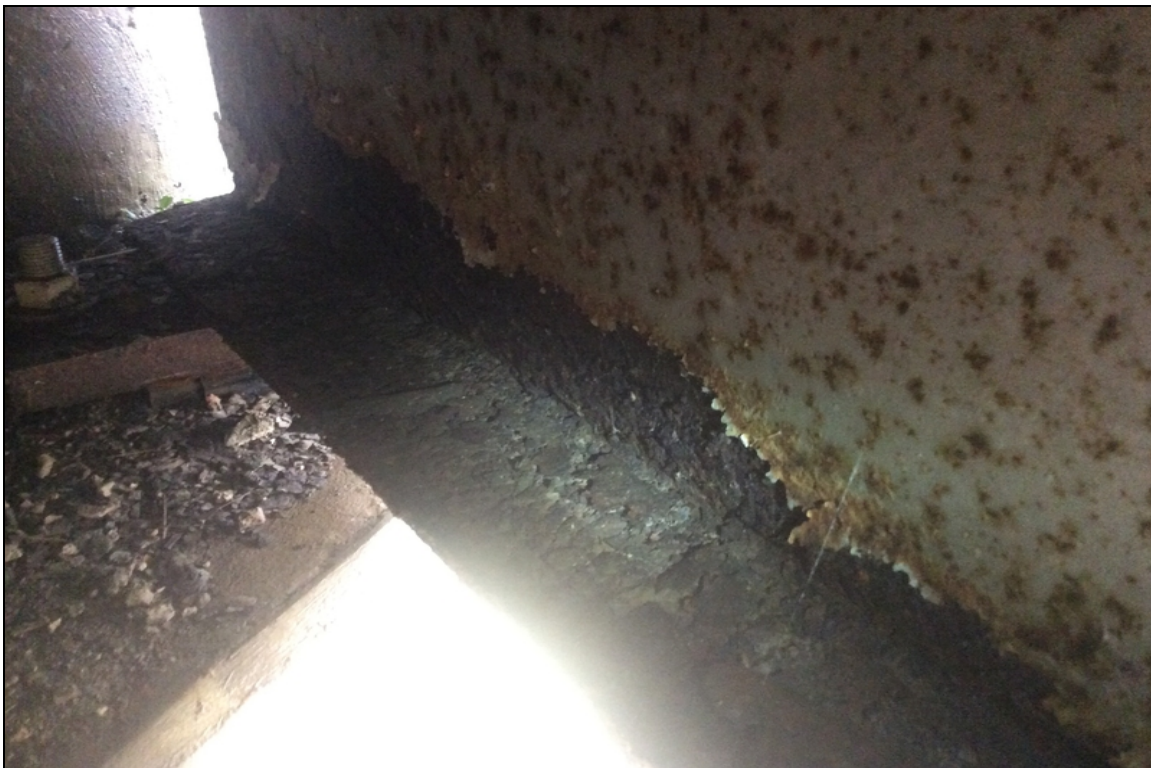
(107)	All beam ends have active corrosion on the bottom flange and web at the deck haunches. Beams 6 and 10 at bent 4 have section loss to the bottom flange and lower web. Scattered areas of freckling rust on the webs & lower flanges of all beams. The paint system is failing.						
205	Reinforced Concrete Column	EA	8	0	6	2	0
1190	Abrasion/Wear (PSC/RC)	EA	8	0	6	2	0

Bent 4 beam 10, corrosion with section loss to bottom flange and lower web.

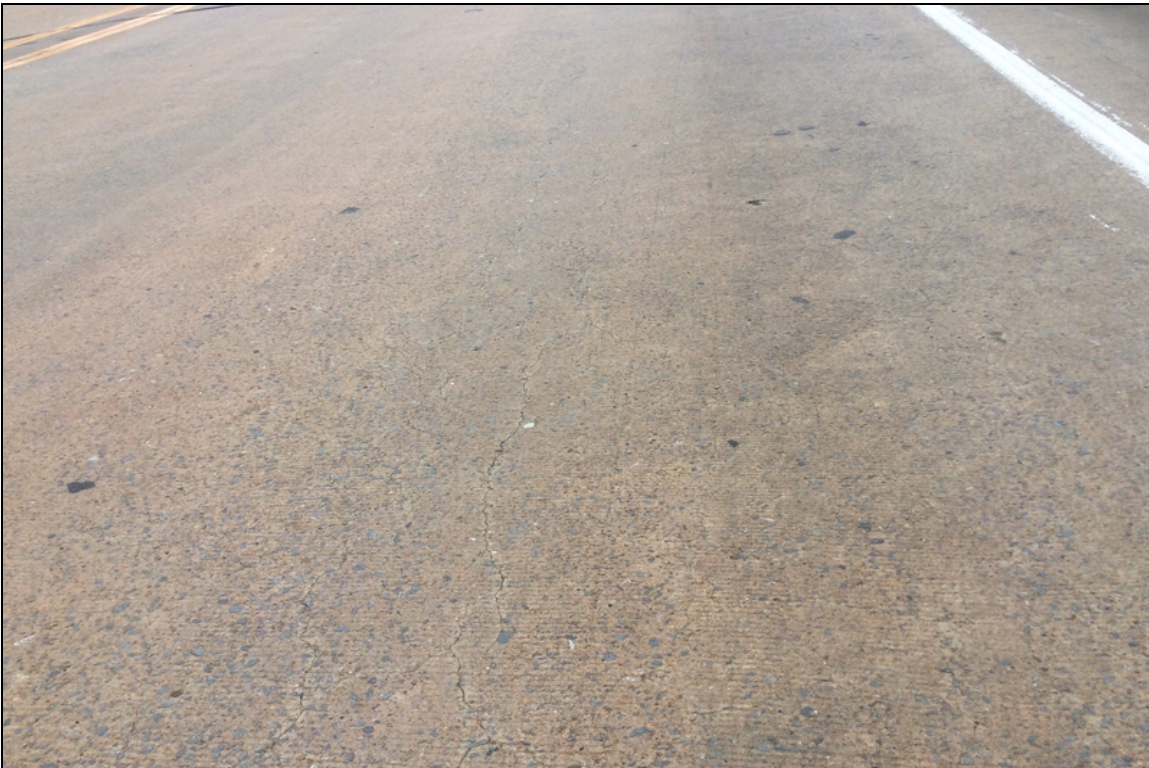
Span 1, longitudinal cracks.

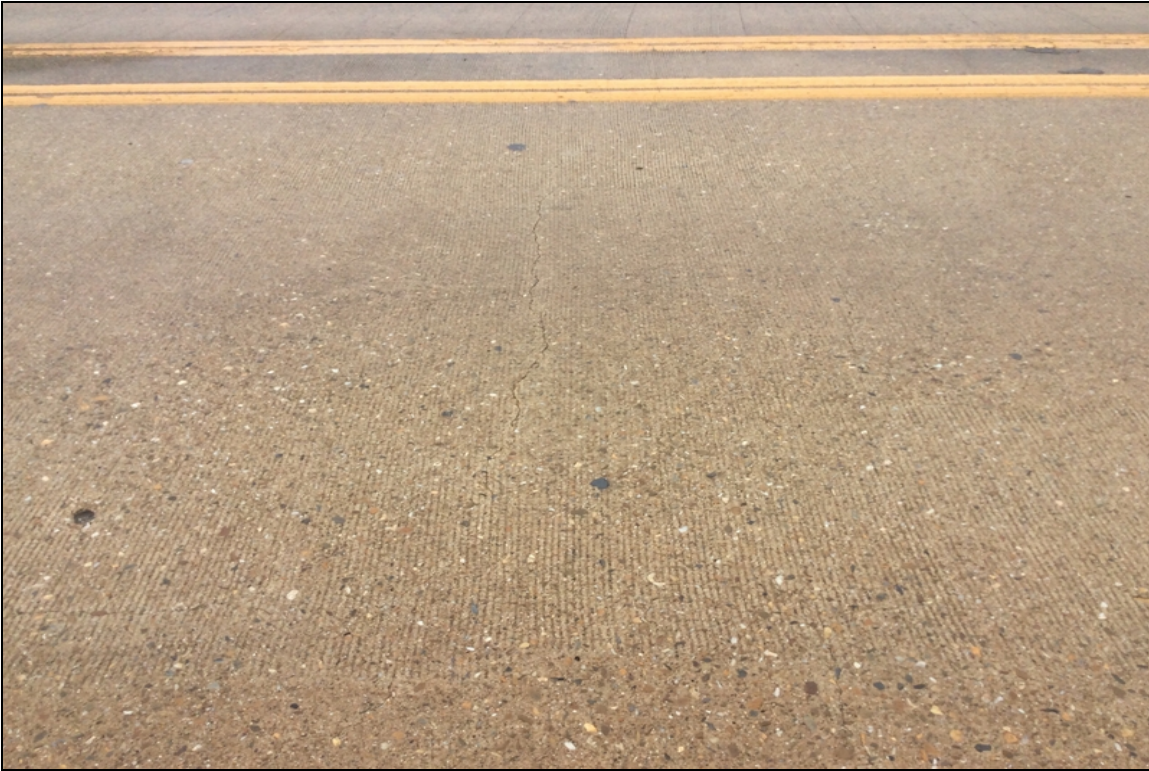
Transverse crack Span 1.
