Bridge #06024(Routine)

US 270-7 Log 2.85 over COVE CREEK

Team Lead: Shane Byrd Inspection Date: December 09, 2020

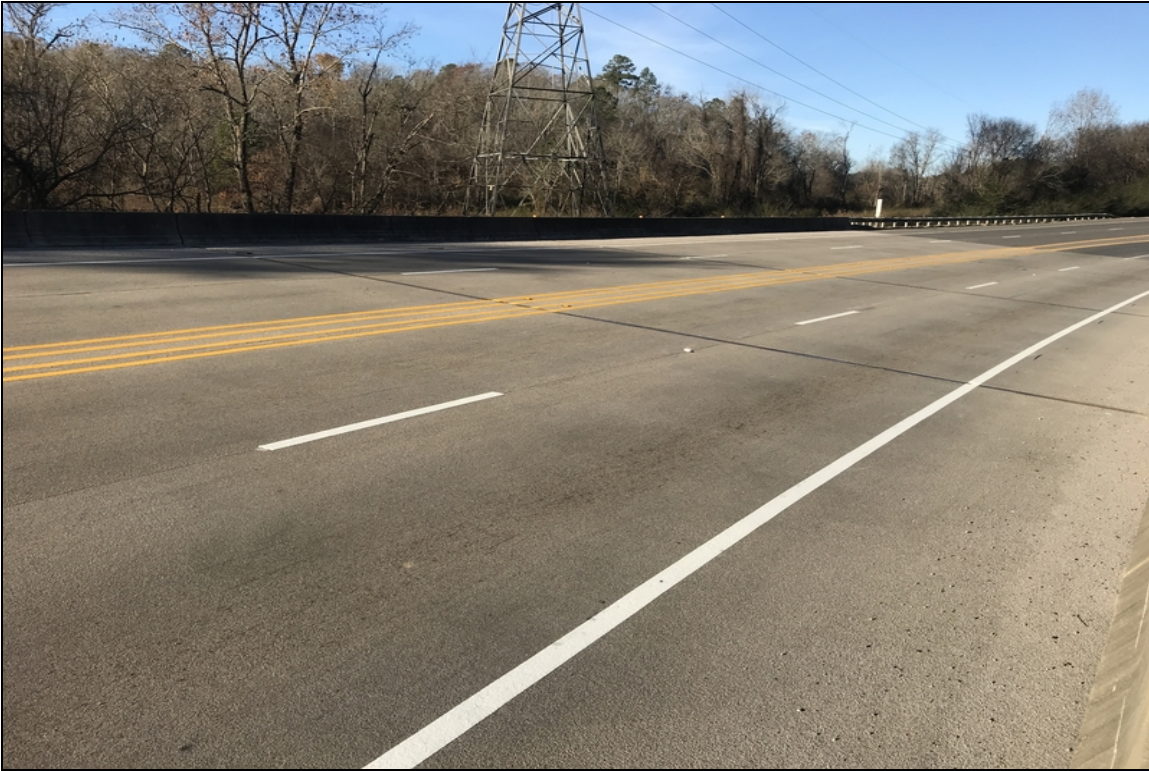
Deck overview.

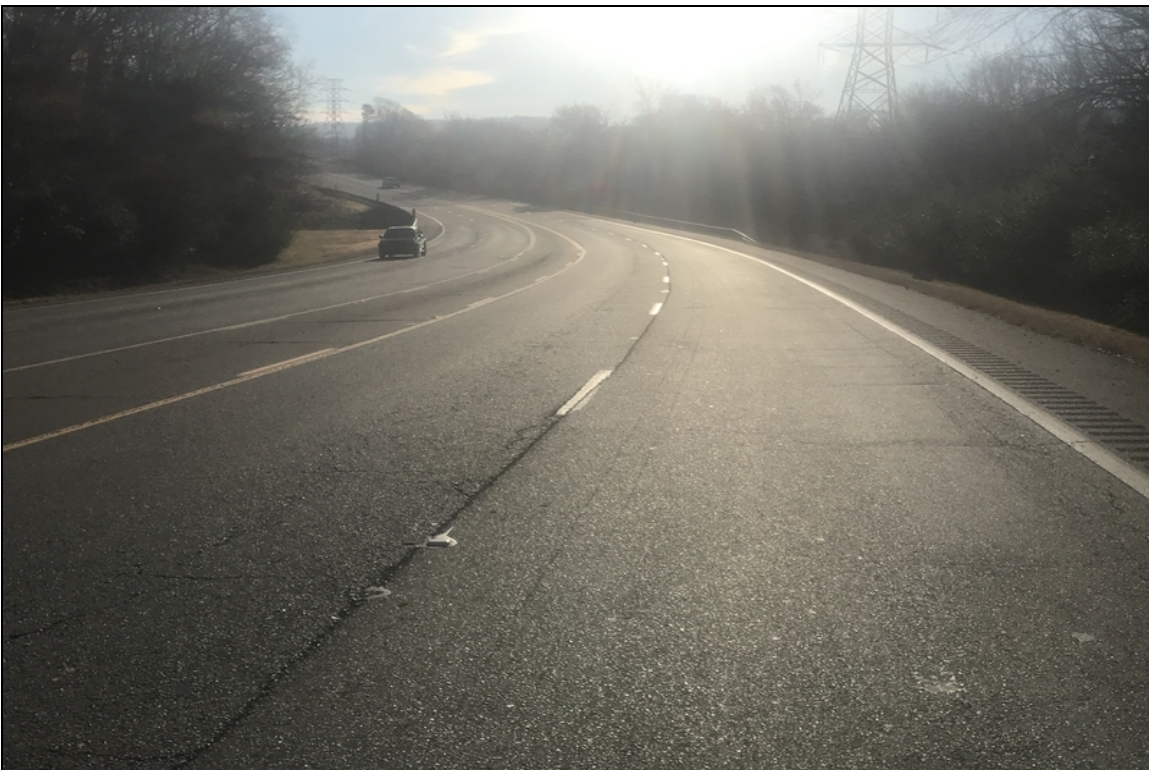
Approach Eastbound.

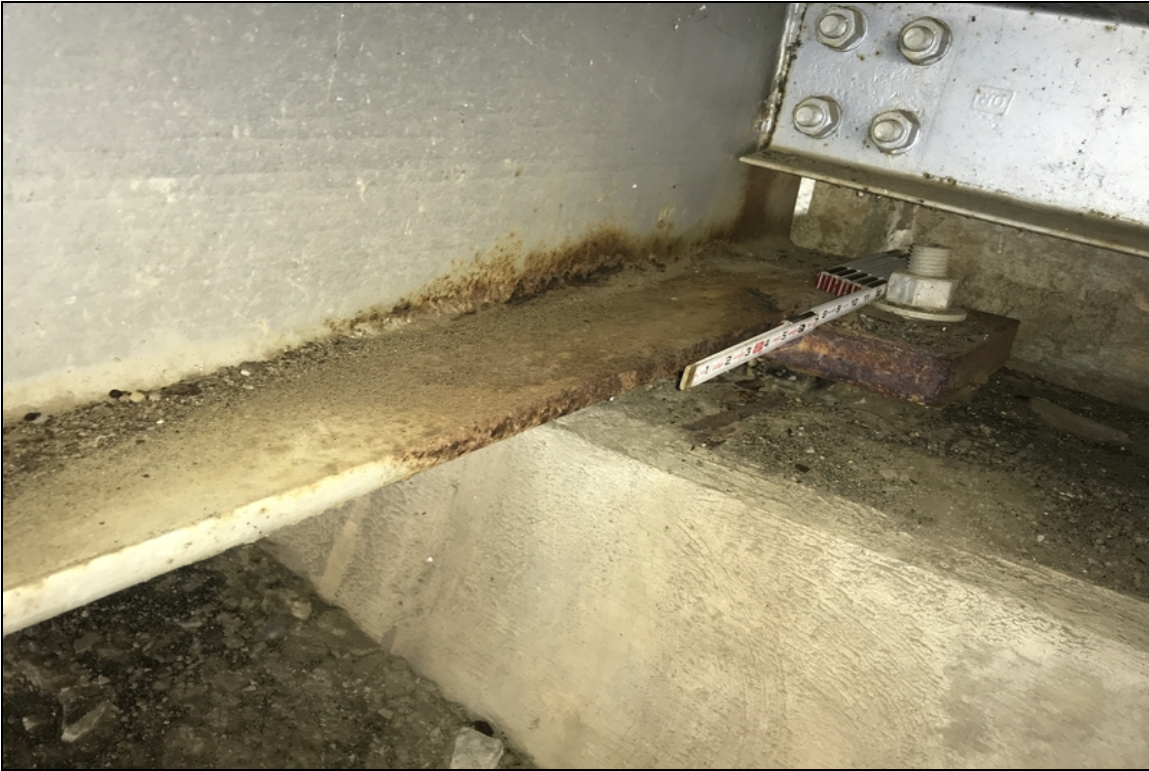
(107)							
Most ends of the girders have active corrosion with section loss in the haunch, lower web and bottom flange due to leaking joints. 1/8" section loss is typical. Bent 2, span 2, right side of beam 6, diaphragm bolts are missing. The protective system is effective with the exception of the girder ends.							
205	Reinforced Concrete Column	EA	12	8	4	0	0
1090	Exposed Rebar	EA	4	0	4	0	0

Girder 3 bent 1 has pitting up to 1/16" to bottom flange.

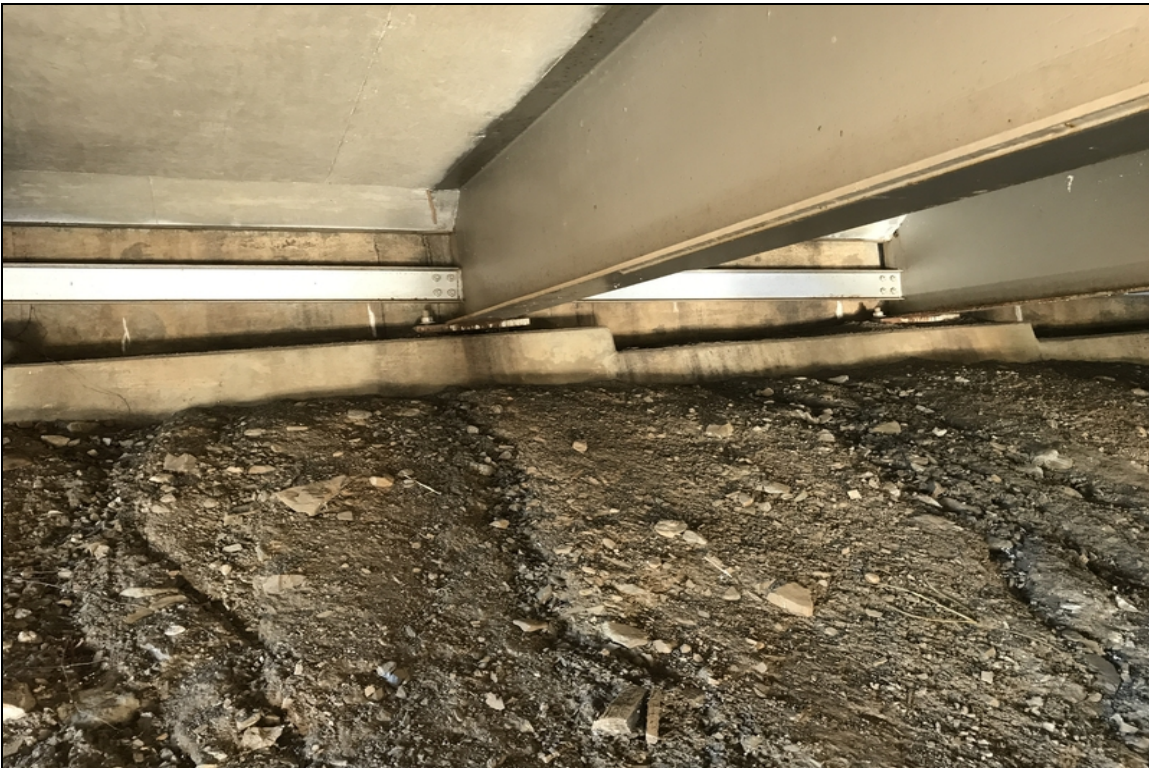
(215)							
Bents 1 and 5 have vertical cracks with efflorescence in the back wall.							
234	Reinforced Concrete Pier Cap	LF	212	208	4	0	0
1090	Exposed Rebar	LF	1	0	1	0	0
1130	Cracking (RC and Other)	LF	3	0	3	0	0

Bent 1 abutment has cracks with efflorescence in the back wall.

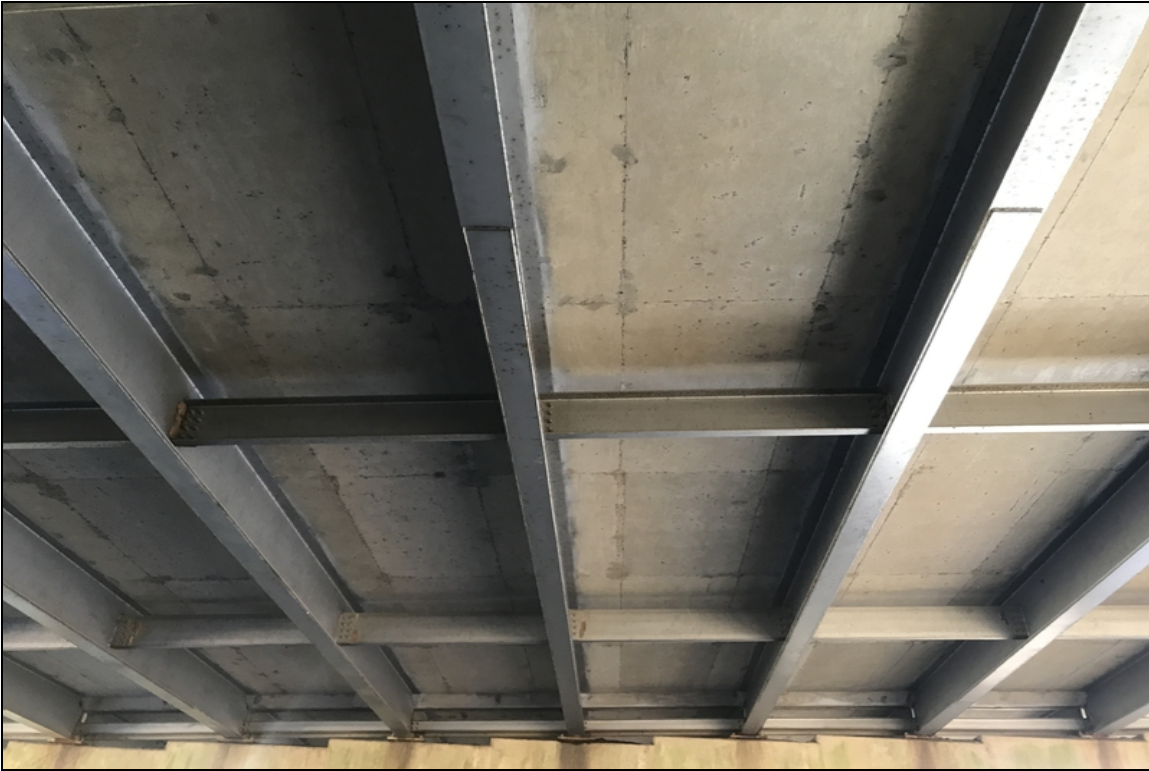
Span 2 soffit overview.

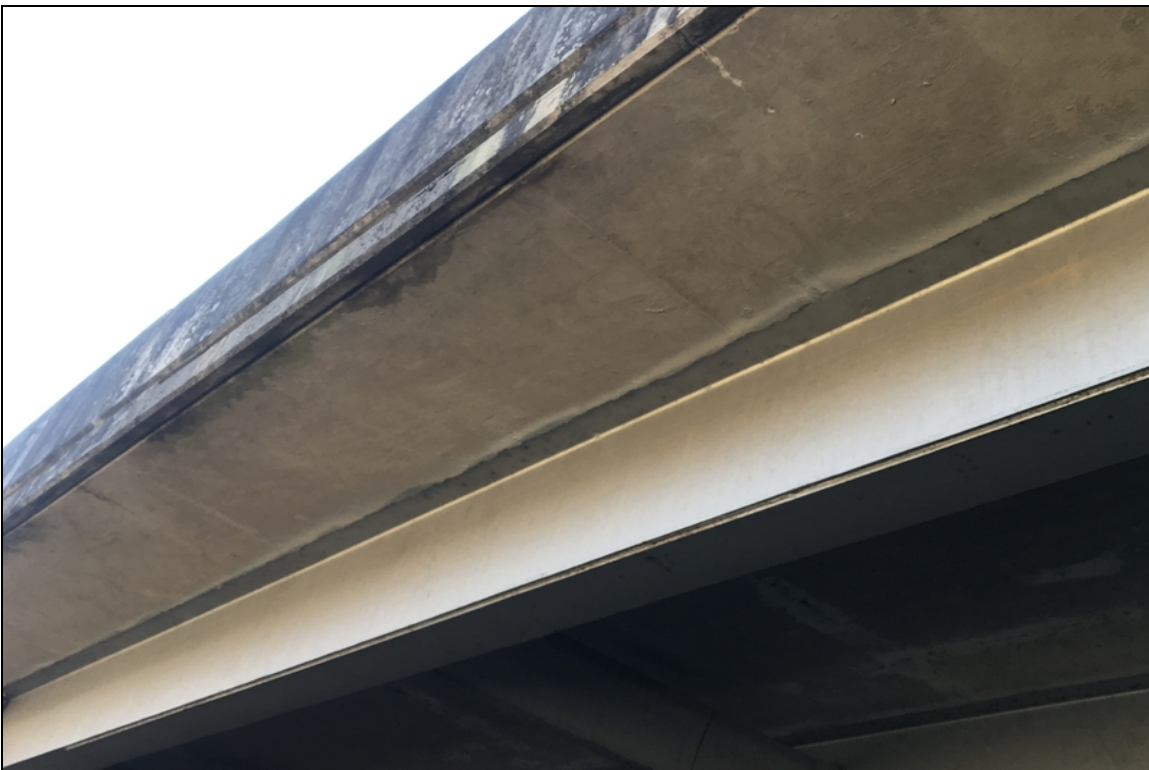
(12)							
Deck has new polymer overlay under job #. 012350 12/9/2020 All spans have cracks with efflorescence in the overhang soffits.							
107	Steel Open Girder/Beam	LF	1620	1543	0	77	0
1000	Corrosion	LF	76	0	0	76	0
1020	Connection	LF	1	0	0	1	0
515	Steel Protective Coating	SF	11070	10942	0	0	128
3440	Effectiveness (Steel Protective Coatings)	SF	128	0	0	0	128

Span 3 left side soffit overhang has cracks with efflorescence.

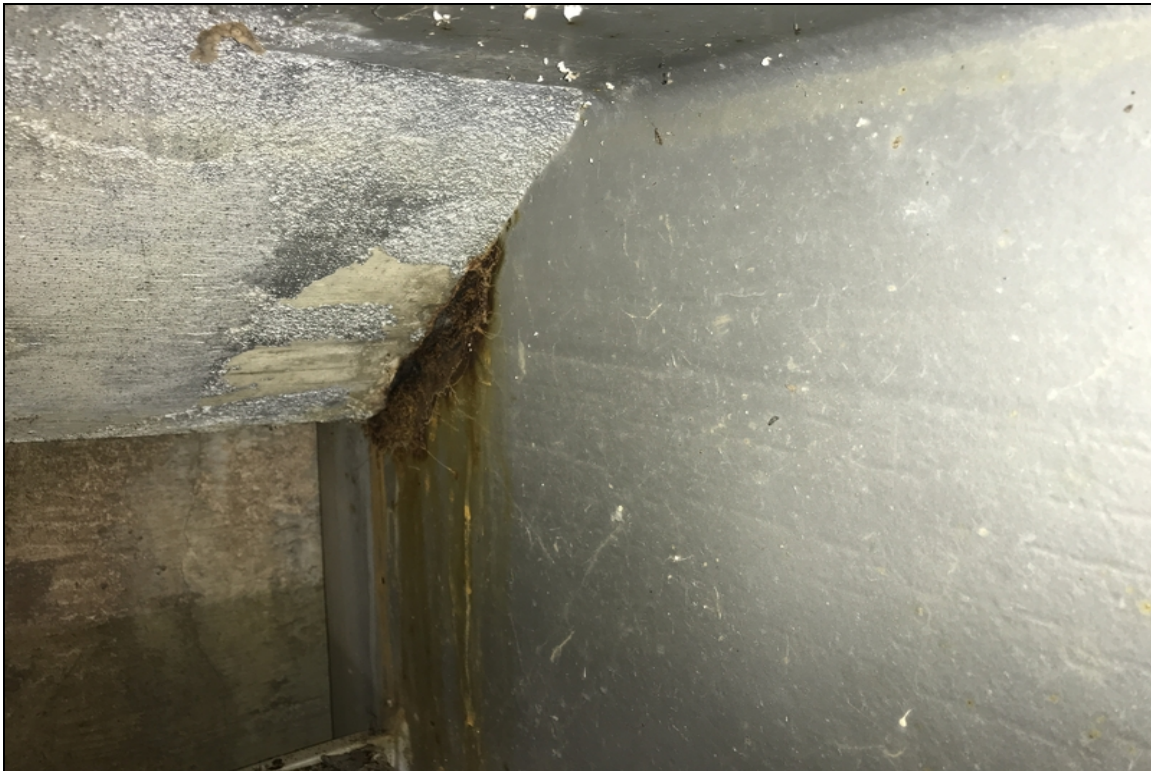
Bent 1 girder 4 right side has pitting up to 1/8" in the haunch area of the upper web.

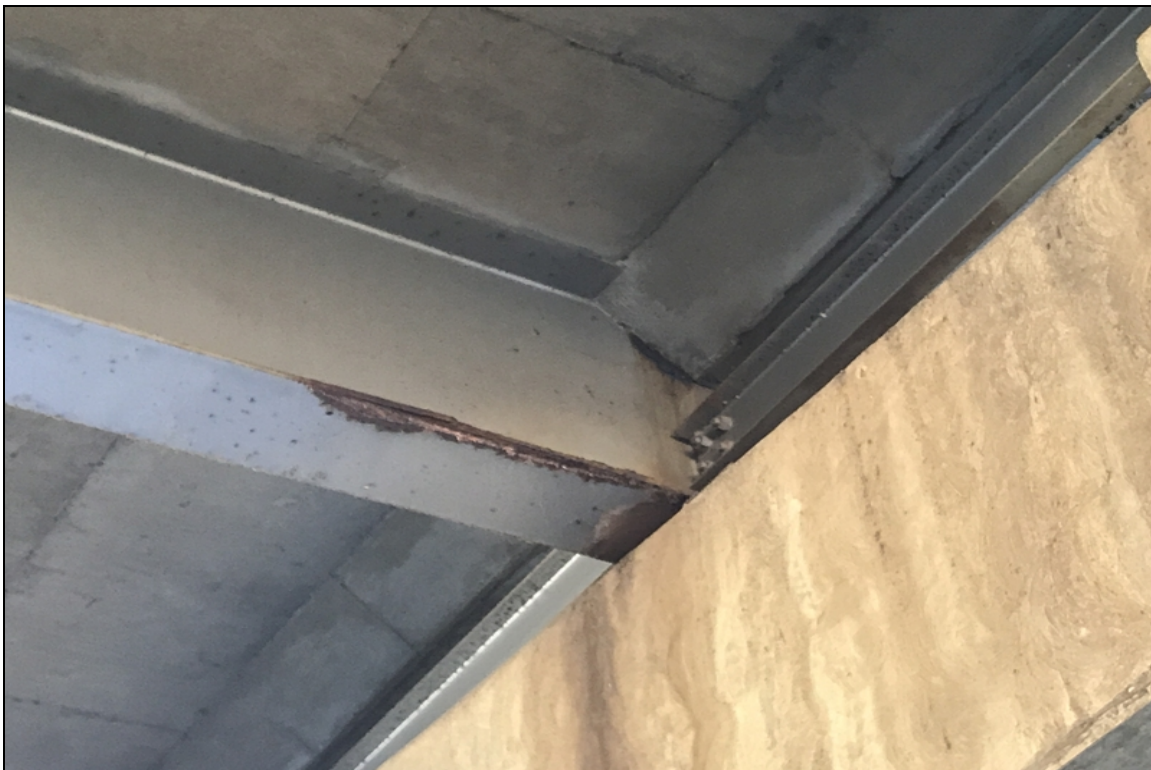
Bent 2 beam 3 has corrosion lower flange and upper web haunch area.

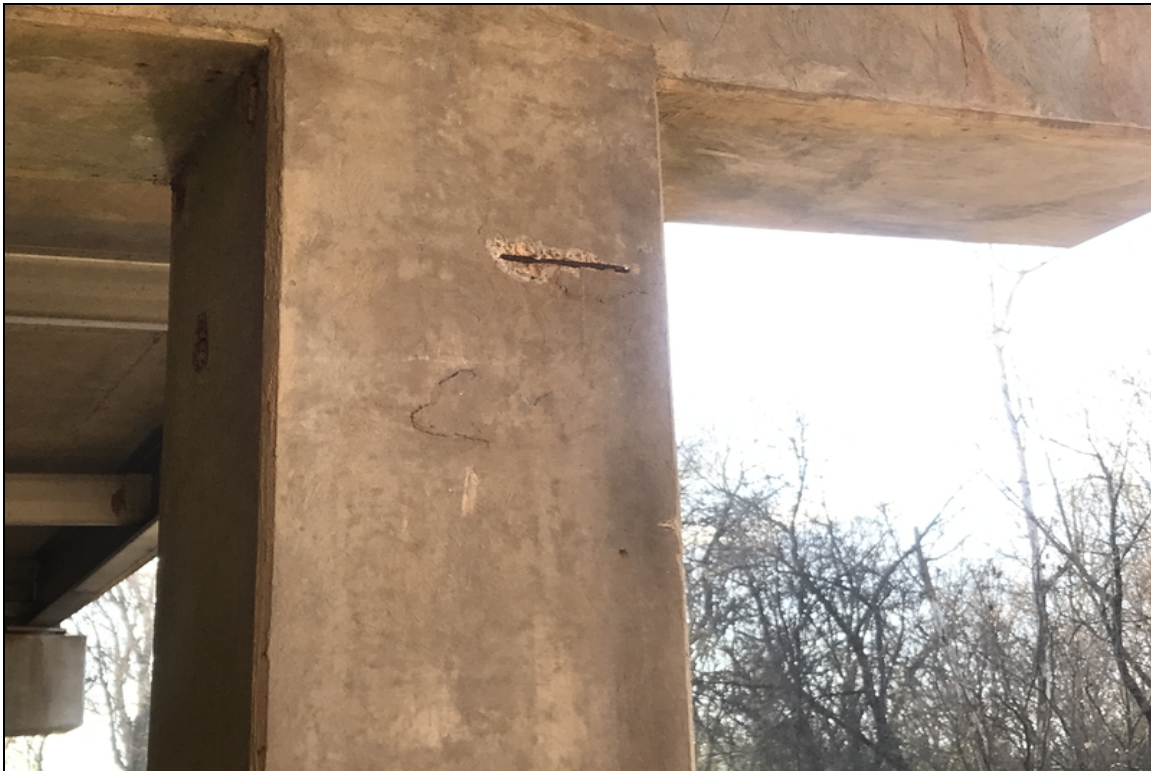
(205)							
Bent 2 columns 3 and 4 have spalls with exposed rebar. Bent 3 columns 1 and 2 have exposed rebar.							
215	Reinforced Concrete Abutment	LF	166	149	17	0	0
1120	Efflorescence/Rust Staining	LF	17	0	17	0	0

Bent 2 column 4 has spall with exposed rebar.

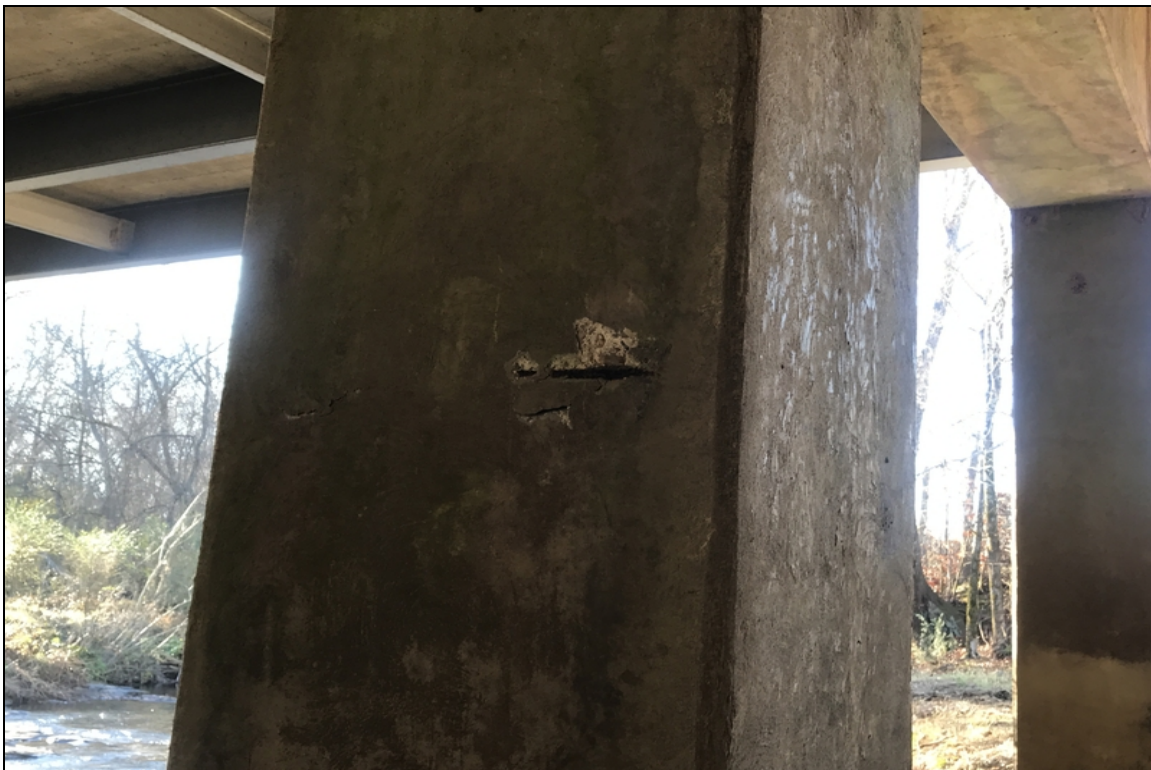
Bent 2 column 3 left side has spall with exposed rebar.

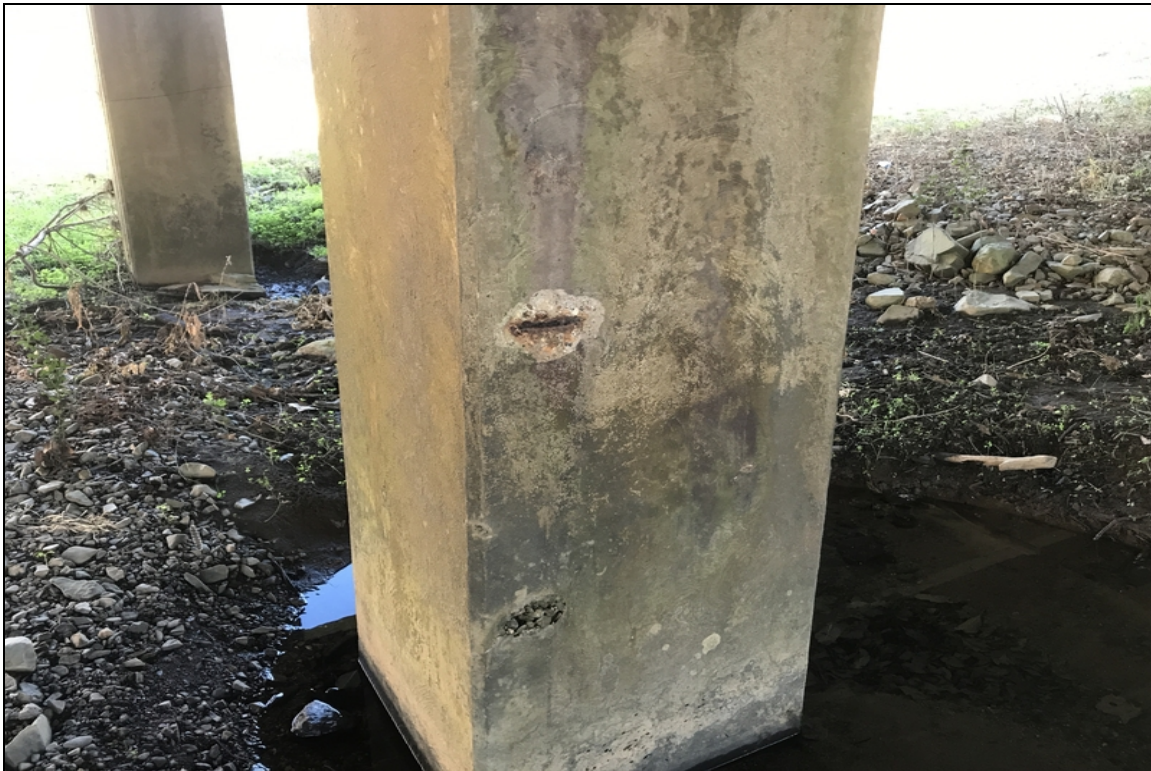
Bent 3 column 2 has spall with exposed rebar.

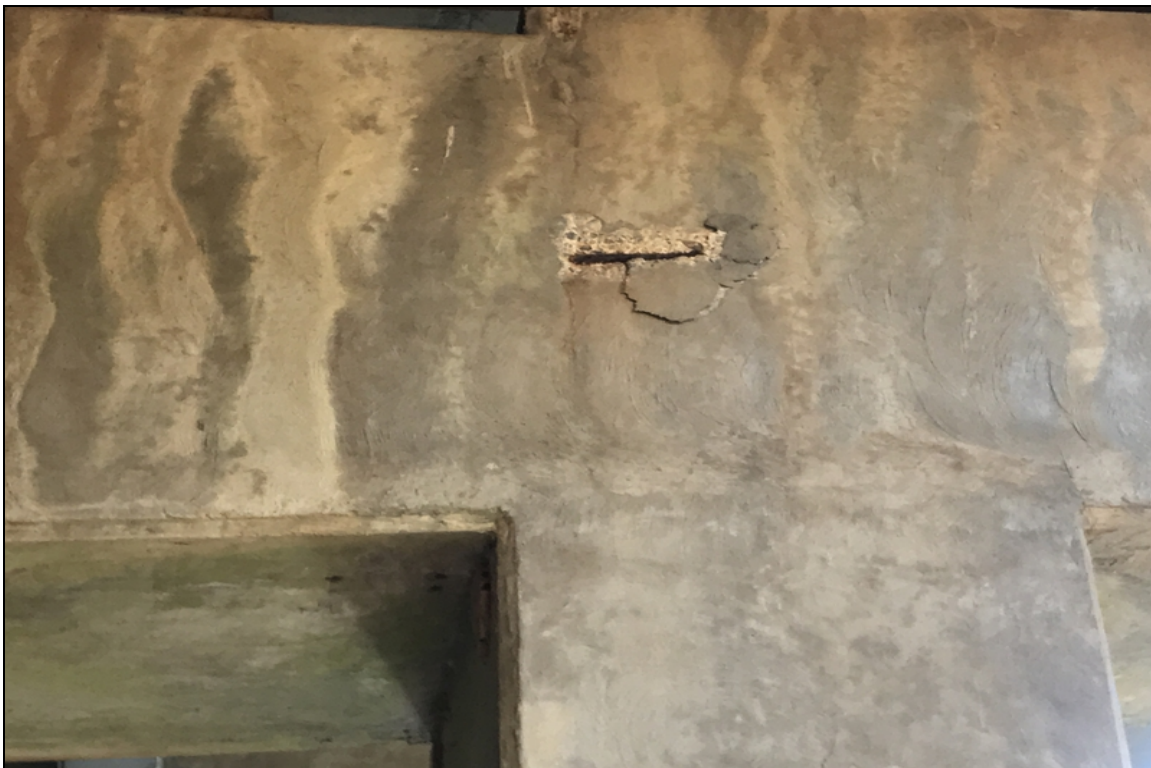
(234)							
Bent 2, exposed rebar on the back side. Bent 3 ahead side has small cracks. Bent 4 has crack on the backside.

Bent 2 cap back has spall with exposed rebar.

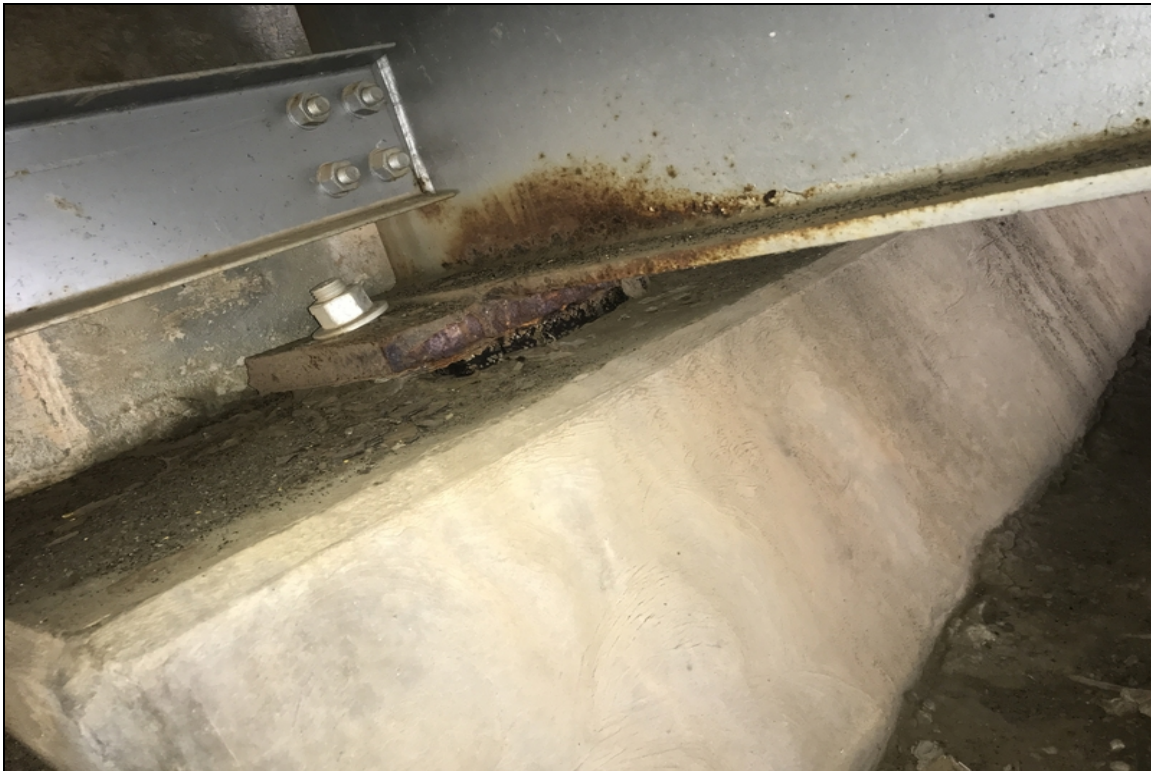
Bent 5 beam 5 sole plate has active corrosion.

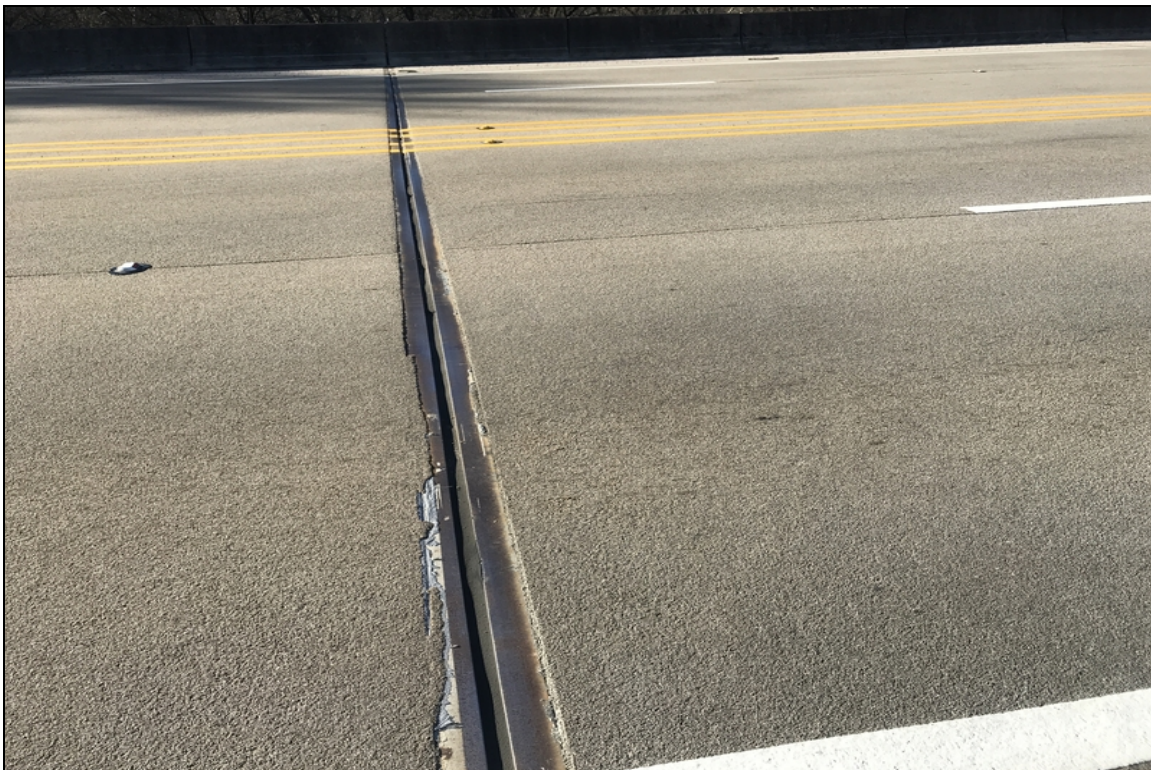
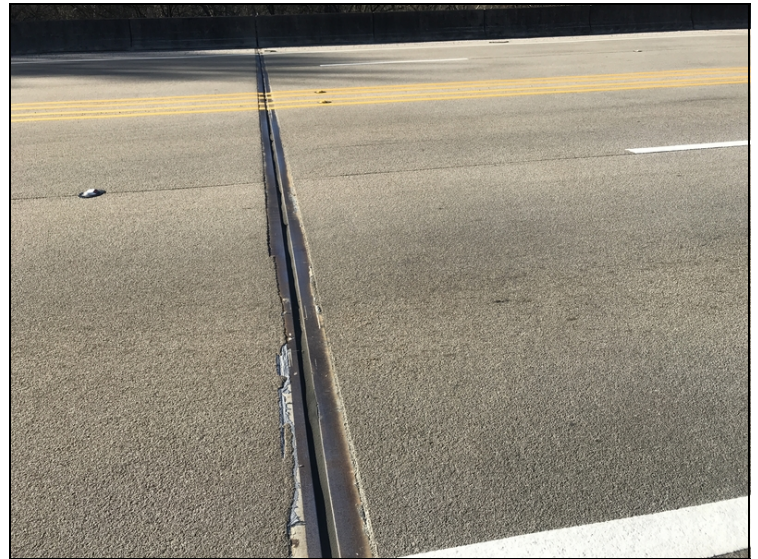
Joint seal at bent 4 has been repaired.

All joint seal is leaking causing active corrosion on beam ends.

Joint seals have been repaired under job 012350

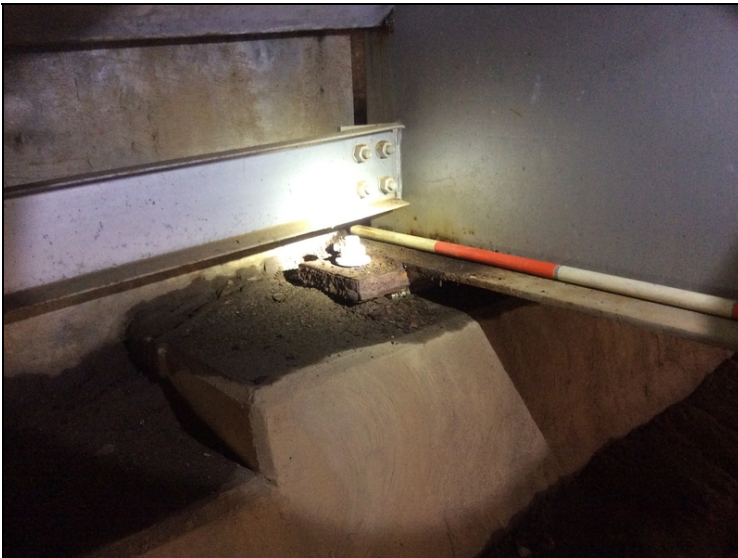
Bt. 4, Bm. 7, corrosion & minor pitting on the bottom flange & sole plate of bearing.

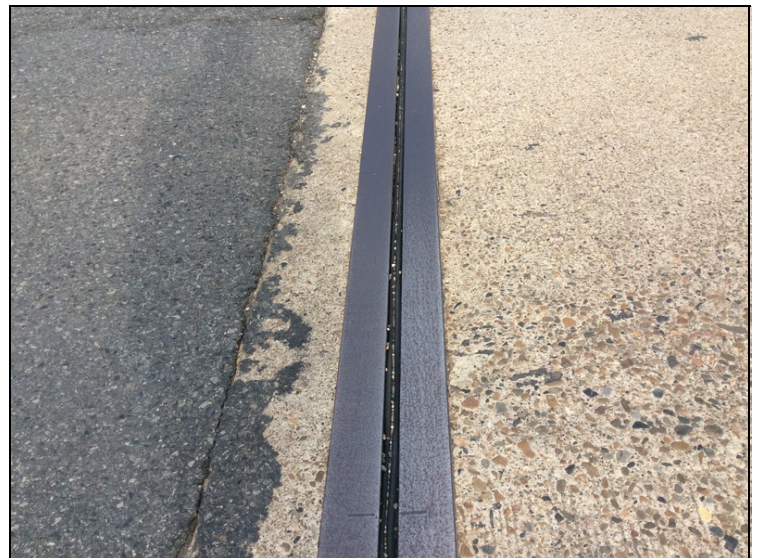
Bent 1 joint has lost adhesion and is leaking.

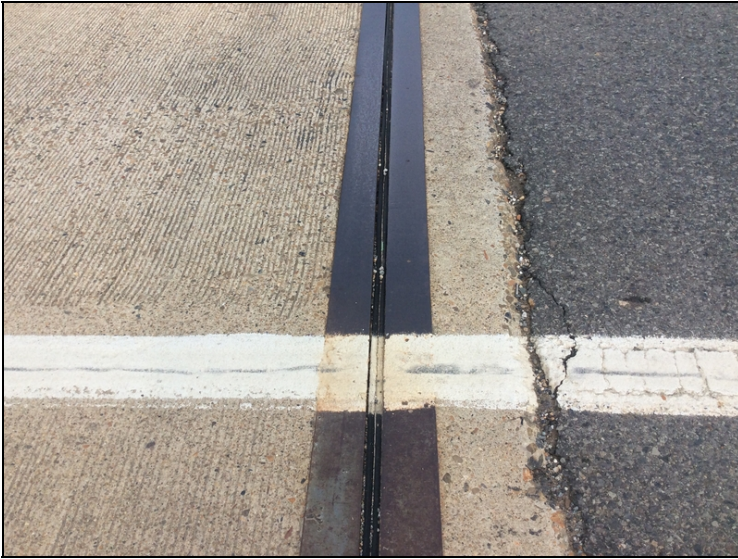
Bent 5 right side, joint has lost adhesion and is leaking.

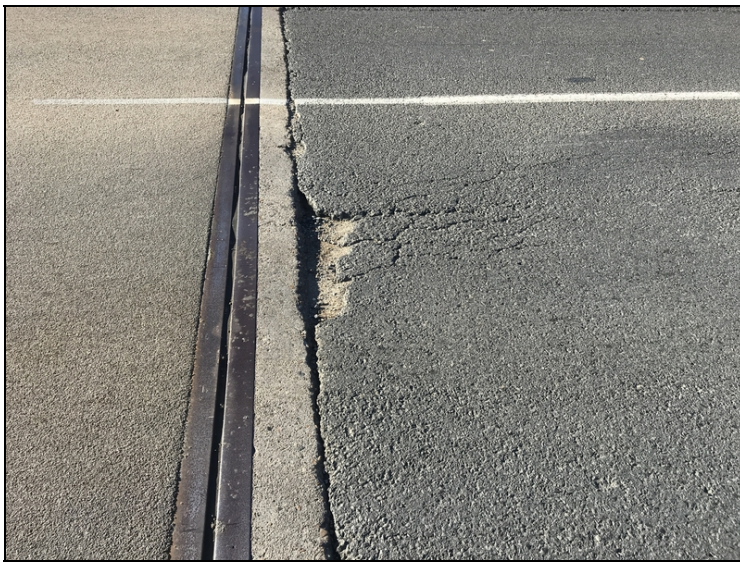
Asphalt approach at both ends of bridge have potholes.

Pothole in asphalt approach at West end of bridge.

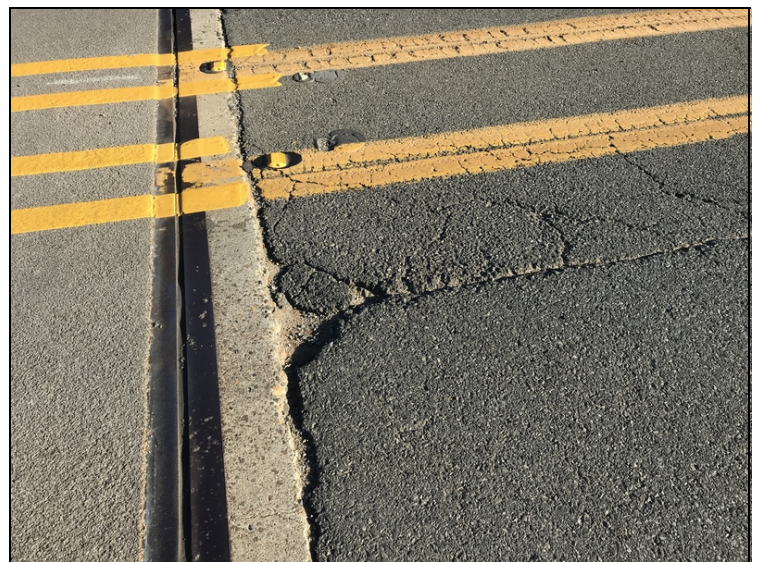
Pothole in asphalt approach at East end of bridge.

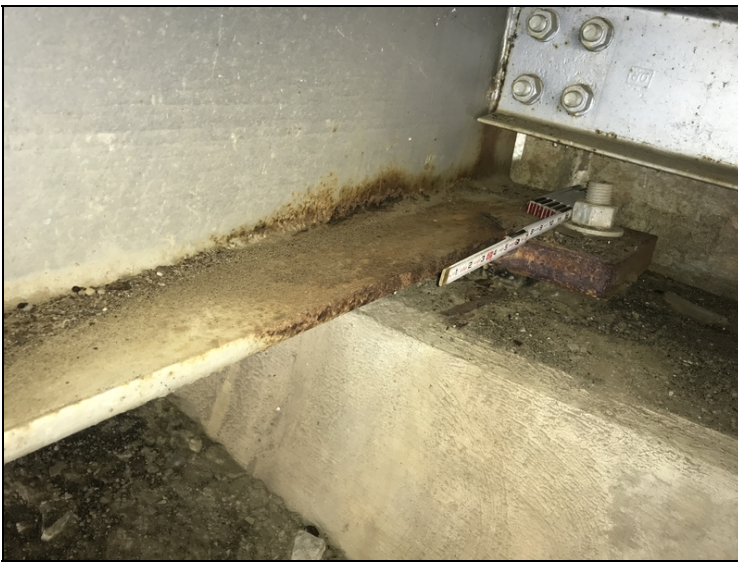
All Beam ends have active rust with moderate pitting to bottom flange and upper web.

Girder 3 bent 1 has pitting up to 1/16" to bottom flange.

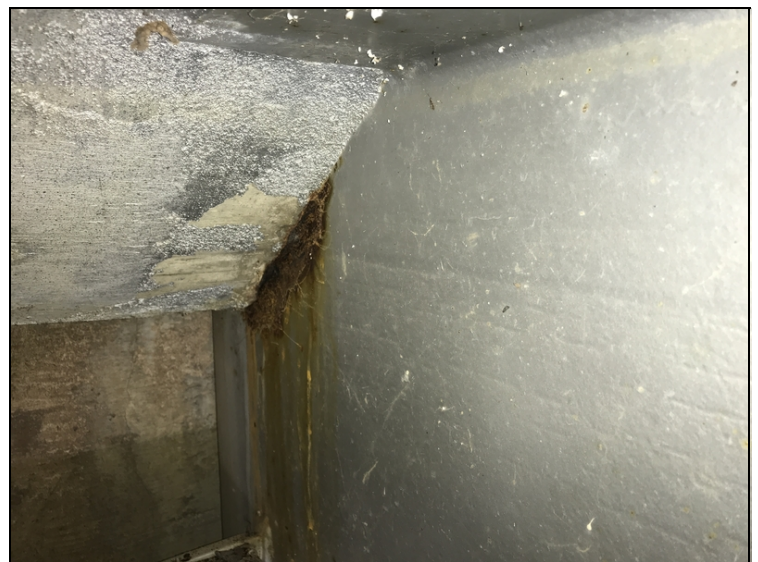
Bent 1 girder 4 right side has pitting up to 1/8" in the haunch area of the upper web.

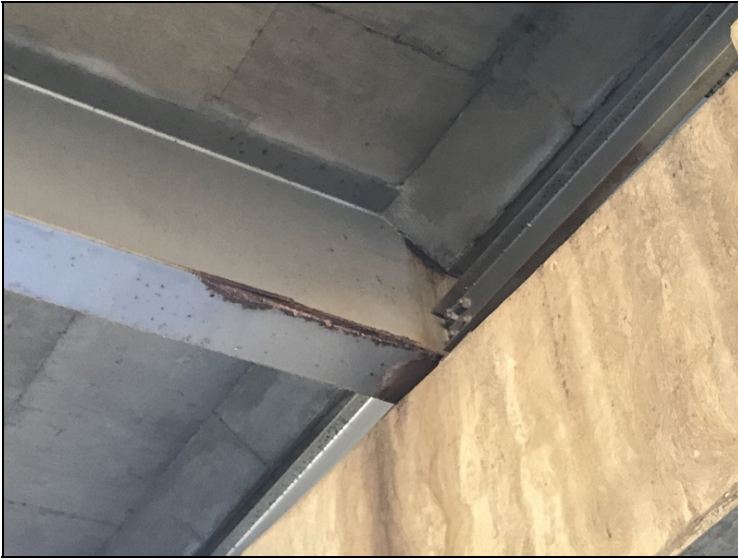
Bent 2 beam 3 has corrosion lower flange and upper web haunch area.
