Bridge #06025(Routine)

US 270-7 Log 4.63 over STONE QUARRY CREEK

Location: 2.6 MI W JCT US270&51

Team Lead: Shane Byrd Inspection Date: December 09, 2020

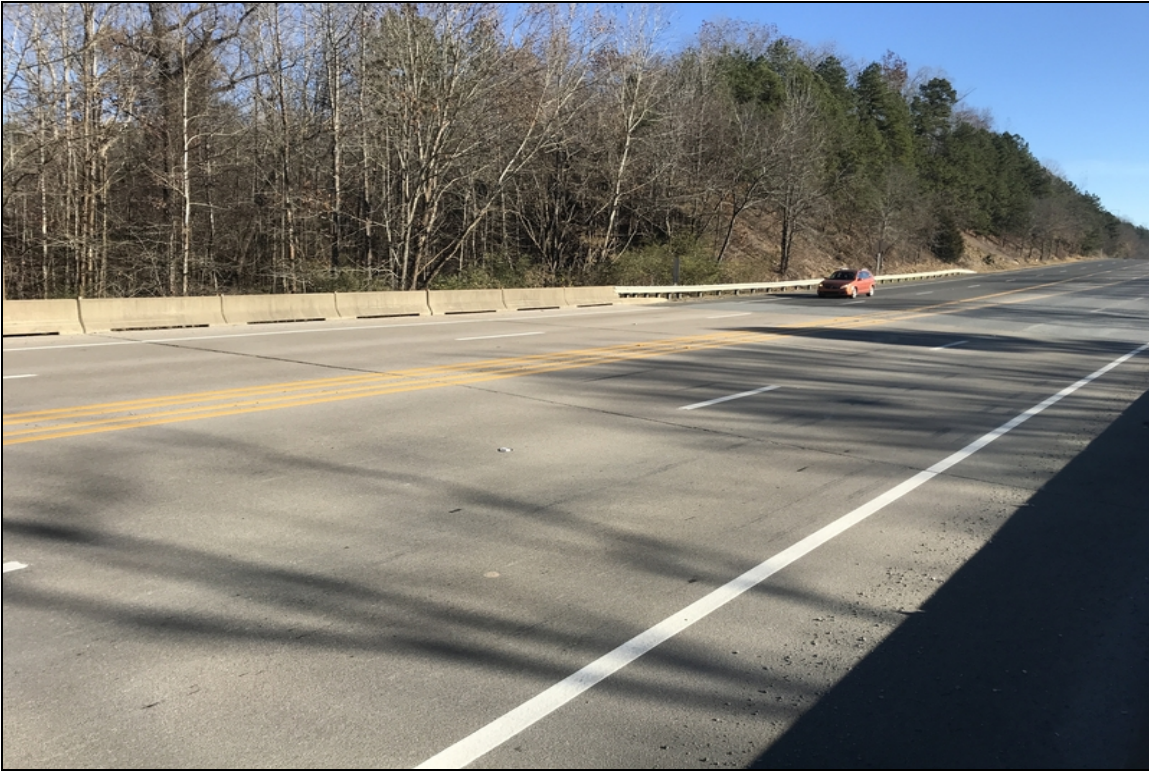
Deck overview.

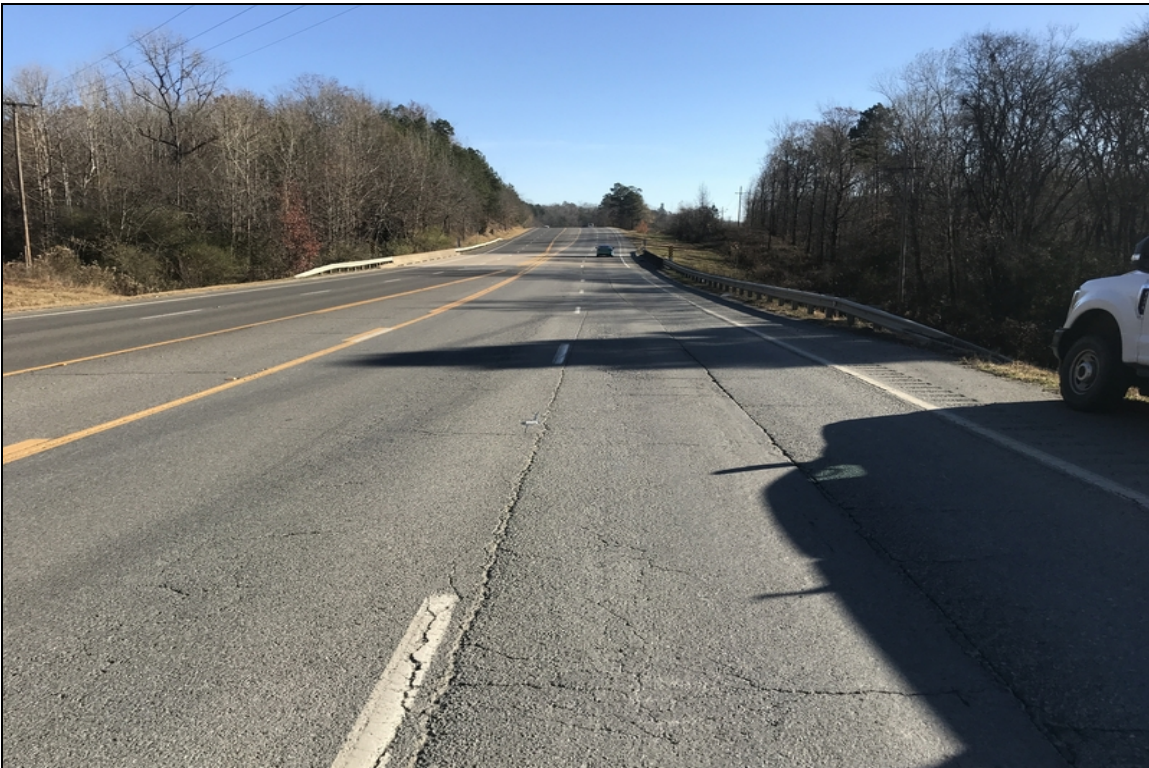
Approach Eastbound.

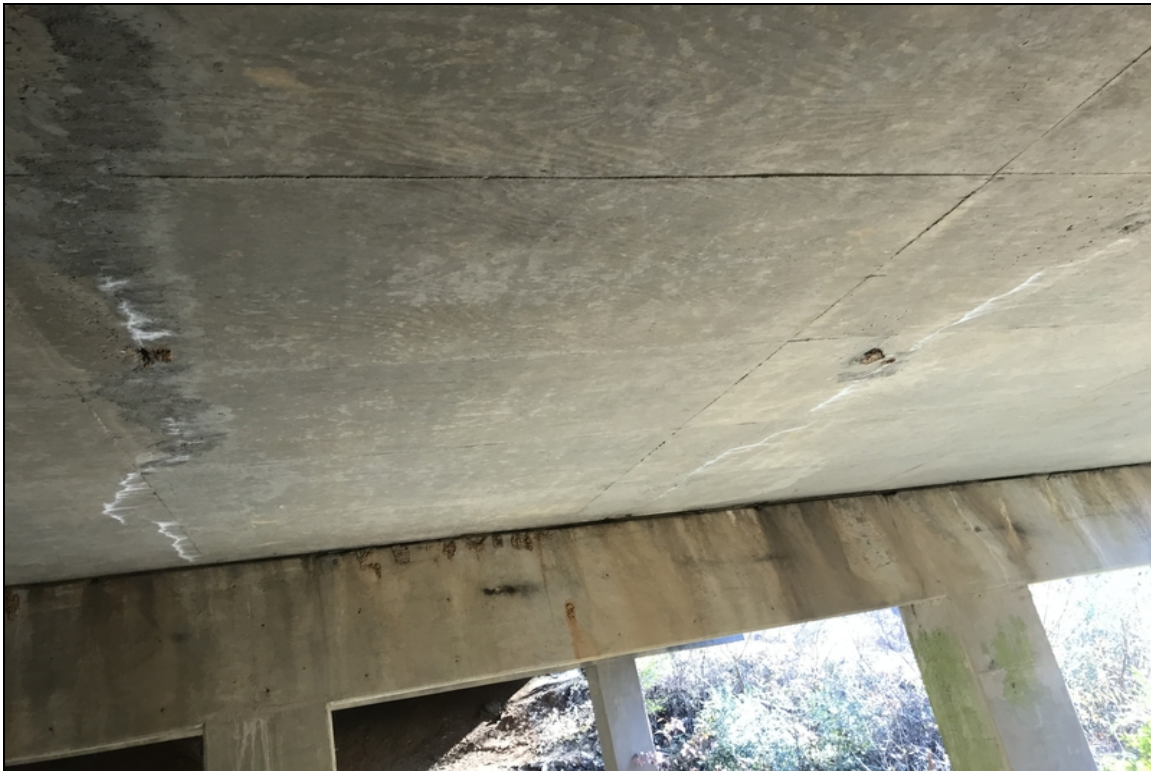
Span 1 soffit has cracks with efflorescence.

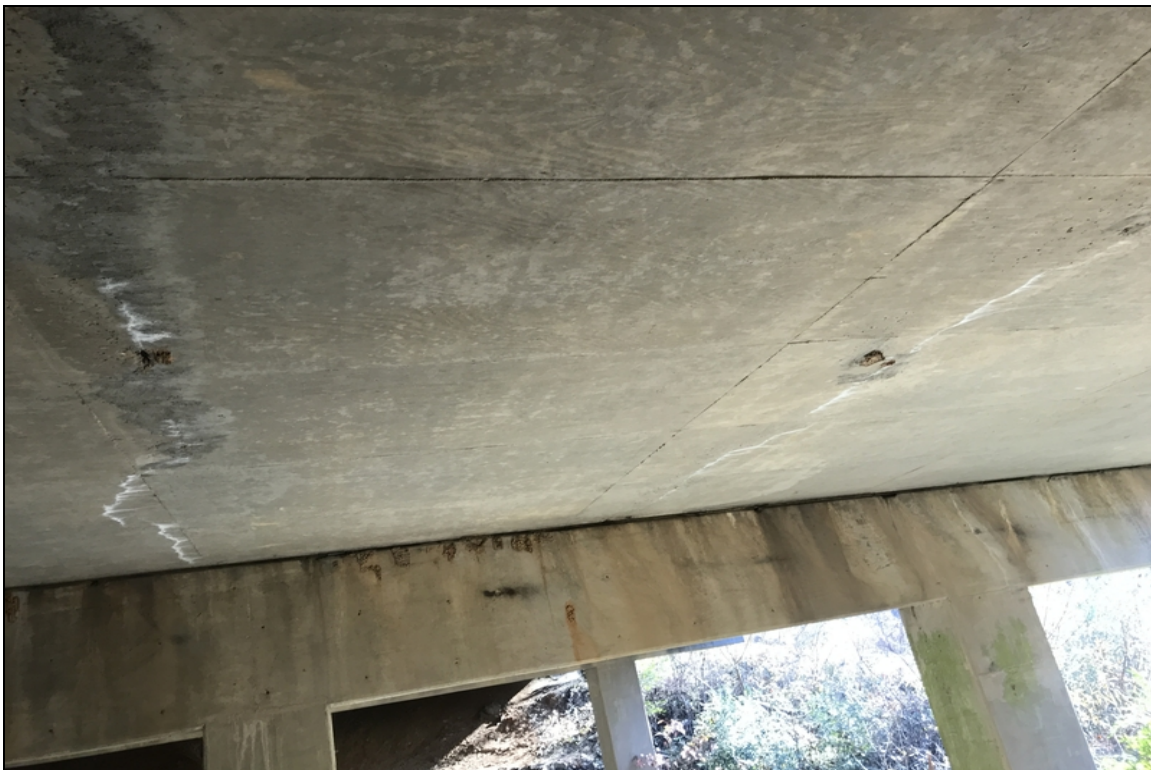
Span 1 soffit has cracks with efflorescence.

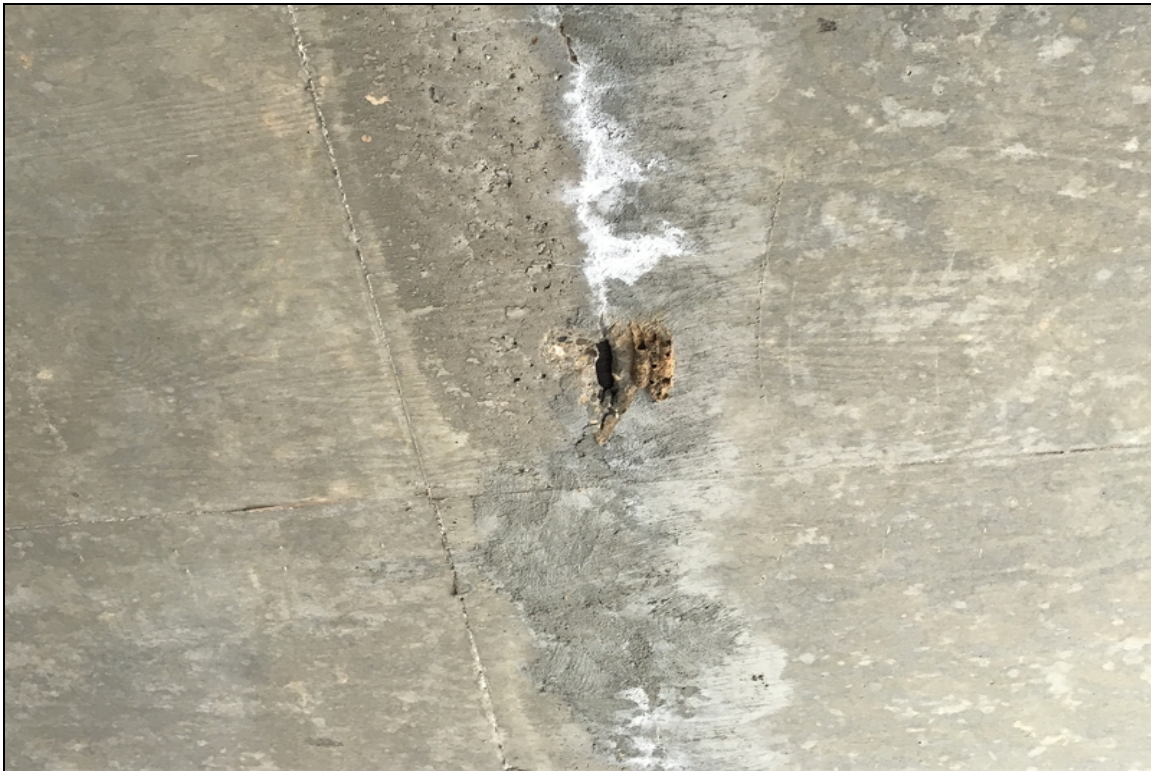
(38)							
Span 1, spall with exposed rebar in soffit. Soffit all spans have cracks with efflorescence. Polymer overlay has been applied to deck under job# 012350							
205	Reinforced Concrete Column	EA	8	7	1	0	0
1080	Delamination/Spall/Patched Area	EA	1	0	1	0	0

Span 1 soffit has spall with exposed rebar.

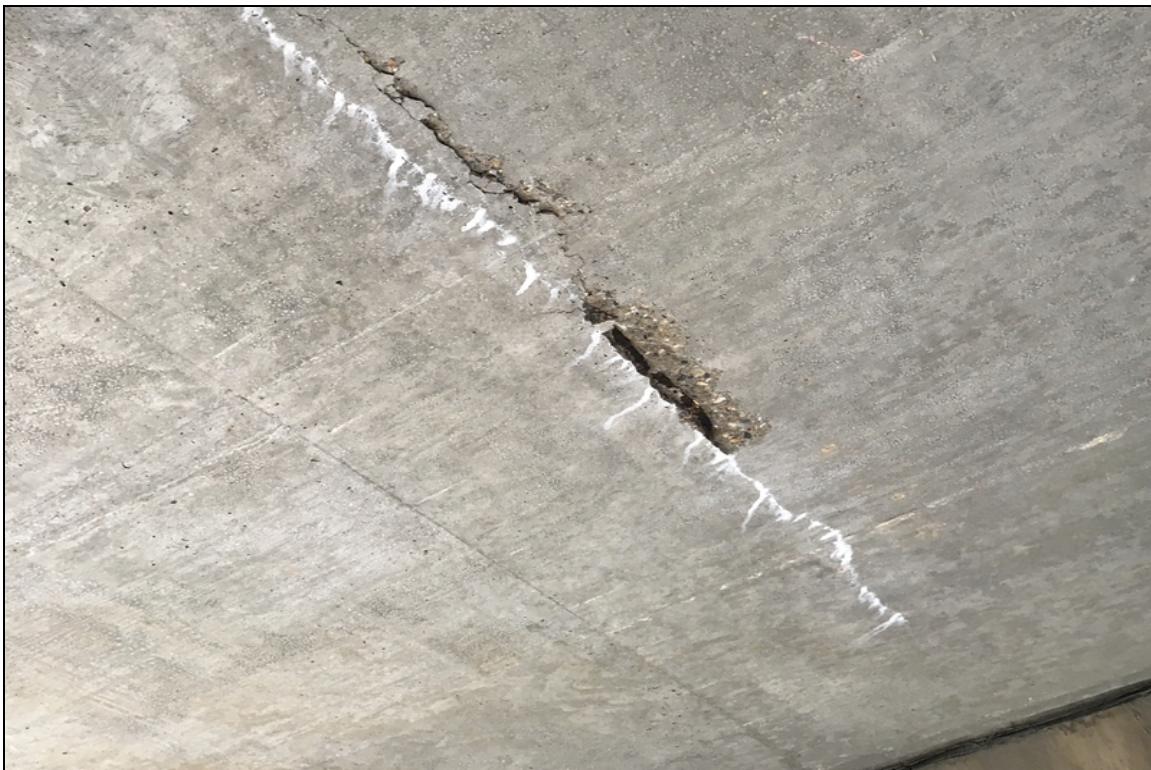
Soffit span 3 has spall with exposed rebar.

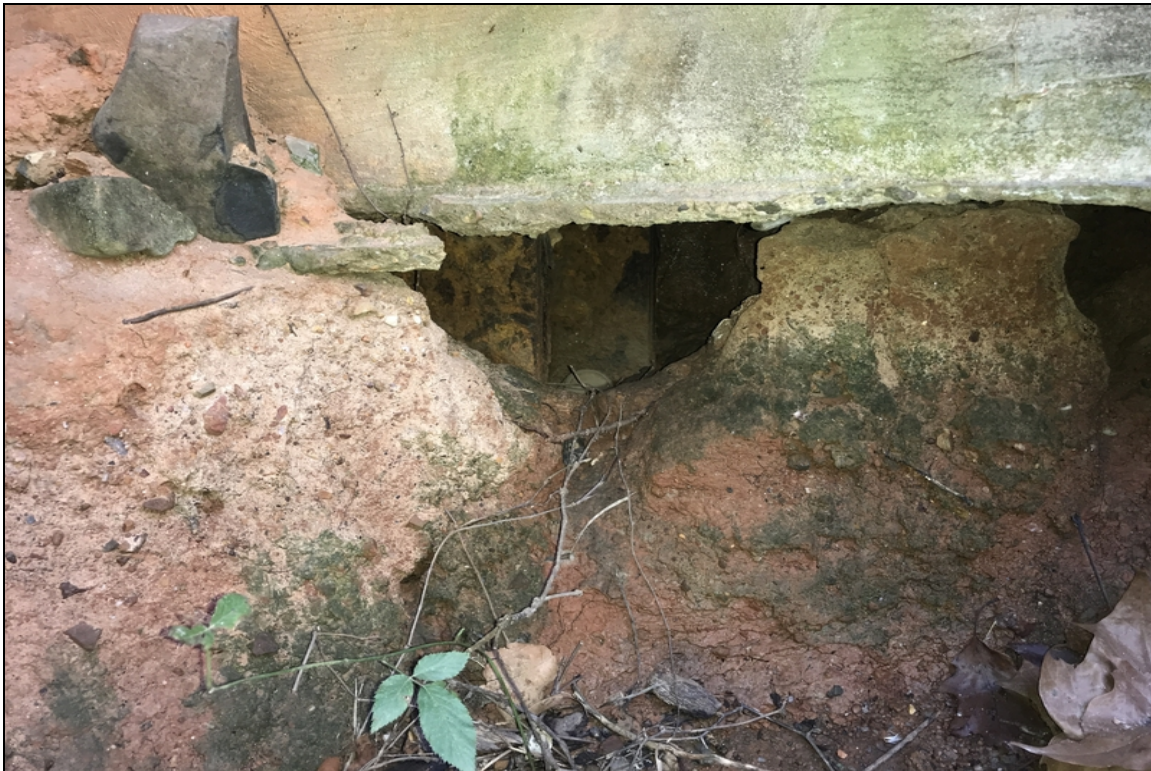
(225)							
Bent 1 Left and right side, pile exposed due to erosion under cap. Pile 1 has laminating rust.							
234	Reinforced Concrete Pier Cap	LF	142	125	10	7	0
1080	Delamination/Spall/Patched Area	LF	9	0	2	7	0
1090	Exposed Rebar	LF	3	0	3	0	0
1120	Efflorescence/Rust Staining	LF	3	0	3	0	0
1130	Cracking (RC and Other)	LF	2	0	2	0	0

Pile exposed due to erosion on left side of bent 1 has active corrosion.

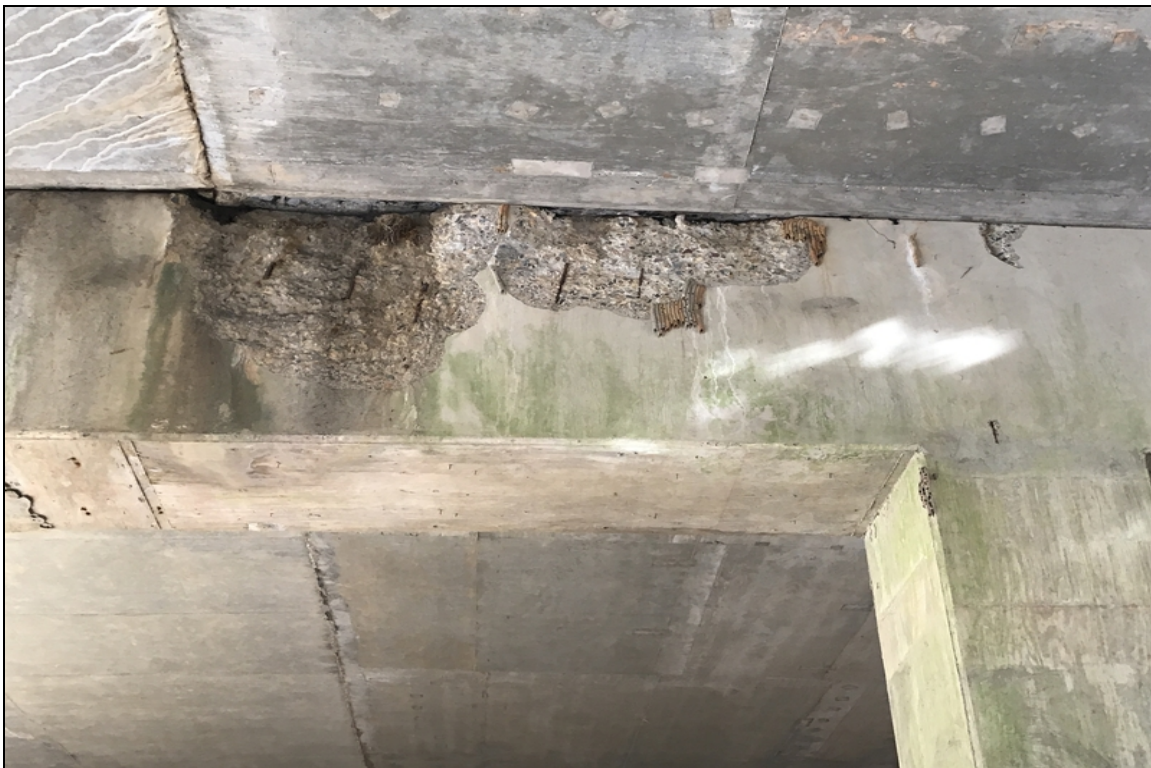
(234)							
Bent 2 ahead side, large spall with exposed rebar, cracks and cracks with efflorescence, small spall. Bent 3 has spalls with exposed rebar on the bottom at centerline and on the ahead face above column 4, cracks with efflorescence, small spall.							
301	Pourable Joint Seal	LF	136	136	0	0	0

Bent 2 cap ahead has large spalls with exposed rebar.

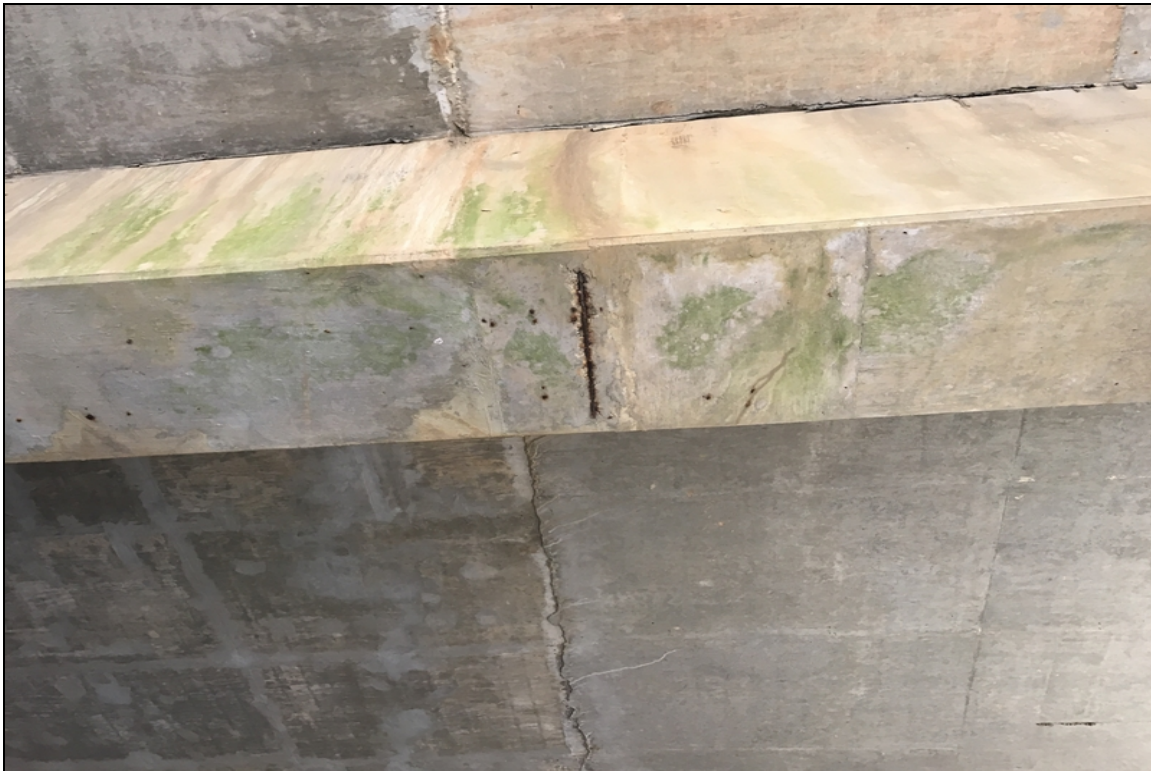
Bent 3 cap bottom between columns 2&3 has spall with exposed rebar.

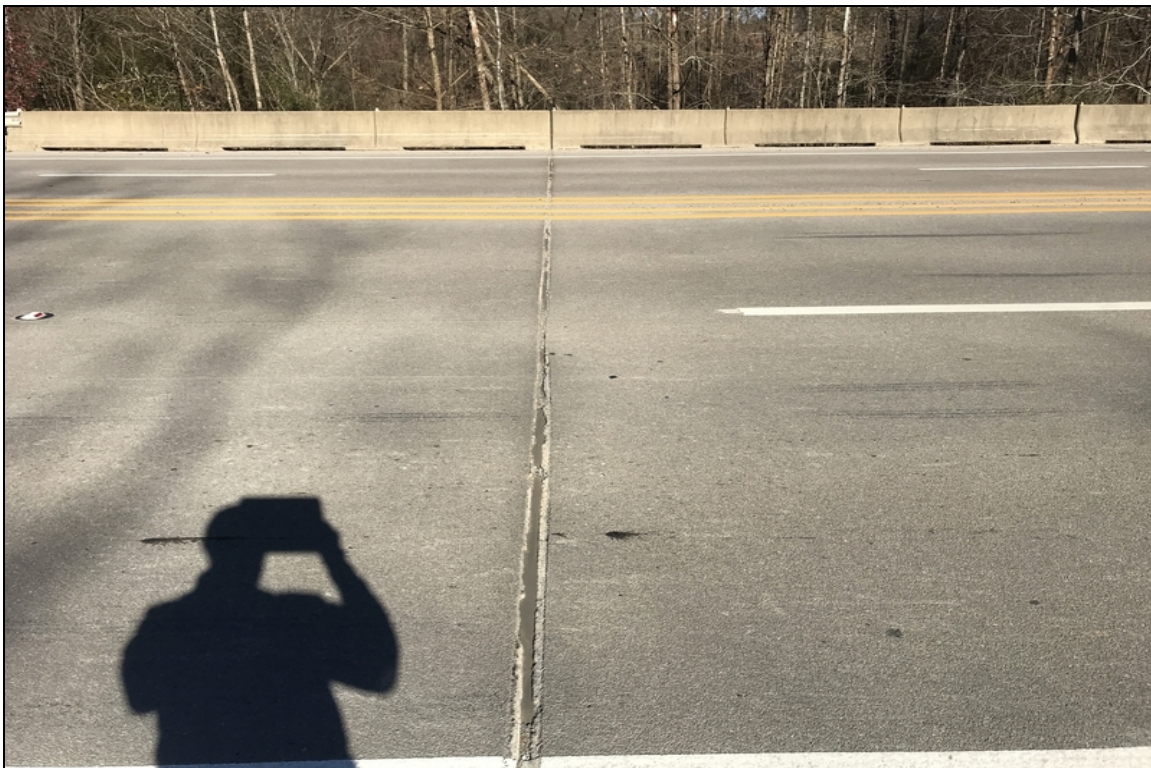
(301)							
Pourable joint seals have been repaired under job#12350

Pourable joint seals have been repaired under job# 012350

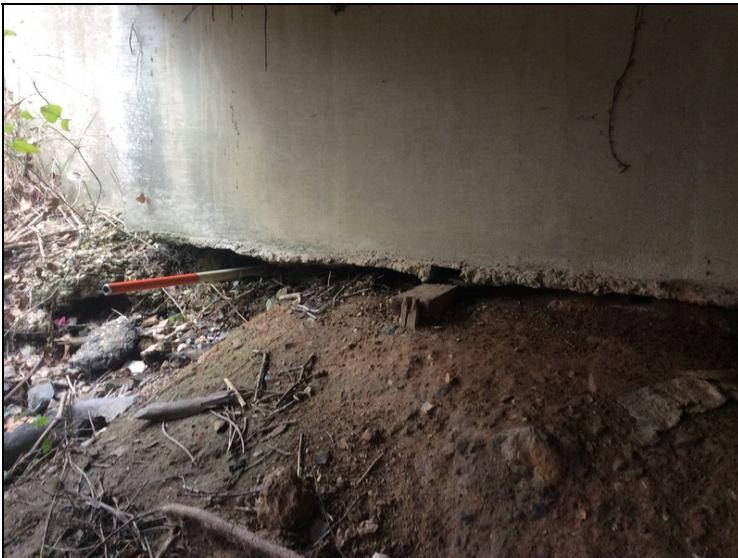
Bent 1 erosion has undermined both ends of bent. Added: 12/12/2018-KRM & RLS- The exterior pile of bent 1 are exposed due erosion.

Bent 1 right side undermined due to erosion.

Date Reported: 11/06/2013
Priority: D- Routine
Type of Work: Repair
Status: Assigned
Component: Substructure

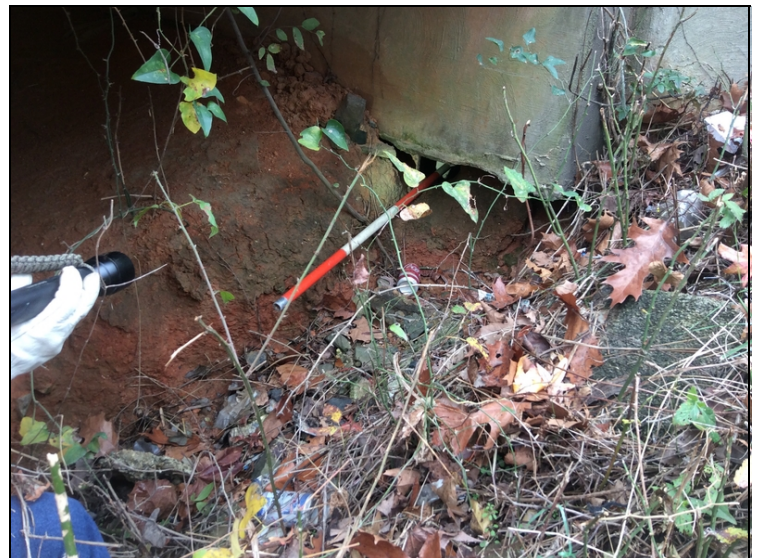
Bent 1 erosion has undermined the left end of bent.

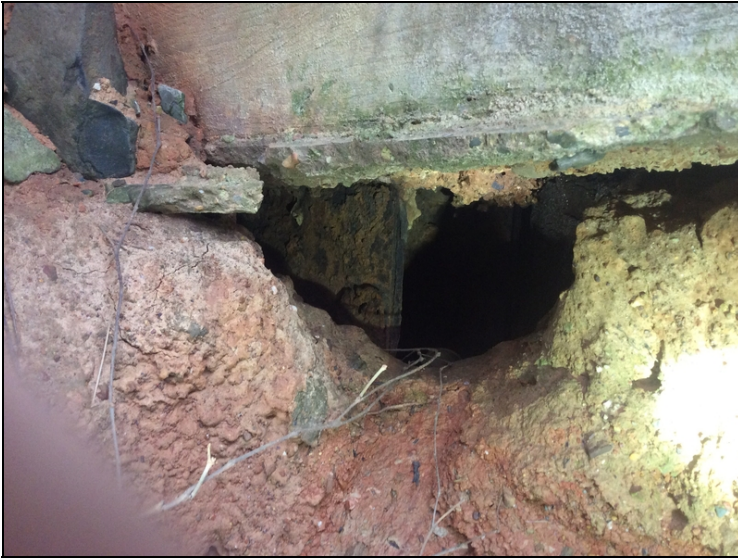
Bent 1, laminating rust on pile exposed due to erosion on the left side.

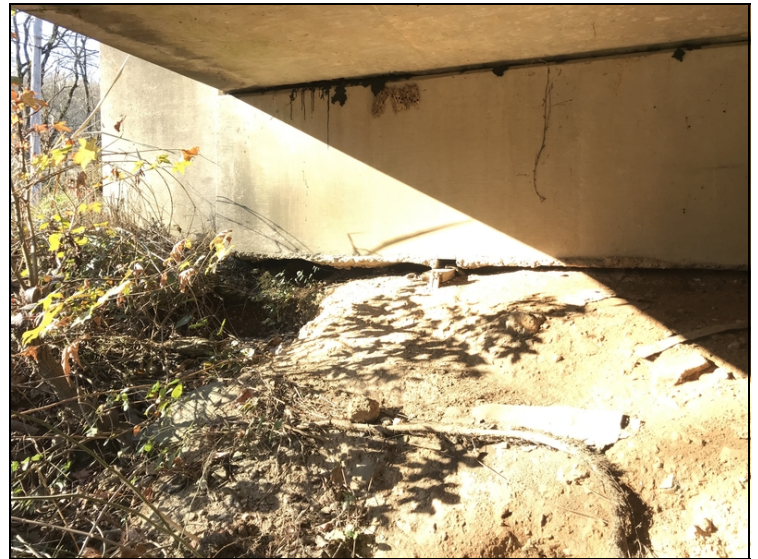
Bent 1 abutment right side undermined due to erosion.
