Bridge #02195(Routine)
US 270B Log 2.23 over FRONT ST, UPRR & 1ST

Location: .38 M N OF US 67 & SH 9

Team Lead: Bryan Saunders Inspection Date: October 23, 2019

IDENTIFICATION	
(1) State Names	Arkansas
(8) Structure Number	02195
(5) Inventory Route	270
(2) Highway Agency District	06
(3) County Code	59-Hot Spring County, Arkansas

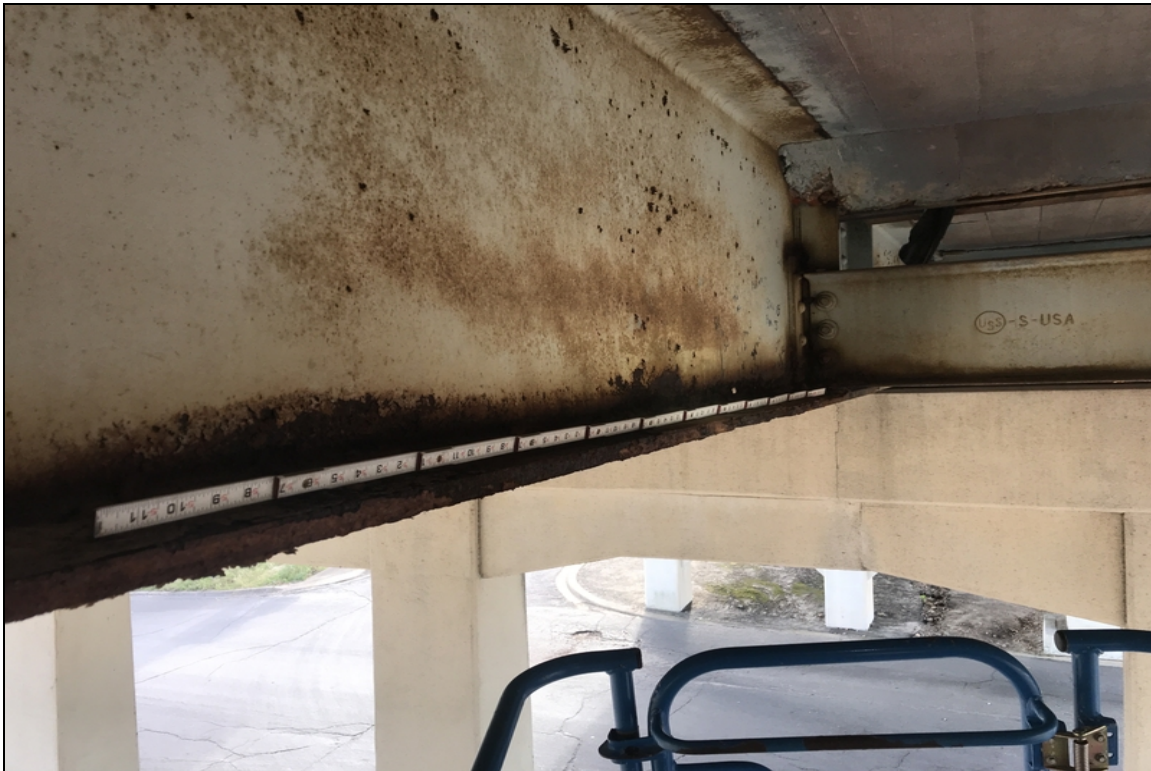
Span 18 girder 5 section loss at lower web and bottom flange

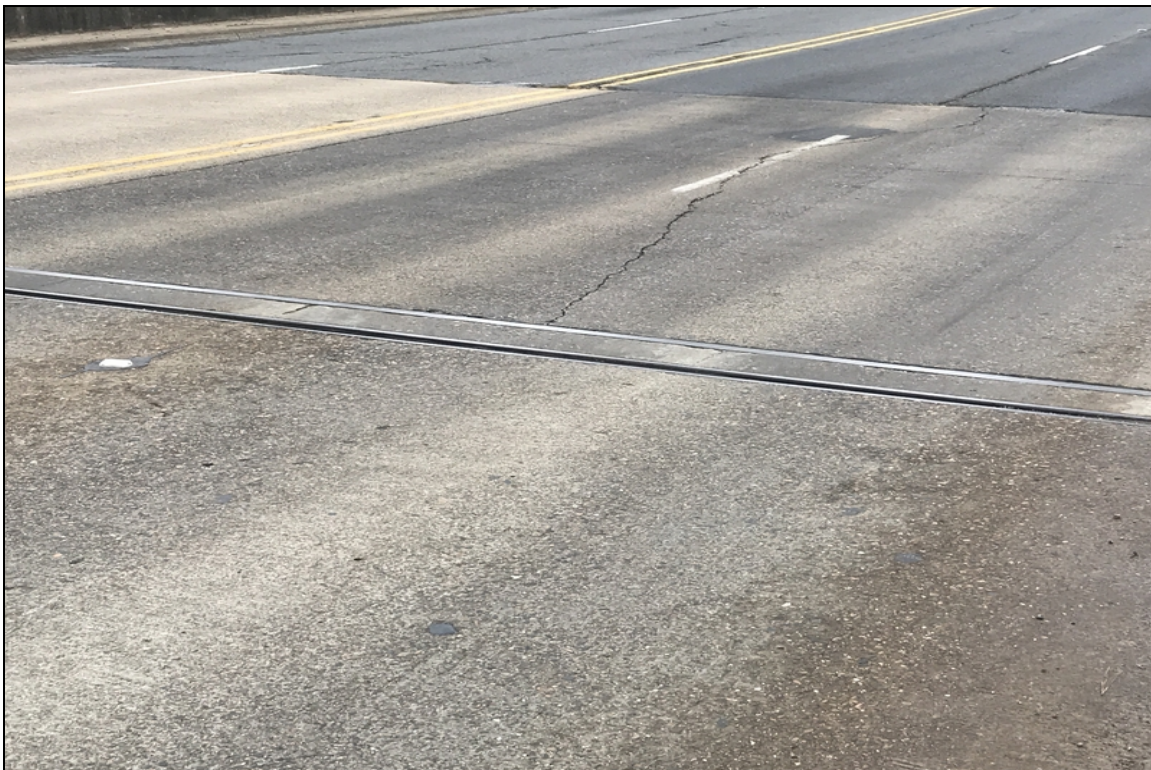
Large cracks in Approach slab at abutment 1

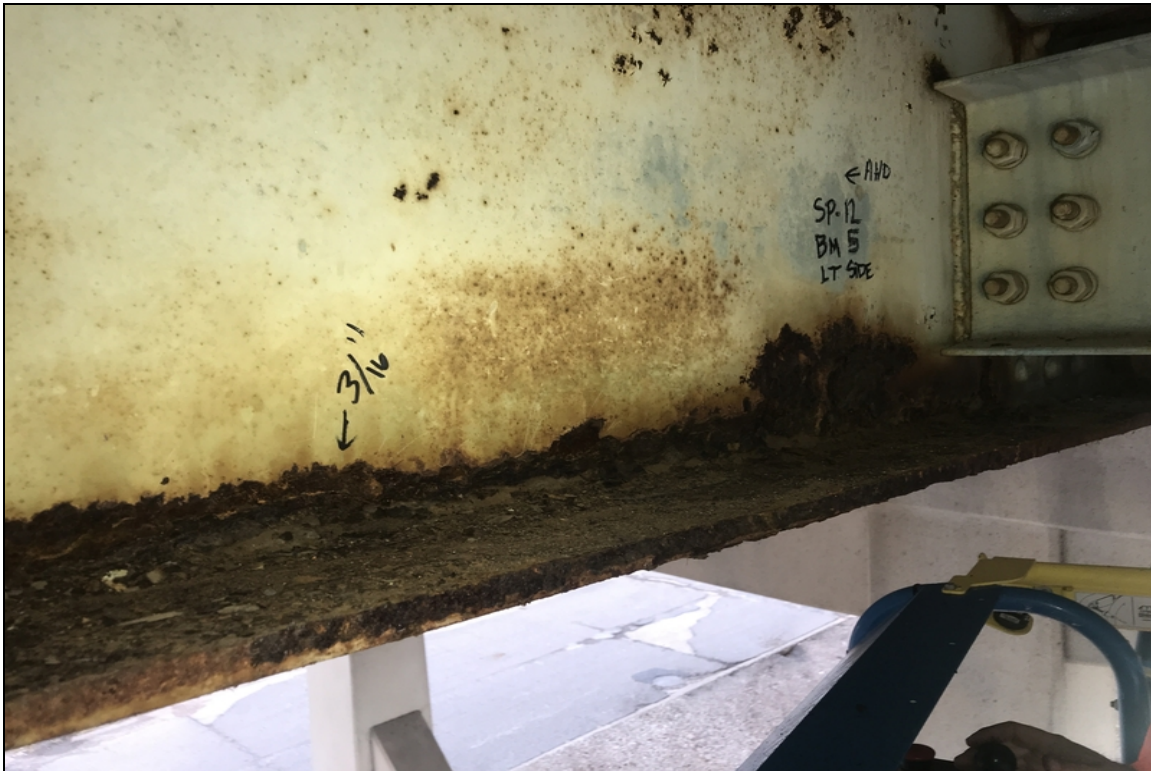
Span 12 Beam 5 lt side 3/16 section loss to lower web

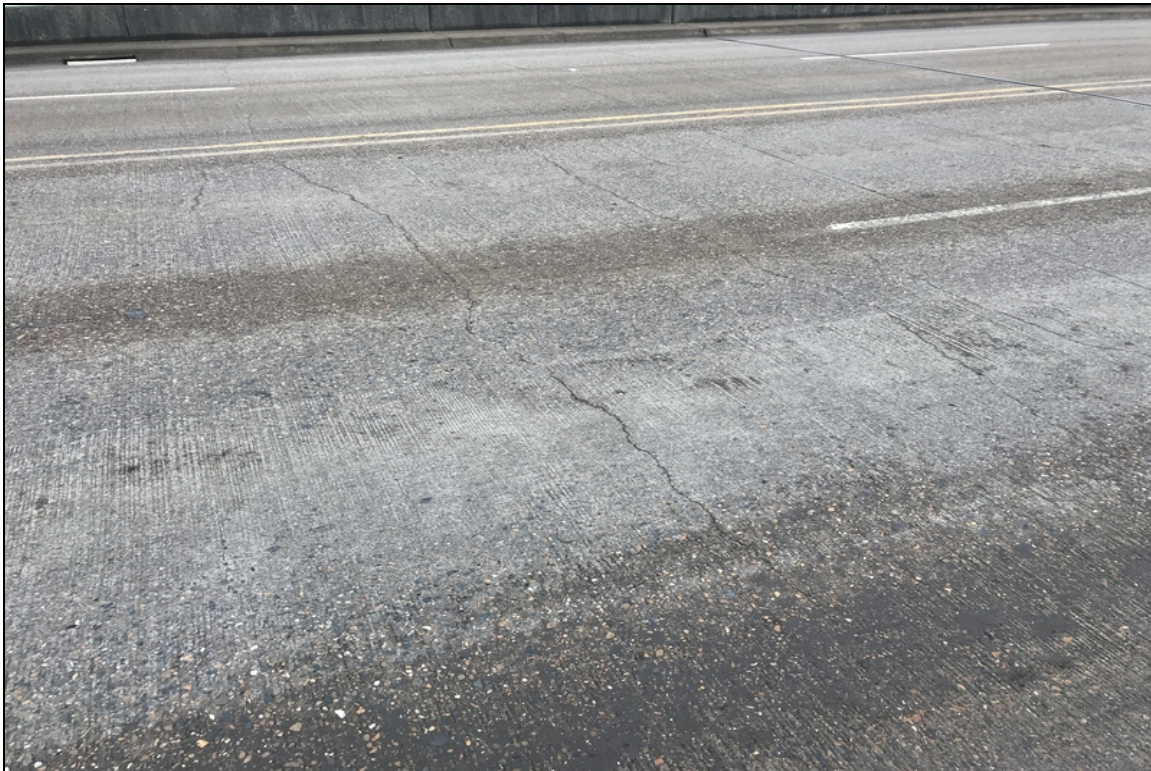
transverse Deck cracks in span 23

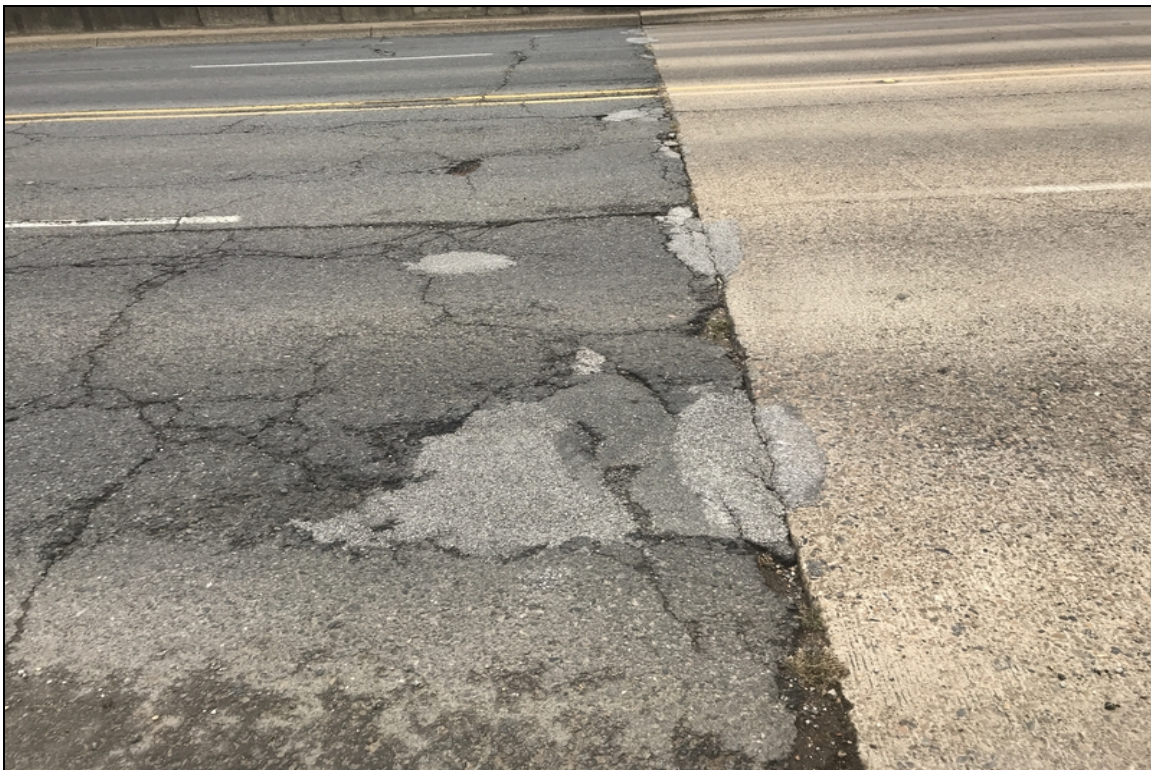
Potholes at the approach slabs at abutment 2

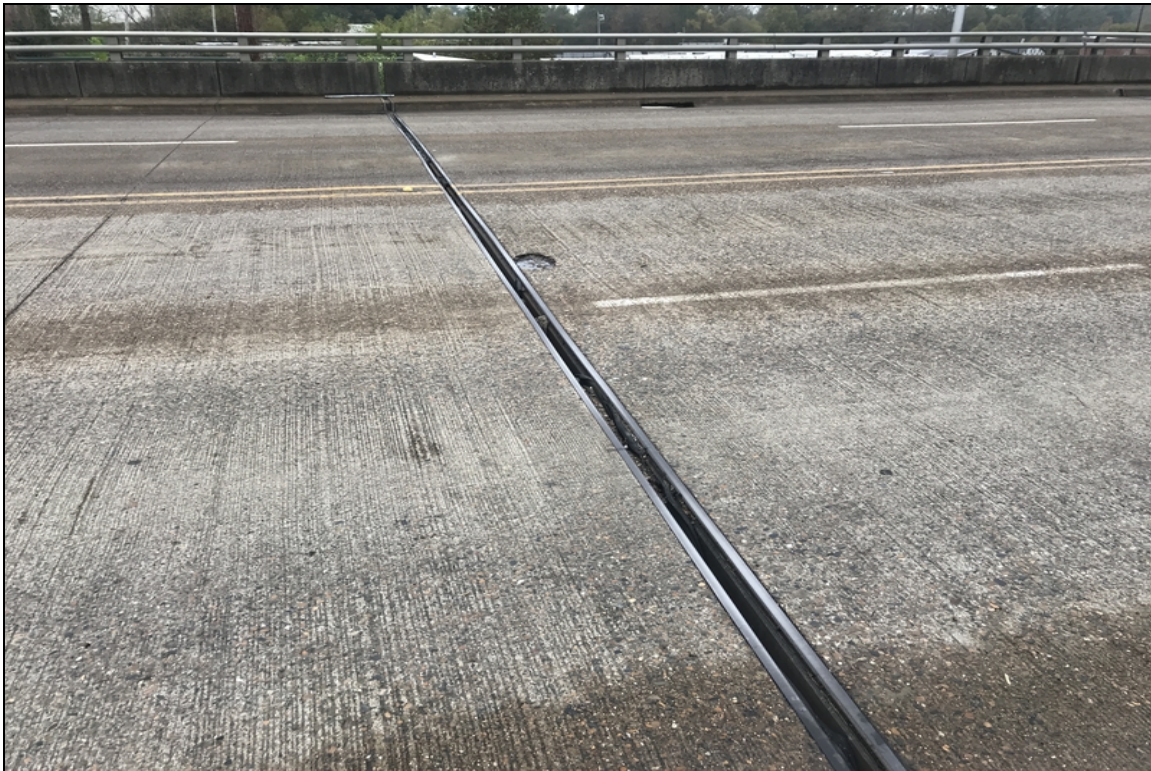
Pothole at the joint in span 22 joint 23

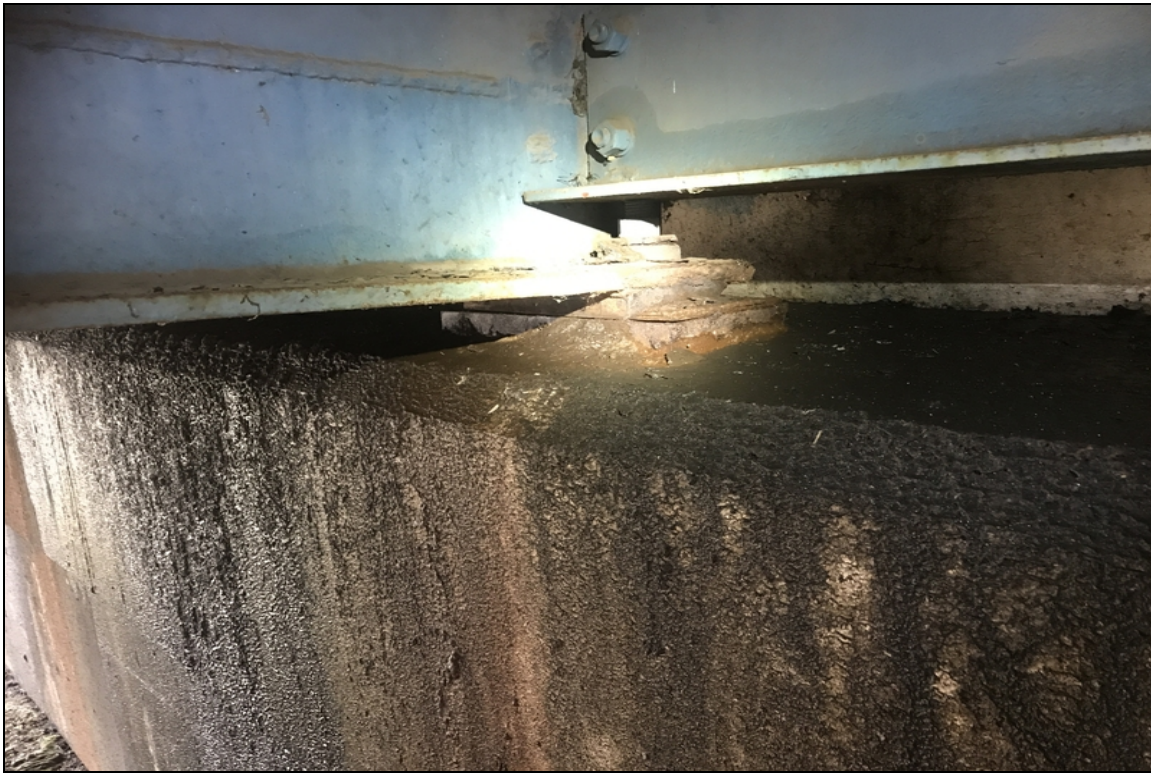
Bearing at abutment 1 beam 7 is corroded with laminating rust

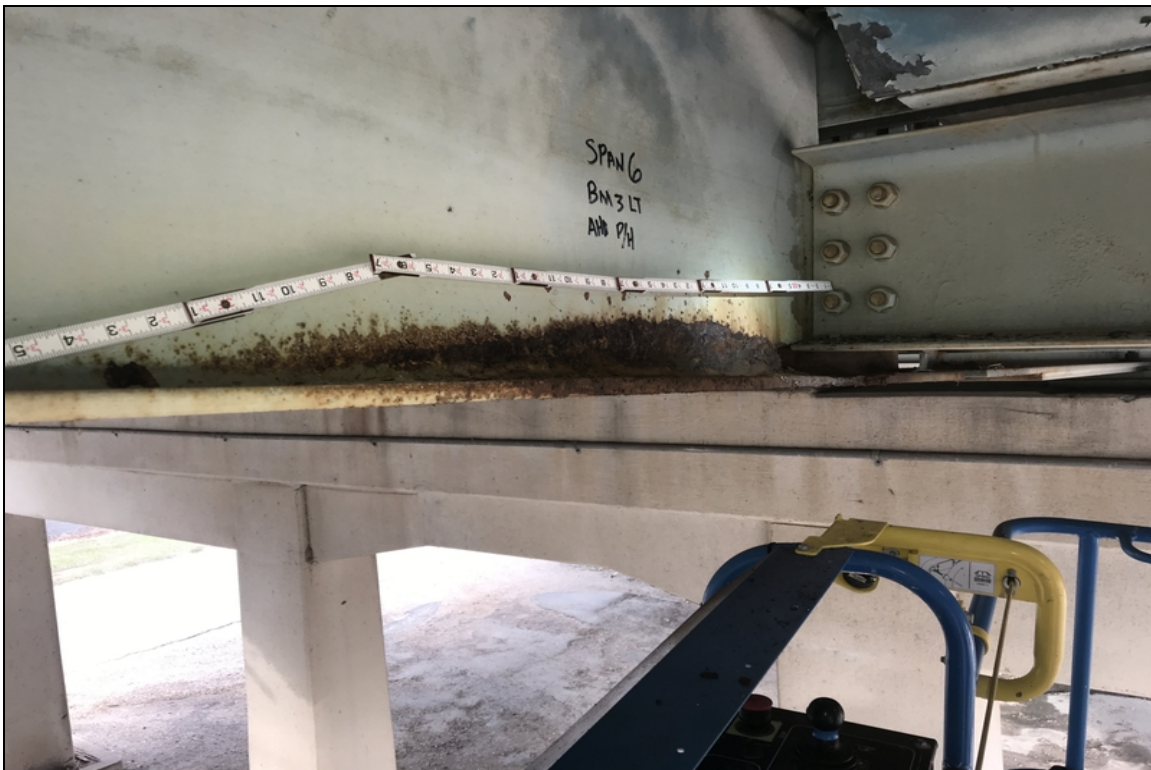
Span 6 beam 3 left side ahead of pin and hanger section loss to lower web and bottom flange

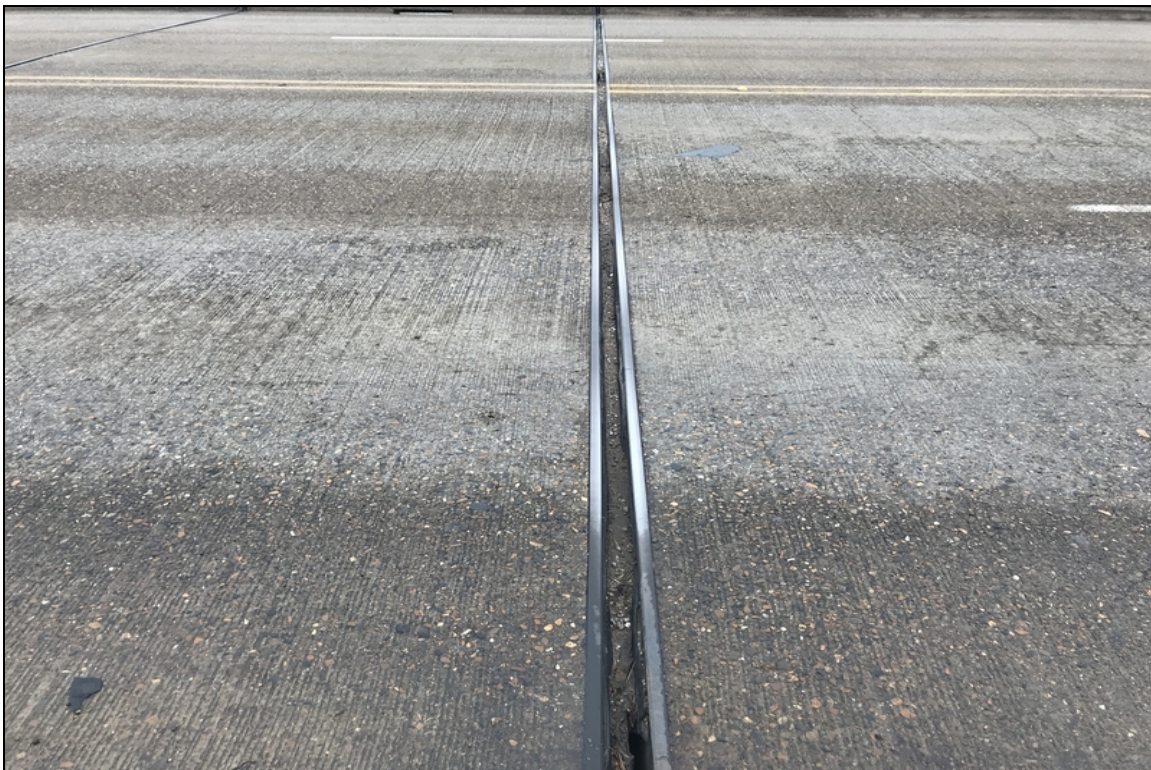
Joint seal at bent 14 is full of debris has lost bond and is leaking

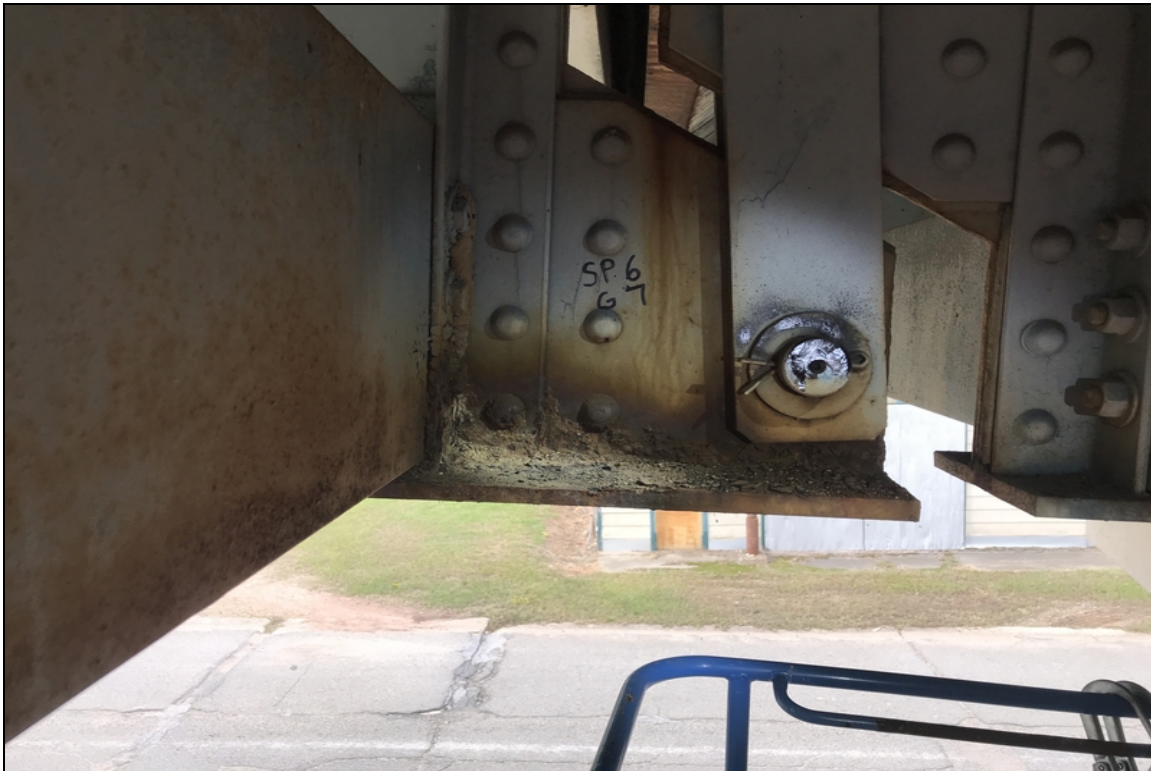
Span 6 beam 7 lower web and bottom flange section loss

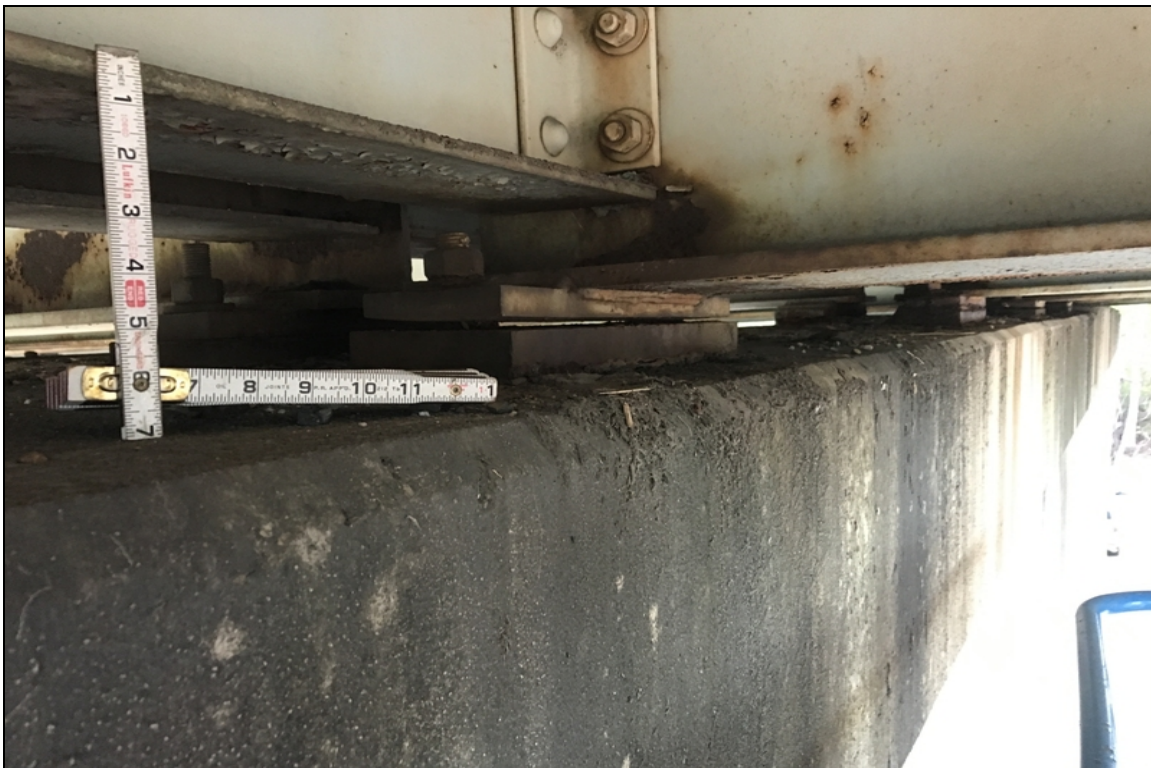
Bent 9 bearings 6 and 8 have an 1/8" gap

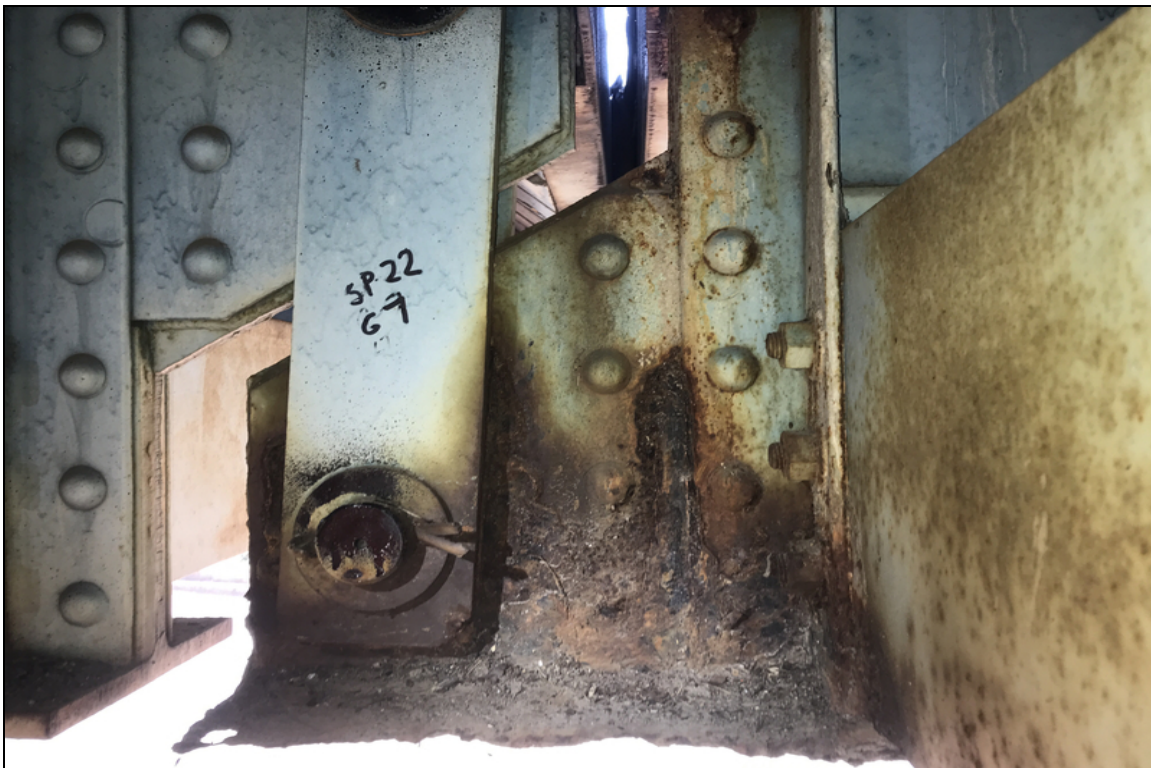
Beam end at Span 22, girder 7, is down to a knife edge in the flange with heavy pitting in the lower web

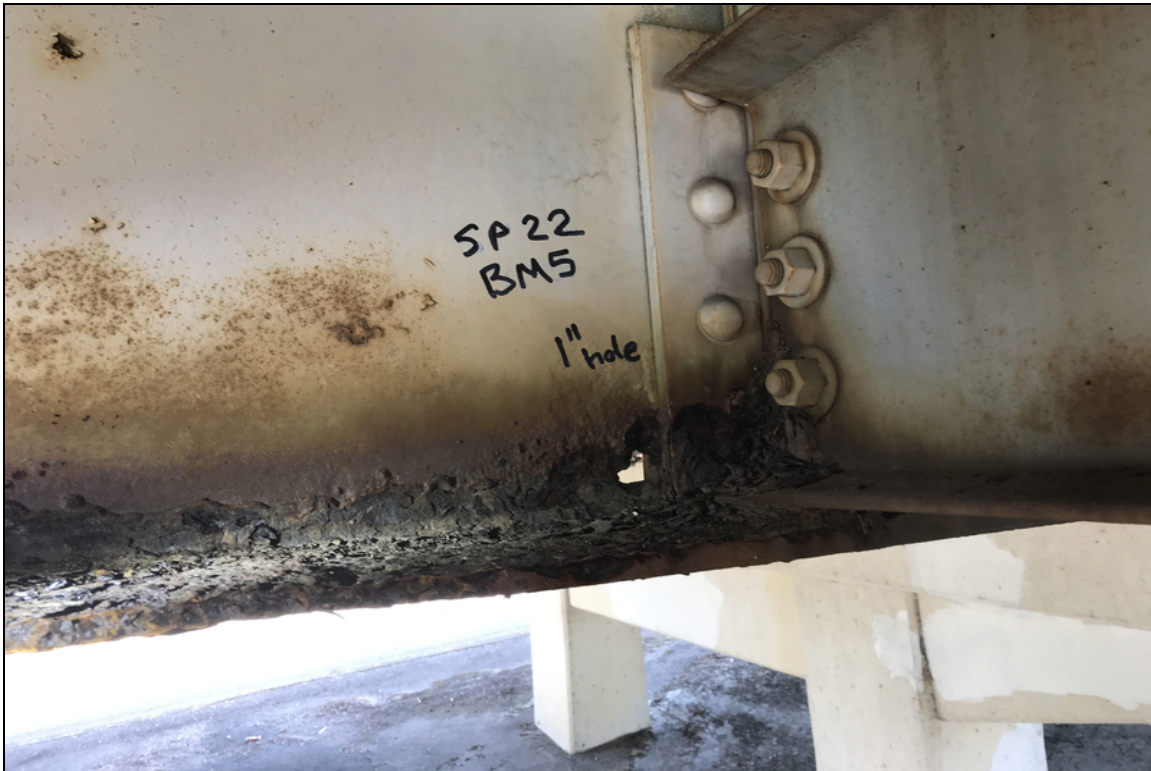
1 inch hole at beam end in span 22 beam 5

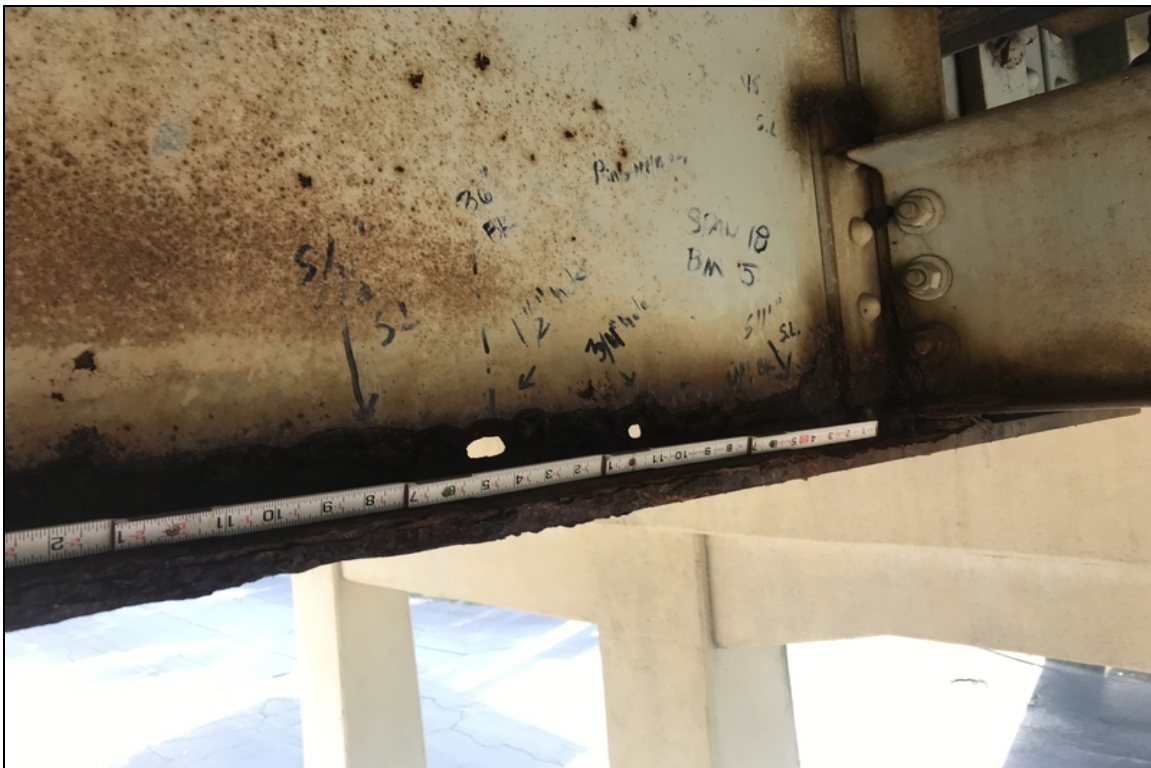
Span 18 beam 5 has 5/16 section loss to bottom flange and two holes, 1 1/2 inch; and 3/4 inch; that are 36 inch; back from beam end

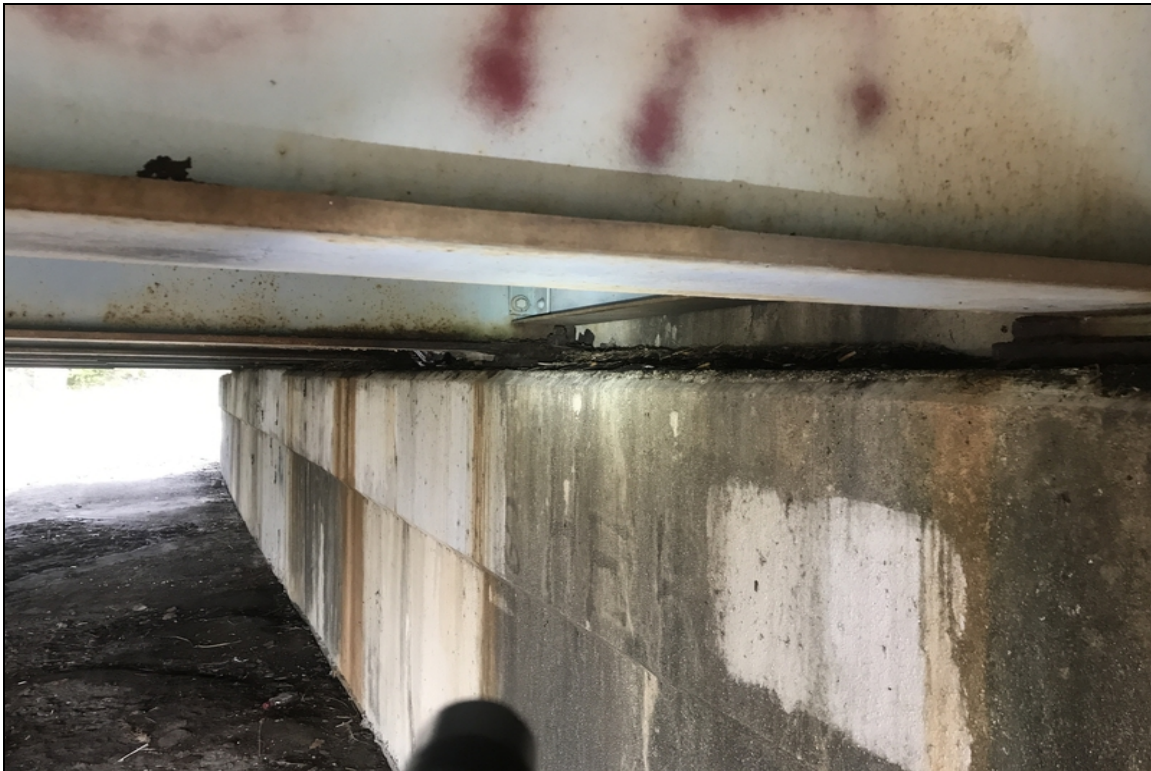
Dirt and debris build up around bearings on the cap at abutment 2

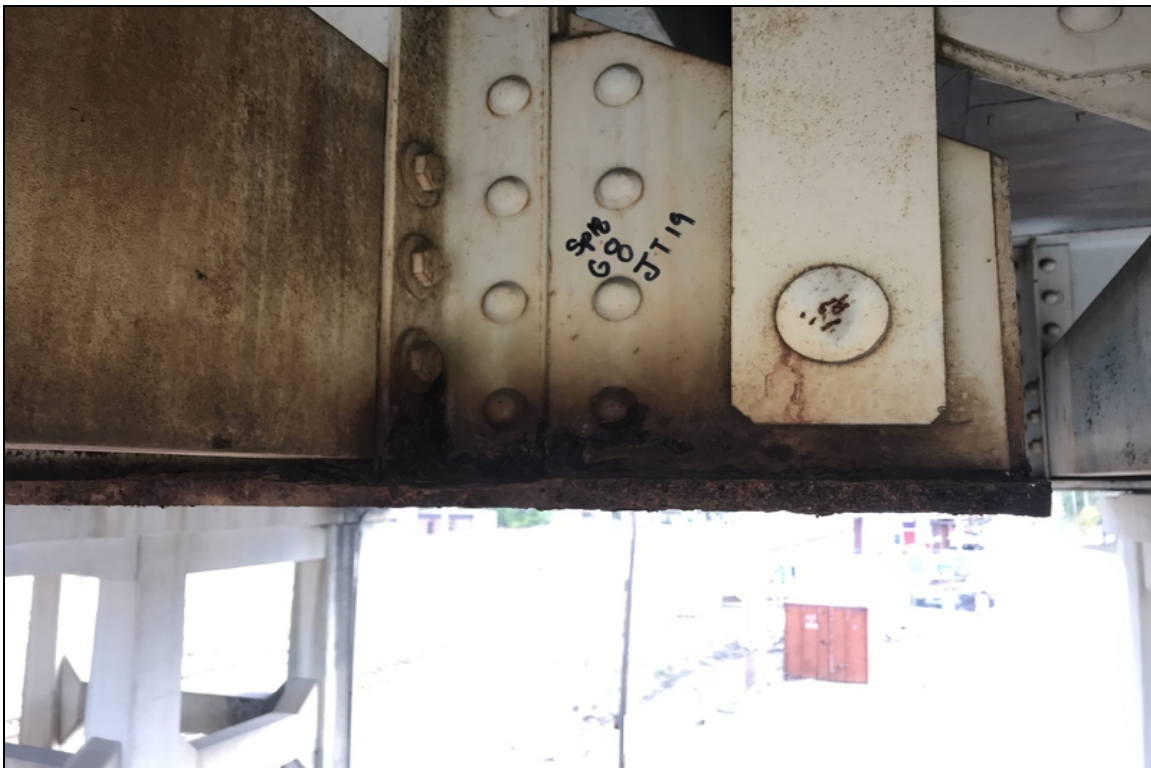
Span 18 beam 8 has 1/4" section loss at the bottom flange

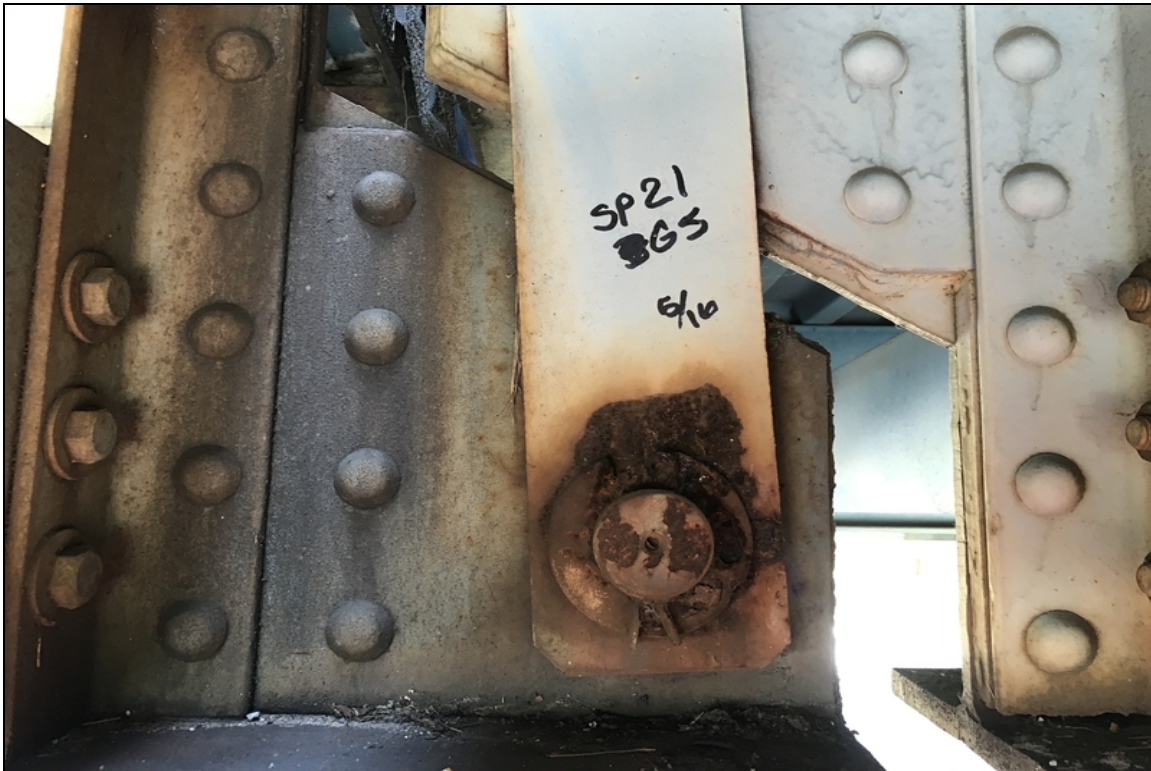
5/16 section loss to hanger at span 21 beam 5

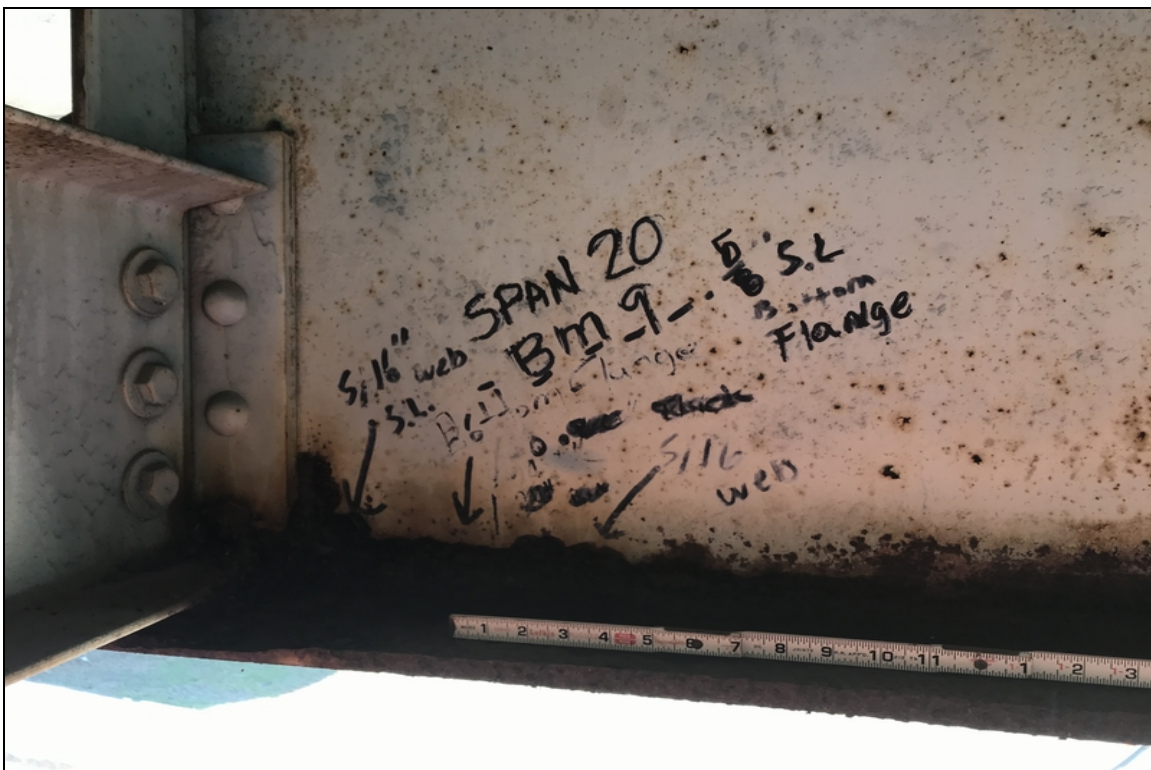
Span 20 beam 9 has 5/16 section loss to lower web and up to 5/8 section loss to the bottom flange

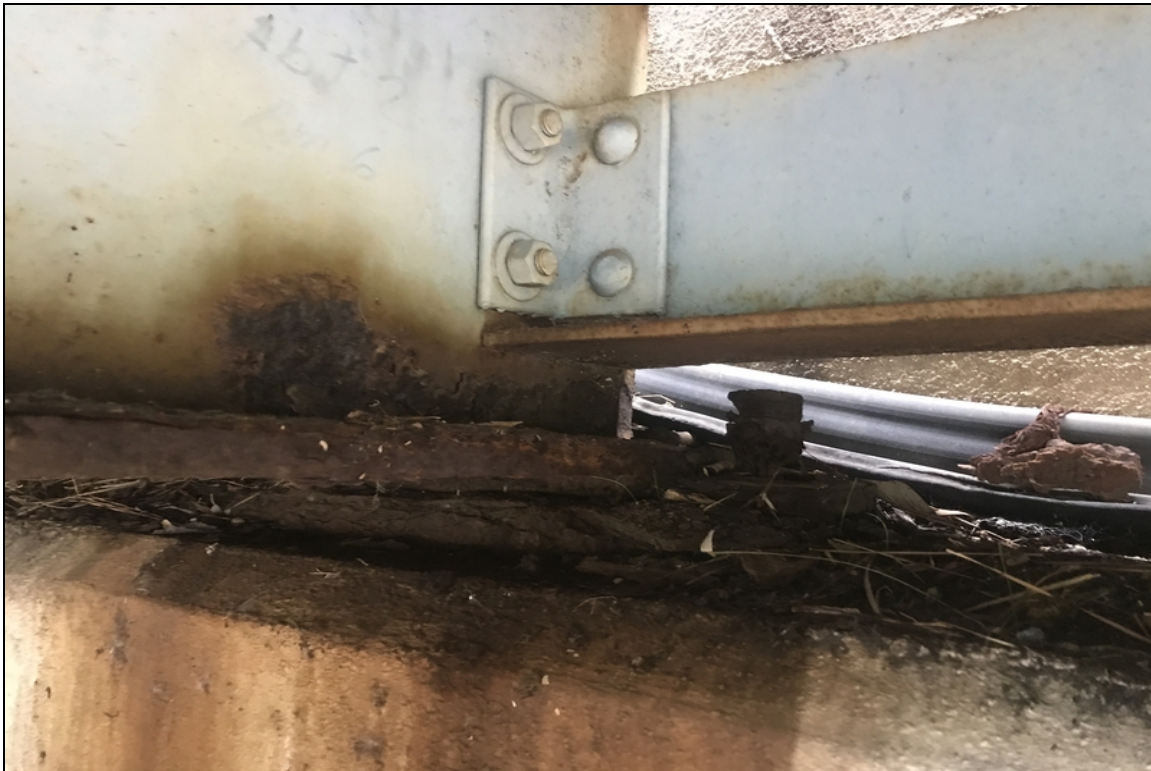
Bearings at Abutment 2 are heavily corroded with the bearing at beam 6 being the worst case

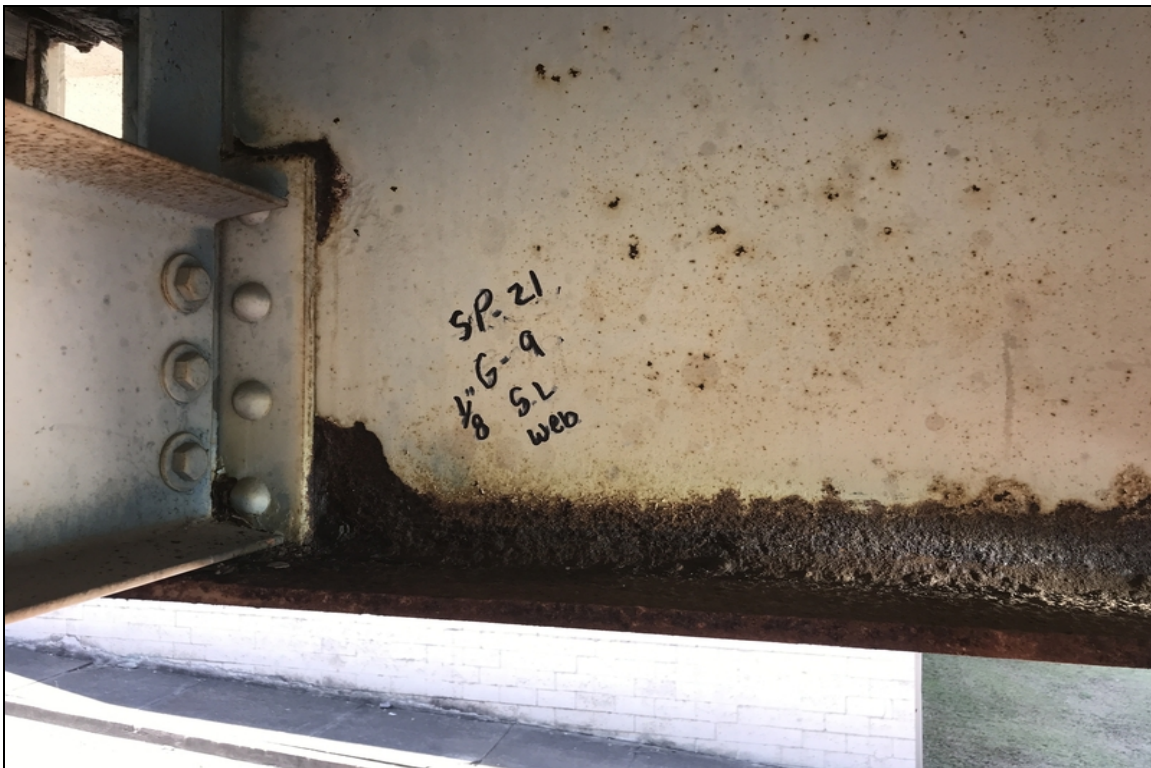
Span 21 beam 9 has 1/8 section loss to the lower web

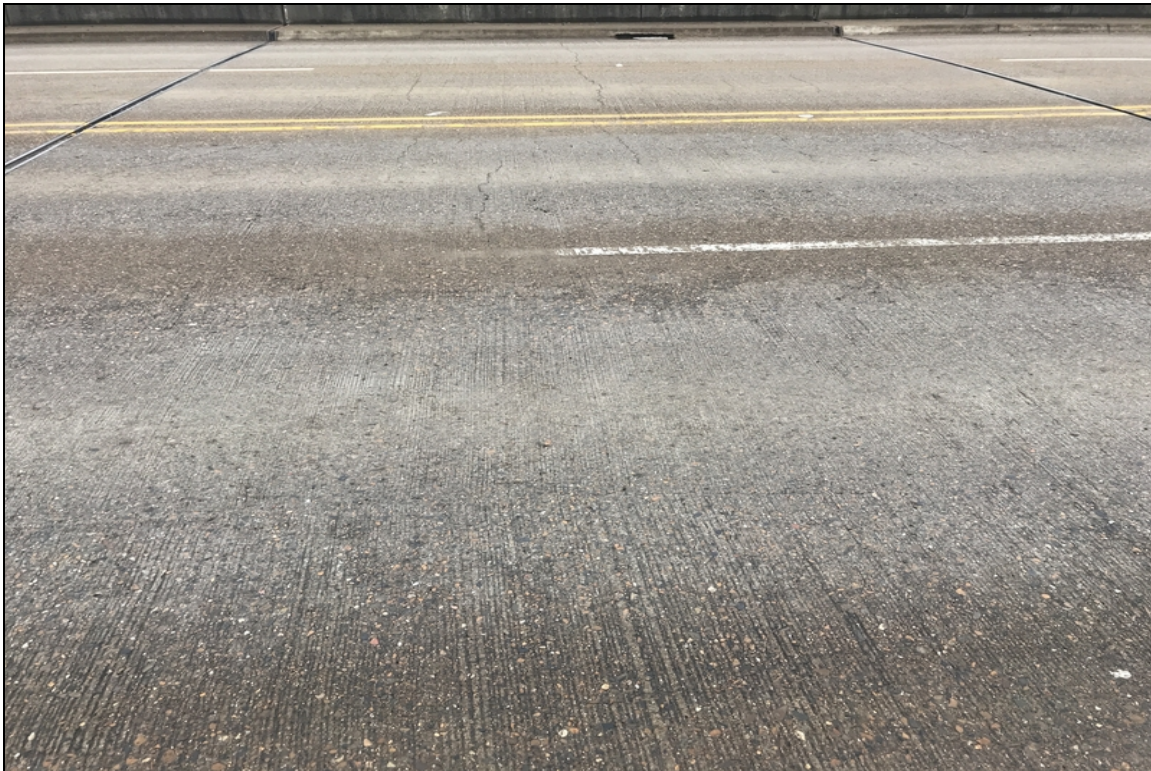
Deck cracks in span 13

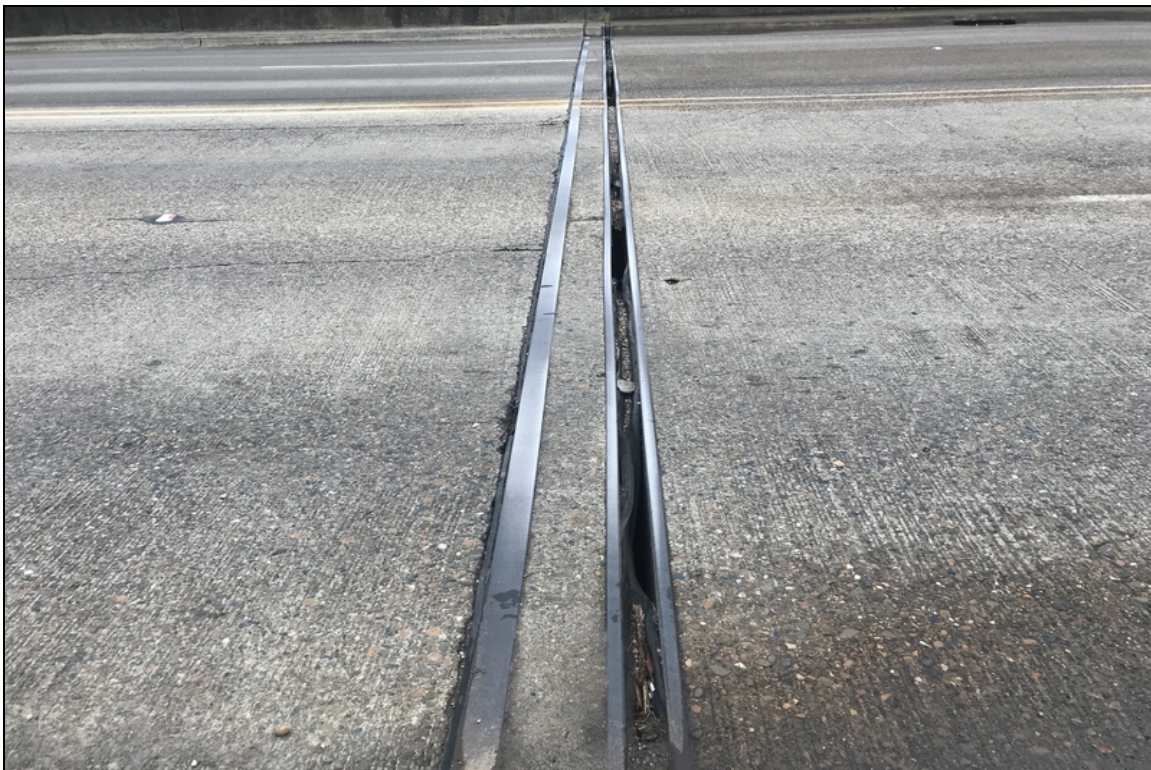
Joint seal at abutment 2 has lost bond and fallen out.

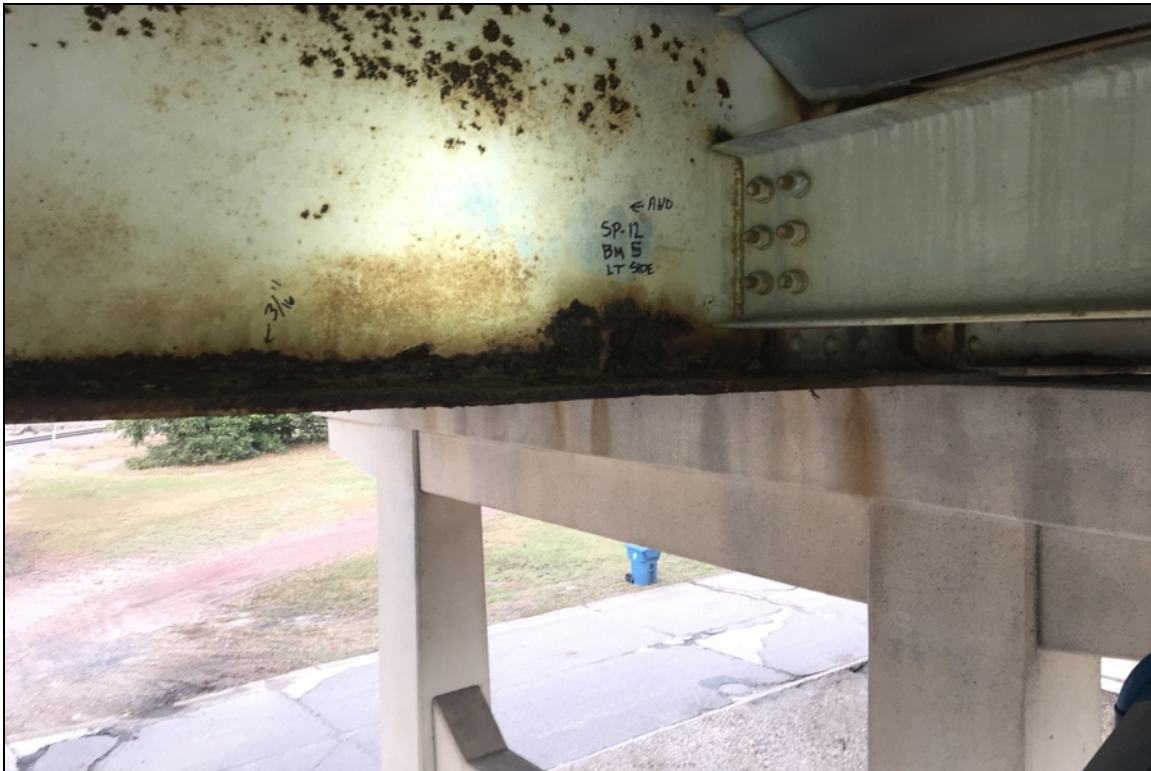
Span 12 Beam 5 lt side 3/16 section loss to lower web

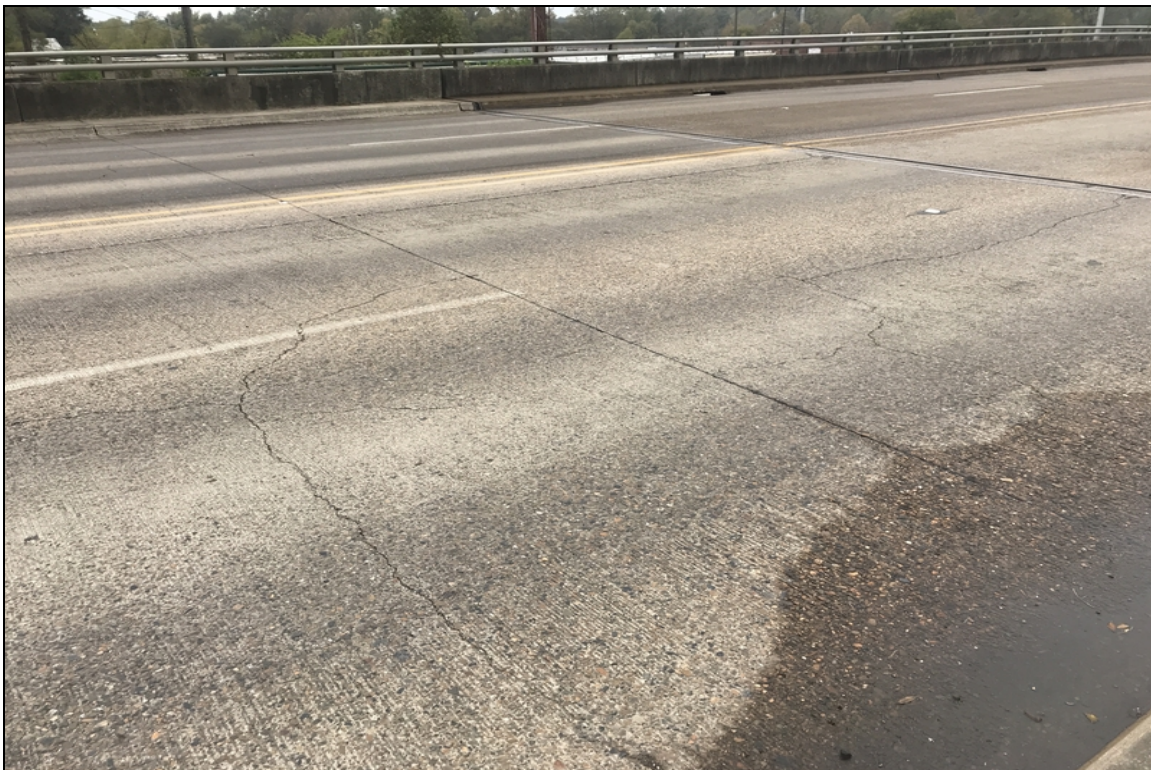
Approach slabs at abutment 2 have large Transverse and longitudinal cracks

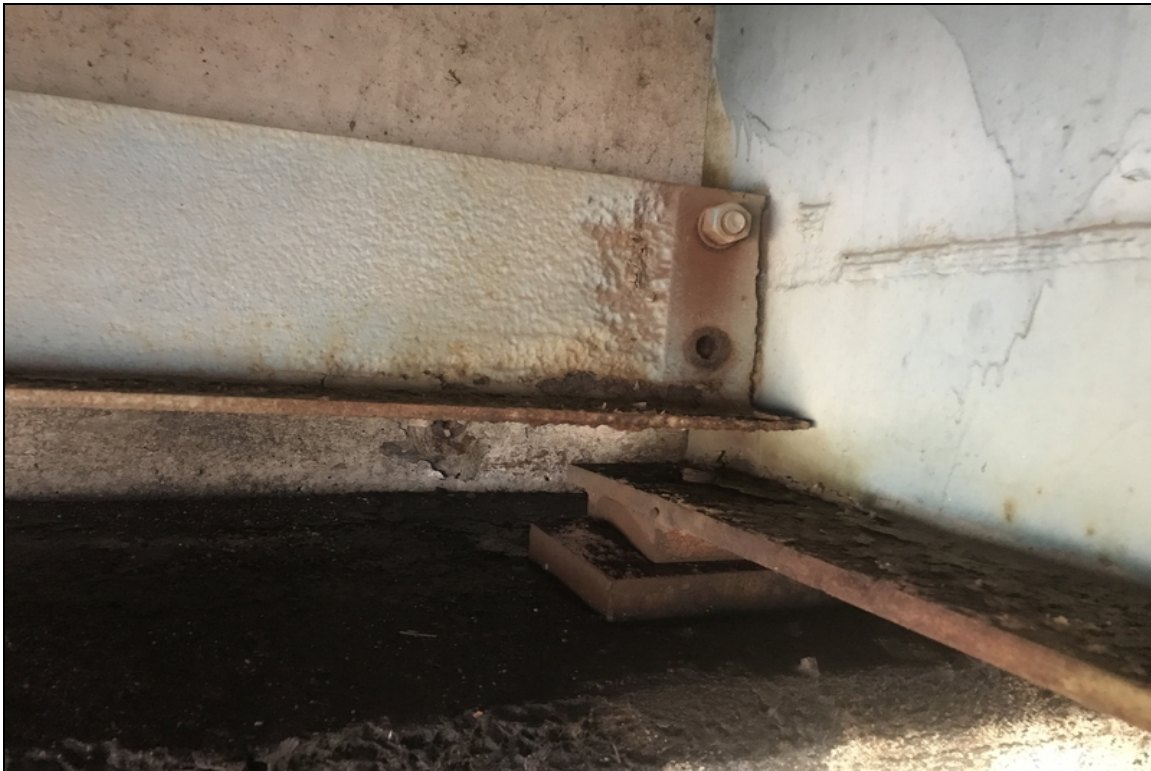
Abutment 1 beam 6 right side at the diaphragm has a missing bolt
