Bridge #02195(Routine)
US 270B Log 2.23 over FRONT ST, UPRR & 1ST

Location: .38 M N OF US 67 & SH 9

Team Lead: Bryan Saunders Inspection Date: October 23, 2019

IDENTIFICATION	
(1) State Names	Arkansas
(8) Structure Number	02195
(5) Inventory Route	270
(2) Highway Agency District	06
(3) County Code	59-Hot Spring County, Arkansas

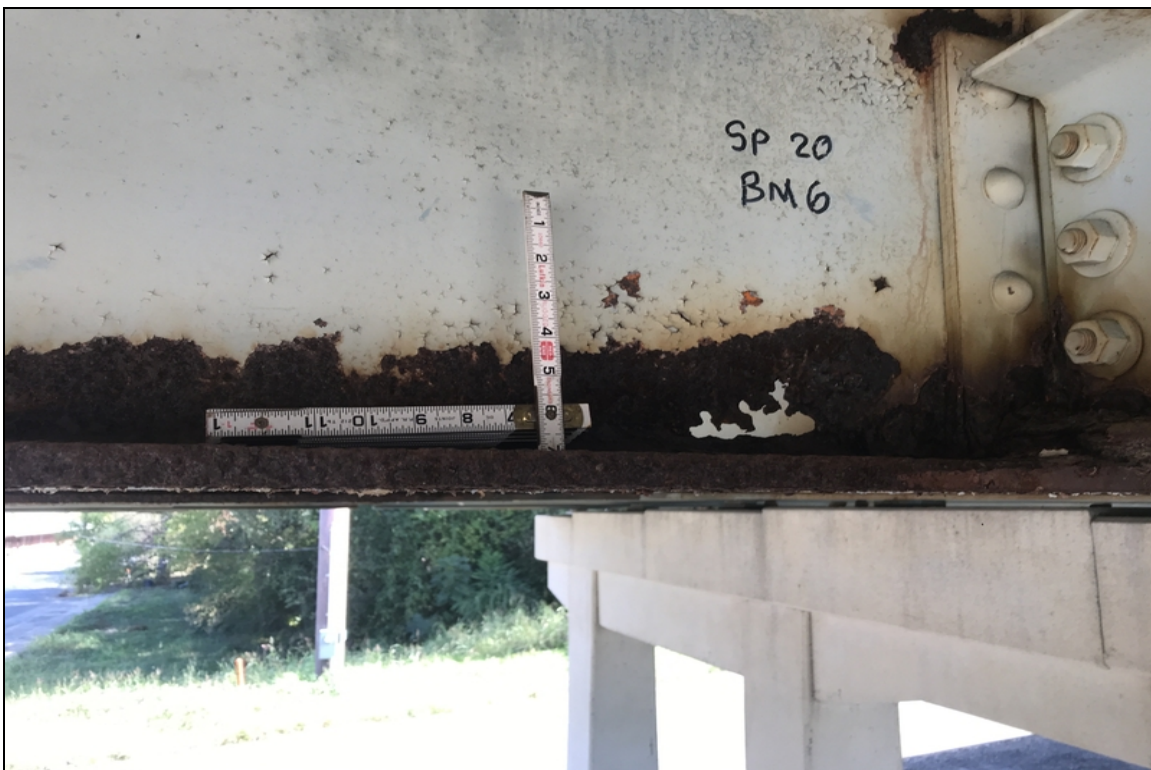
3.5 x2 hole at span 20 beam 6

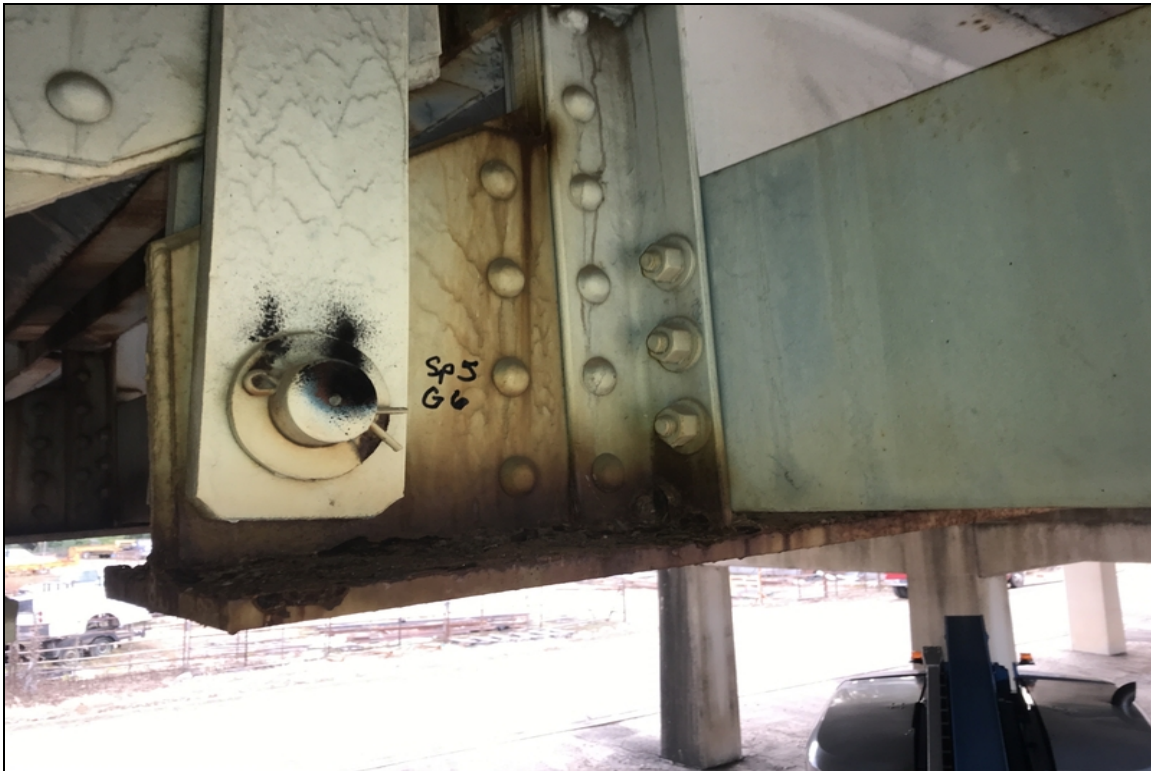
Lower web at span 5 beam 6t

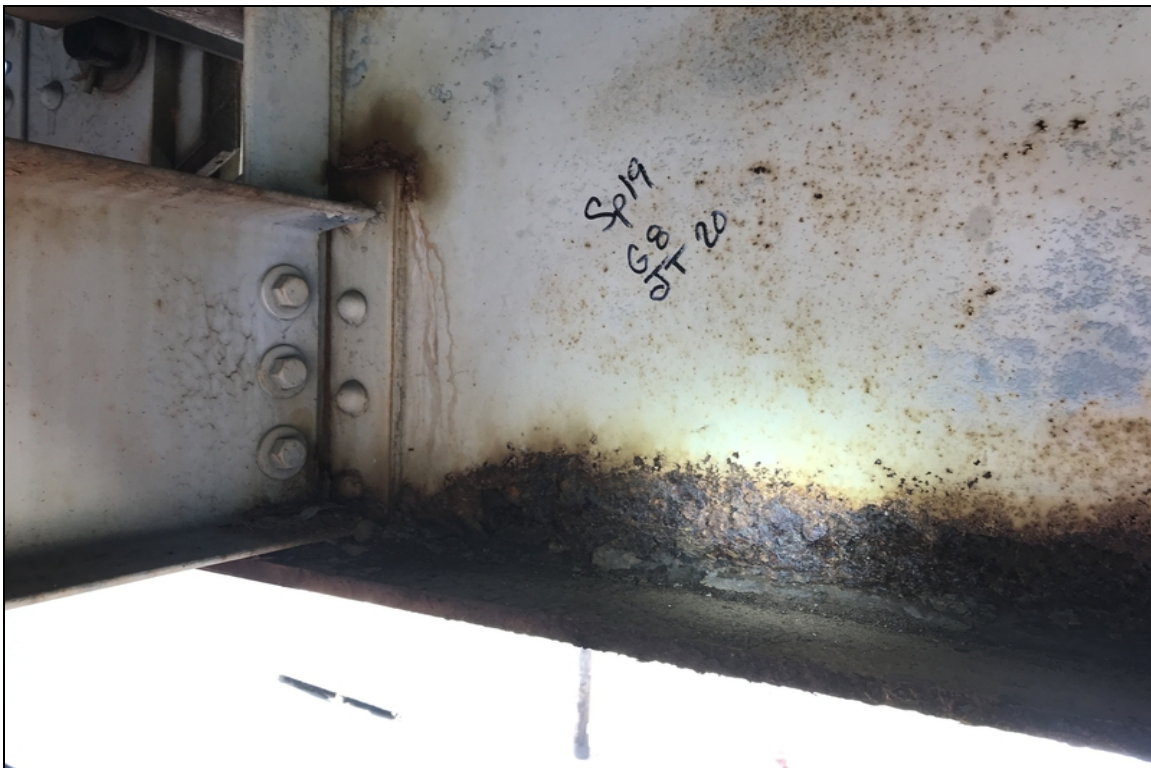
span 19 beam 8 joint 20 has 1/8" section loss

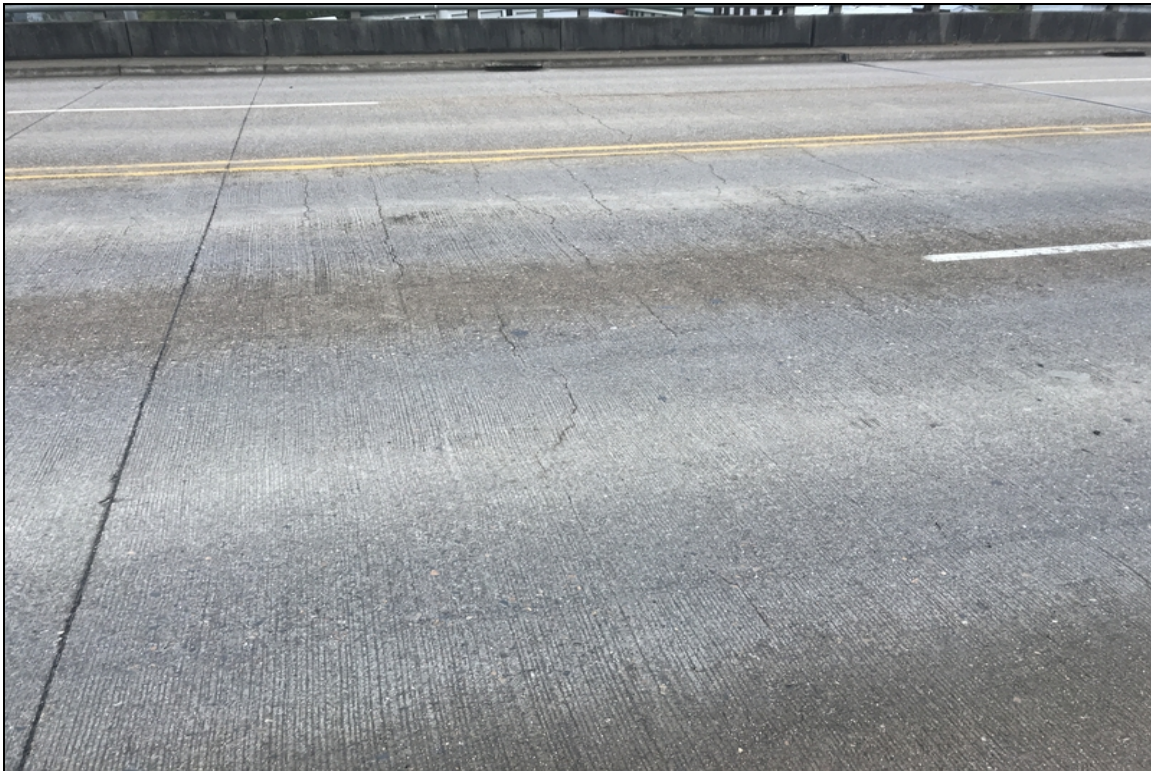
Transverse Deck cracks in span 4

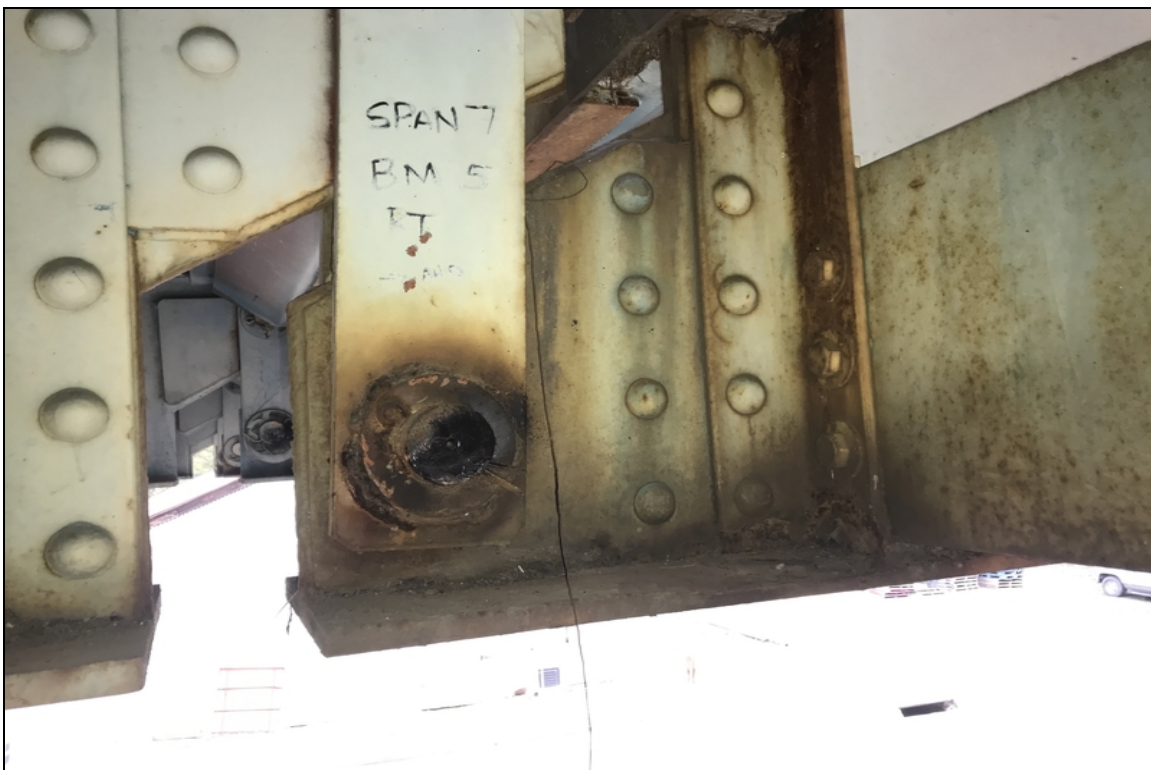
Span 7 beam 5 ahead hanger at lower pin has section loss up to 1/8" behind washer

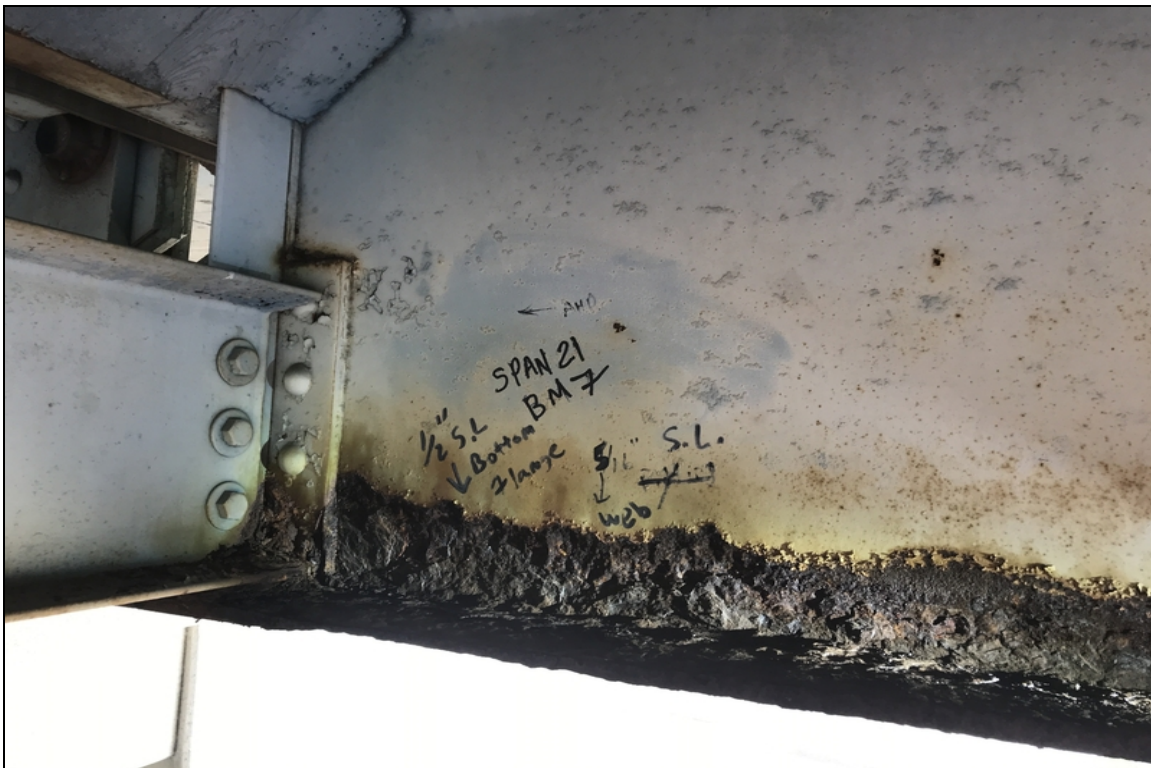
Span 21 beam 7 has 1/2" section loss to bottom flange and 5/16" section loss to lower web

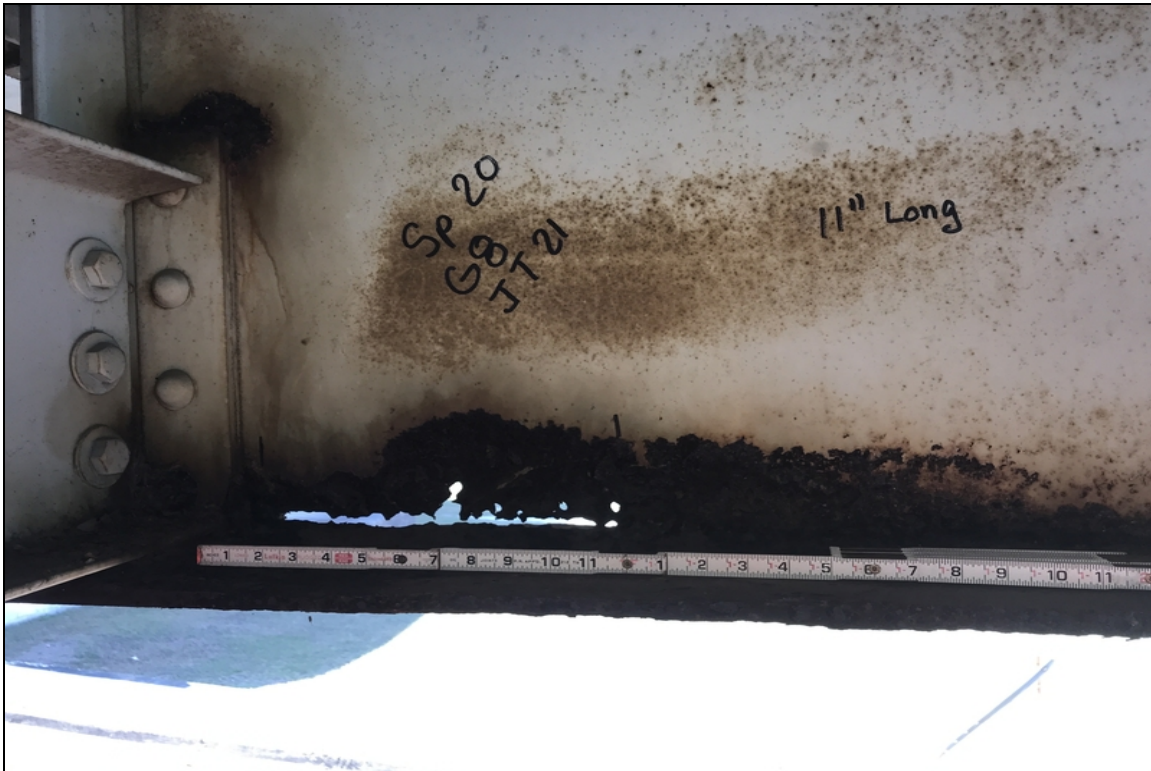
11" x 1.5 hole at span 20 beam 8 joint 21
