**Bridge #05177(Routine)**  
**US 270-SEC 7B over PARK DRIVE, UPRR**  
**Location: .75 MI NW JCT US 270 & 67**

**Team Lead: Bryan Saunders Inspection Date: September 26, 2019**

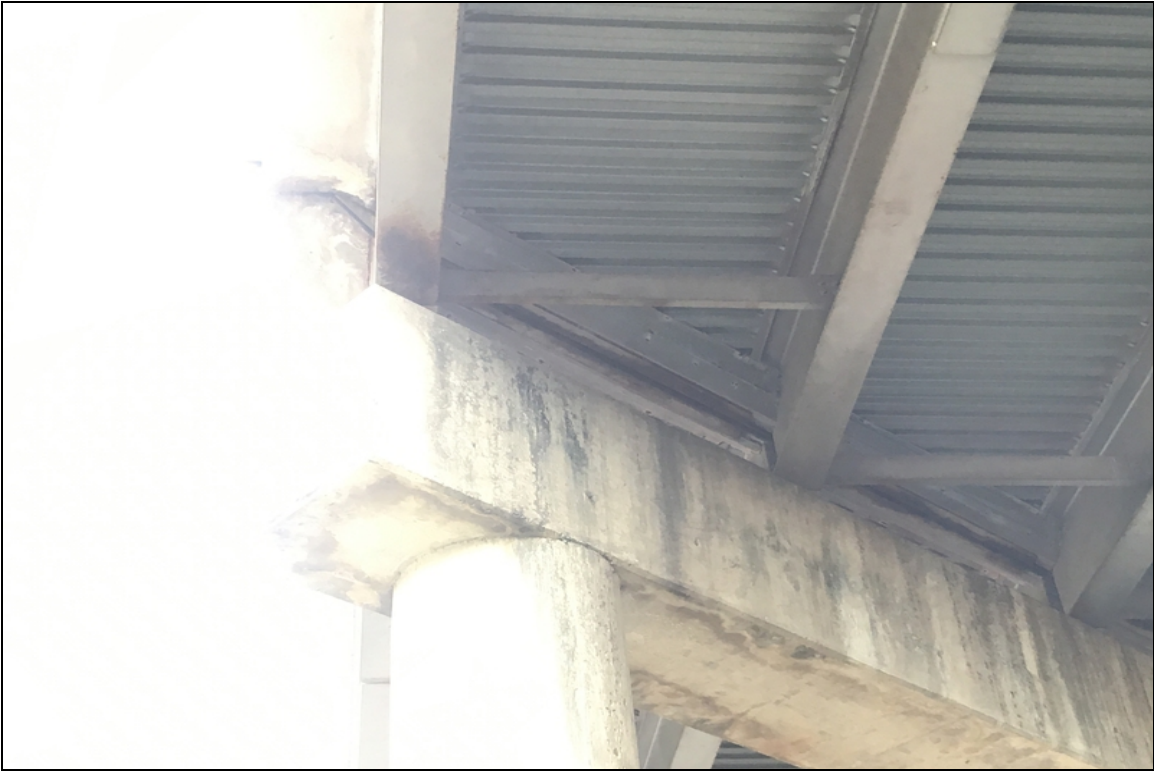
(107)	All beam ends have minor corrosion due to torn and leaking joint seals. All beams have scattered areas of corrosion						
205	Reinforced Concrete Column	EA	21	12	0	9	0
1080	Delamination/Spall/Patched Area	EA	1	0	0	1	0
1090	Exposed Rebar	EA	8	0	0	8	0

Corrosion on the beam ends at bent 2

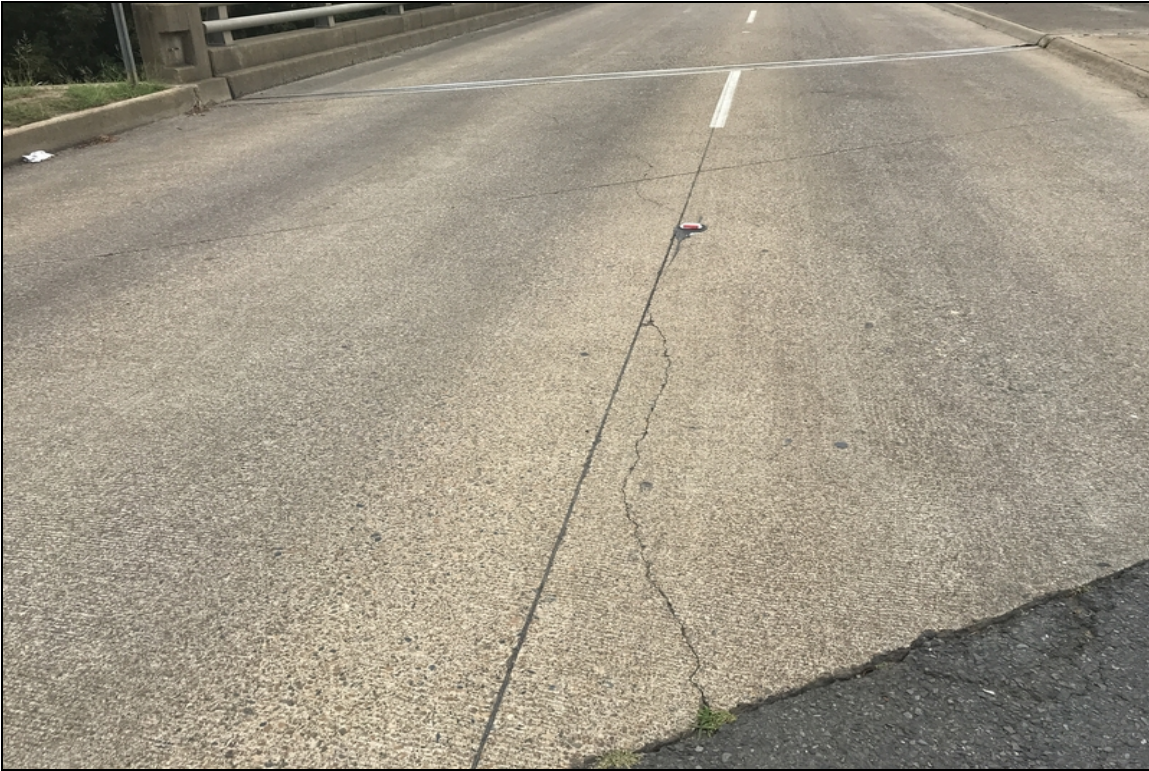
All approach slabs have large unsealed cracks

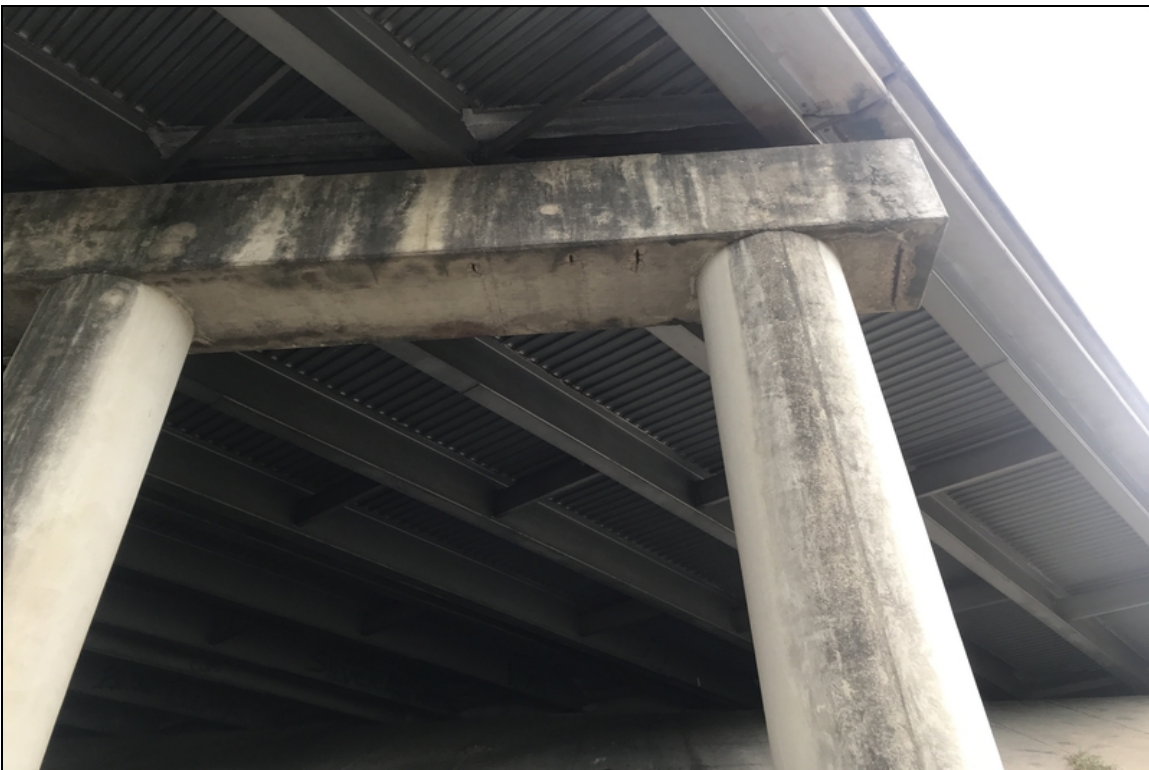
(234)	All caps have horizontal cracks and delaminations , cap at bent 4 has large spalls with rebar exposed						
302	Compression Joint Seal	LF	439	0	334	90	15

Spalls with rebar in the underside of the cap at bent 4

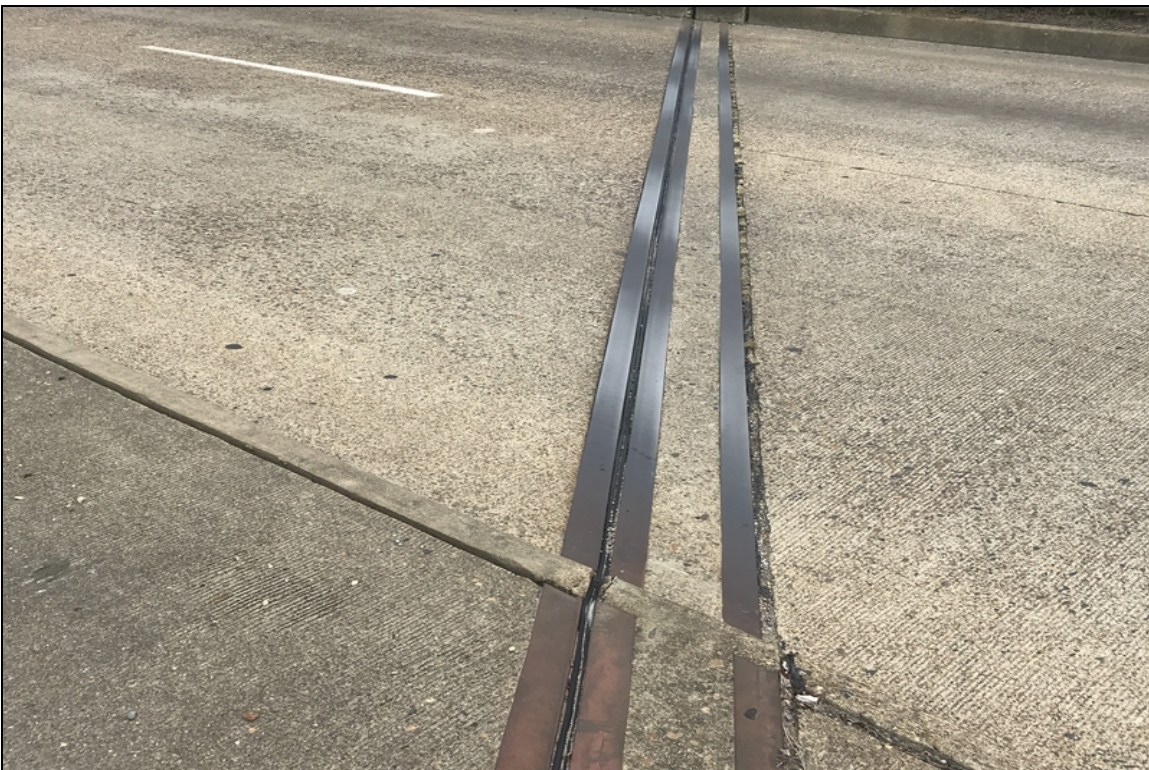
ELEM	DESCRIPTION	UNITS	TOTAL	CS1	CS2	CS3	CS4
2310	Leakage	LF	349	0	334	0	15
2330	Seal Damage	LF	30	0	0	30	0
2340	Seal Cracking	LF	60	0	0	60	0
(302)	All joint seals are Torn and leaking. Bent 4 has 15" of missing joint seal.						
311	Movable Bearing	EA	52	0	46	6	0
1000	Corrosion	EA	52	0	46	6	0
(311)	All bearings have corrosion due to leaking joint seals						
313	Fixed Bearing	EA	52	0	48	4	0
1000	Corrosion	EA	52	0	48	4	0
(313)	Most All bearings have corrosion due to leaking joint seals						
321	Reinforced Concrete Approach Slab	SF	4750	4395	100	255	0
1130	Cracking (RC and Other)	SF	355	0	100	255	0
(321)	Approach slabs have large unsealed cracks						
330	Metal Bridge Railing	LF	472	472	0	0	0
331	Reinforced Concrete Bridge Railing	LF	472	472	0	0	0

Joint seal at bent 5 is torn and leaking

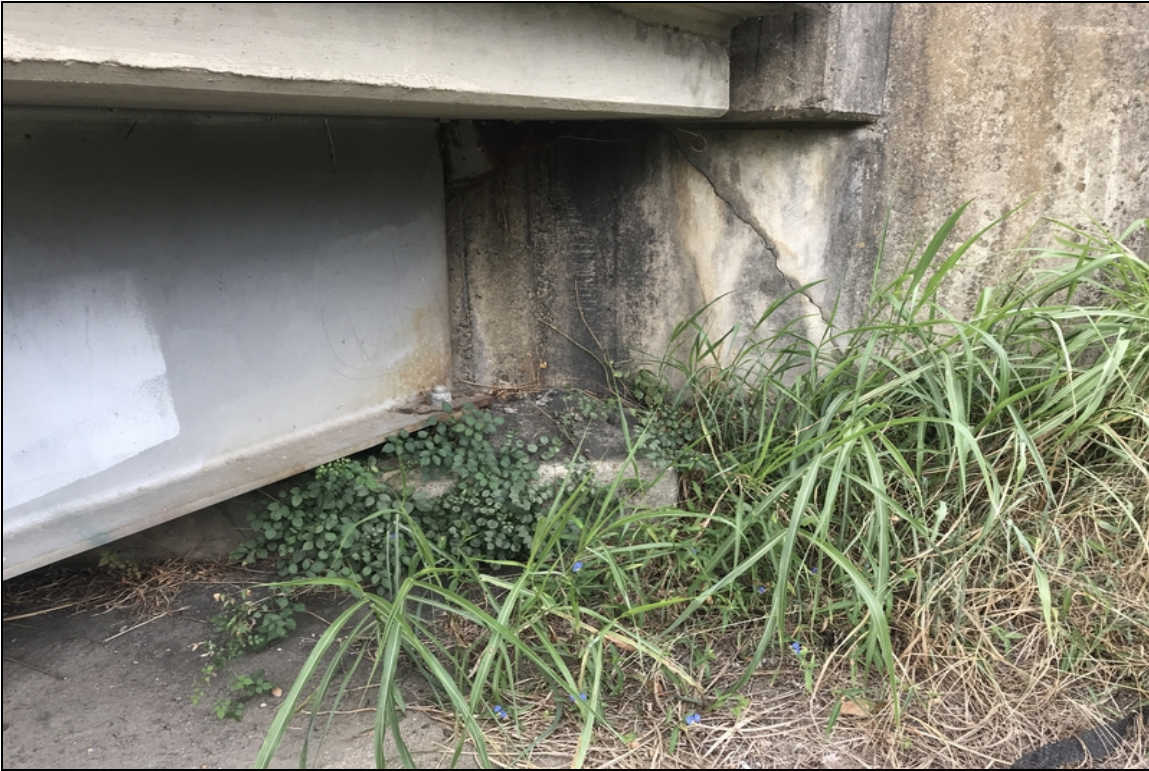
Cracks in back wall at bent 1 beam 1

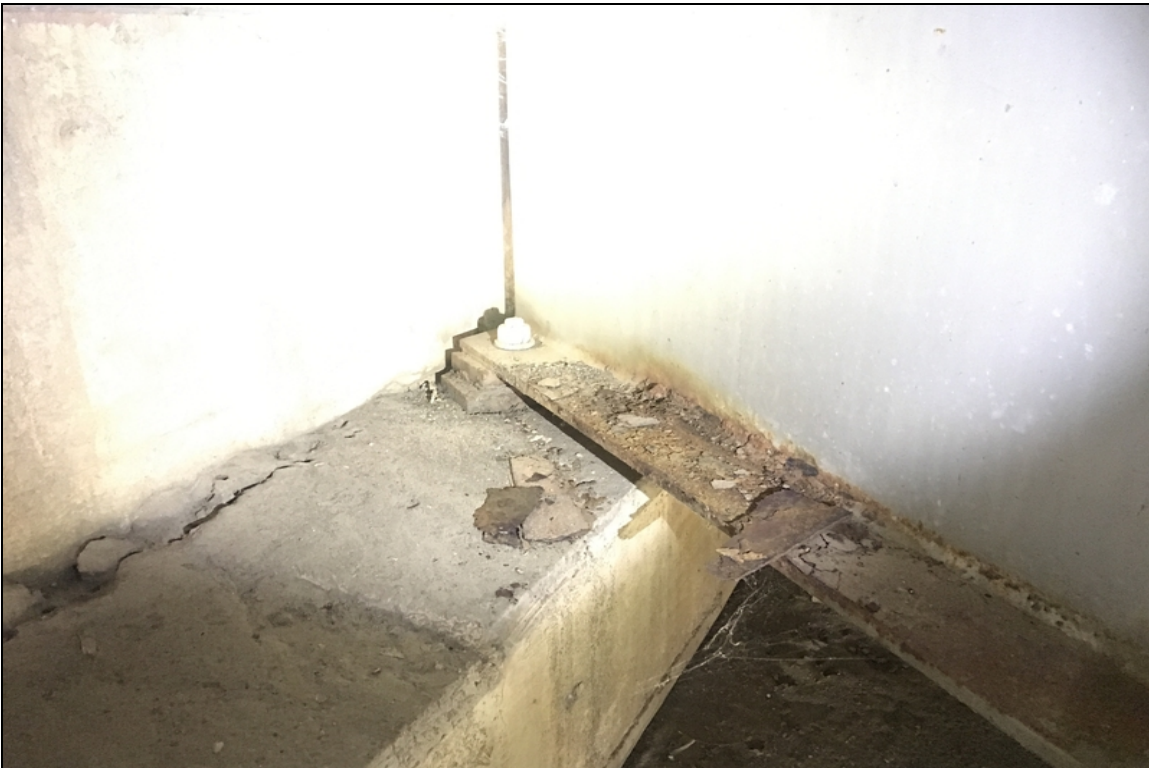
beam ends have light to moderate corrosion starting to form due to leaking joints.

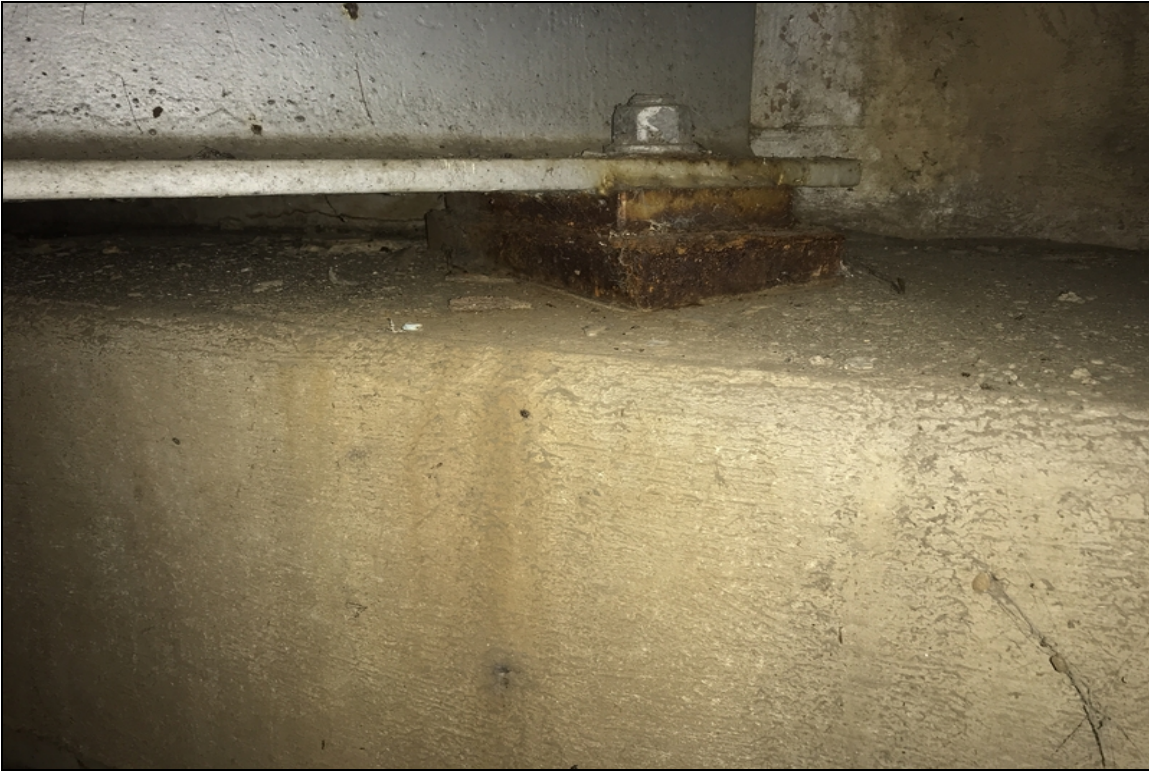
all Bearings have heavy corrosion and laminating rust

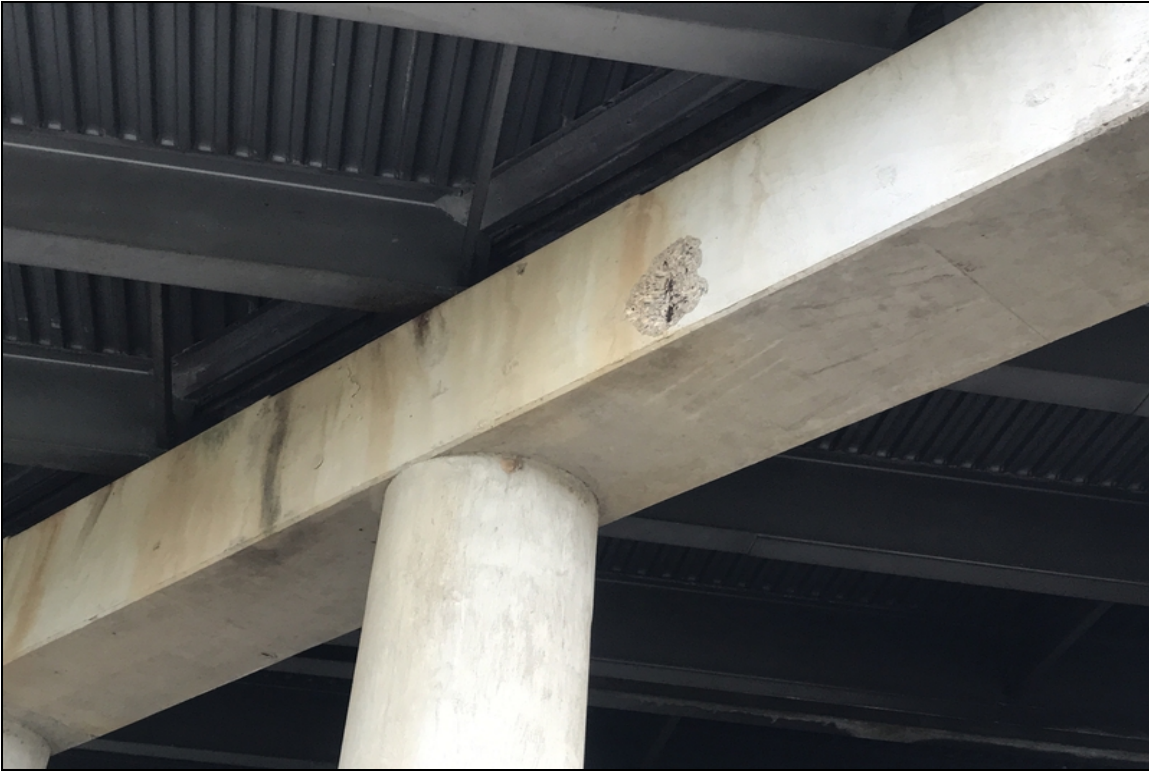
(205)	Bent 2 column 7 has exposed Rebar and large vertical cracks. Bent 2 column 1, bent 3 columns 1&7 & bent 4 columns 1&7 all have spalls with exposed rebar. Bent 4 column 6 has large delam.						
215	Reinforced Concrete Abutment	LF	208	168	38	2	0
1130	Cracking (RC and Other)	LF	40	0	38	2	0

Spalls with rebar at bent 3

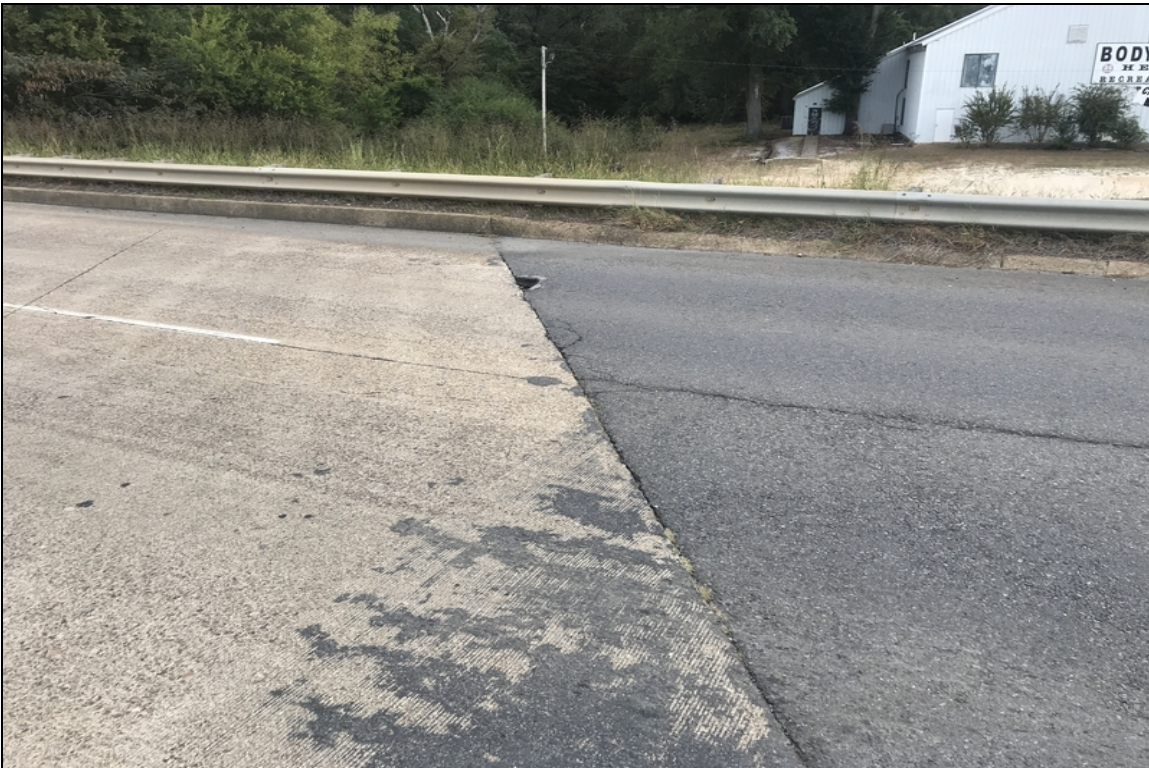
Potholes at south east end of the bridge

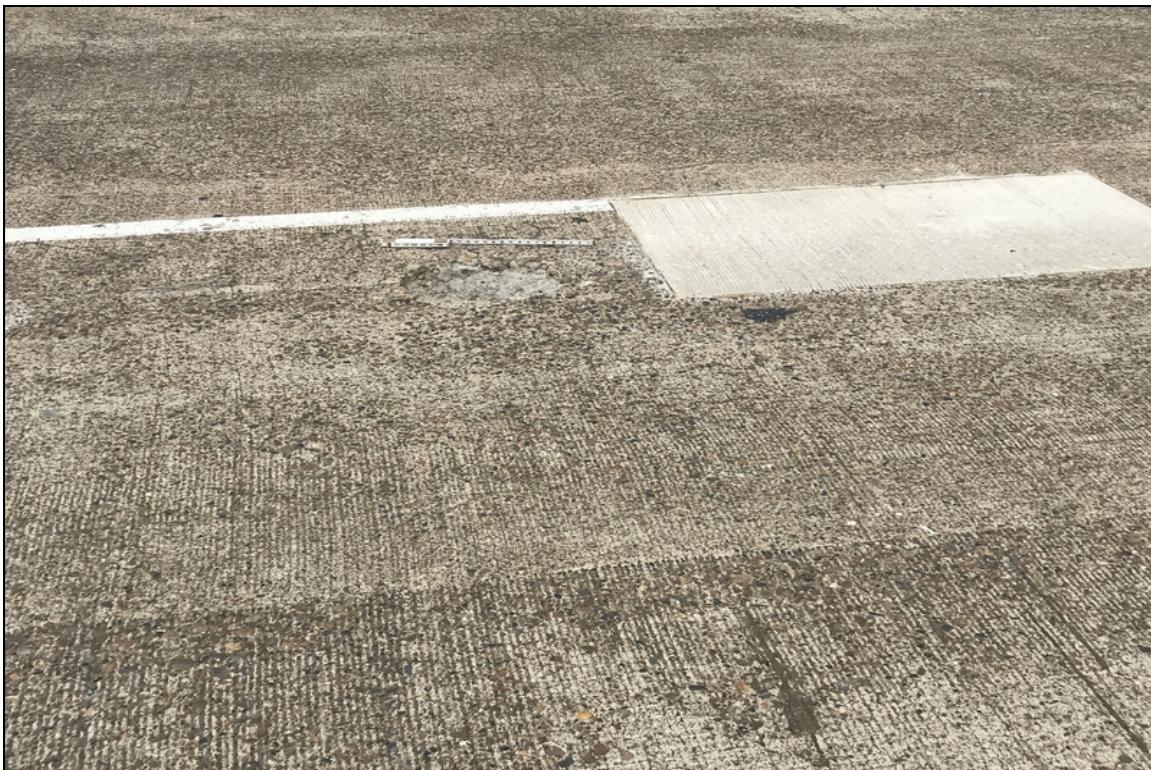
(12)	Deck has small unsealed cracks Eastbound lane has a large spall with with rebar exposed						
107	Steel Open Girder/Beam	LF	3068	2618	450	0	0
1000	Corrosion	LF	450	0	450	0	0
515	Steel Protective Coating	SF	23265	18397	4068	0	800
3410	Chalking (Steel Protective Coatings)	SF	1800	0	1800	0	0
3440	Effectiveness (Steel Protective Coatings)	SF	3068	0	2268	0	800

right side of span 2 has a large pothole with exposed rebar

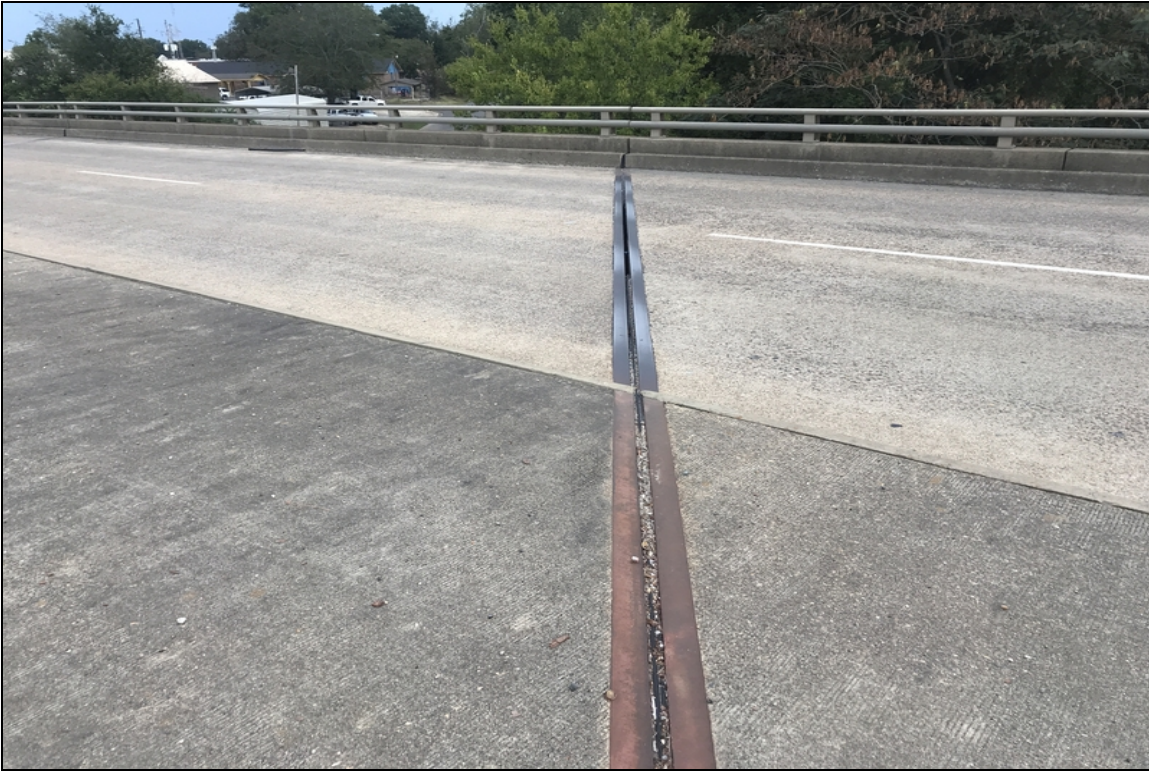
Joint seal has fallen out at bent 4

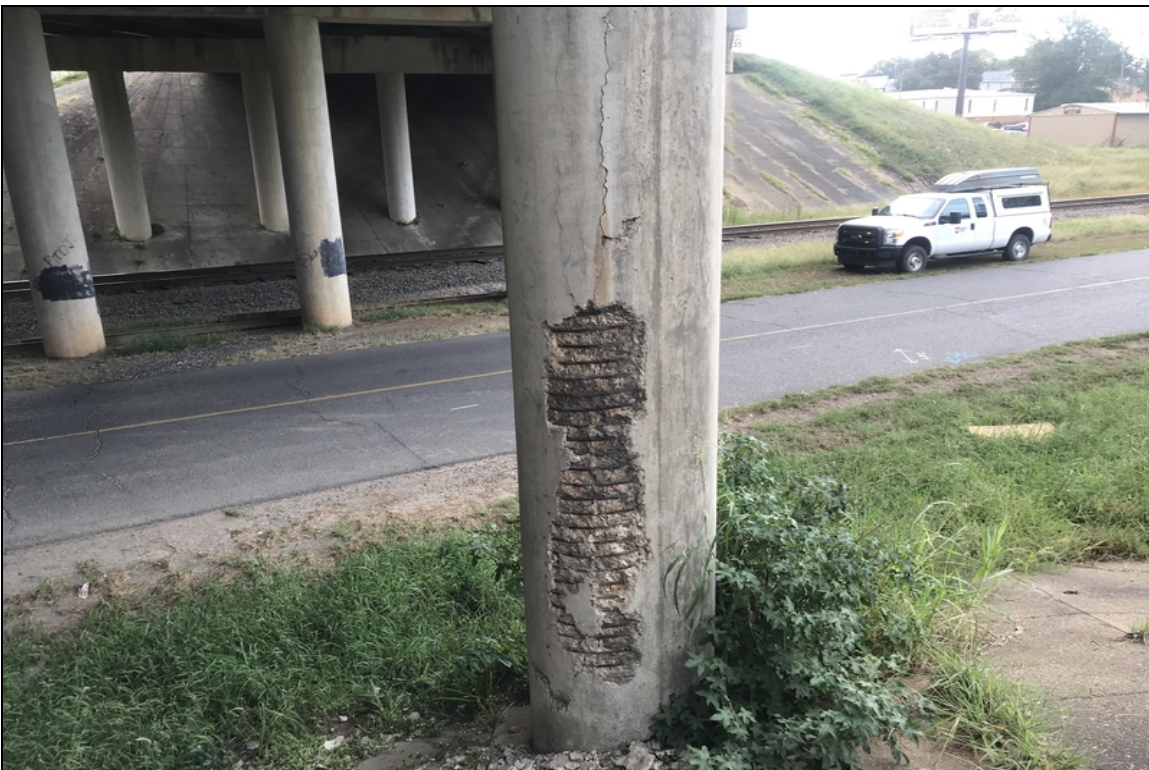
Column 7 at bent 2 has large spall with exposed rebar and large vertical cracks
