**Bridge #05238(Routine)**  
**SH 5 Log 4.72 over FOUR MILE CREEK**  
**Location: 2.5 MI N OF JCT SH 5 & 89**

**Team Lead: Keith Harris Inspection Date: October 12, 2021**

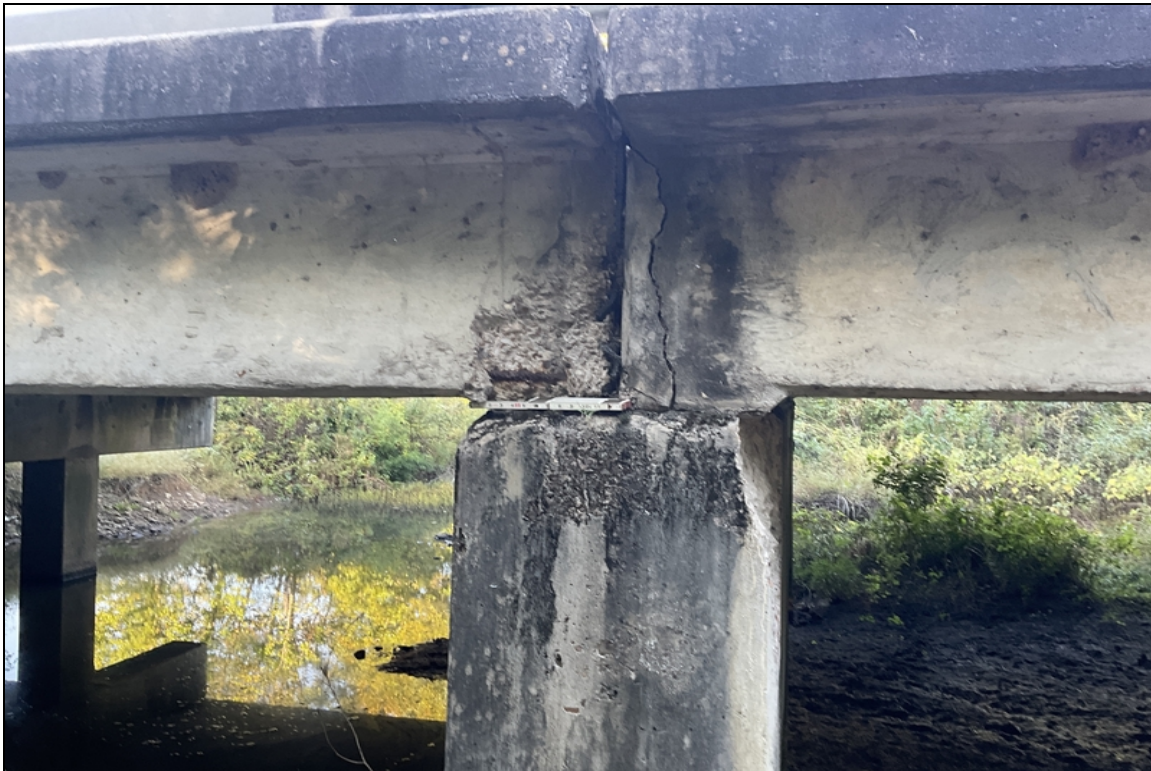
Right side of spans 2&3 over bent 3: spall and spall with exposed rebar

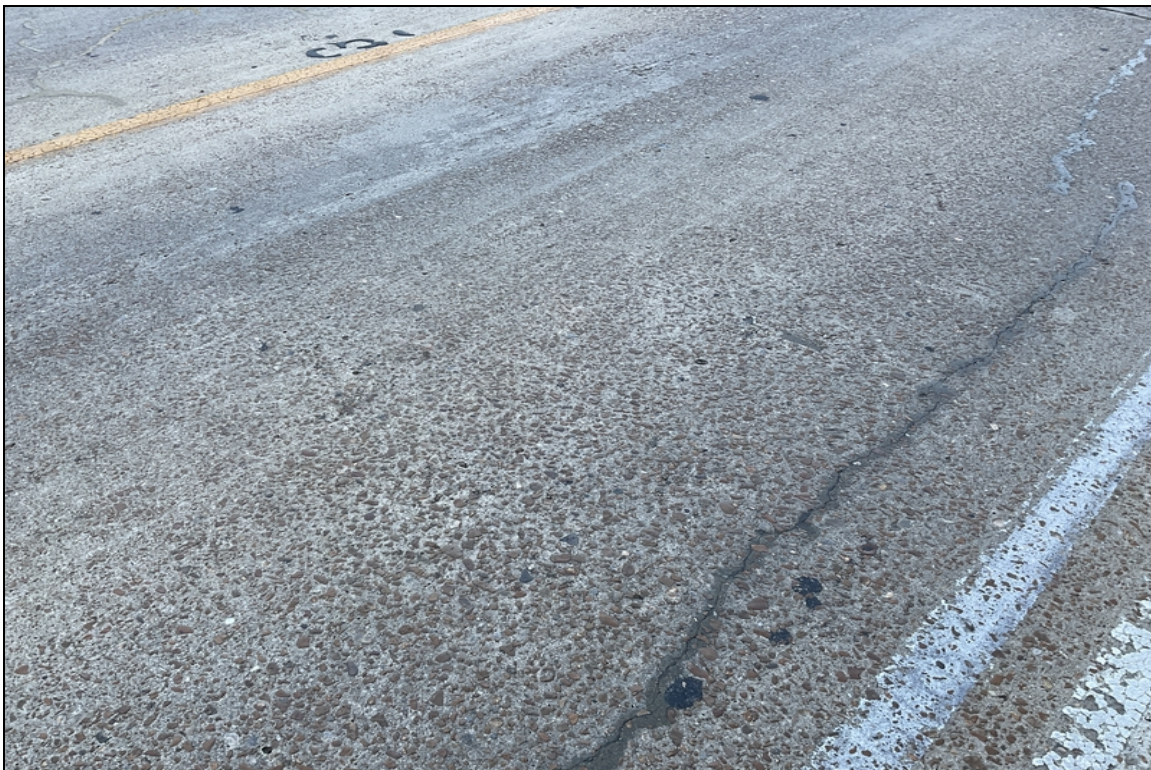
Span 1 abrasion

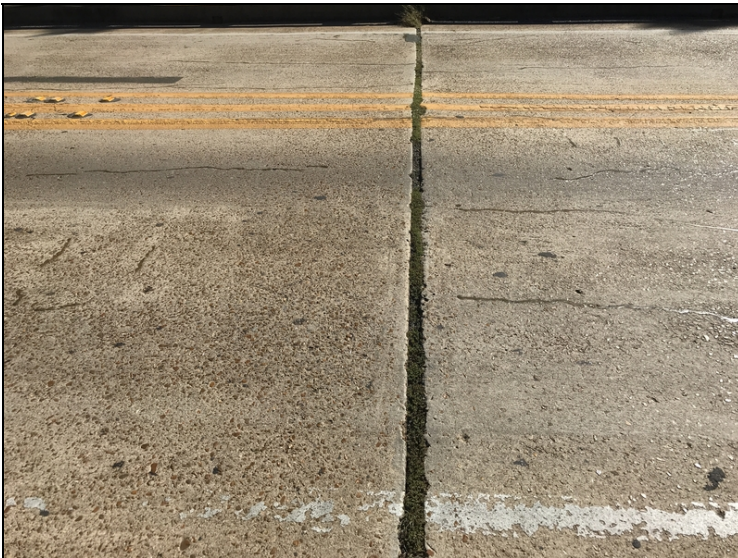
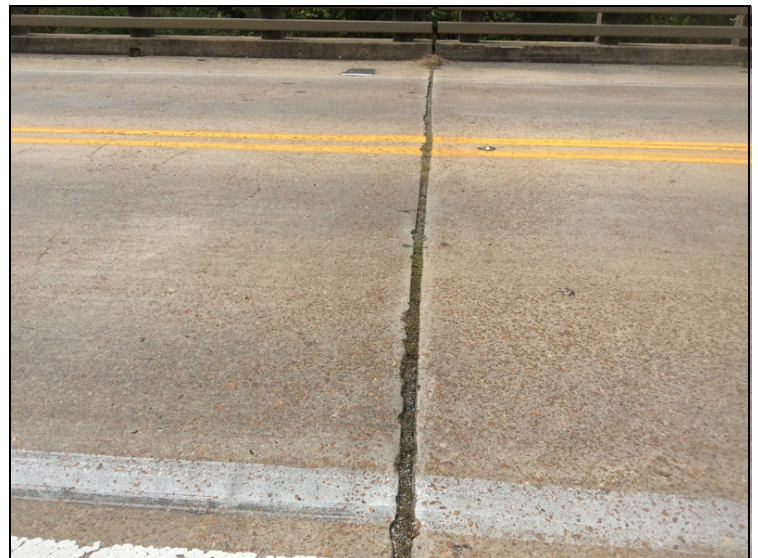
All of joint seal material is missing and all of the joints are impacted, causing the bridge to lengthen at least 2 1/2".

Bent 3 looking left. The joint seal is missing and the joint is 1 1/4" width and filled with debris.

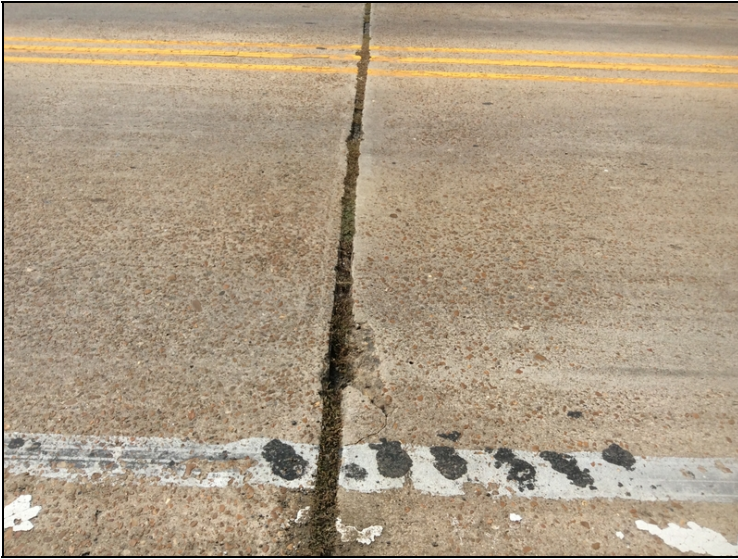
Joint at bent 4, looking left. 1 5/8 inch wide with no seal.

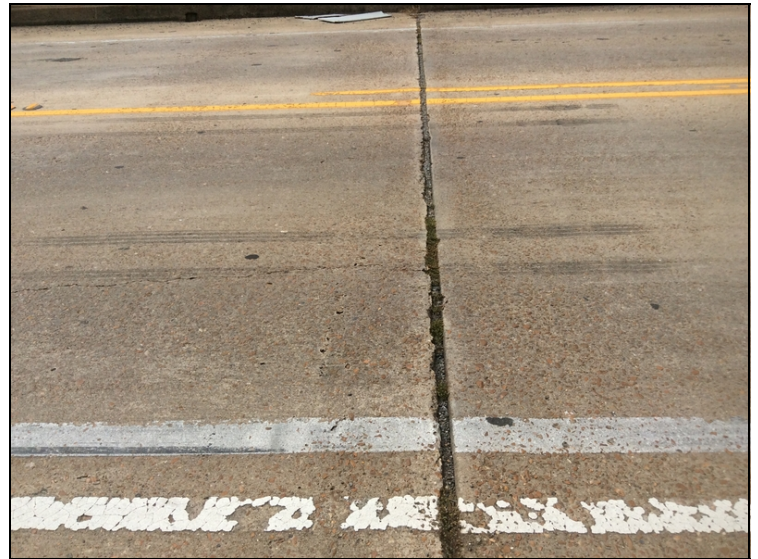
Bent 2, the joint seal is missing and impacted with debris. 1" width.

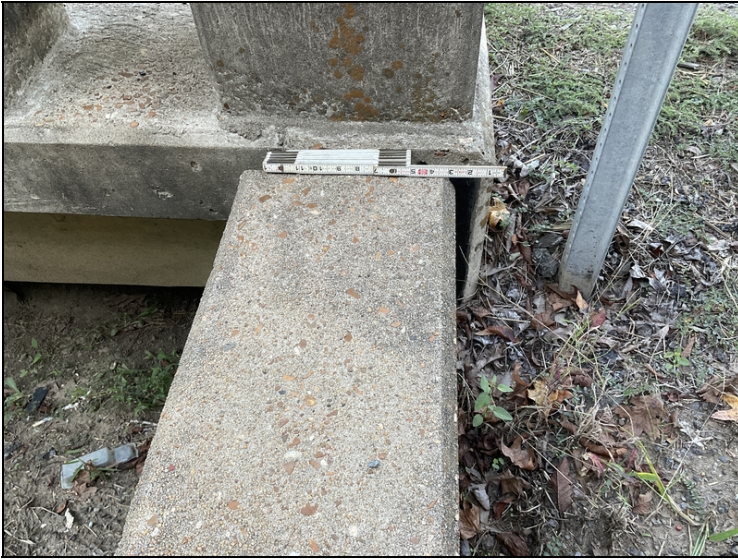
Northeast corner of bridge.

All of joint seal material is missing and all of the joints are impacted, causing the bridge to lengthen at least 2 1/2".

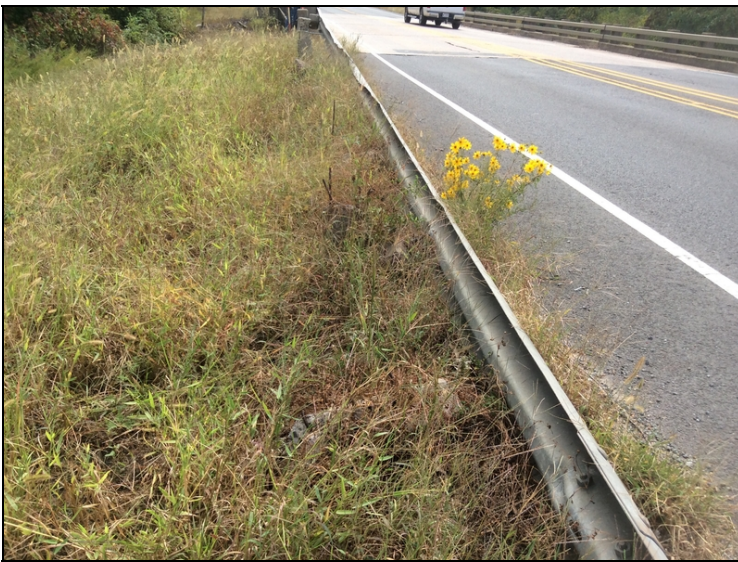
Looking southbound, the left approach rail has all of the posts and spacer block broken due to collision damage.

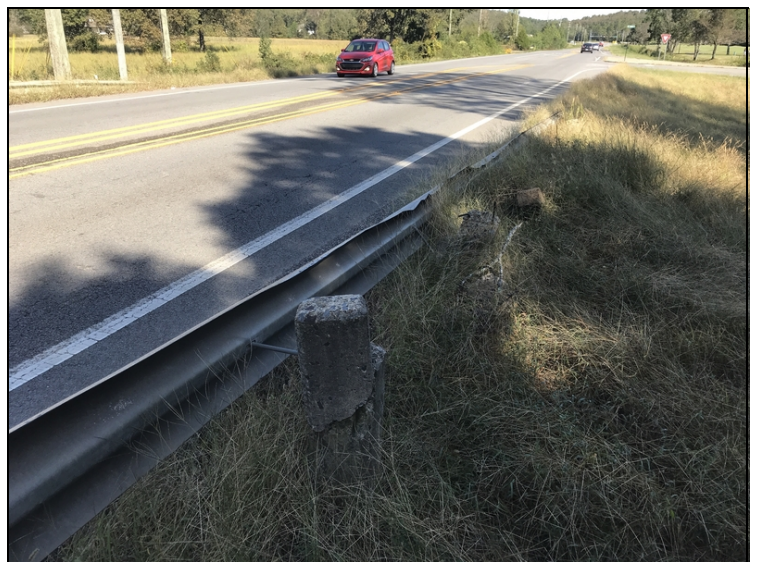
North side of the northbound lane: the approach rail is damaged and 7 of the posts are broken off allowing rebar to stick up.

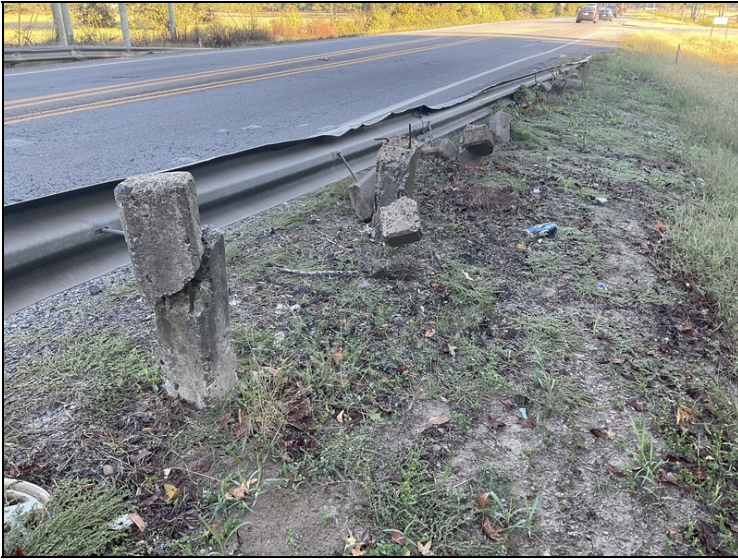
North side of the northbound lane: the approach rail is damaged and 7 of the posts are broken off allowing rebar to stick up.

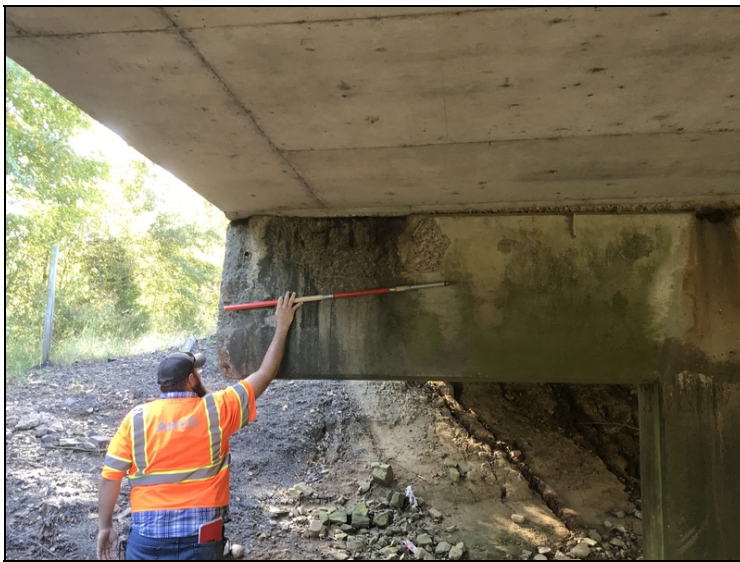
Bent 2, right end cap has spall with exposed rebar.  
Bent 3 right end of cap has spall with exposed rebar.

Ahead side of bent 2: large spall with exposed rebar

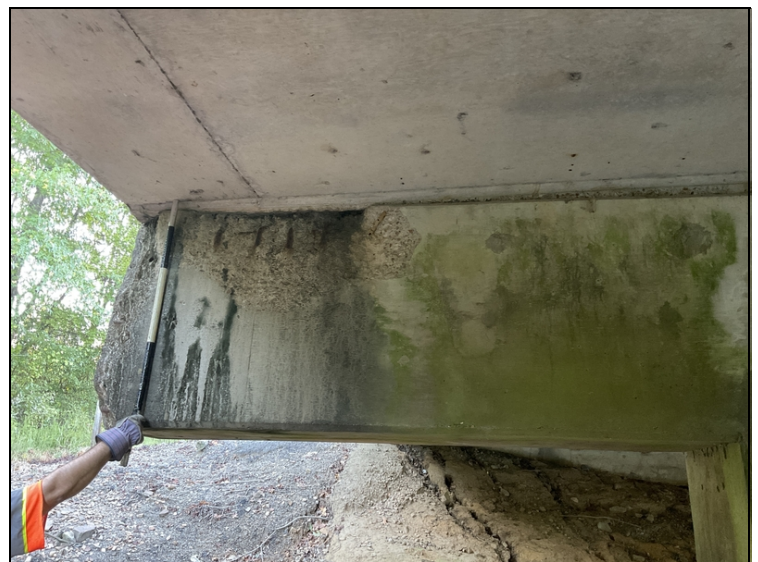
Bent 2 spall with exposed rebar on ahead face
