Bridge #05239(Routine)

SH 5 Log 6.39 over MAGNESS CREEK

Team Lead: Keith Harris Inspection Date: October 12, 2021

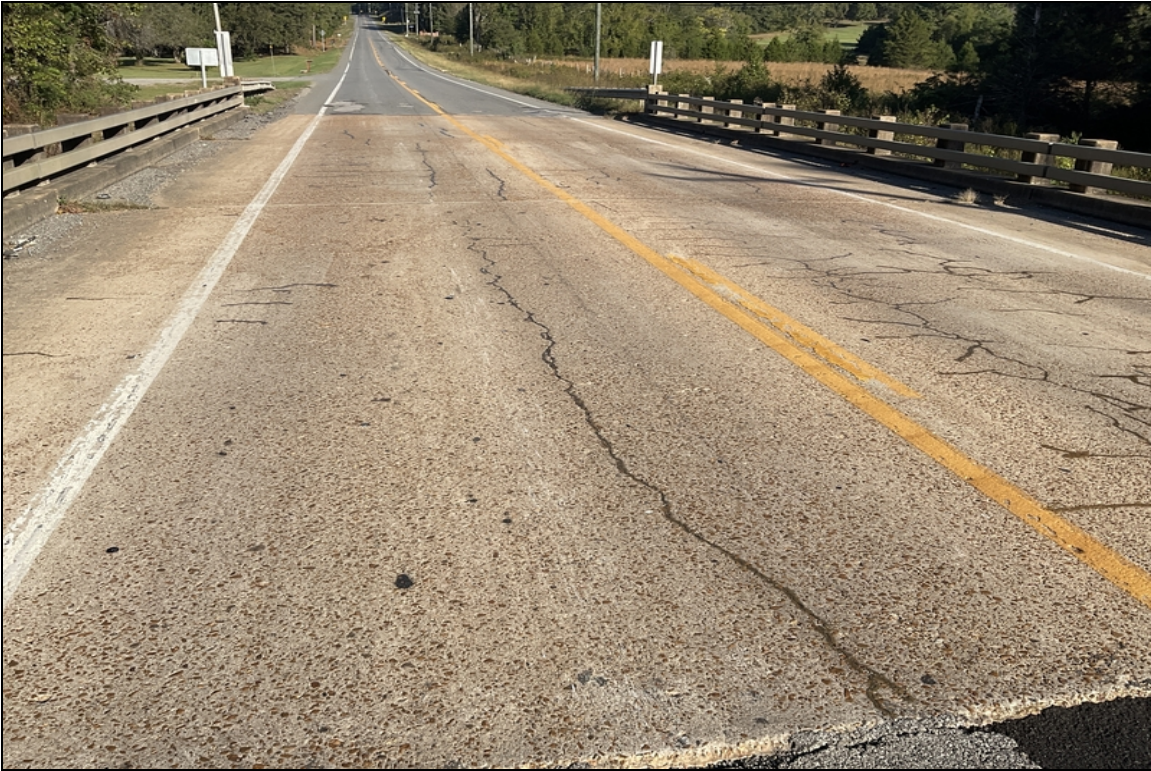
Deck overview

(38) Deck all spans cracks have been sealed by state forces. Soffit all spans cracks and delams have been sealed and patched, light efflorescence and rust stains are leaching back through patched areas. Deck span 2 & 3 at bent 3 left side has spall and delam. Both lanes have light abrasion							
205	Reinforced Concrete Column	EA	4	0	4	0	0
1190	Abrasion/Wear (PSC/RC)	EA	4	0	4	0	0

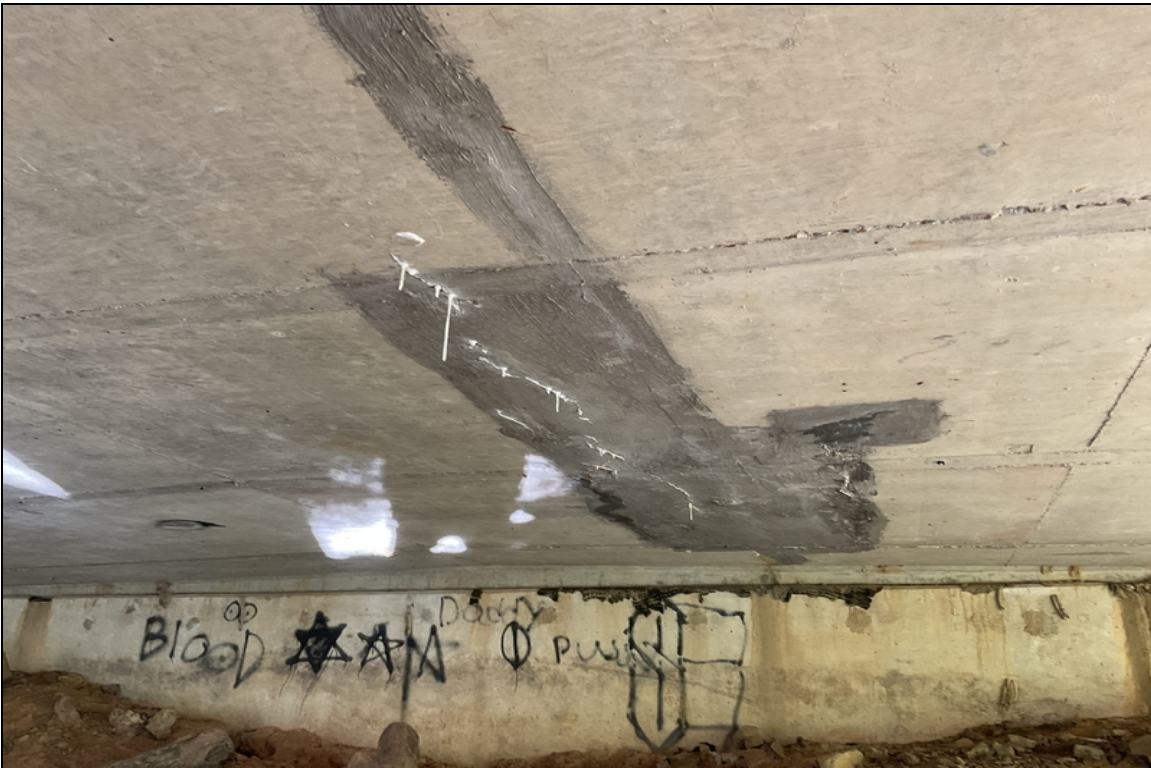
Span 3 efflorescence

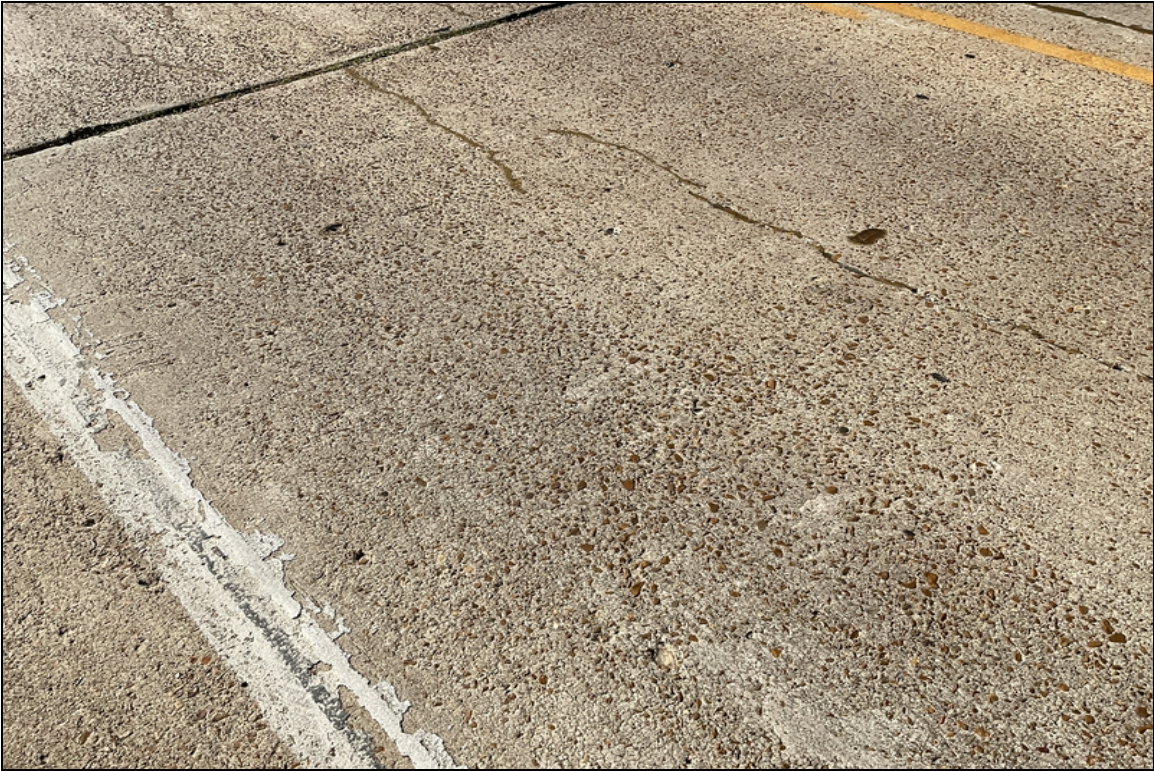
Span 3 abrasion

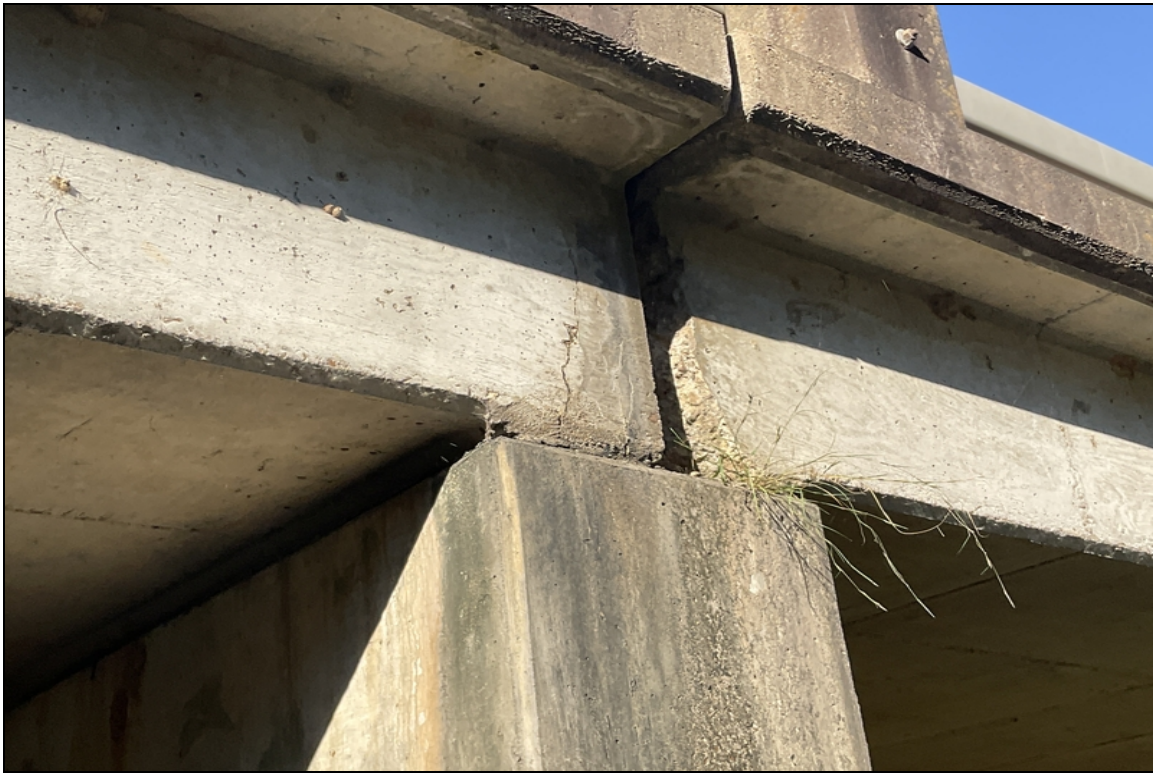
Spalls on the right side of spans 2&3 at bent 3.

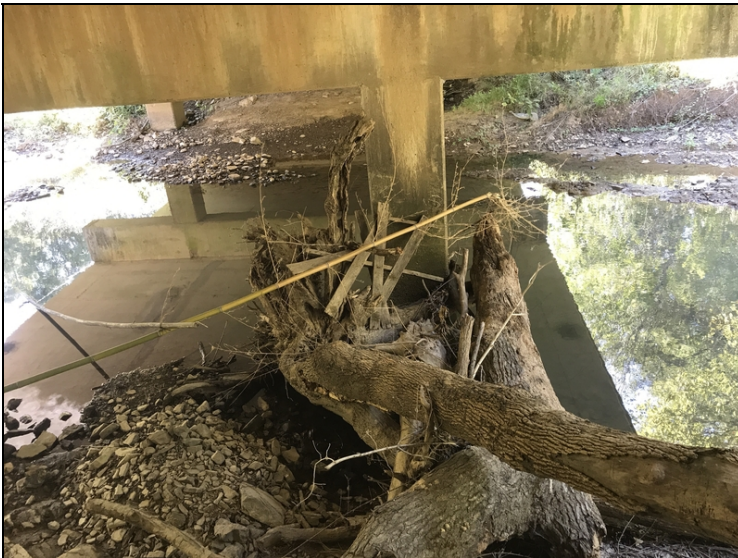
Bent 3: drift and debris build up around column 1

Assigned Pulaski 1 06601 12/4/19  
Drift has been removed
