Bridge #05240(Routine)

SH 5 Log 8.98 over CYPRESS BAYOU

Team Lead: Keith Harris Inspection Date: October 12, 2021

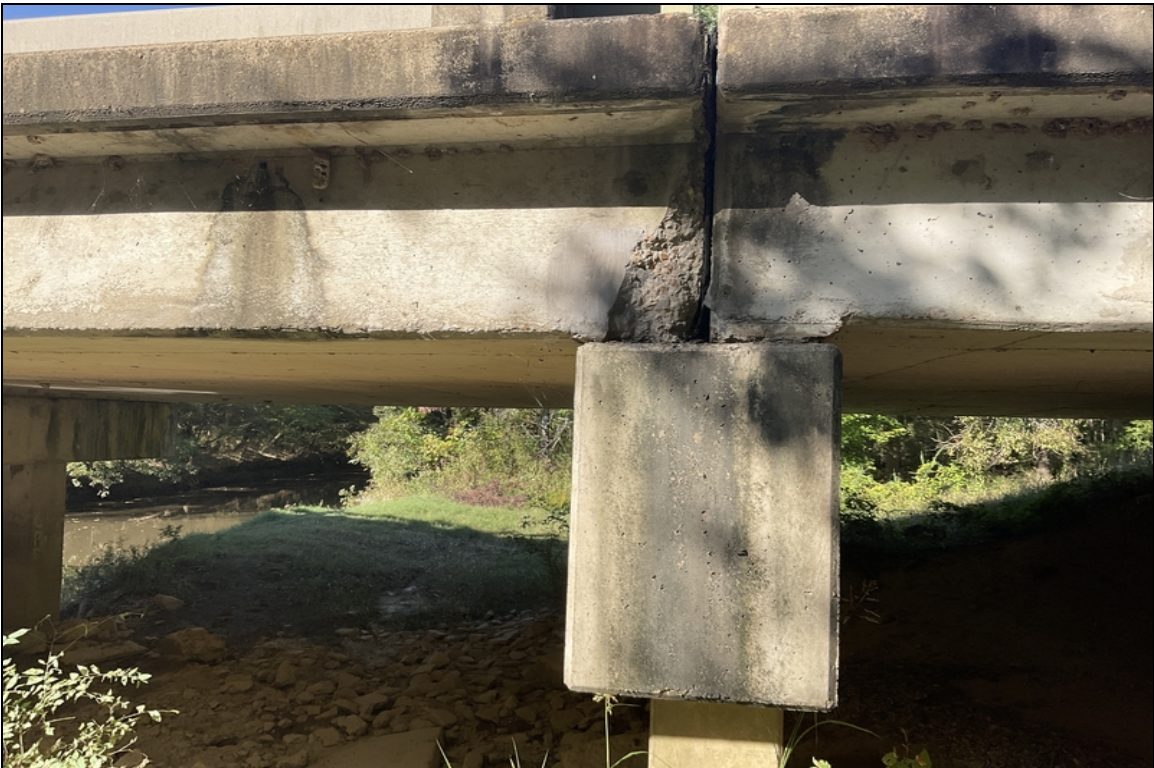
Spall on Right side of span 5 at bent 6

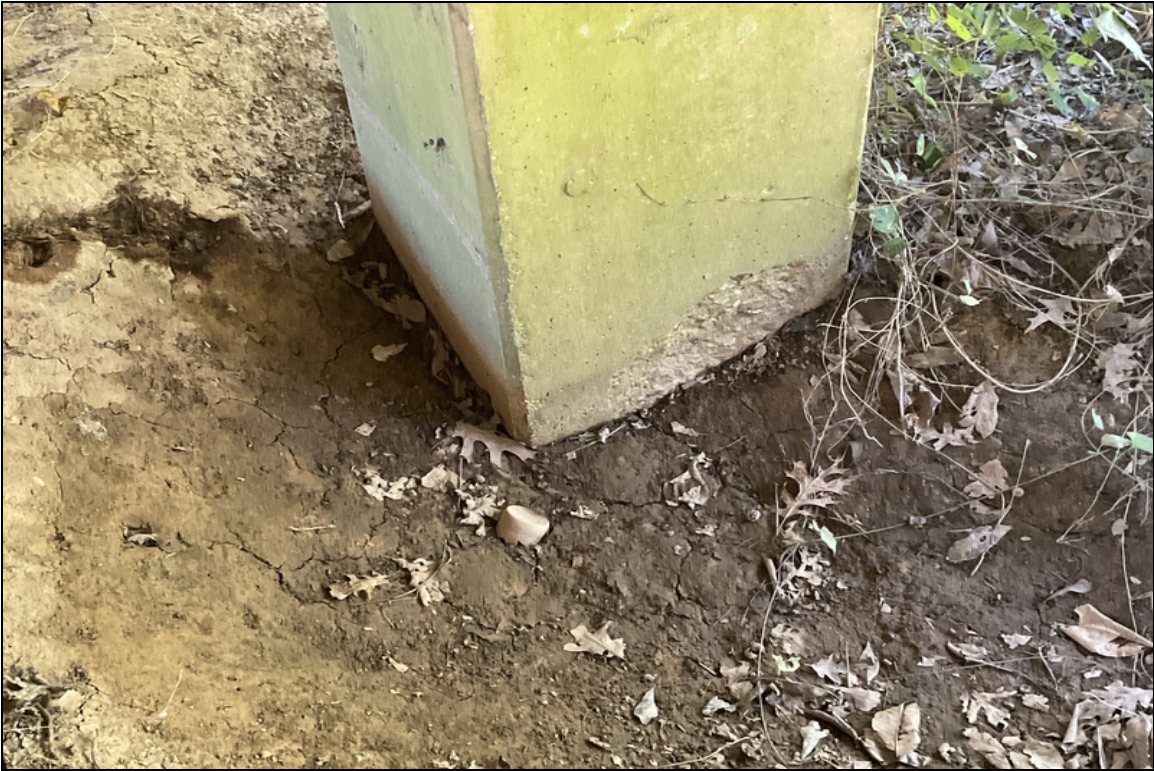
(205)							
The columns of bents 3,4 & 5 have surface abrasion on the lower four feet. Bent 2 column 1 has a spall at ground line.							
215	Reinforced Concrete Abutment	LF	78	78	0	0	0
234	Reinforced Concrete Pier Cap	LF	170	161	0	9	0
1080	Delamination/Spall/Patched Area	LF	3	0	0	3	0
1090	Exposed Rebar	LF	6	0	0	6	0

Bent 2 column 1 has a spall at ground line.

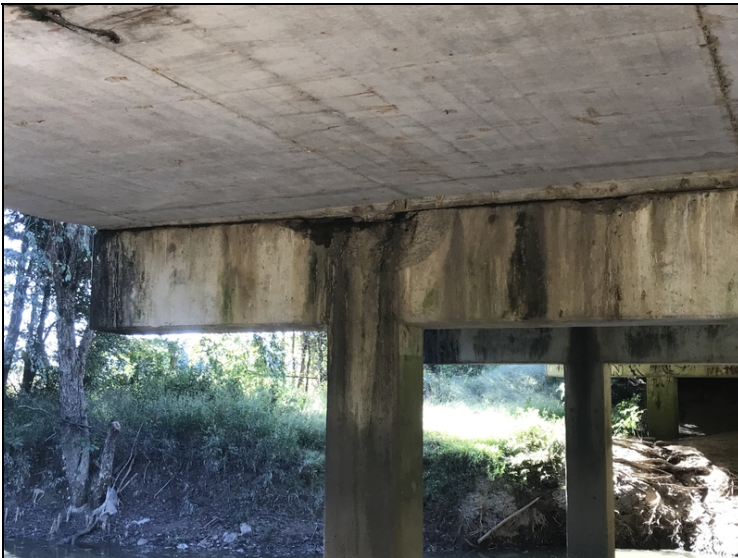
(234)							
The ahead face of bent 4 has Spalls and exposed rebar.							
330	Metal Bridge Railing	LF	336	336	0	0	0
(330)							
Double tubular aluminum rail on both bridge rail.

Bent 4, ahead side of the cap.  
Spalls with exposed rebar.

Ahead side of bent 4 with couple large spalls with exposed rebar.

**Date Reported:** 10/08/2015  
**Priority:** C - Important  
**Type of Work:** None  
**Status:** Monitor  
**Component:**

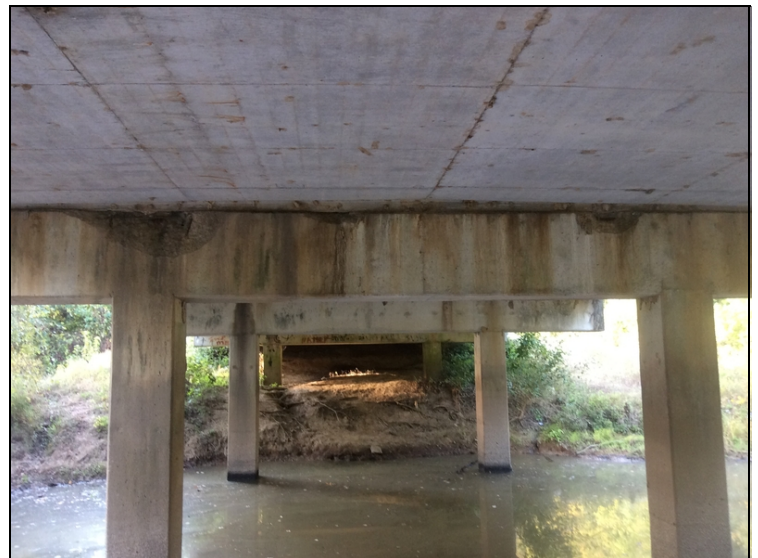
Bent 4 ahead side, looking back.  
Spalls and exposed rebar.

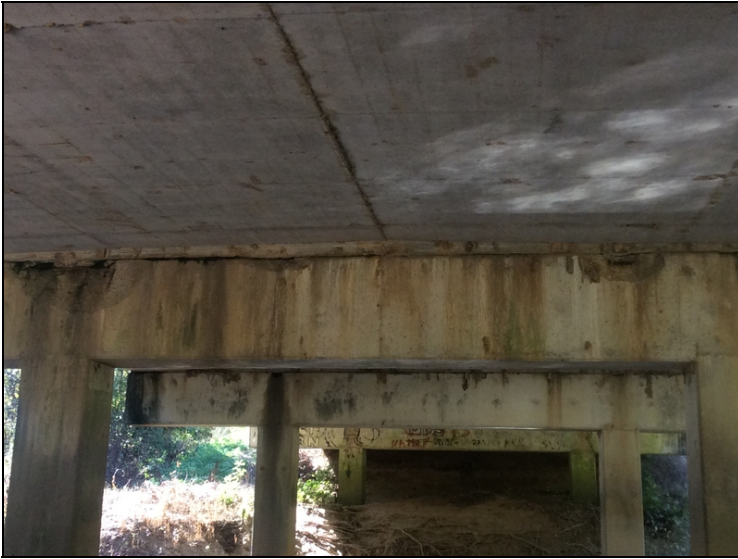
Bent 4 cap ahead spalls with exposed rebar.

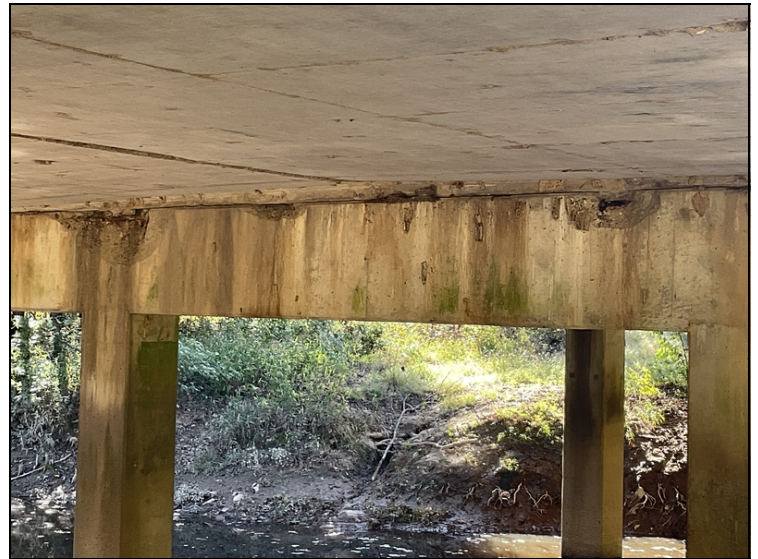
Ahead side of bent 4 with couple large spalls with exposed rebar.

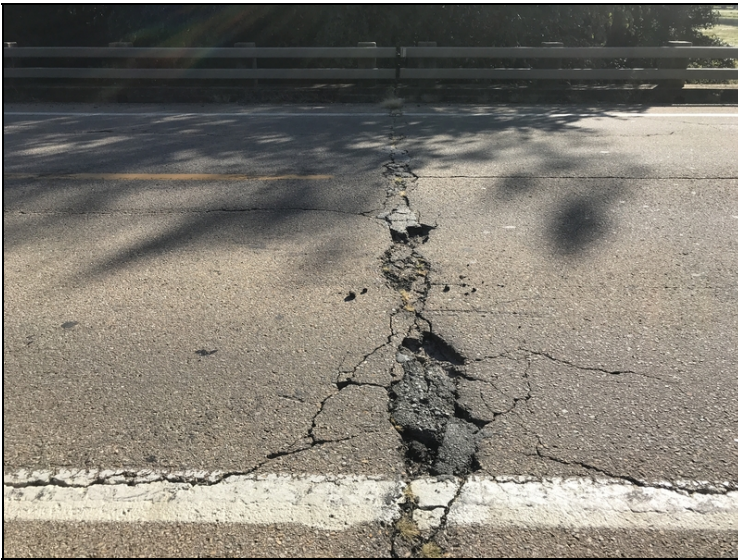
Bents 2,4,5&6 have open spalls in the asphalt overlay over joints

Bent 3: joint with open spalls in the asphalt overlay

Assigned to Pulaski I 7/15/2020

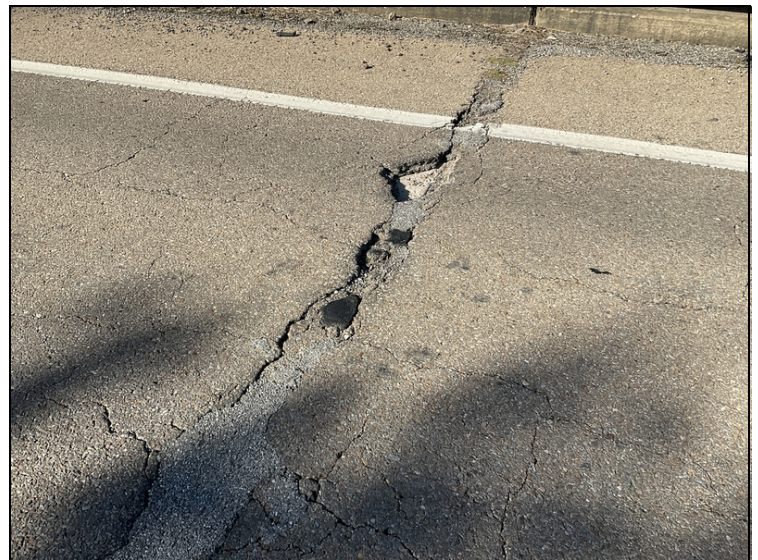
Bent 2 joint with open spalls in the asphalt overlay
