Bridge #05333(Routine)
SH 5 Log 0.14 over US 67-SEC 11Log 0.71

Location: SH 5 AT US 67

Team Lead: Chris Doggett Inspection Date: May 19, 2020

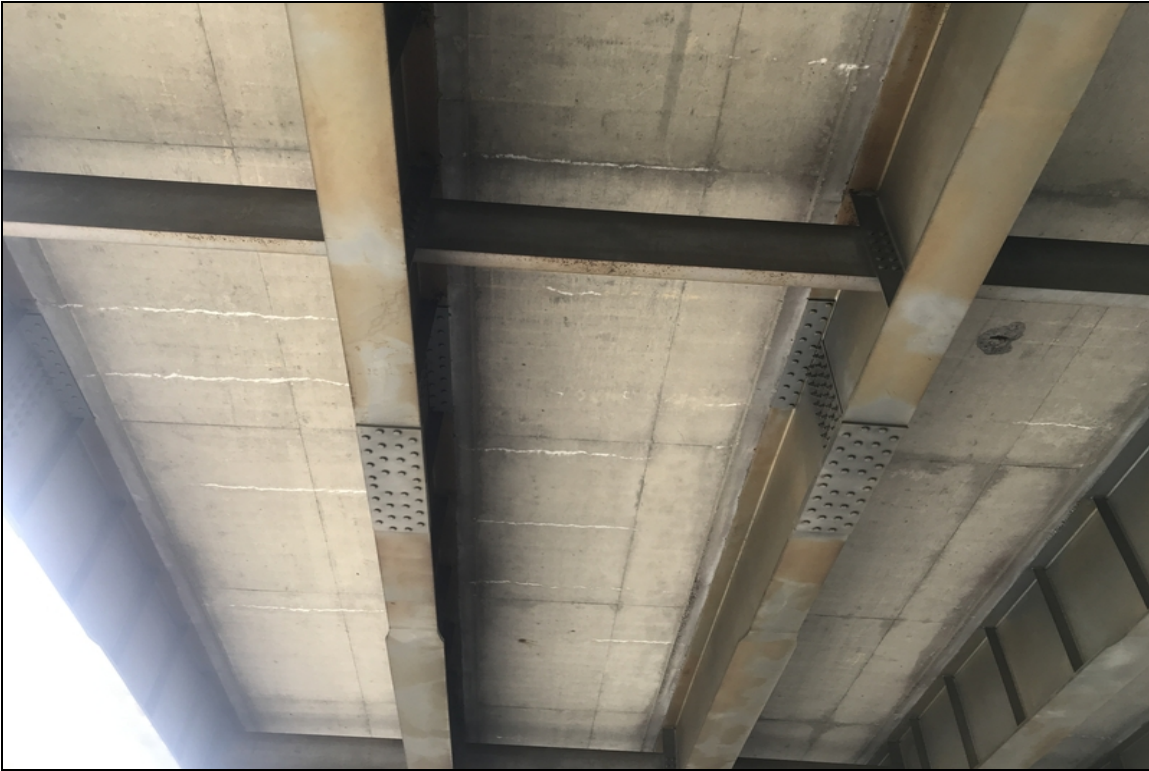
(12)	State forces have sealed most all transverse cracks. See photo. Soffit has scattered transverse cracks with light efflorescence. See photo. Span 1 has spall in deck and spall in soffit see photo. Span 2 left side has 1 delam in the overhang.						
107	Steel Open Girder/Beam	LF	1122	988	134	0	0
1000	Corrosion	LF	134	0	134	0	0
515	Steel Protective Coating	SF	12903	0	6317	6318	268
3420	Peeling/Bubbling/Cracking	SF	0	0	0	0	0
3440	Effectiveness (Steel Protective Coatings)	SF	12903	0	6317	6318	268

Span 1: scattered transverse cracks with efflorescence staining

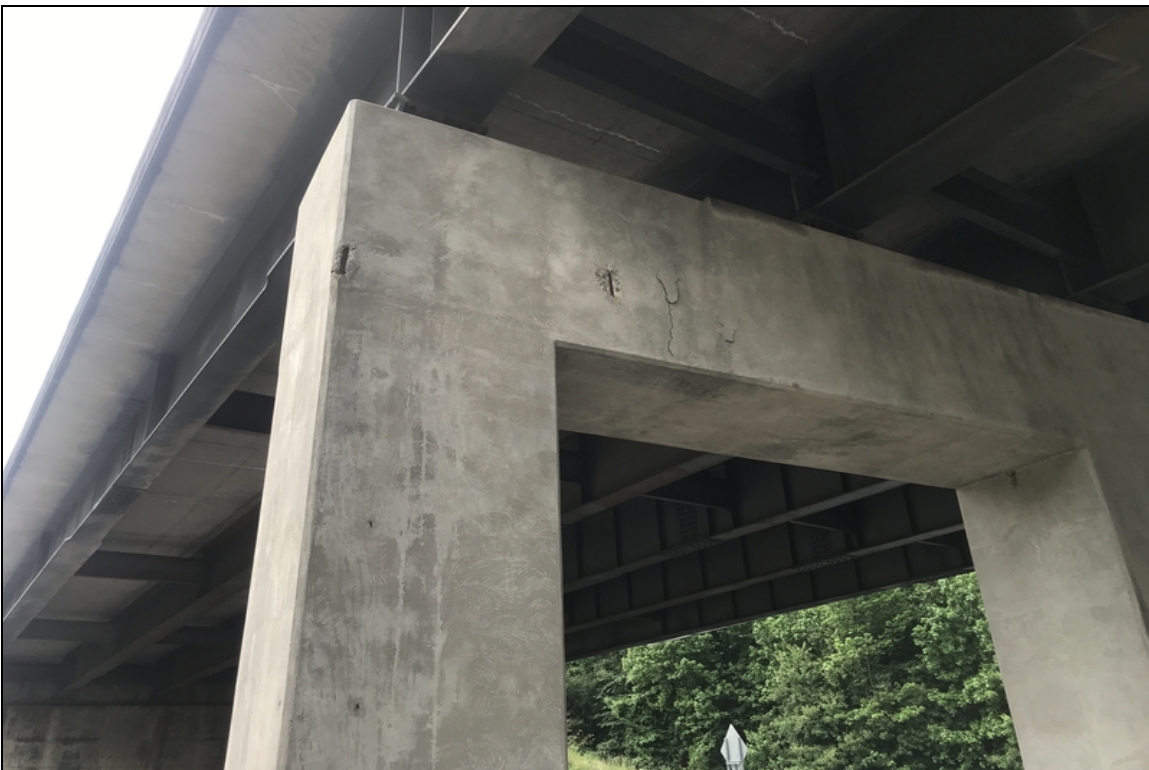
(234)	Bent 2 Small spall back face of cap. 2' of exposed rebar on the ahead side of Bt. 2.						
302	Compression Joint Seal	LF	92	0	0	0	92

Ahead side of bent 2: a couple of spalls with exposed rebar

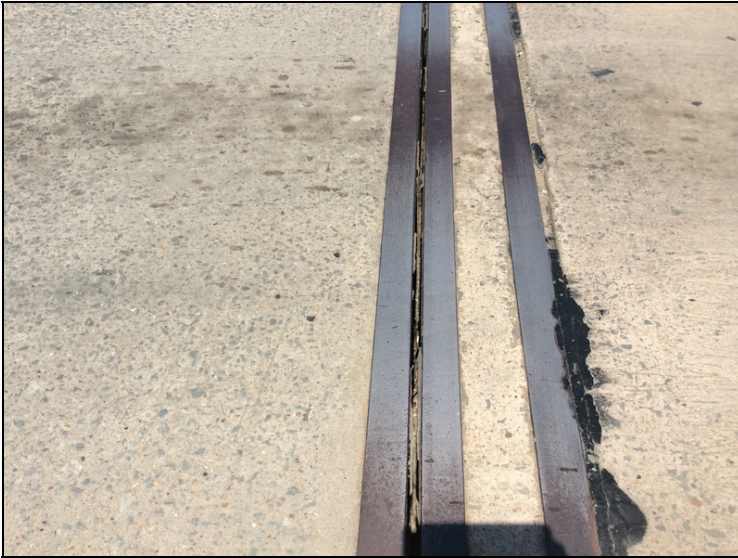
ELEM	DESCRIPTION	UNITS	TOTAL	CS1	CS2	CS3	CS4
2330 (302)	Seal Damage	LF	92	0	0	0	92
All of the joint material is missing at Bt. 1 & 3.							
311	Movable Bearing	EA	12	0	12	0	0
1000 (311)	Corrosion	EA	12	0	12	0	0
All of the bearings are beginning to rust.							
313	Fixed Bearing	EA	6	0	6	0	0
1000 (313)	Corrosion	EA	6	0	6	0	0
All of the bearings are beginning to rust.							
321	Reinforced Concrete Approach Slab	SF	1752	81	1671	0	0
1080	Delamination/Spall/Patched Area	SF	16	0	16	0	0
1130	Cracking (RC and Other)	SF	155	0	155	0	0
4000 (321)	Settlement	SF	1500	0	1500	0	0
Both approach slabs have settled & cracked on either side of the grade beam, the app. Slab at Bt. 1 has scattered spalls & scaling. State forces have sealed transverse cracks.							
330	Metal Bridge Railing	LF	379	379	0	0	0
331	Reinforced Concrete Bridge Railing	LF	379	346	33	0	0
1130 (331)	Cracking (RC and Other)	LF	33	0	33	0	0
Concrete bridge railing has scattered cracks.

Joint seals are missing at Bent 1 and 3. Photo attached.

Joint material is missing at Bt. 1 & 3.

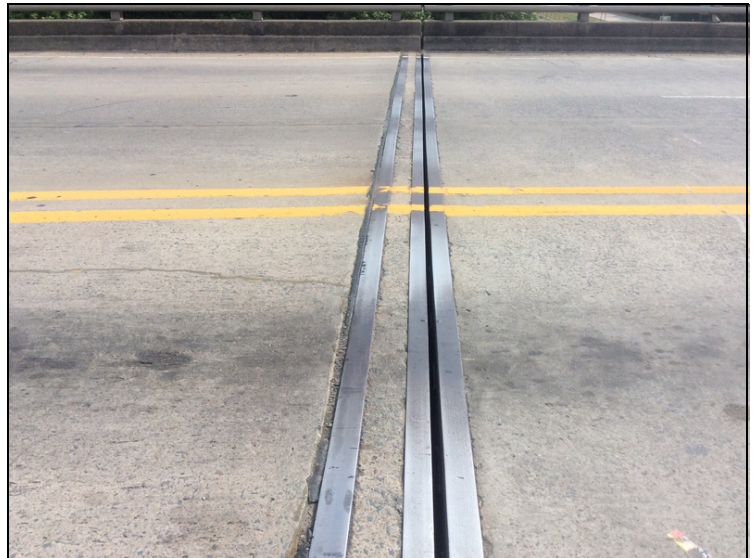
Bent 3 joint seal is missing.

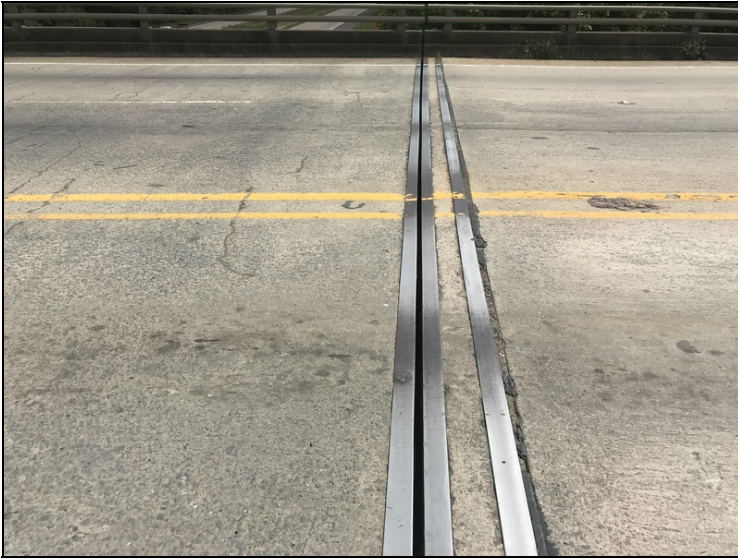
Bent 1: joint seal missing
