Arnold Road ID:43x5x12xA, Arnold Log mile:2.077

Bridge #B7017(Routine)
SH 5 Log 2.09 NB over Two Prairie Bayou
Location: 2 Mi. N. of US 67

Team Lead: Keith Harris Inspection Date: November 04, 2021

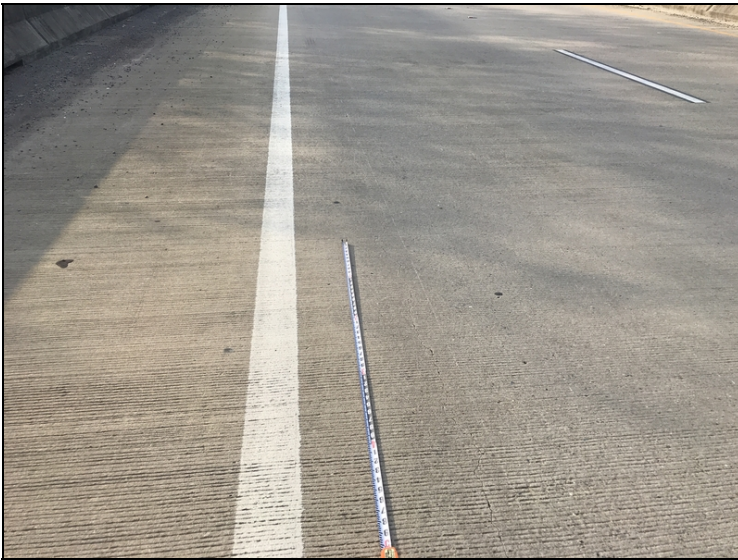
Unsealed deck cracks up to 0.030 inch.

Span 2: Unsealed deck cracks up to 0.030 inch.
Common to all spans

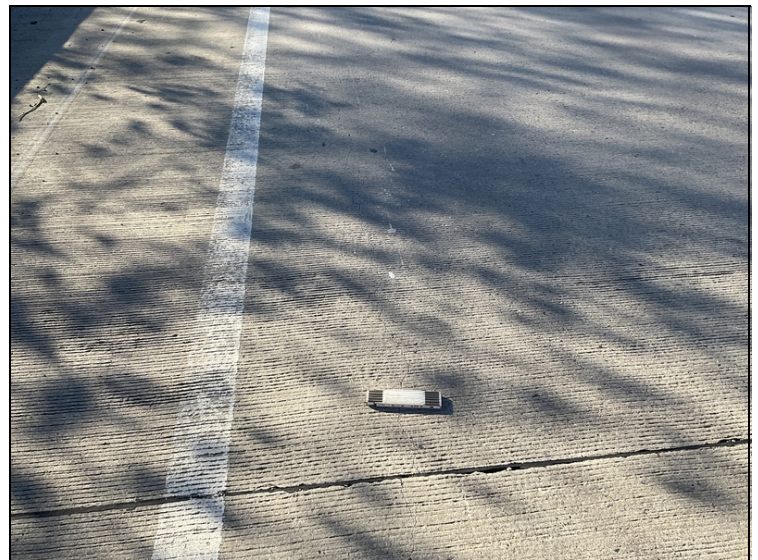
Span 2: Unsealed deck cracks up to 0.030 inch.
Common to all spans

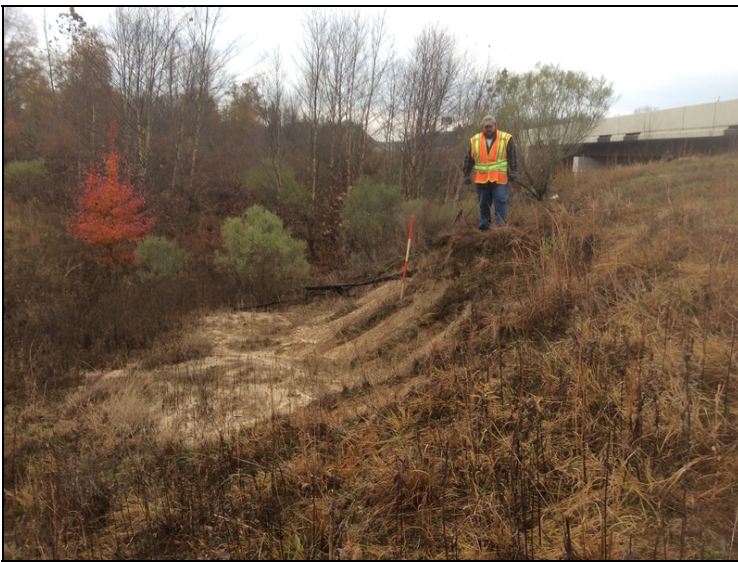
The emankment at the north end of the bridge on the right side has eroded, causing the side ditch to become partially blocked. Photo attached.

Looking south at the north end of the bridge on the right side.
The embankment has eroded and caused the side ditch to become partially blocked.

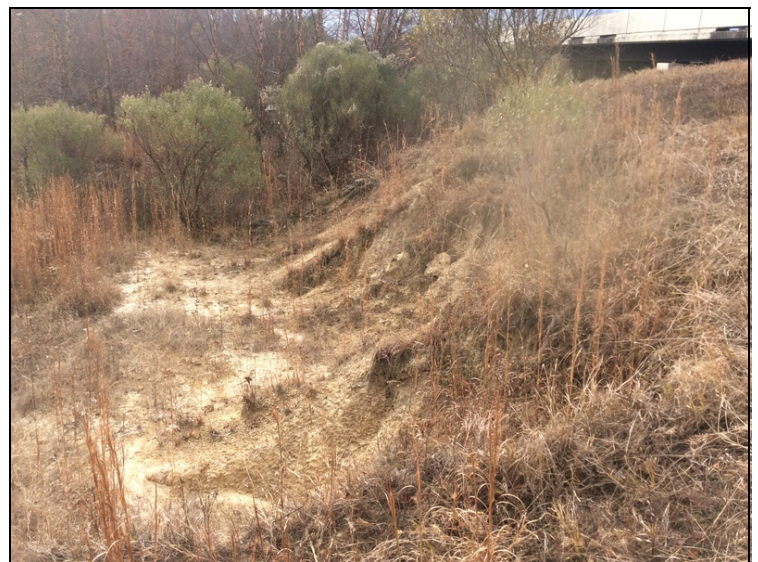
The emankment at the north end of the bridge on the right side has eroded, causing the side ditch to become partially blocked.
