Bridge #07053(Routine)

SH 176 Kiehl Ave. over US 67 Log 4.95

Team Lead: Chris Doggett Inspection Date: March 08, 2021

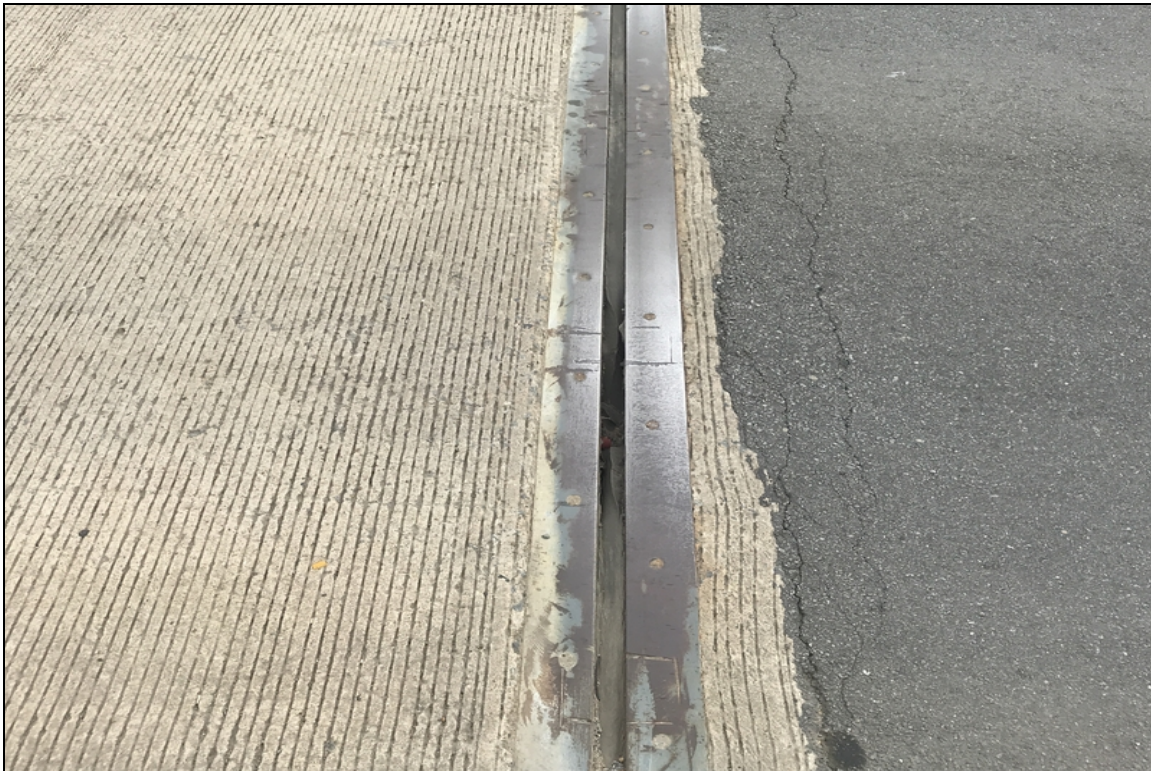
(301)	Joint seal has areas where joint seal is lost bond.						
310	Elastomeric Bearing	EA	45	45	0	0	0
330	Metal Bridge Railing	LF	632	632	0	0	0
515	Steel Protective Coating	SF	632	632	0	0	0
331	Reinforced Concrete Bridge Railing	LF	632	427	205	0	0

Bent 5: Joint seal has lost bond in numerous locations.

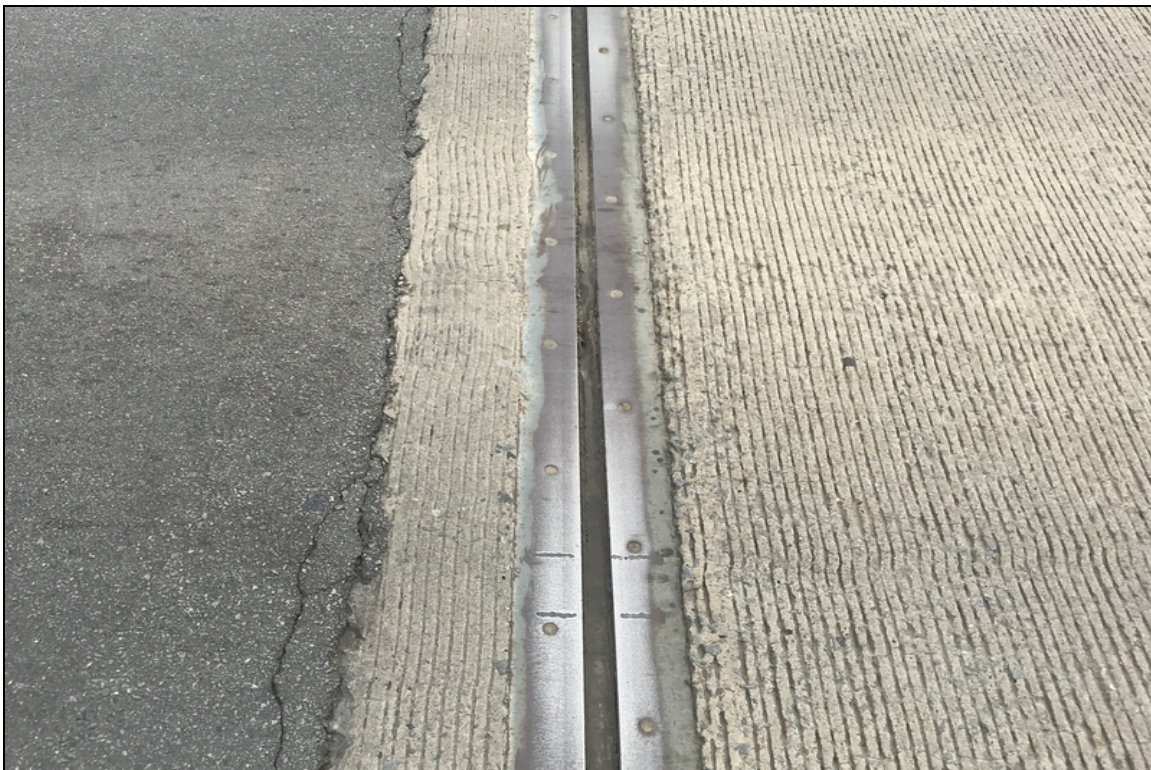
Bent 1: joint seal is losing bond allowing water to seep through.

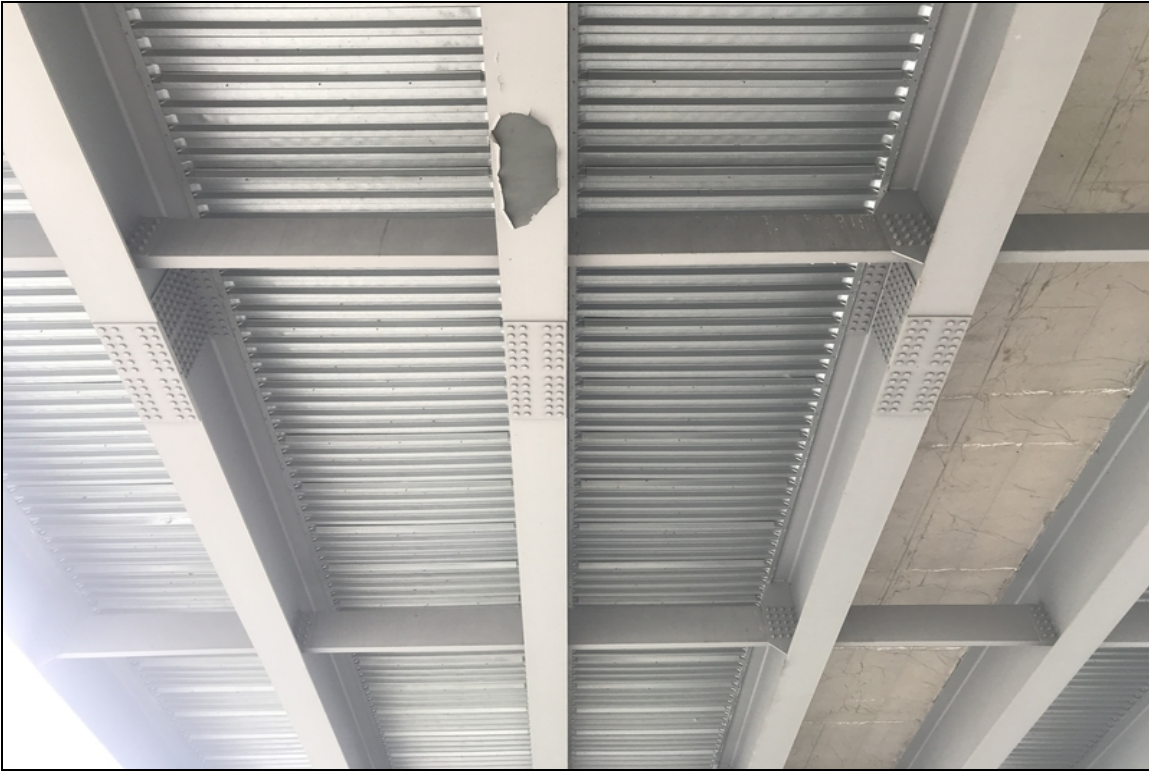
(107)	Paint peeled at span 3, girder 3 bottom flange. (107-515) Paint peeled at span 3, girder 3 bottom flange.						
205	Reinforced Concrete Column	EA	12	12	0	0	0
215	Reinforced Concrete Abutment	LF	286	286	0	0	0

Span 3, girder 3: Area of paint is peeling.

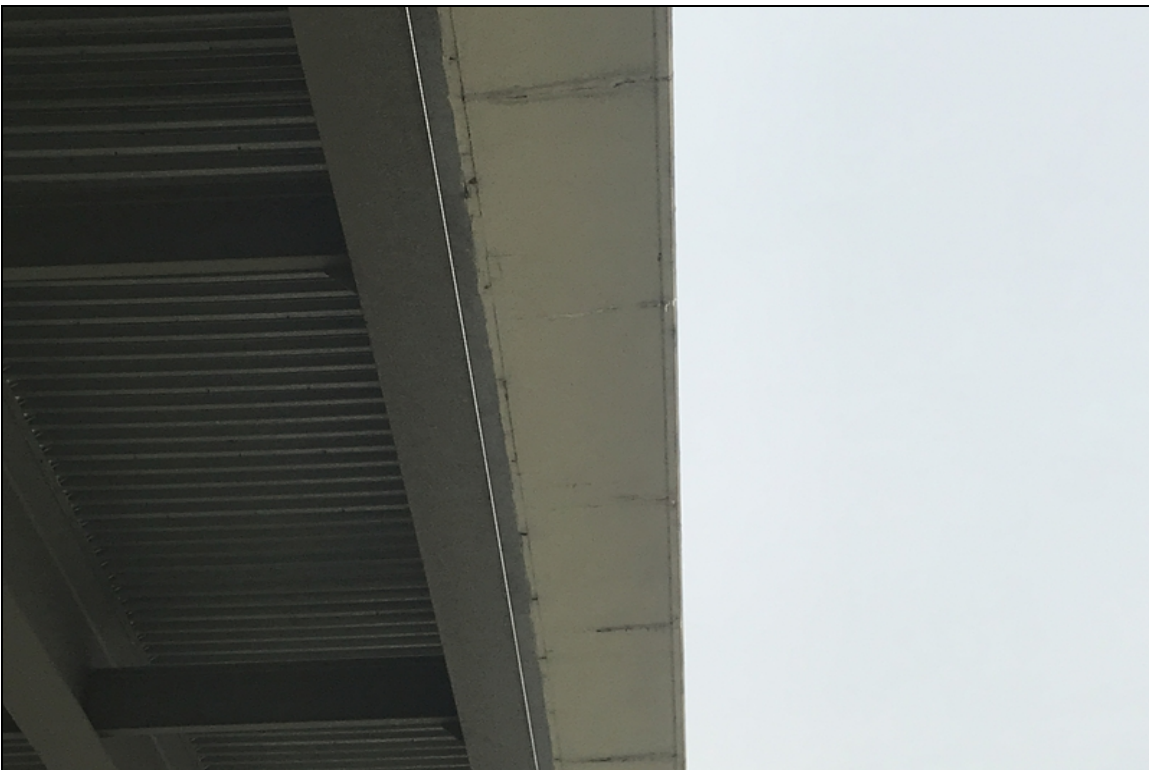
(12)	Longitudinal cracks up to 0.020" wide and transverse cracks up to 0.035" wide. Soffit has transverse cracks with efflorescence on the over hangs and between beams 4 & 5. No stay in place forms due to stage construction.						
107	Steel Open Girder/Beam	LF	2844	2844	0	0	0
515	Steel Protective Coating	SF	28724	28722	2	0	0
3420	Peeling/Bubbling/Cracking	SF	2	0	2	0	0

Overhang with numerous transverse cracks with efflorescence build up.

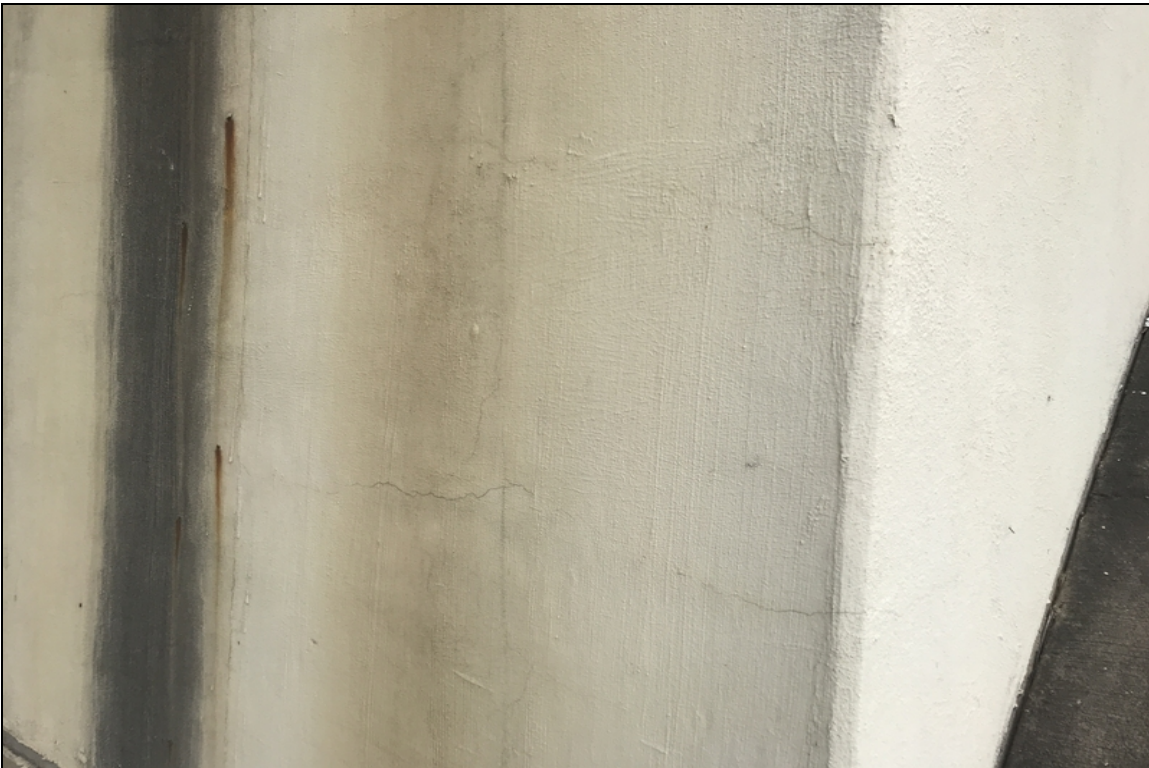
(234)	Scattered small hairline cracks in steps of caps.						
301	Pourable Joint Seal	LF	146	36	0	96	14
2310	Leakage	LF	14	0	0	0	14
2320	Seal Adhesion	LF	96	0	0	96	0

Bent 5 has horizontal cracking
