Bridge #03022(Routine)
SH 35 Log 9.97 over MUD CREEK
Location: .47 MI N OF GRANT CO LINE

Team Lead: Chris Doggett Inspection Date: March 03, 2022

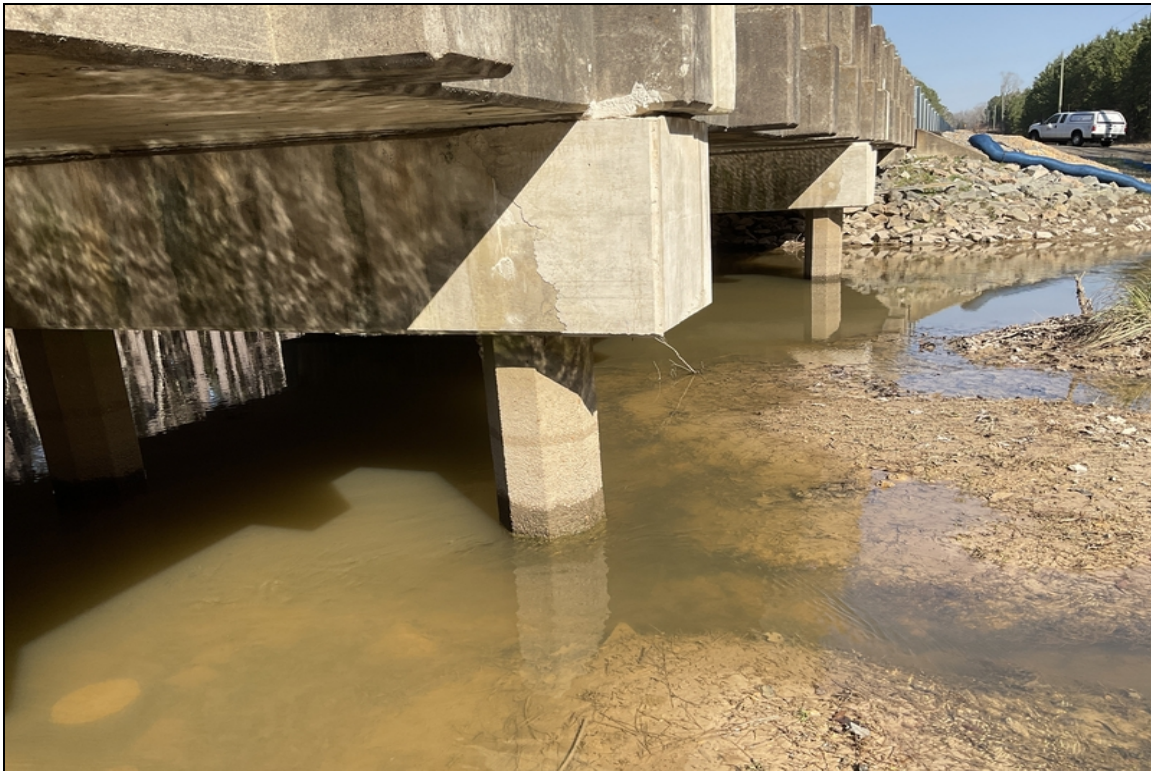
Bent 3: left end of cap has been repaired by contractor

| ELEM | DESCRIPTION | UNITS | TOTAL | CS1 | CS2 | CS3 | CS4 |
|---|---|---|---|---|---|---|---|
| Bent 3 back side has delam and cracks with efflorescence. Bent 2 back side has cracking. At both bents 2 and 3 the ends of the caps have been repaired as per job 012375 | | | | | | | |

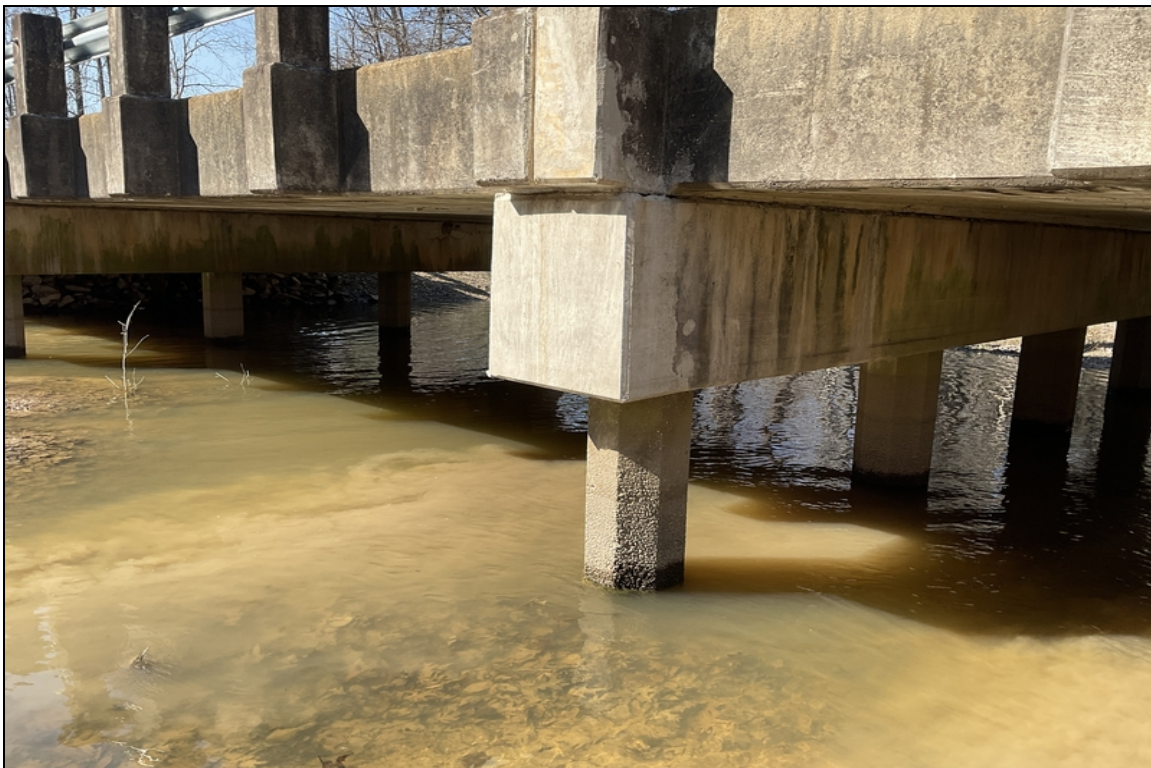
Bent 2: left end of cap has been repaired by contractor 2022.

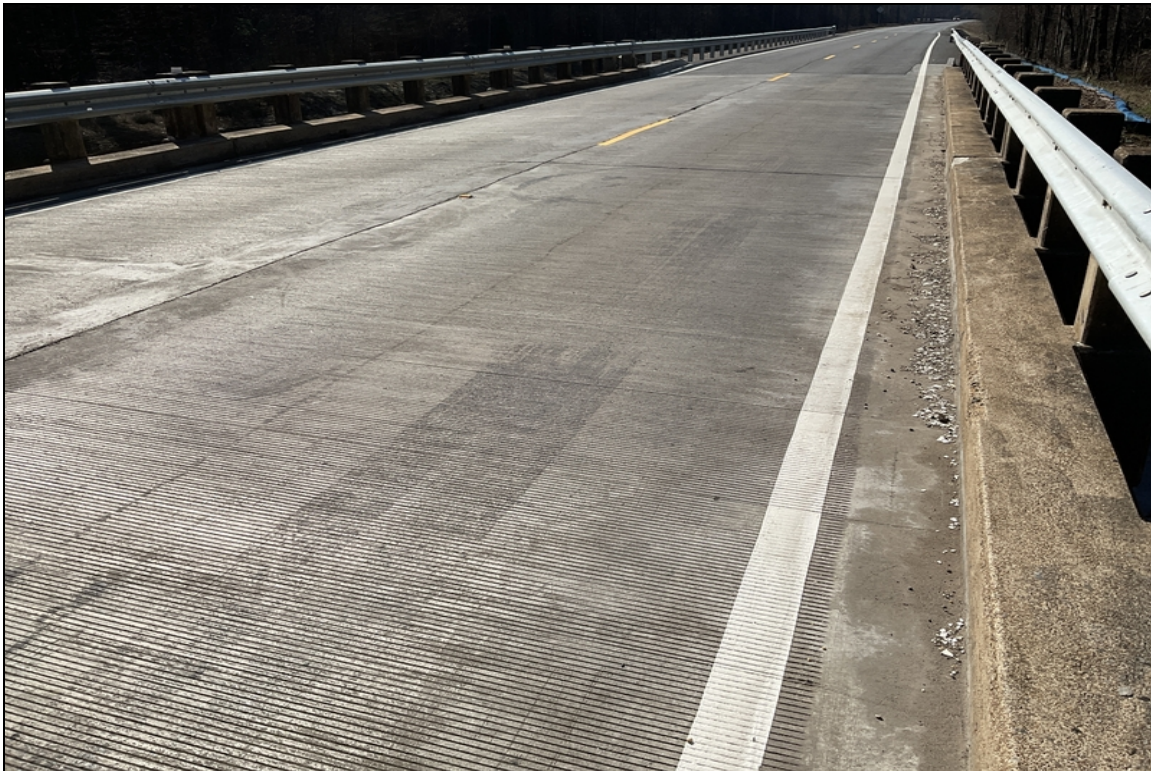
Deck view

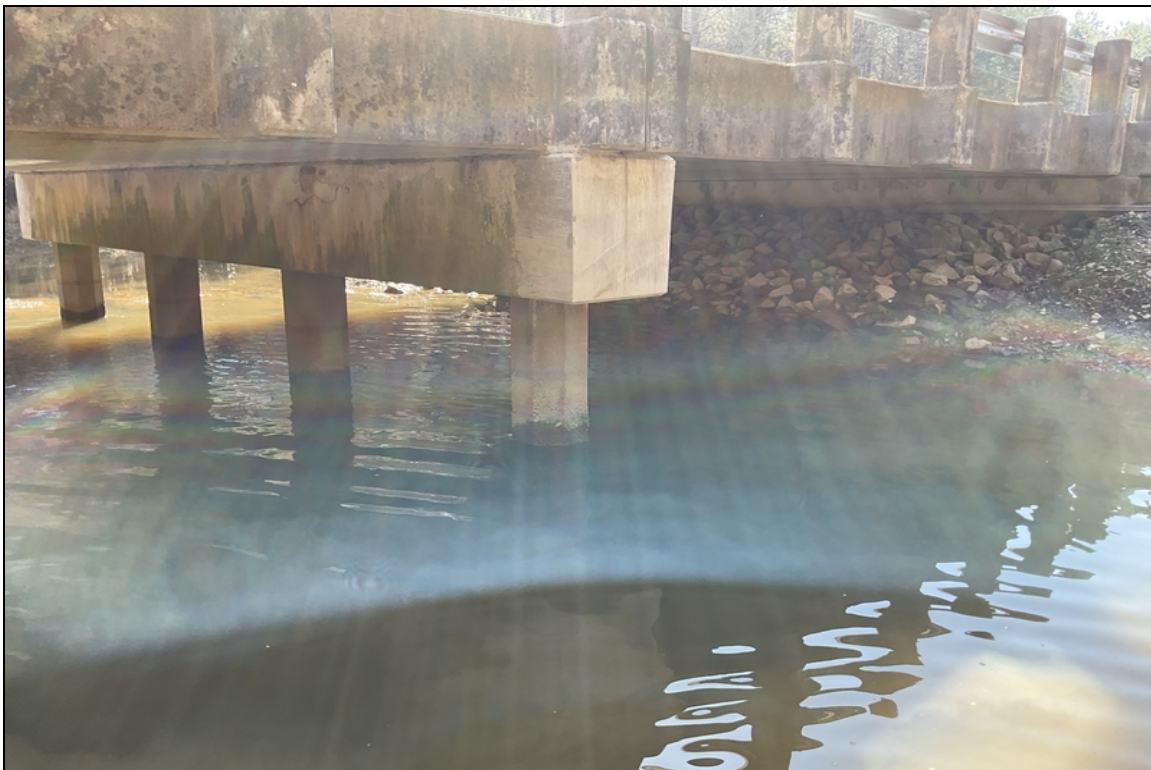
Bent 3: left side of cap has been repaired.

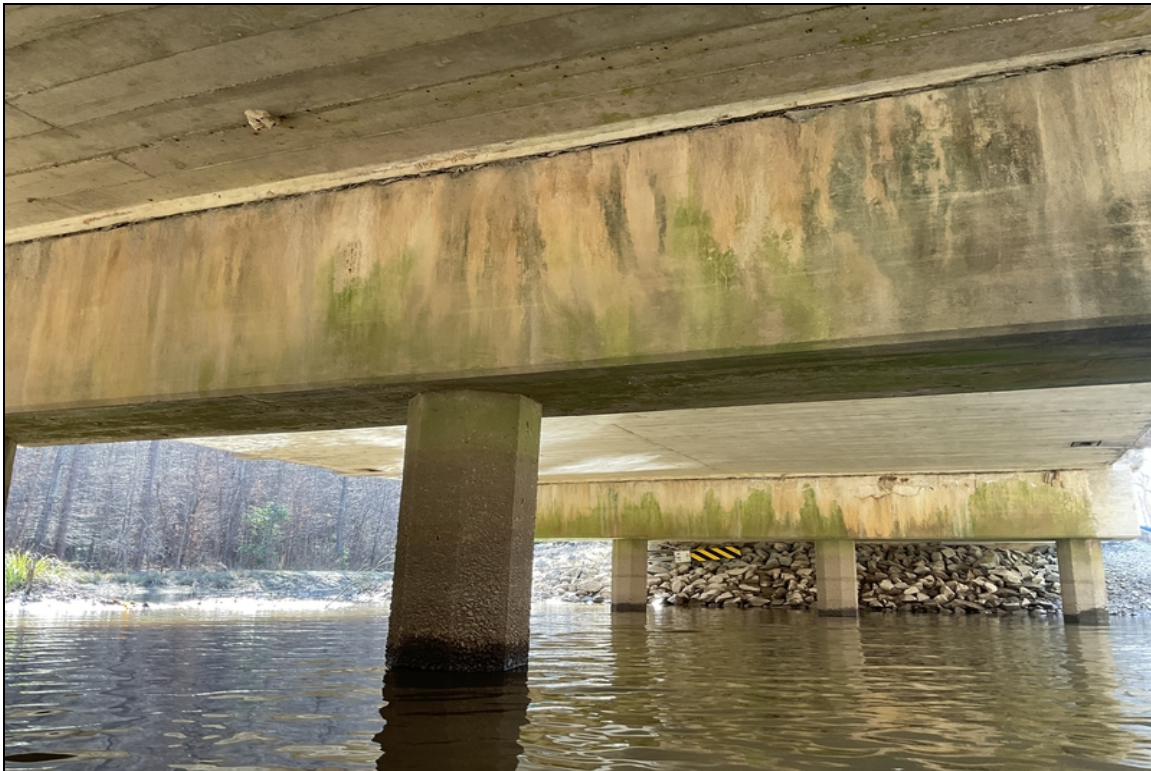
| ELEM | DESCRIPTION | UNITS | TOTAL | CS1 | CS2 | CS3 | CS4 |
|---|---|---|---|---|---|---|---|
| Span 1 soffit has exposed rebar. As per Job 012375 the deck surface has hydrodemolition and a latex modified conc. overlay added. (1 1/2" thick). | | | | | | | |

Soffit view

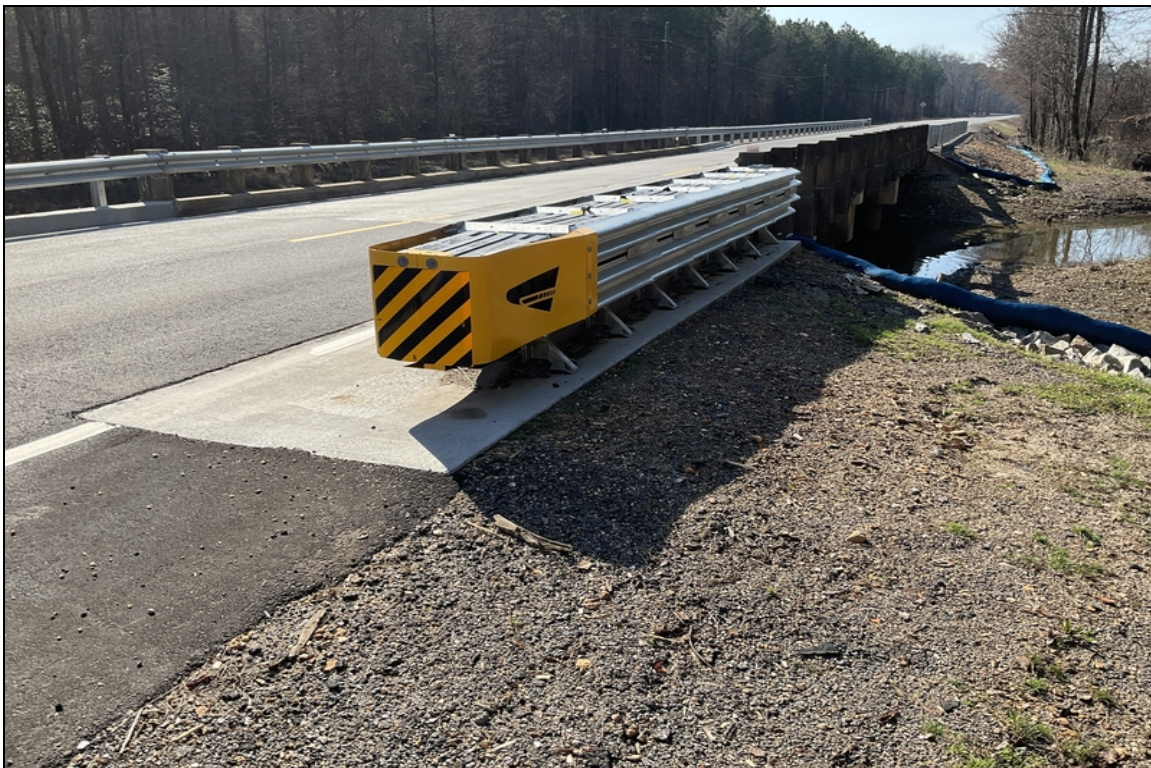
Updated end treatment added 2022

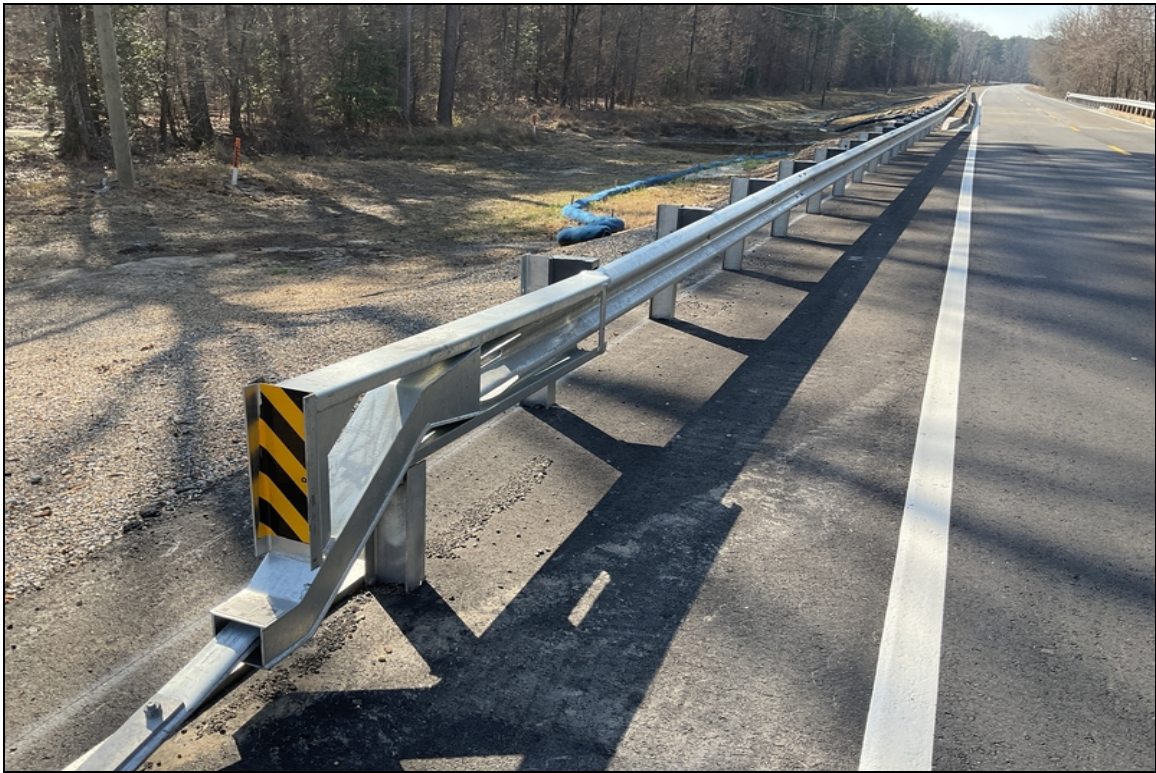
Contractor has updated guard railing and end treatments. (added in 2022)

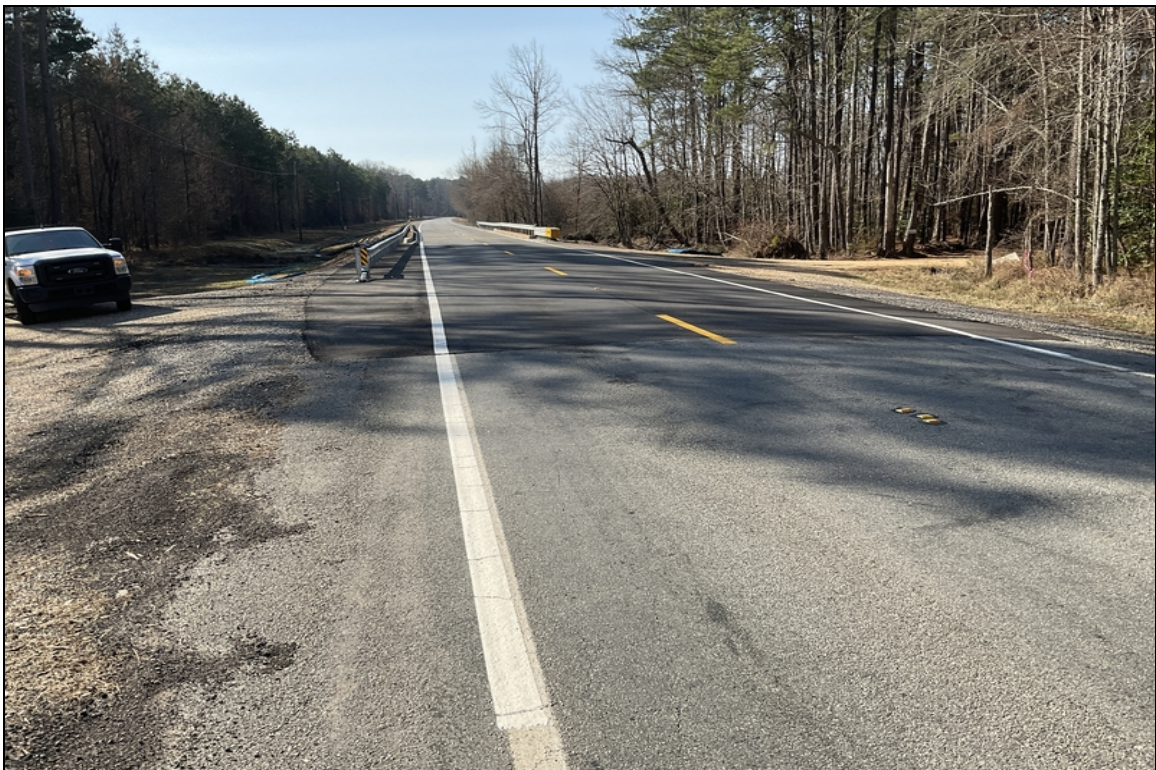
Inventory looking south

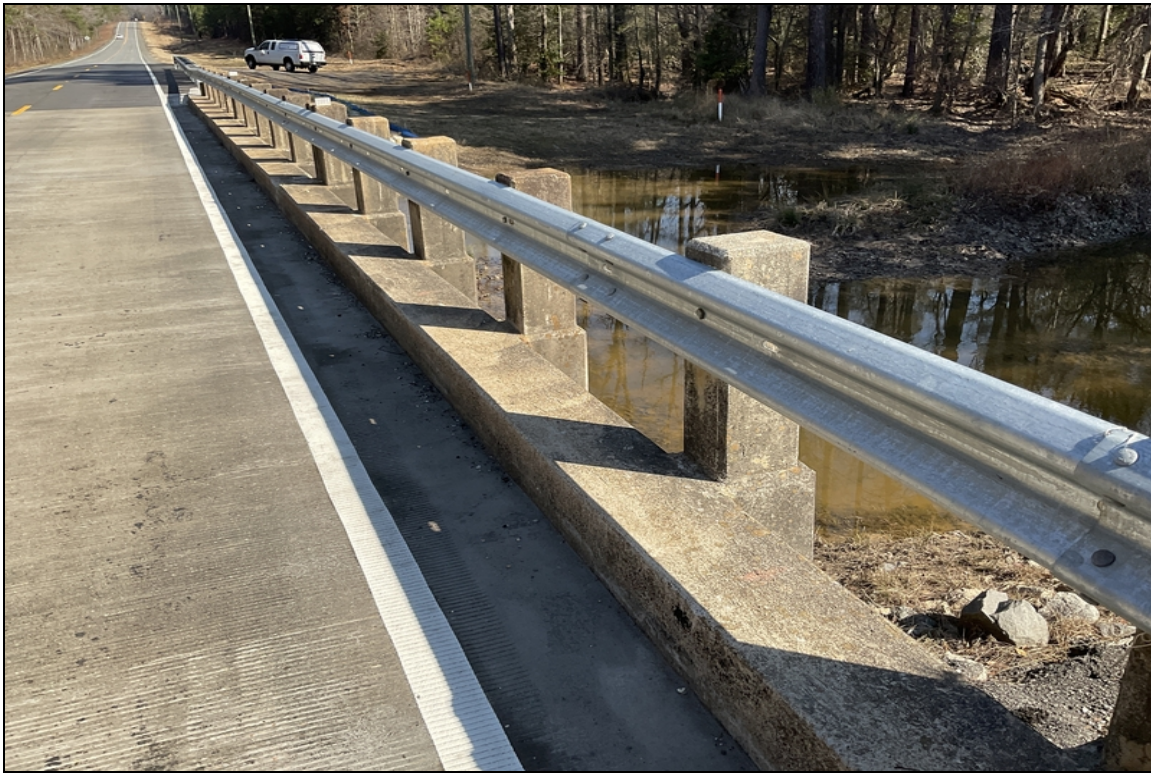
New railing added in 2022

| ELEM | DESCRIPTION | UNITS | TOTAL | CS1 | CS2 | CS3 | CS4 |
|---|---|---|---|---|---|---|---|
| The railing has been replaced in 2022 as per job 012375 | | | | | | | |

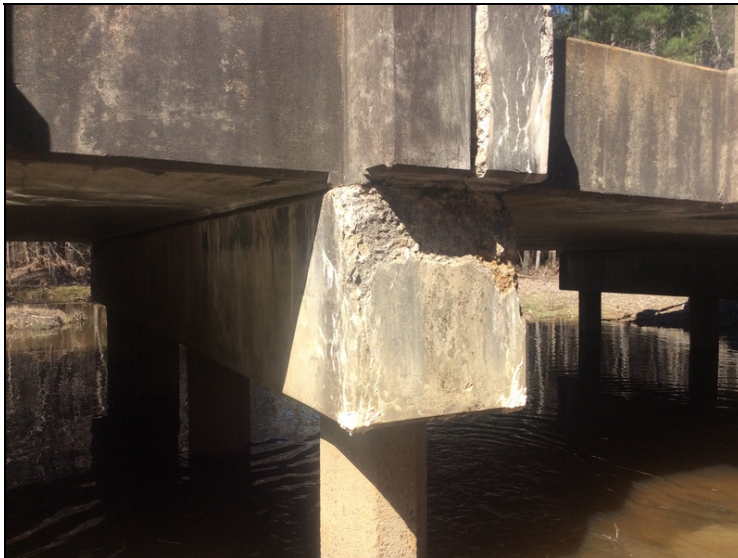
Cap ends at bents 2 and 3
Spalls with efflorescence. See photo.

Bent 3 left side has spalls with efflorescence.

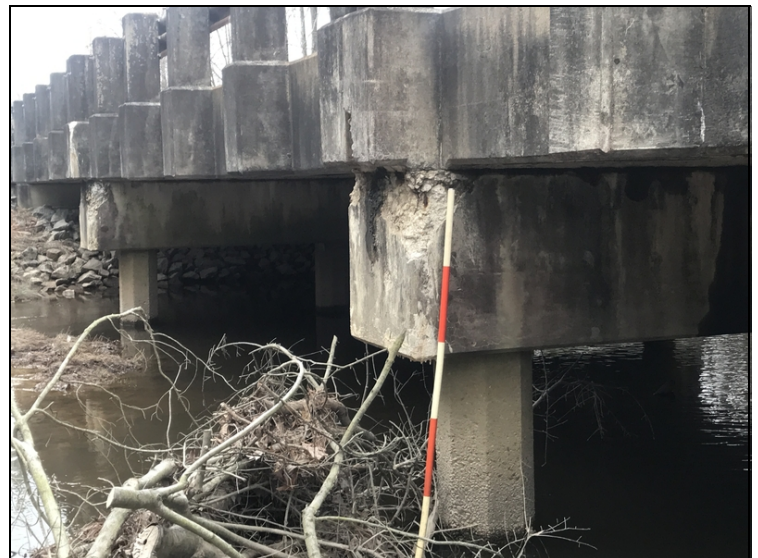
Bt. 2 & Bt. 3, left ends of caps have spalls with exposed rebar.
Bt. 3 right end is similar.

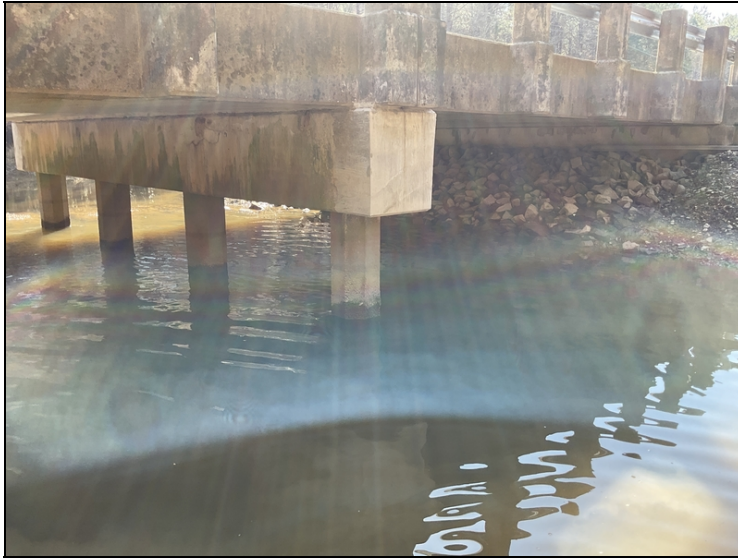
Bent 3: left side of cap has been repaired.

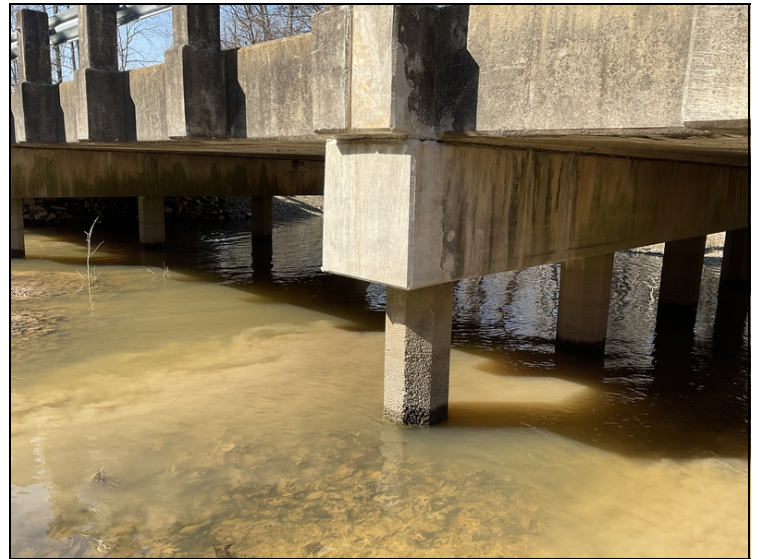
Bent 2: left end of cap has been repaired by contractor 2022.

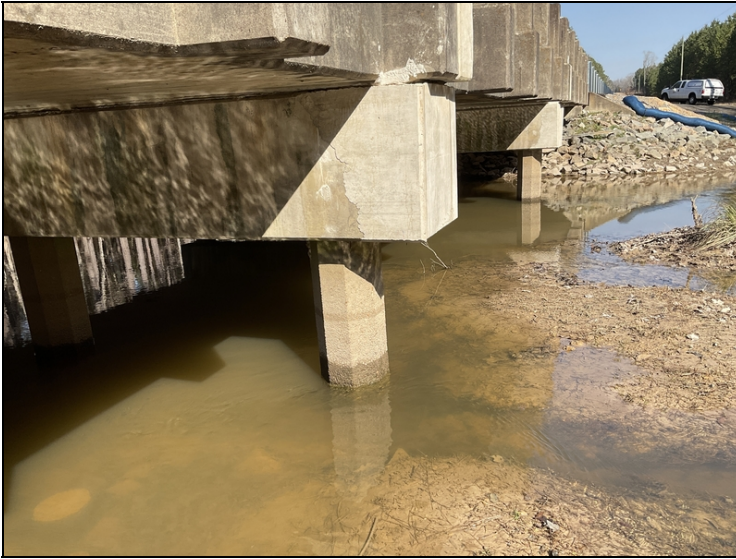
Bent 3: left end of cap has been repaired by contractor

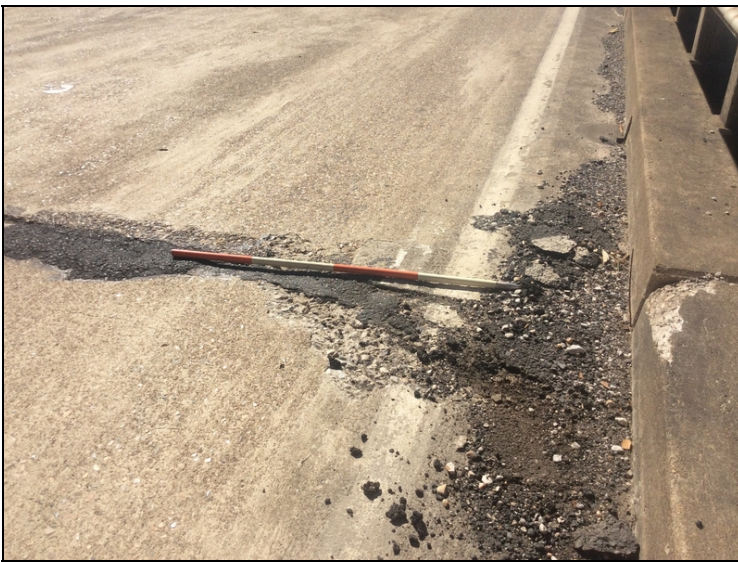
Deck and deck joints on all 3 spans.
Spalls with heavy scaling and pourable joint seal is missing. See photo.

Span 1 failed asphalt patch at joint.

As per Job 012375 the deck surface has hydrodemolition and a latex modified conc. overlay added. (1 1/2" thick).

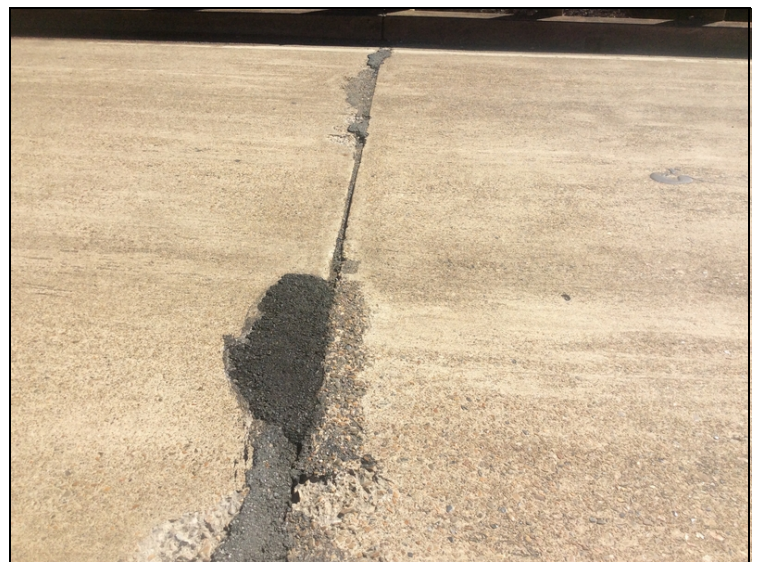
Joint at bent 1 is partially filled with asphalt.

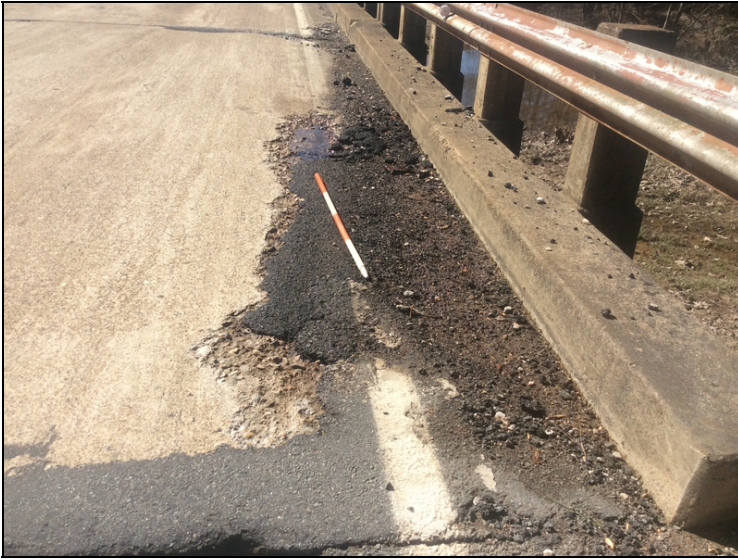
Span 1 right lane failed asphalt patch.

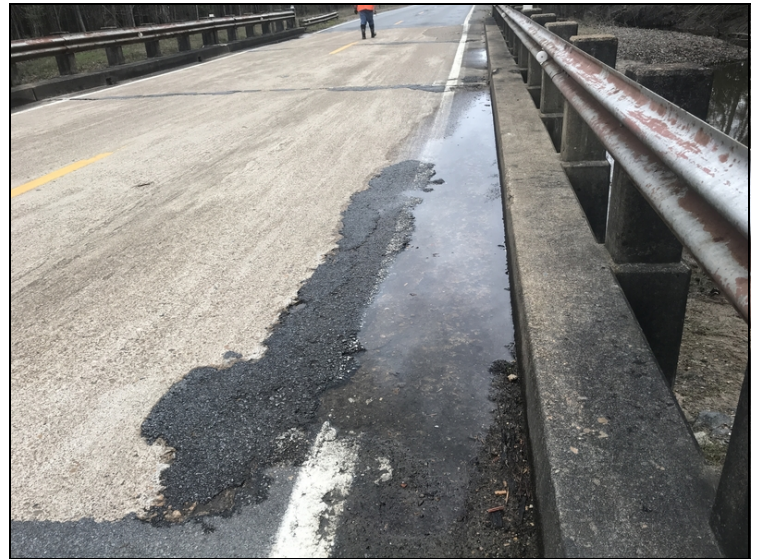
Spalls filled with asphalt, heavy scaling, joint seal missing.

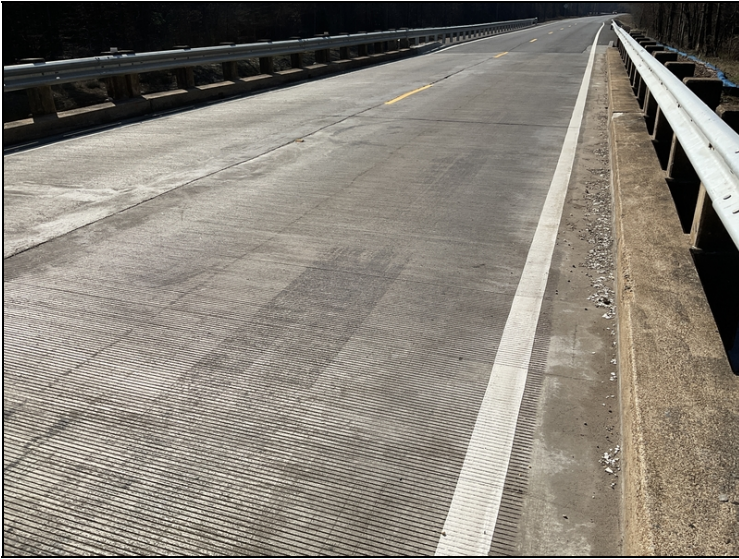
Deck view

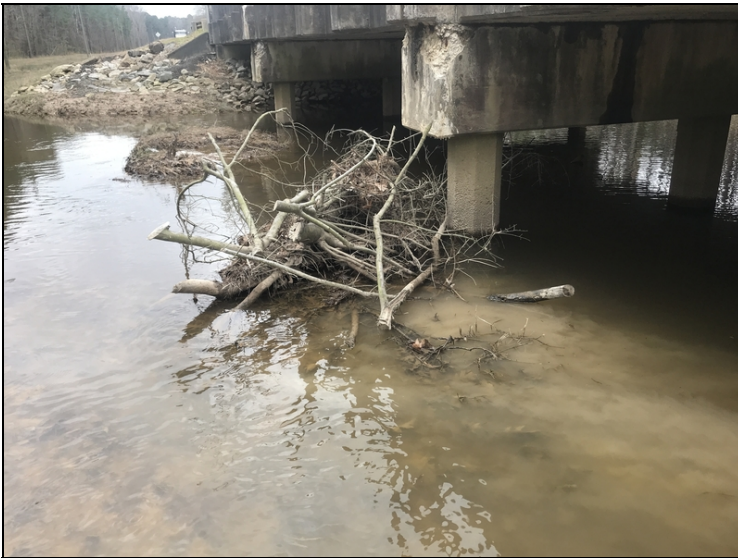
Brush & debris have built up against column 1, at Bt. 2.

Brush has built up against column at Bt. 2.

This debris has been removed as of 2022
