Bridge #07089(Routine, Underwater type 2)

SH 35 Log 2.66 over DEPOT CREEK

Team Lead: Chris Doggett Inspection Date: April 14, 2022

IDENTIFICATION	
(1) State Names	Arkansas
(8) Structure Number	07089
(5) Inventory Route	35
(2) Highway Agency District	06
(3) County Code	125-Saline County, Arkansas

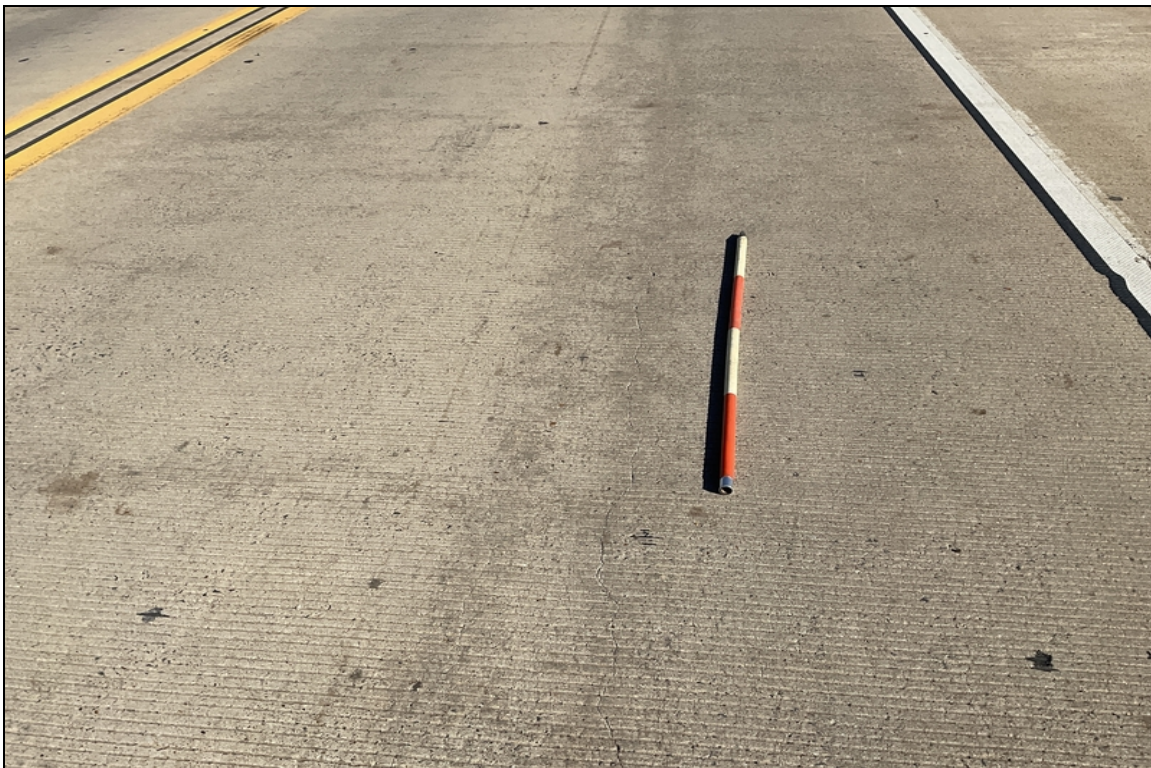
(12)							
Deck has longitude/transverse cracks longitude cracks run full length of bridge. Soffits have transverse cracks with efflorescence staining.							
107	Steel Open Girder/Beam	LF	1750	1750	0	0	0
515	Steel Protective Coating	SF	10710	10710	0	0	0
3430	Oxide Film Degradation Color/Texture Adherence(Steel Protective Coatings)	SF	0	0	0	0	0

Span 6: multiple unsealed longitudinal cracks

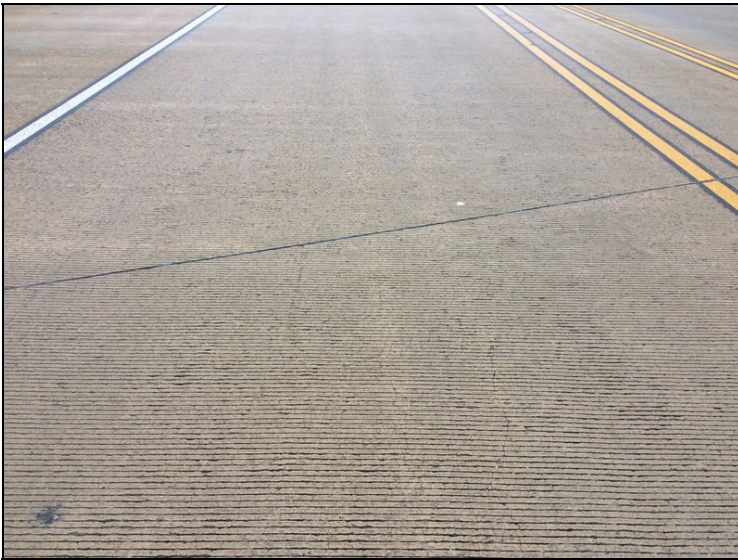
Deck has sealable longitude cracks that run full length of structure in all lanes.

Span 1 longitude cracks.

**Date Reported:** 04/03/2018  
**Priority:** C - Important  
**Type of Work:** None  
**Status:** Monitor  
**Inspection Direction** N to S  
**Component:**

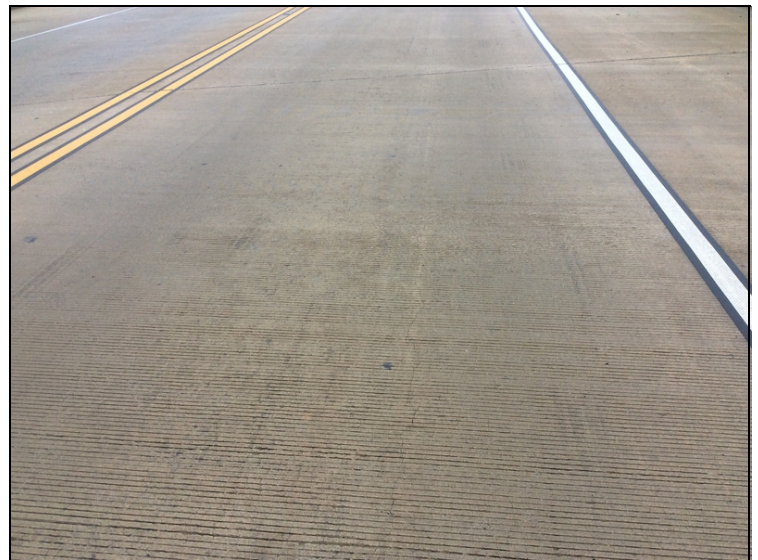
Span 7 longitudinal crack.

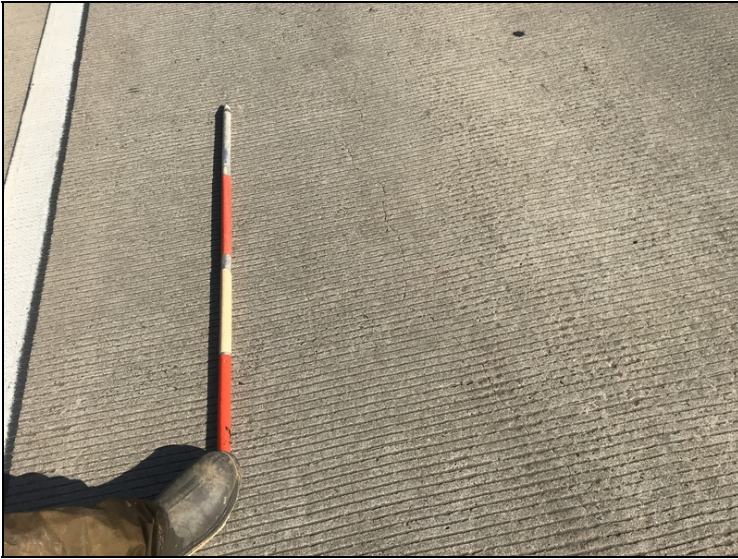
Deck span longitudinal crack

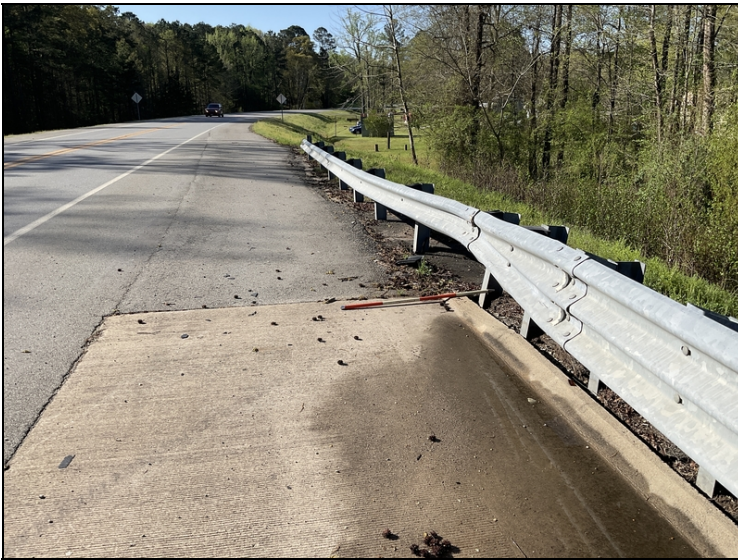
South west guardrail has been damaged due to traffic impact.

**Date Reported:** 04/14/2022  
**Priority:** C - Important  
**Type of Work:** Repair  
**Status:** Open  
**Inspection Direction** N to S  
**Component:** Approach

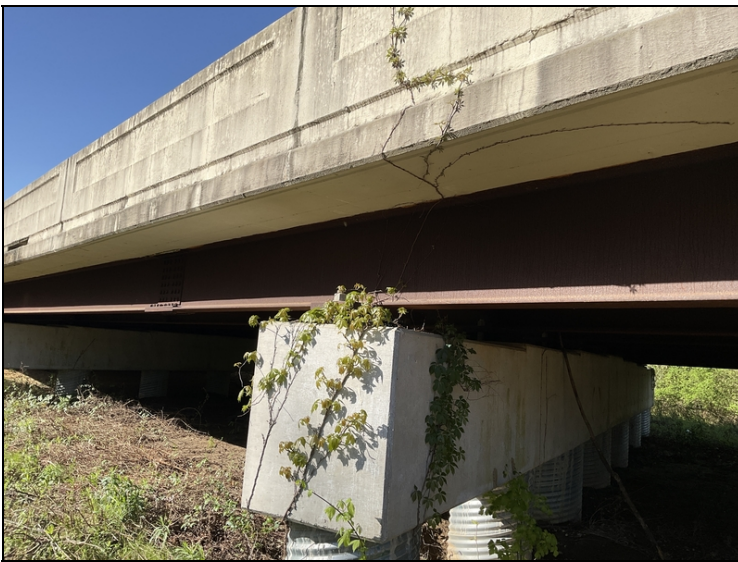
Bent 5: vines climbing onto bridge railing

**Date Reported:** 04/14/2022  
**Priority:** G - General/ Preventive maintenance  
**Type of Work:** Clean  
**Status:** Open  
**Inspection Direction** N to S  
**Component:** Bridge

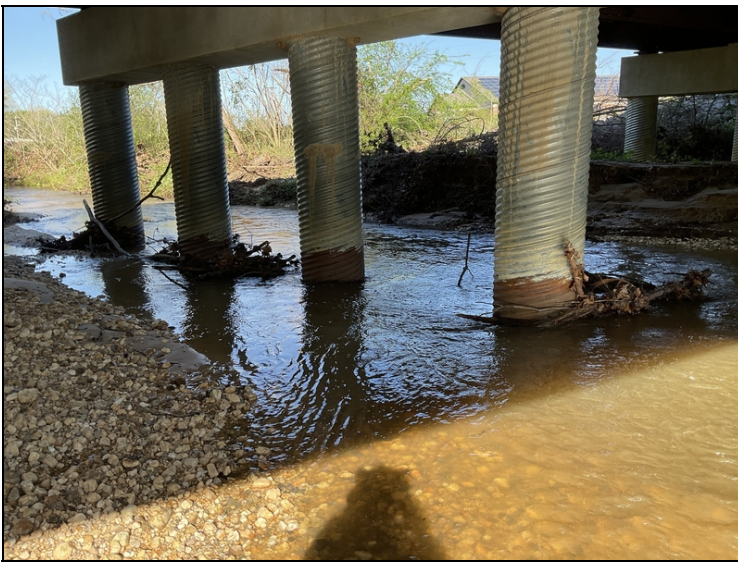
Drift has accumulated at bent 3, columns 3,4,6, and 7.

Drift has accumulated at bent 3, columns 3,4,6,  
and 7.

**Date Reported:** 04/14/2022  
**Priority:** C - Important  
**Type of Work:** Clean  
**Status:** Open  
**Inspection Direction** N to S  
**Component:** Channel
