**Bridge #06077**(Routine, Underwater type 2)  
**SH 128-11 Log 8.45 over SO FK SALINE RIVER**

**Location: .2 MI E JCT SH 5**

**Team Lead: Shane Byrd Inspection Date: October 18, 2021**

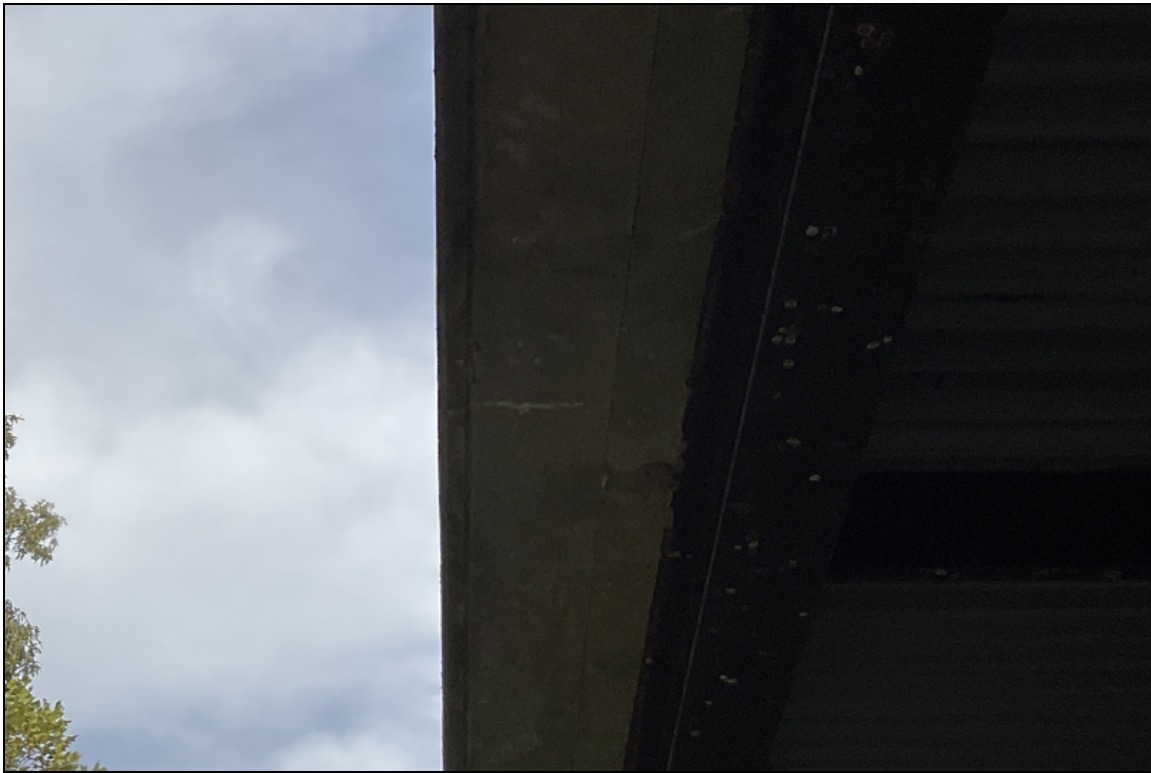
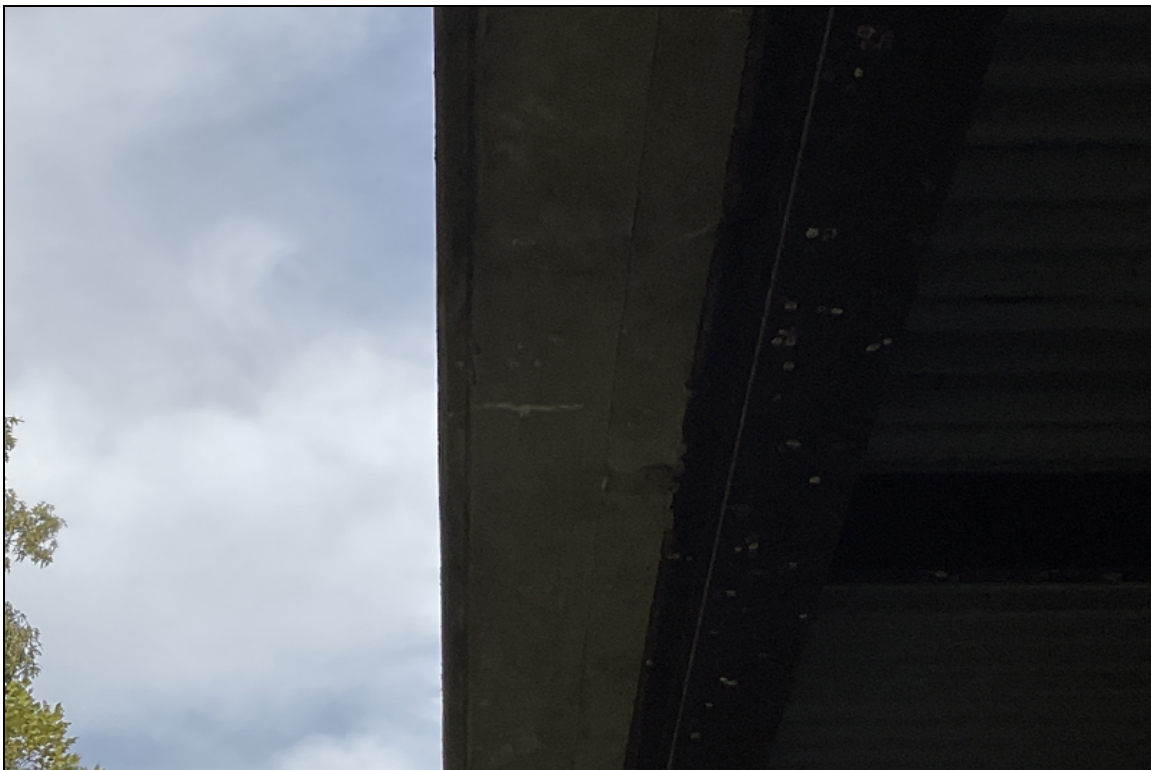
(12)	Deck has map cracking and unsealed cracks up to 0.020" Soffit overhang has small cracks with efflorescence						
107	Steel Open Girder/Beam	LF	896	896	0	0	0
515	Steel Protective Coating	SF	5525	0	5525	0	0
3430	Oxide Film Degradation Color/Texture Adherence(Steel Protective Coatings)	SF	5525	0	5525	0	0

Soffit overhang span 2 left side crack with efflorescence.

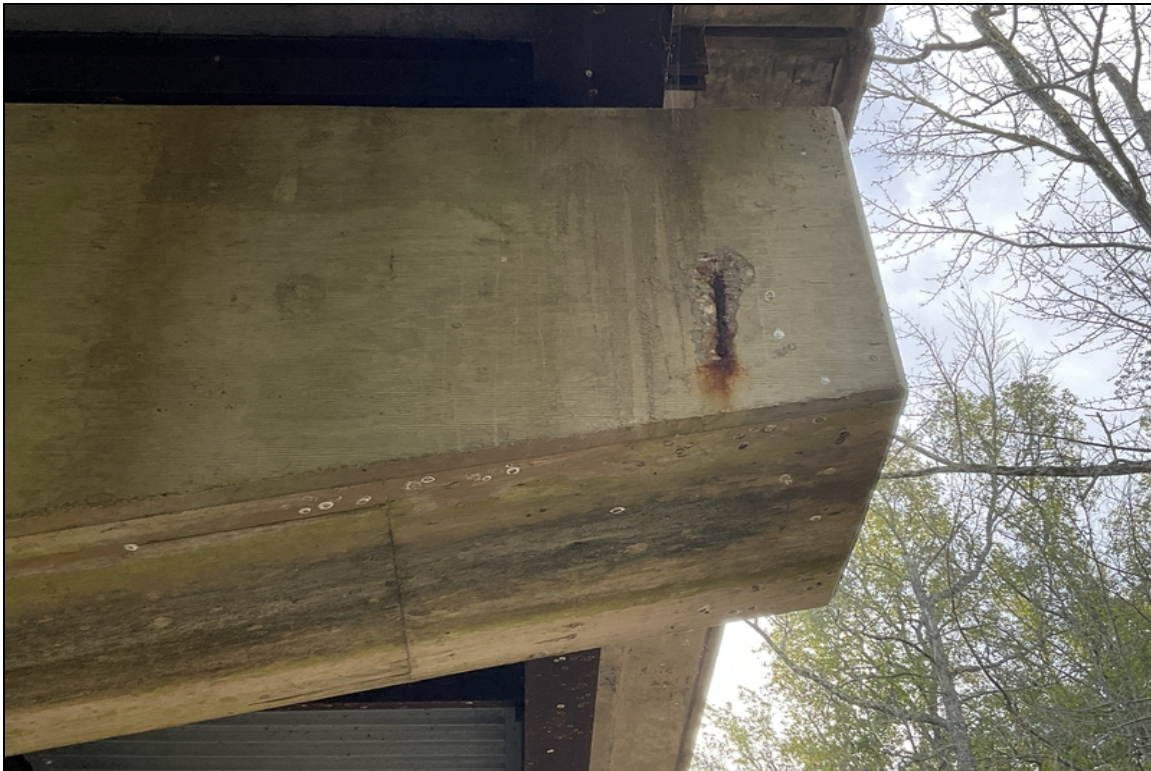
(234)	Caps have small cracks. Bent 3 has crack with efflorescence on the ahead side. Bents 2 and 3 have exposed rebar.						
302	Compression Joint Seal	LF	140	79	61	0	0
2320	Seal Adhesion	LF	46	0	46	0	0

Bent 2 cap left side ahead face spall with exposed rebar.

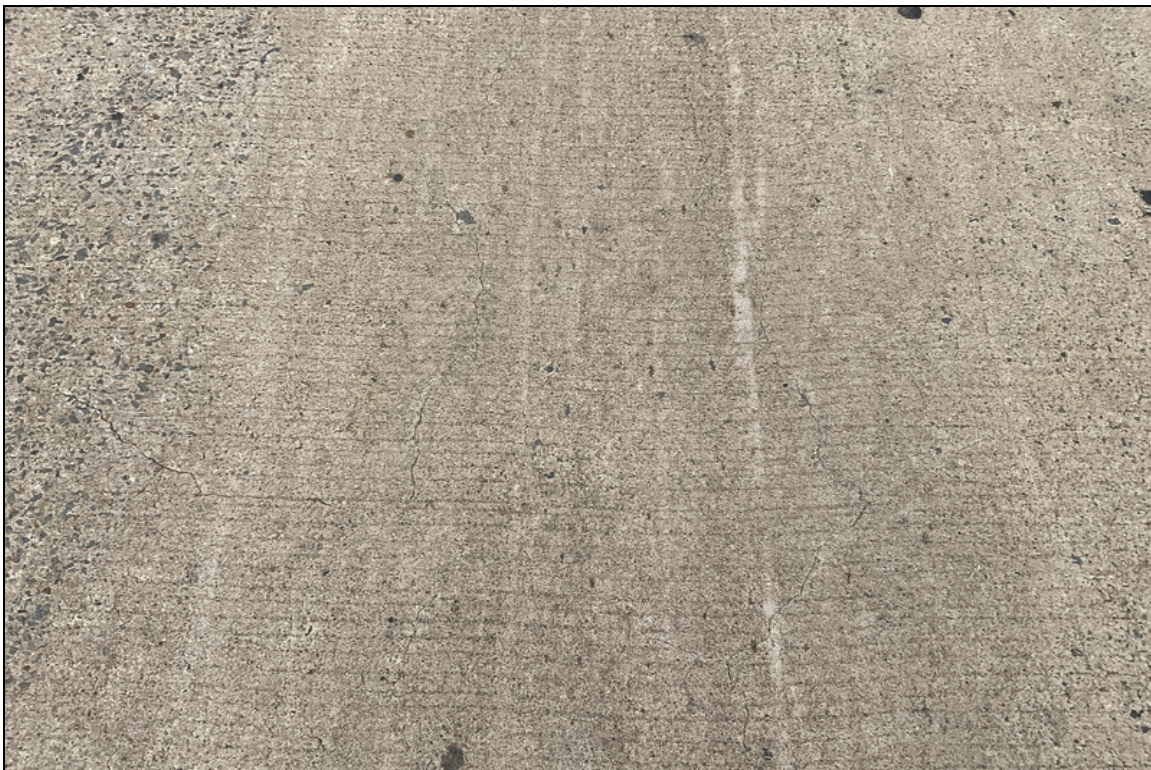
Span 2 longitudinal cracks.

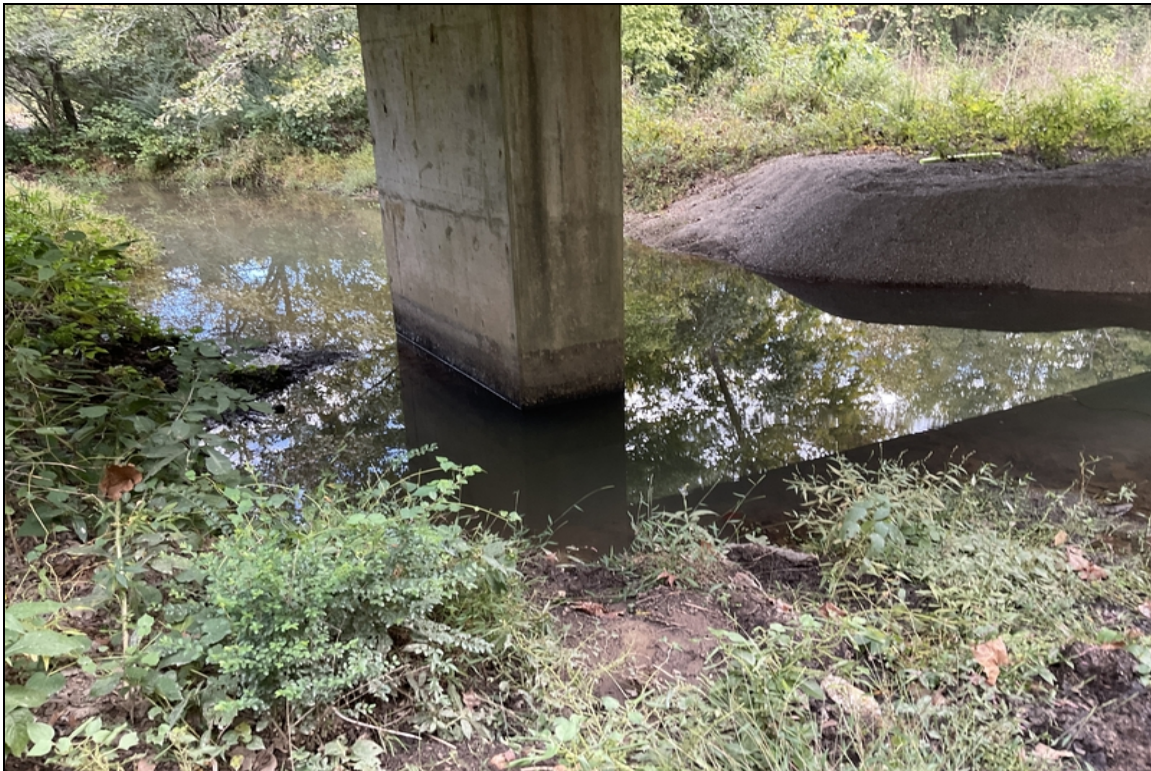
(205)	Local scour at bent 4 column.						
215	Reinforced Concrete Abutment	LF	90	81	9	0	0
1080	Delamination/Spall/Patched Area	LF	1	0	1	0	0
1130	Cracking (RC and Other)	LF	8	0	8	0	0

Local scour at bent 4 column.

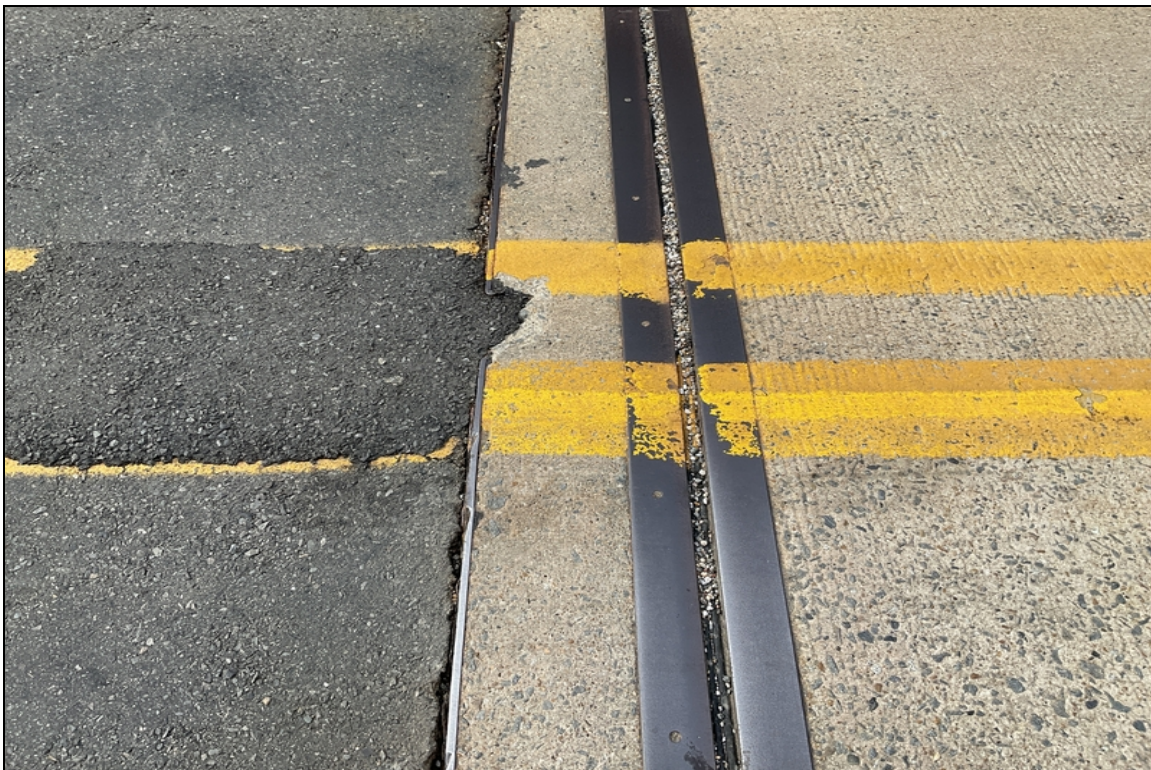
(215)	Both abutments have small cracks Bent 1 spall in top of back wall.						
234	Reinforced Concrete Pier Cap	LF	87	71	16	0	0
1090	Exposed Rebar	LF	2	0	2	0	0
1120	Efflorescence/Rust Staining	LF	1	0	1	0	0
1130	Cracking (RC and Other)	LF	13	0	13	0	0

Bent 1 abutment spall in top of back wall.

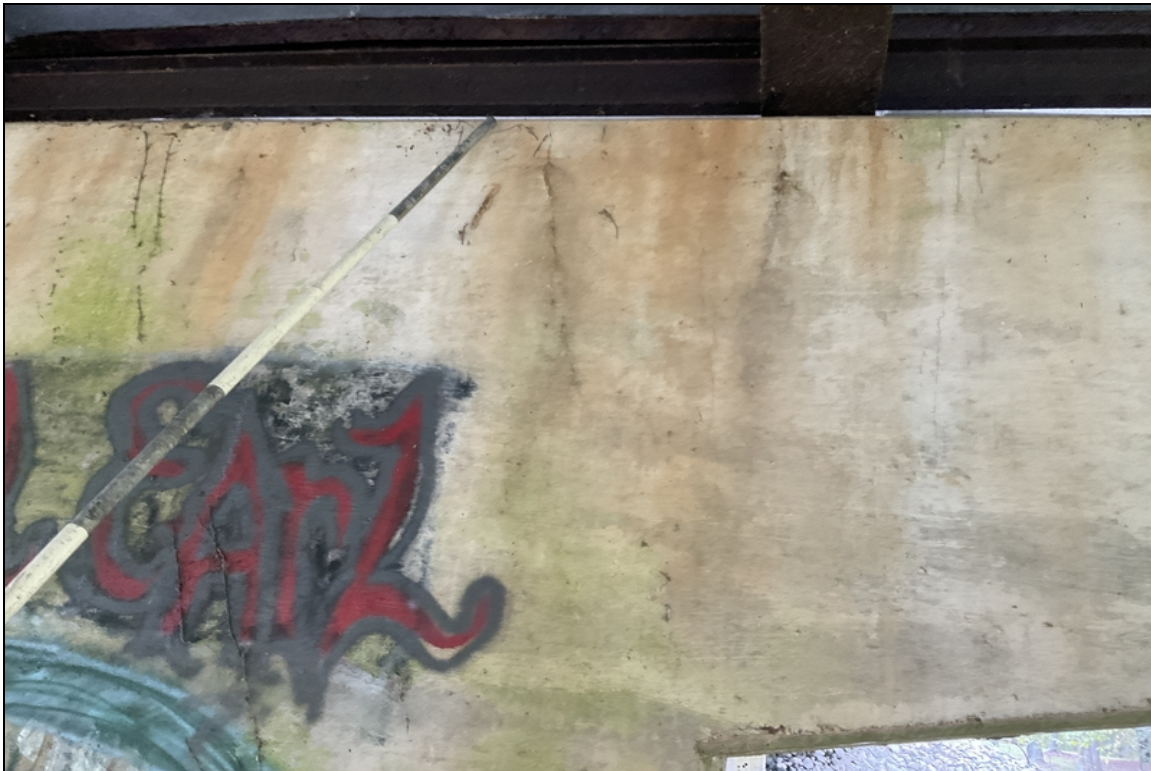
Bent 3 cap ahead face crack and crack with efflorescence.

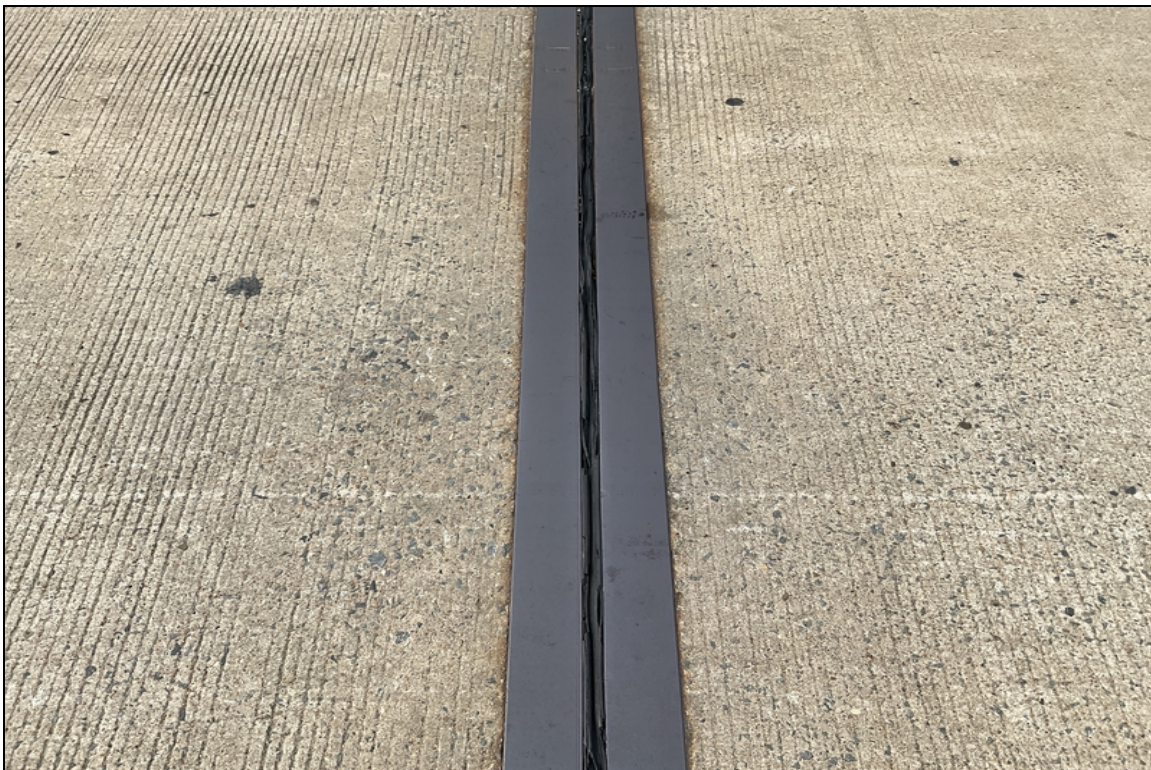
ELEM	DESCRIPTION	UNITS	TOTAL	CS1	CS2	CS3	CS4
2330 (302)	Seal Damage	LF	15	0	15	0	0
All seals have lost adhesion. Bents 2 and 3 have seal damage.							
311	Movable Bearing	EA	16	0	16	0	0
1000 (311)	Corrosion	EA	16	0	16	0	0
All bearings have minor corrosion.							
313	Fixed Bearing	EA	16	0	12	4	0
1000 (313)	Corrosion	EA	16	0	12	4	0
Bent 1 bearings 2,3 and 4 and bent 2 bearings 2 and 4 have laminating rust. All other bearings have minor corrosion.							
331	Reinforced Concrete Bridge Railing	LF	448	429	19	0	0
1130 (331)	Cracking (RC and Other)	LF	19	0	19	0	0
Both bridge rails have small cracks

Bent 2 seal damage.

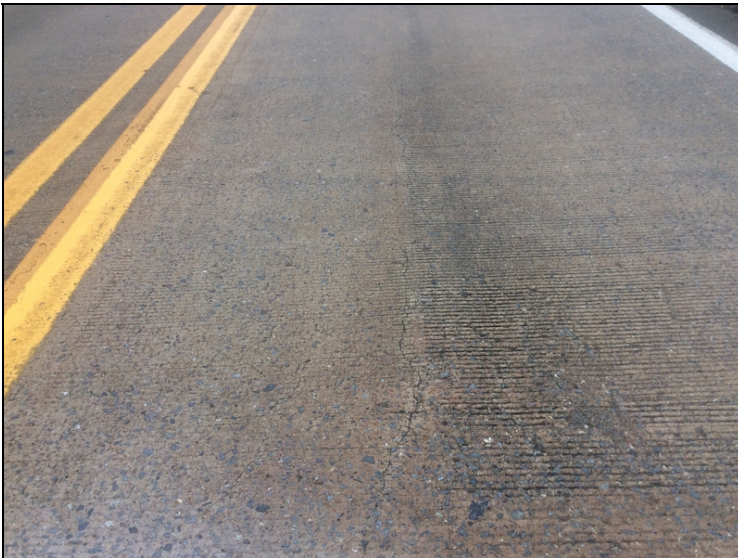
Deck has large unsealed cracks

Span 1, longitudinal cracks.

**Date Reported:** 10/27/2015  
**Priority:** D- Routine  
**Type of Work:** Repair  
**Status:** Monitor  
**Component:** Deck

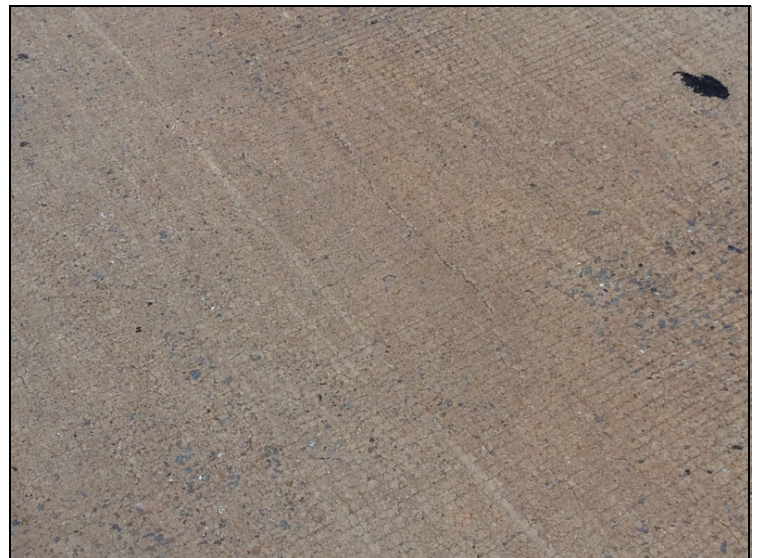
Deck cracks

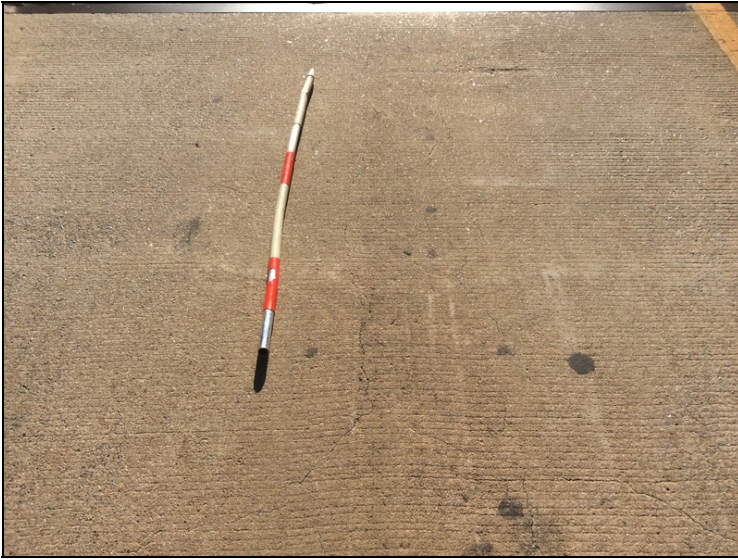
Span 2 unsealed cracks in deck up to 0.020"

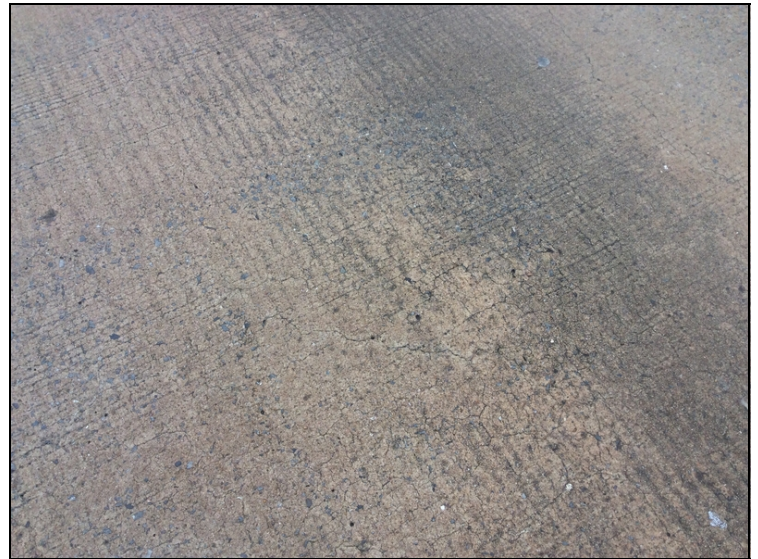
Span 1, map cracking.

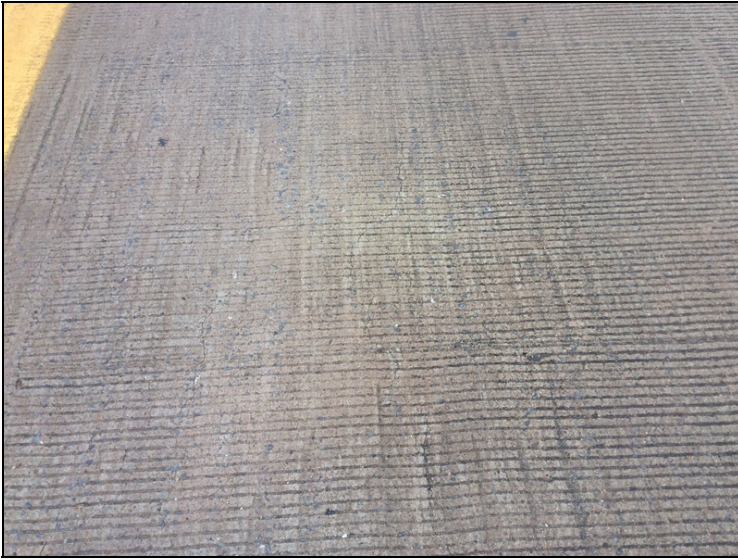
San 4, longitudinal cracks.

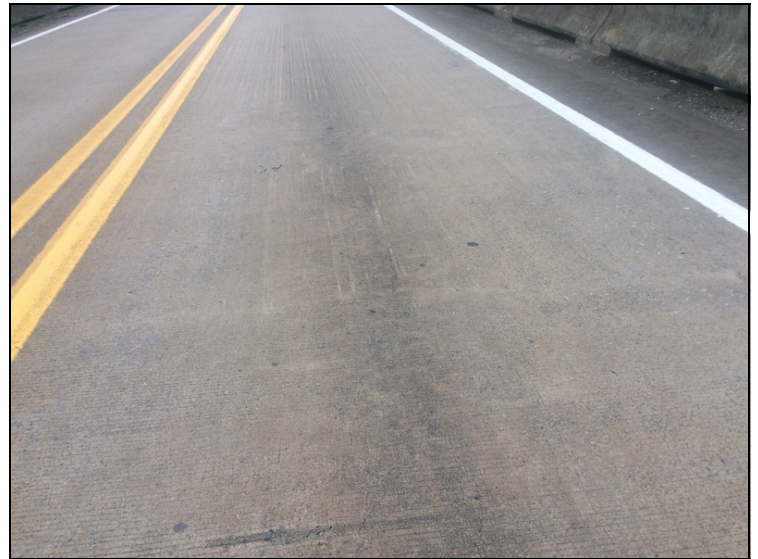
Span 2, longitudinal cracks.

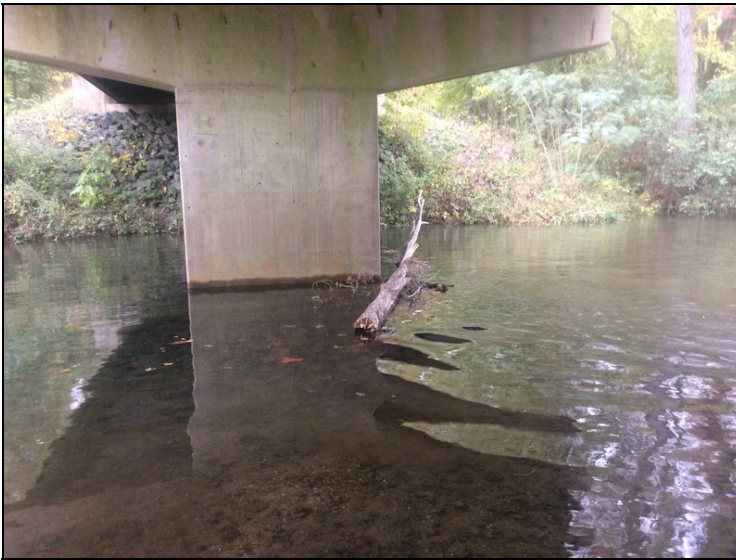
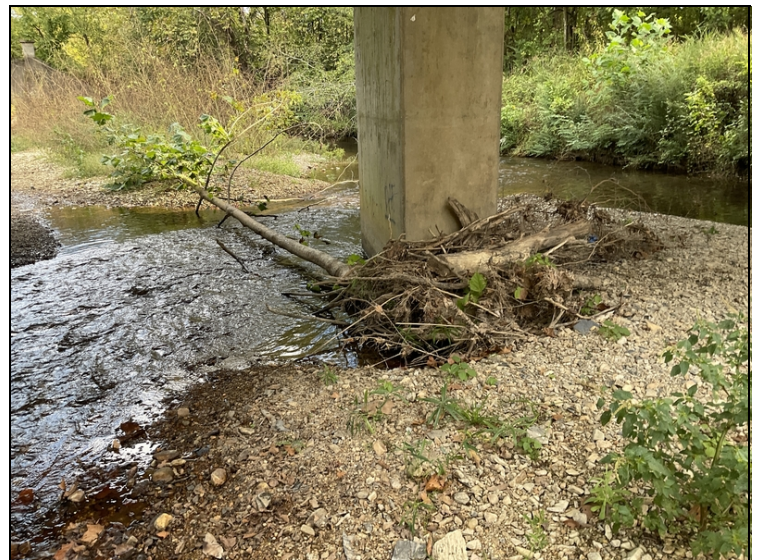
logs and debris build up at bent 2

Bent 2, debris.

Tree and debris against column at bent 2.

**Date Reported:** 10/28/2019  
**Priority:** C - Important  
**Type of Work:** Clean  
**Status:** Assigned  
**Component:** Substructure

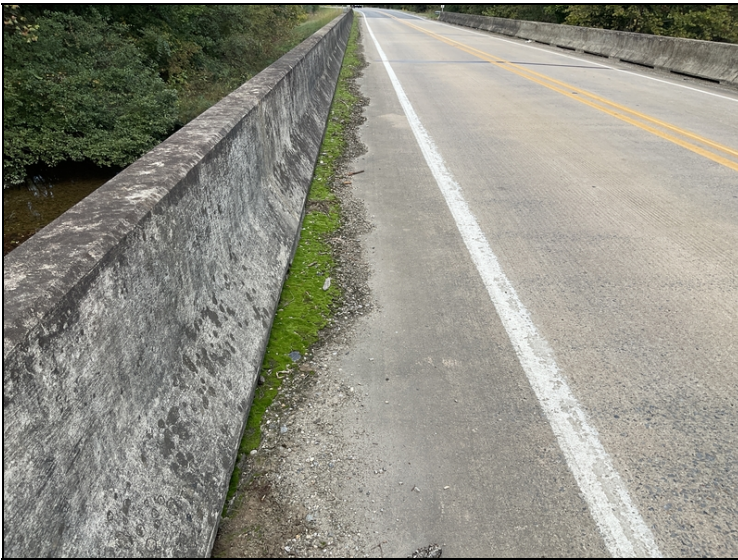
Both gutter lines dirt and debris restricting scupper drains.

**Date Reported:** 10/18/2021  
**Priority:** C - Important  
**Type of Work:** Clean  
**Status:** Open  
**Component:** Deck
