Bridge #06078(Routine, Underwater)

SH 128- Log 6.42 over MILL CREEK

Team Lead: Shane Byrd Inspection Date: October 18, 2021

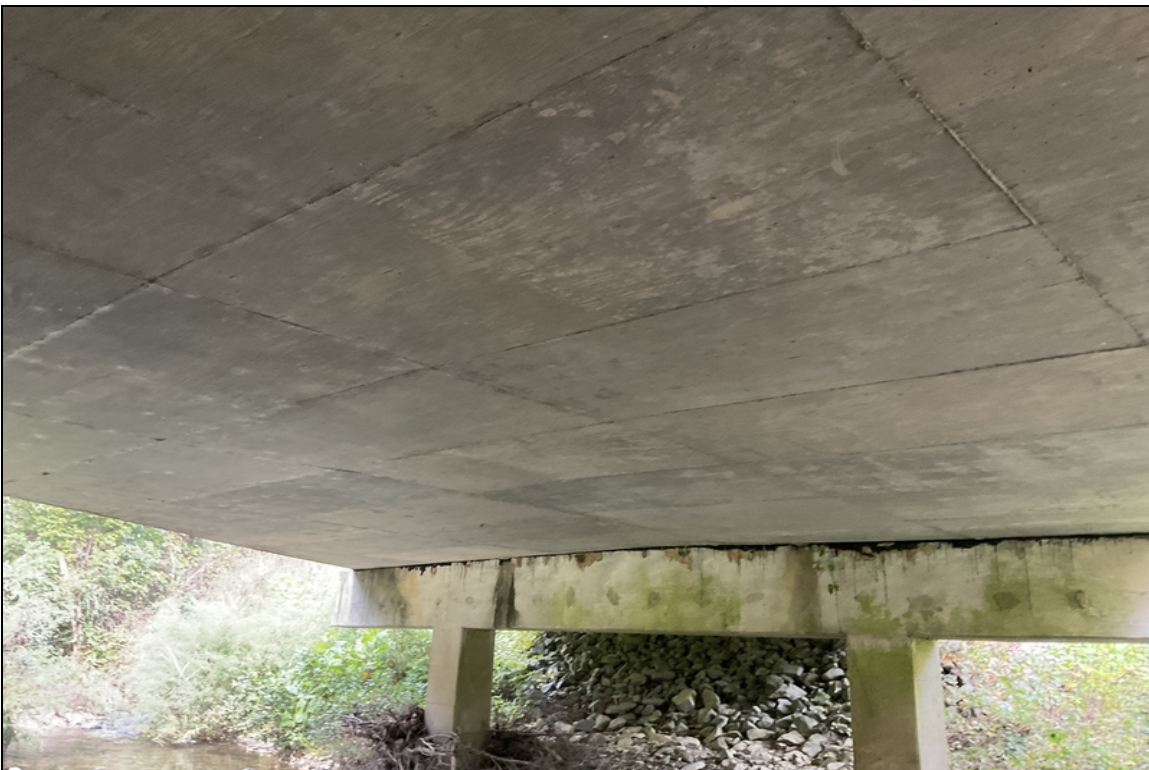
Span 2 soffit no sign of distress. Common all spans.

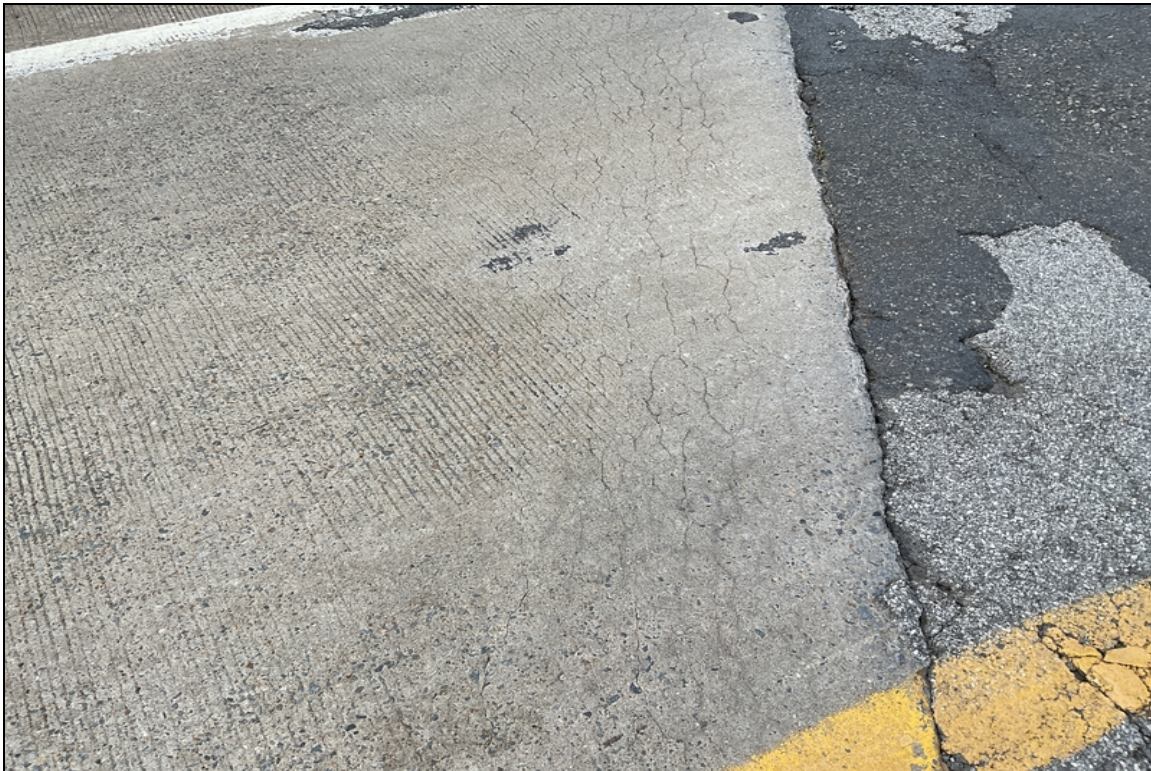
(38)							
Deck has small unsealed cracks. Sides of slabs at bents have scattered cracks and cracks with light efflorescence.							
205	Reinforced Concrete Column	EA	4	0	4	0	0
1190	Abrasion/Wear (PSC/RC)	EA	4	0	4	0	0

Span 3 deck map cracks. Worst case this bridge.

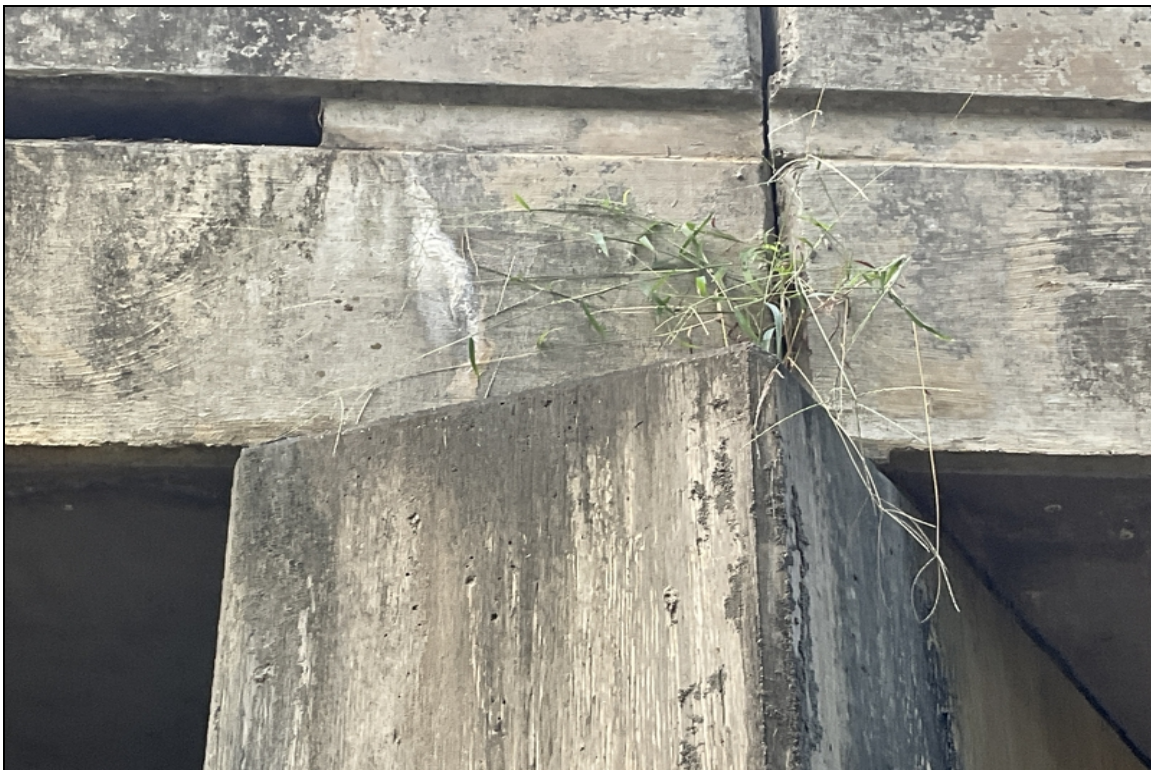
Slab right side at bent 2 vertical crack with light efflorescence.

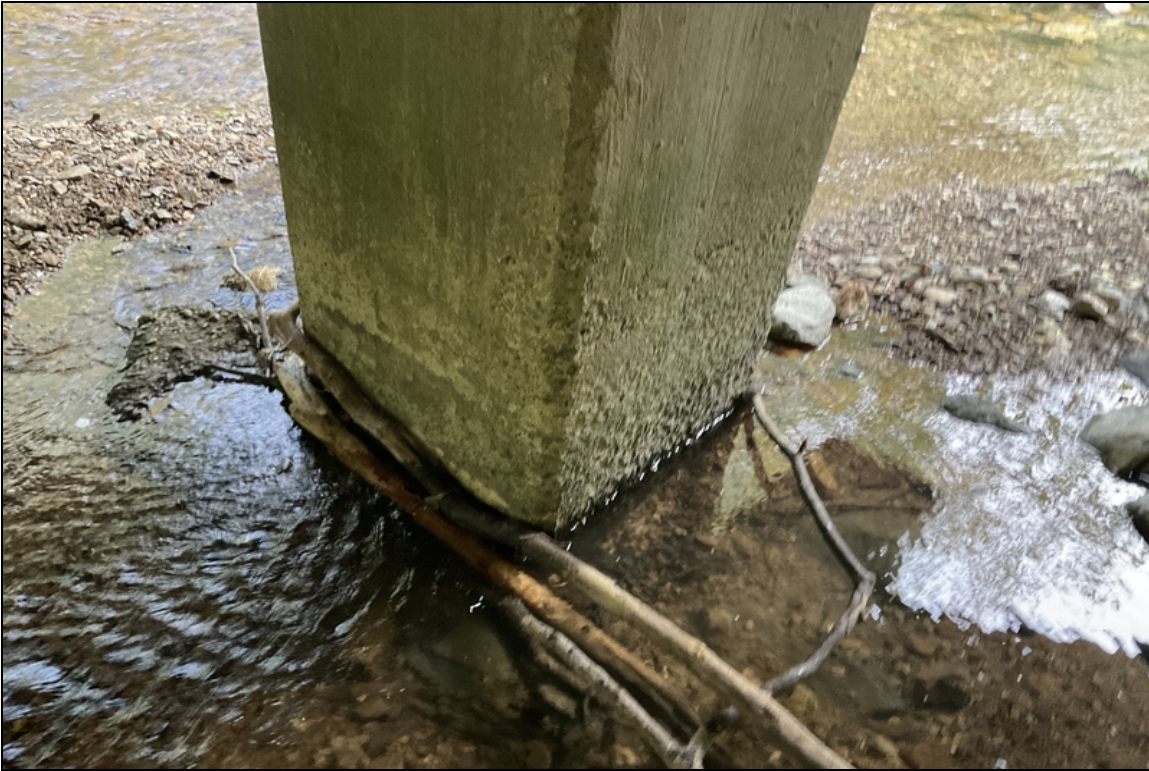
(205)							
All columns have light abrasion.							
215	Reinforced Concrete Abutment	LF	99	98	1	0	0
1130	Cracking (RC and Other)	LF	1	0	1	0	0
(215)							
Bt. 4 has 1 vertical crack.							
234	Reinforced Concrete Pier Cap	LF	71	63	8	0	0
1080	Delamination/Spall/Patched Area	LF	5	0	5	0	0
1120	Efflorescence/Rust Staining	LF	1	0	1	0	0
1130	Cracking (RC and Other)	LF	2	0	2	0	0

Bent 2 column 1 minor abrasion.

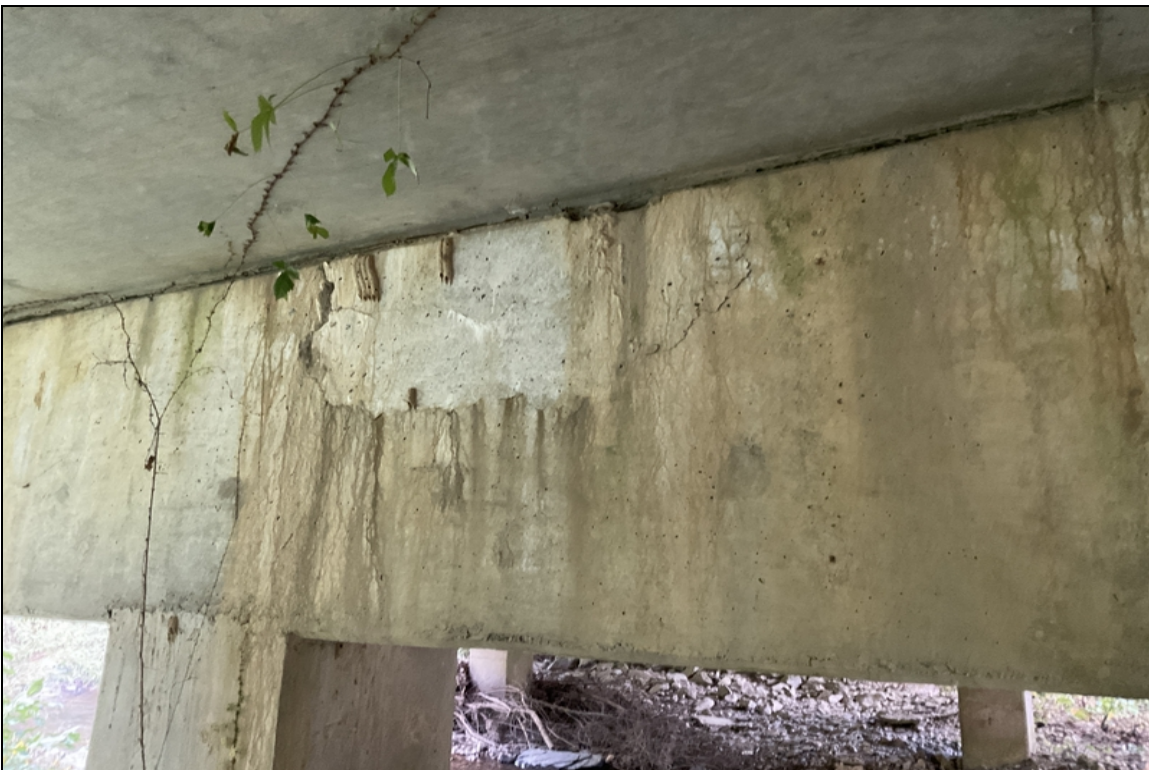
(234)							
Bent 2 cap has 1 delam on the back side, 2 small cracks and 1 small spall on the ahead side. Bent 3, crack with efflorescence on the ahead side.							
301	Pourable Joint Seal	LF	65	0	65	0	0
2310	Leakage	LF	65	0	65	0	0

Bent 2 cap back at column 2 delam.

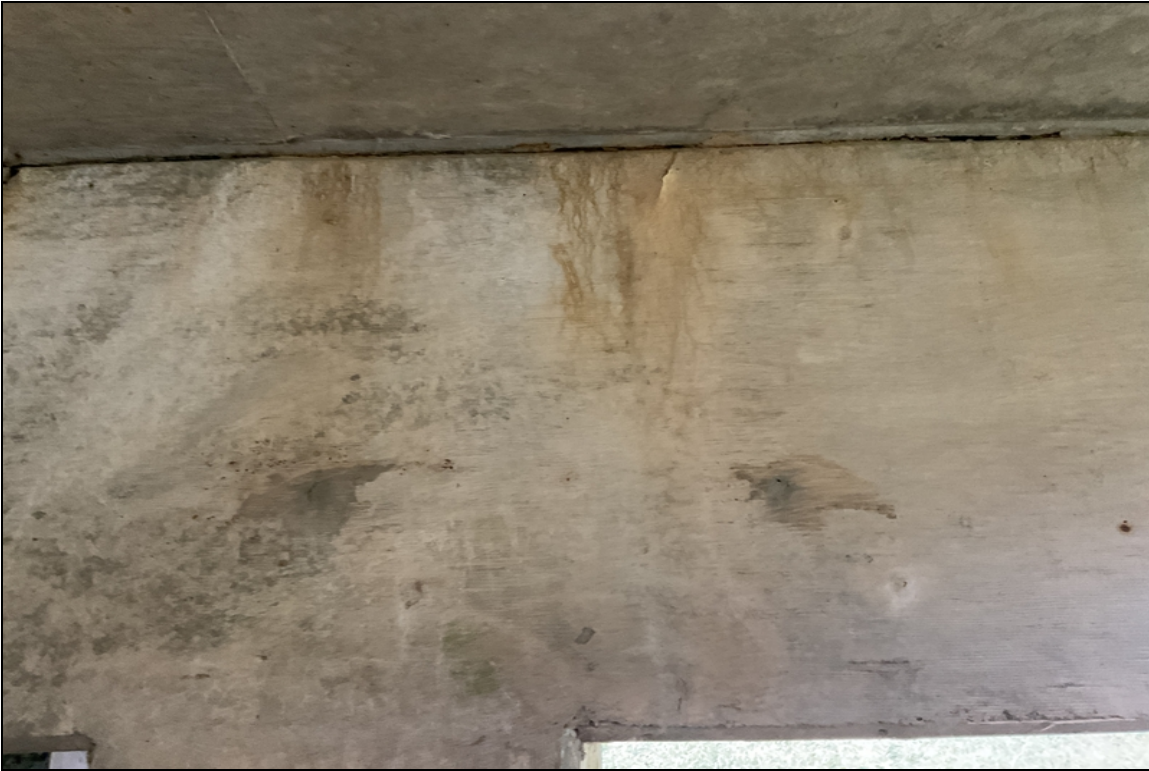
Bent 2 cap ahead crack with minor efflorescence.

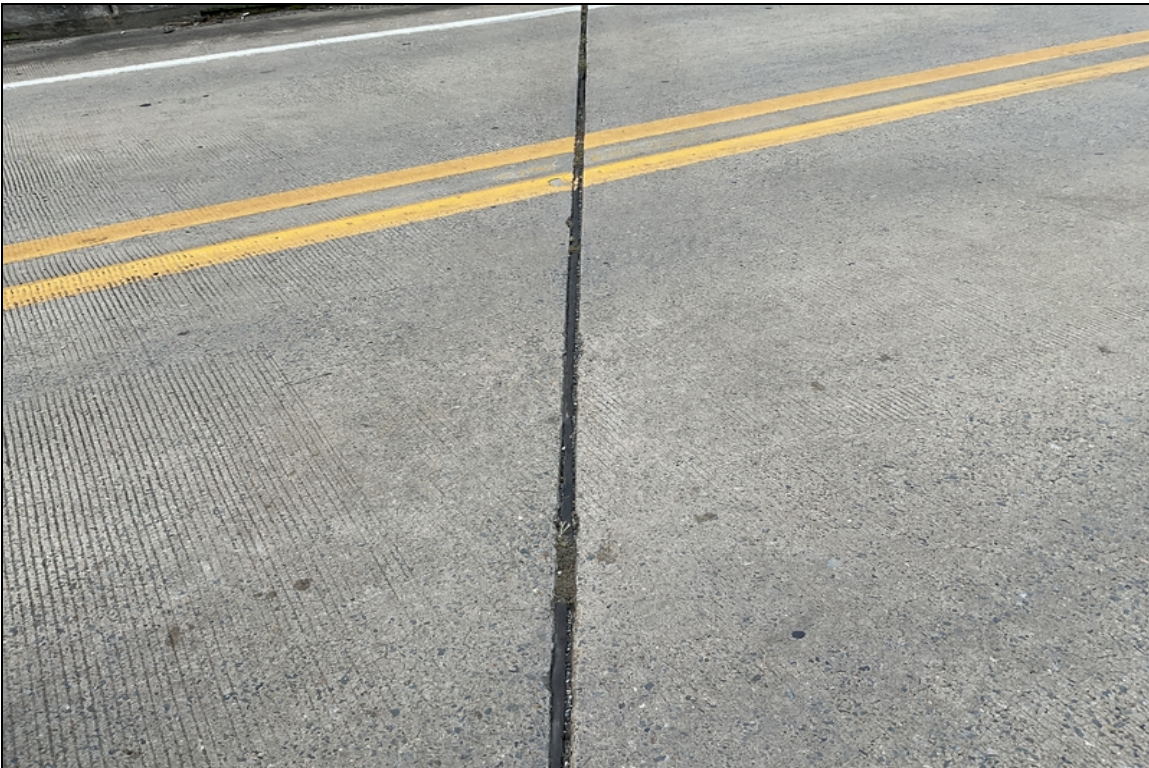
(301)							
Both seals are leaking and have lost adhesion.							
331	Reinforced Concrete Bridge Railing	LF	210	174	36	0	0
1130	Cracking (RC and Other)	LF	36	0	36	0	0

Bent 2 joint seal has lost bond.

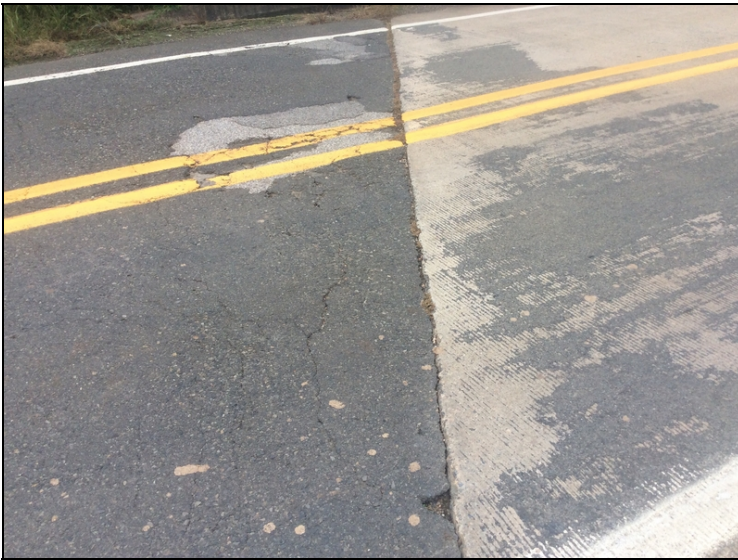
Approach roadway has settled both ends of bridge.

Bent 1, approach roadway has settled.

Date Reported: 10/27/2015
Priority: C - Important
Type of Work: Repair
Status: Assigned
Component: Approach

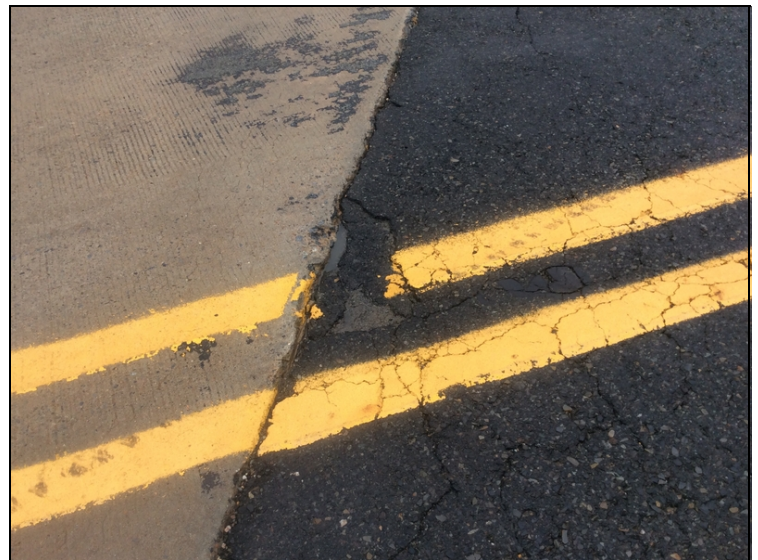
Approach roadway has settled and has small potholes

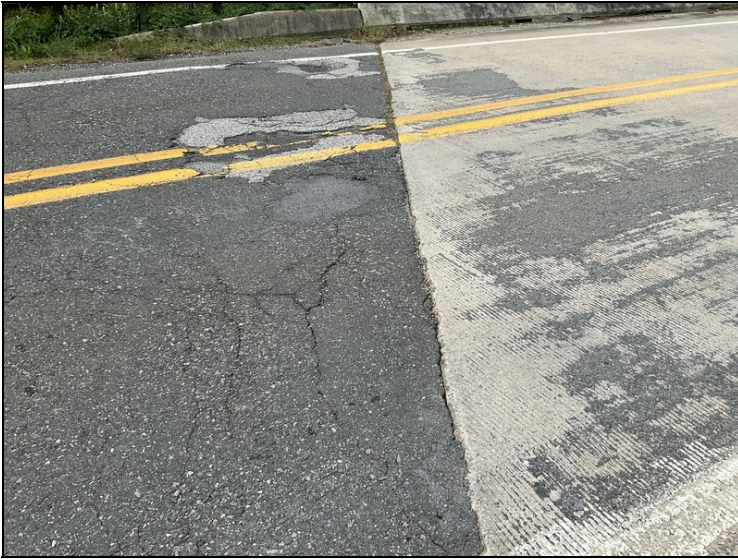
Bent 1, approach roadway has settled.

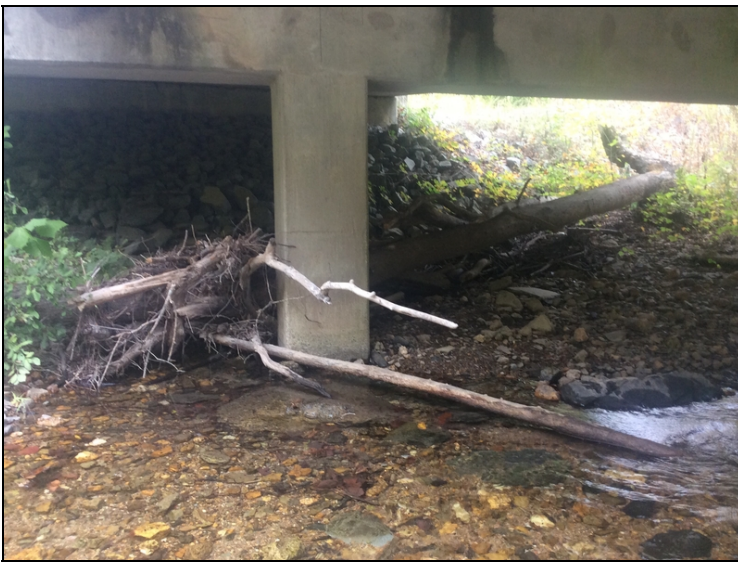
Debris piled against the columns at bent 3

Bent 3, span 3, large tree and debris against column 1.

Date Reported: 10/28/2019
Priority: D- Routine
Type of Work: Clean
Status: Assigned
Component: Substructure

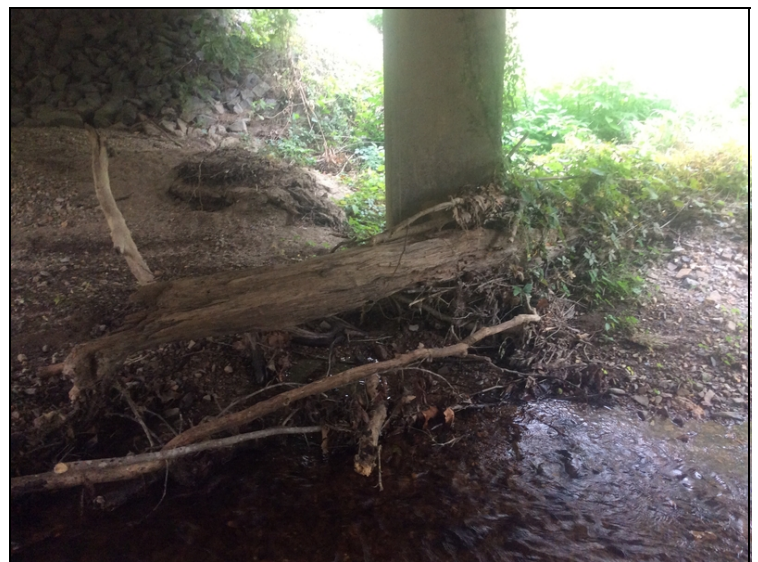
Bent 2, debris laying against column 1.

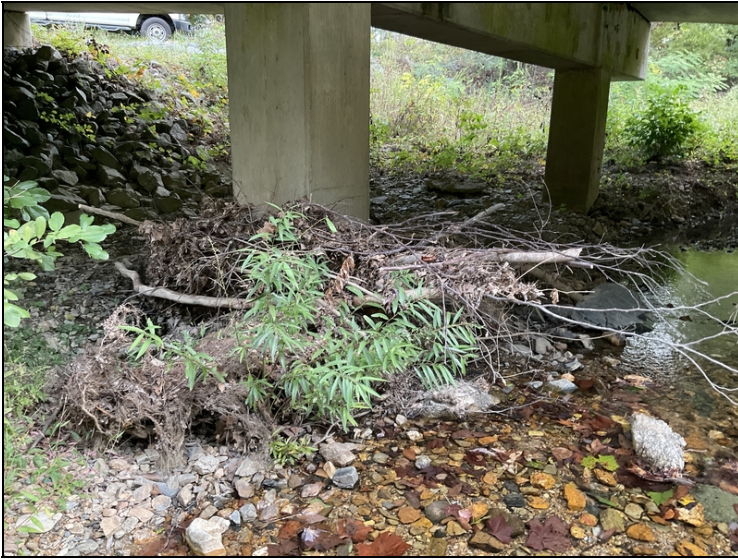
Debris at bent 3 column.
