Bridge #06079(Routine)
SH 128- 11 Log 1.3 over SMITH CREEK
Location: 1.4 MI W JCT US 70

Team Lead: Keith Harris Inspection Date: October 12, 2021

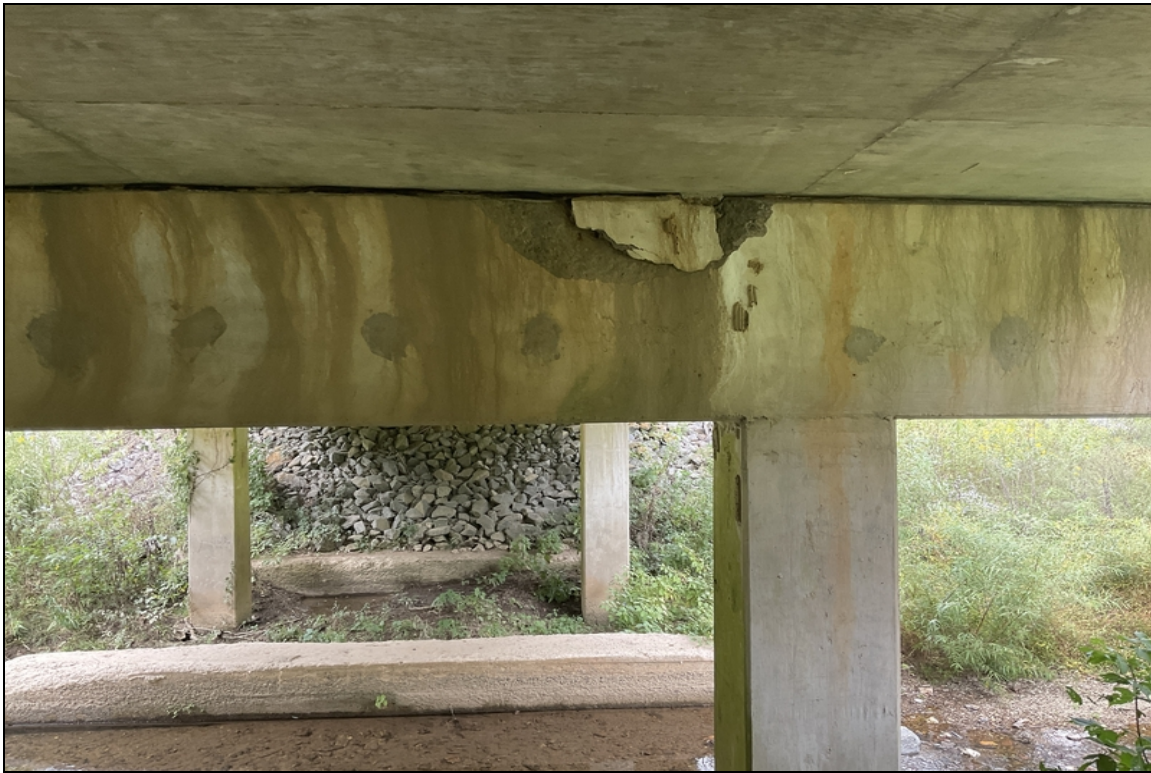
| ELEM | DESCRIPTION | UNITS | TOTAL | CS1 | CS2 | CS3 | CS4 |
|---|---|---|---|---|---|---|---|
| (234) | Bent 2, backside, has a large spall and delam. | | | | | | |

Spall on back side of Bent 2 cap

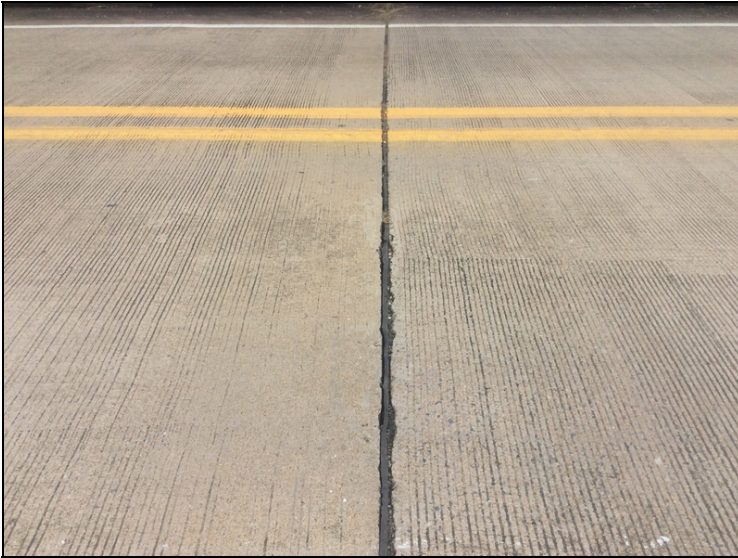
| ELEM | DESCRIPTION | UNITS | TOTAL | CS1 | CS2 | CS3 | CS4 |
|---|---|---|---|---|---|---|---|
| (301) | Joint seals have lost adhesion and are leaking. | | | | | | |

Joint seals have lost adhesion and are leaking

Bent 2 joint leaking due to lost adhesion.

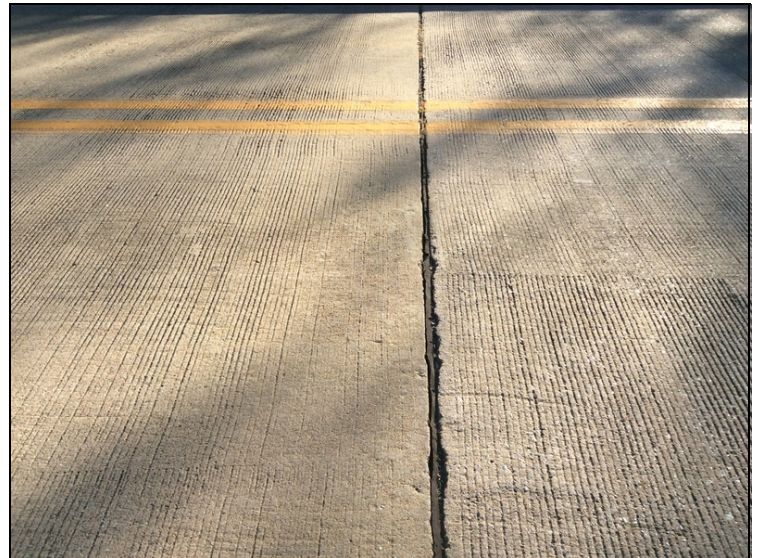
Bt. 2, joint seal has loss adhesion & leaking.

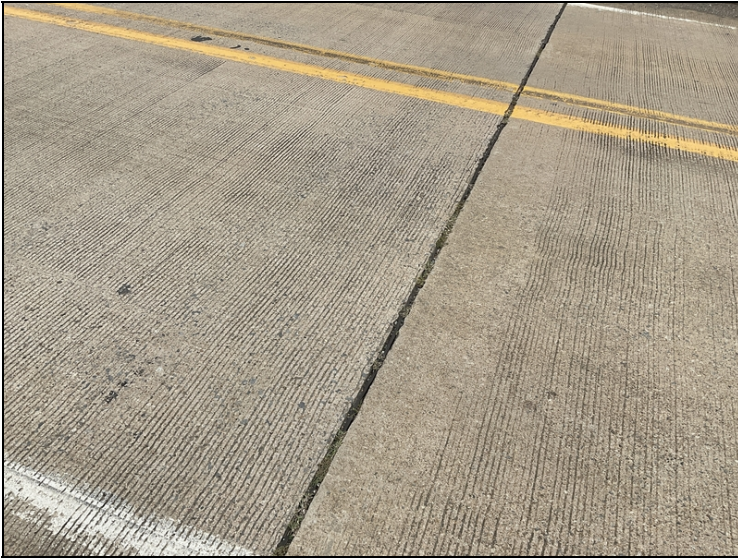
Bent 2 joint seal has lost adhesion

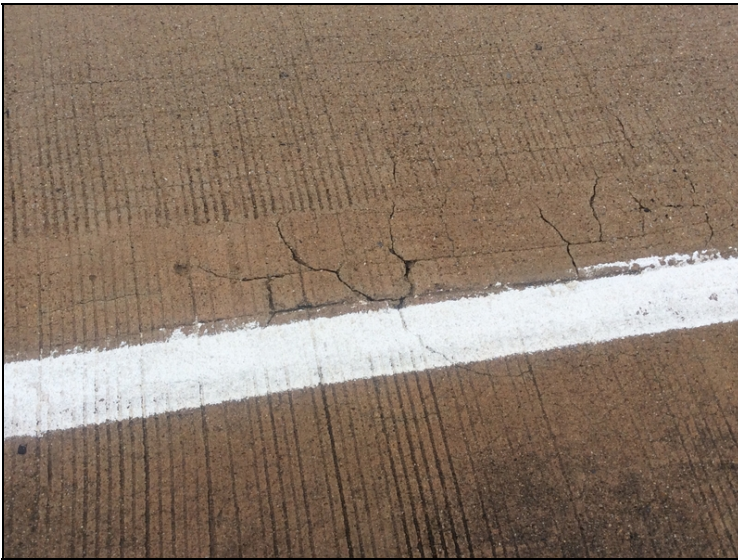
| ELEM | DESCRIPTION | UNITS | TOTAL | CS1 | CS2 | CS3 | CS4 |
|---|---|---|---|---|---|---|---|
| (38) | Deck has small and large unsealed cracks. | | | | | | |

Deck has large unsealed cracks

Deck cracks

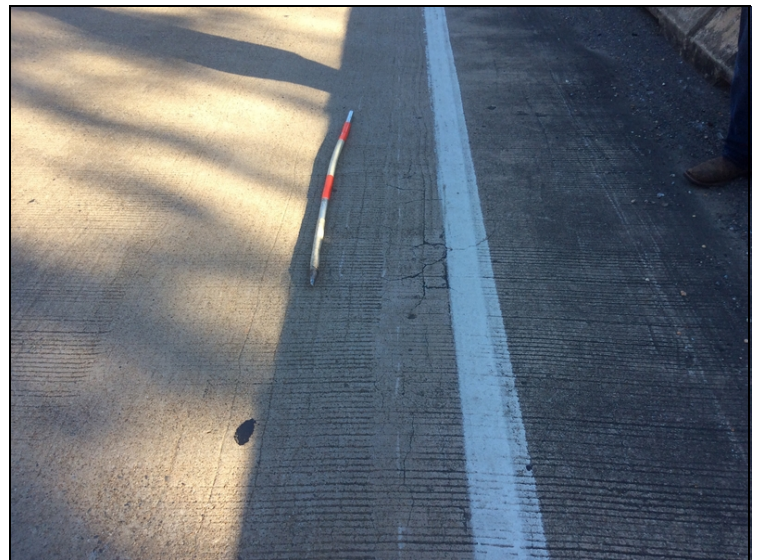
Span 3, unsealed map cracking.

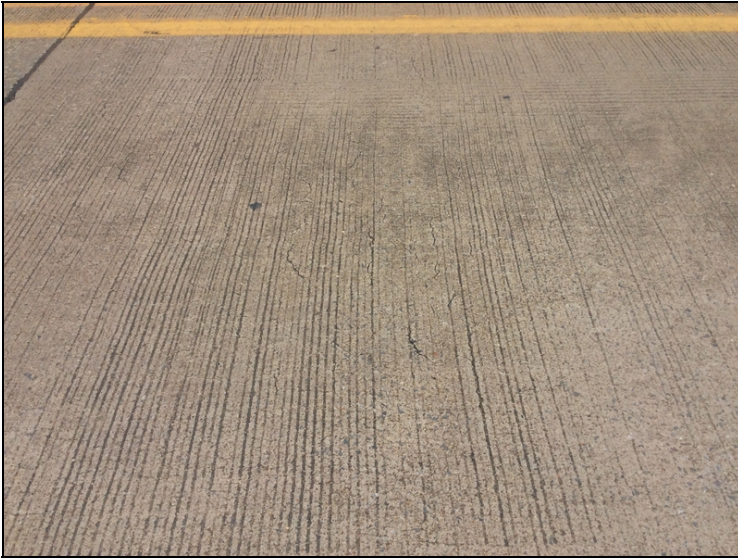
Span 3, large transverse cracks.

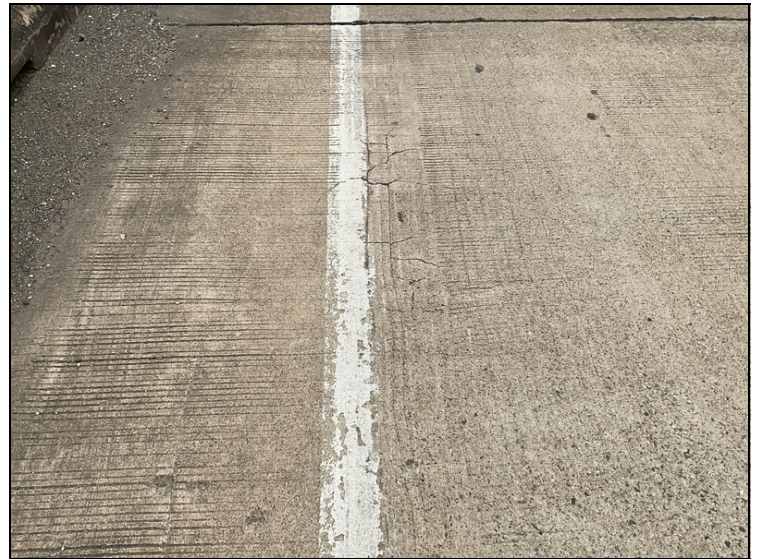
Span 3 right side unsealed map cracking.

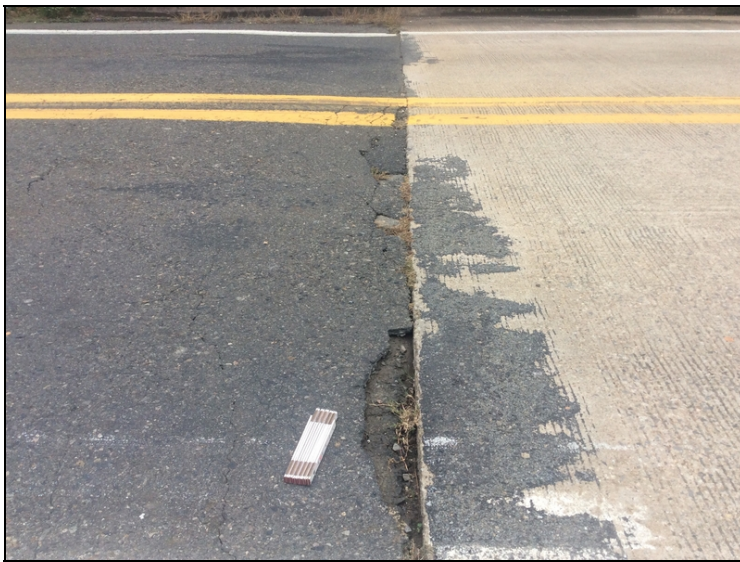
The approach roadway has potholes on the west side.

East end of bridge, pothole and patches.
