Bridge #B6426(Routine)

US 270, EB 0.88 over HOT SPRINGS CREEK

Team Lead: Shane Byrd Inspection Date: October 14, 2020

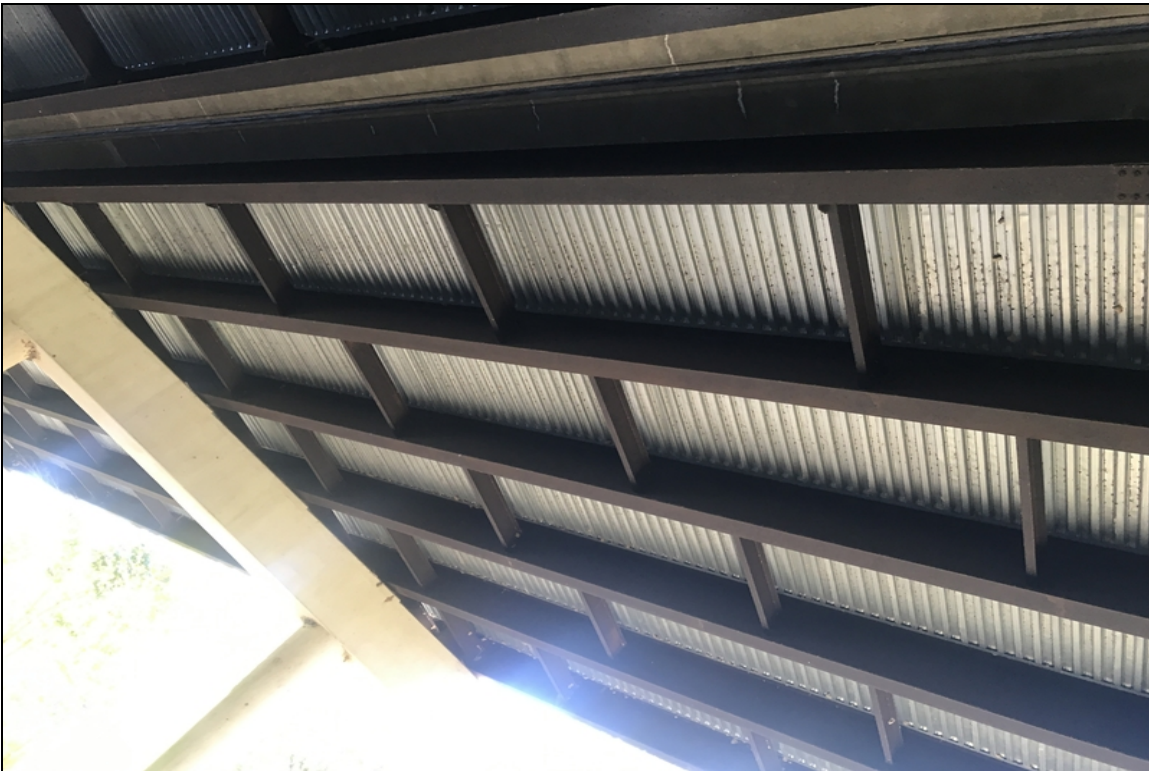
(12)	All spans have unsealed transverse and longitudinal cracks. Most of the transverse cracks are 0.040 inch in width, the longitudinal cracks avg. 0.025 inch in width. Soffits have cracks with efflorescence.						
107	Steel Open Girder/Beam	LF	2070	2042	28	0	0
1000	Corrosion	LF	25	0	25	0	0
1020	Connection	LF	3	0	3	0	0
515	Steel Protective Coating	SF	16947	16947	0	0	0

Span 2 left side soffit overhang has cracks with efflorescence.

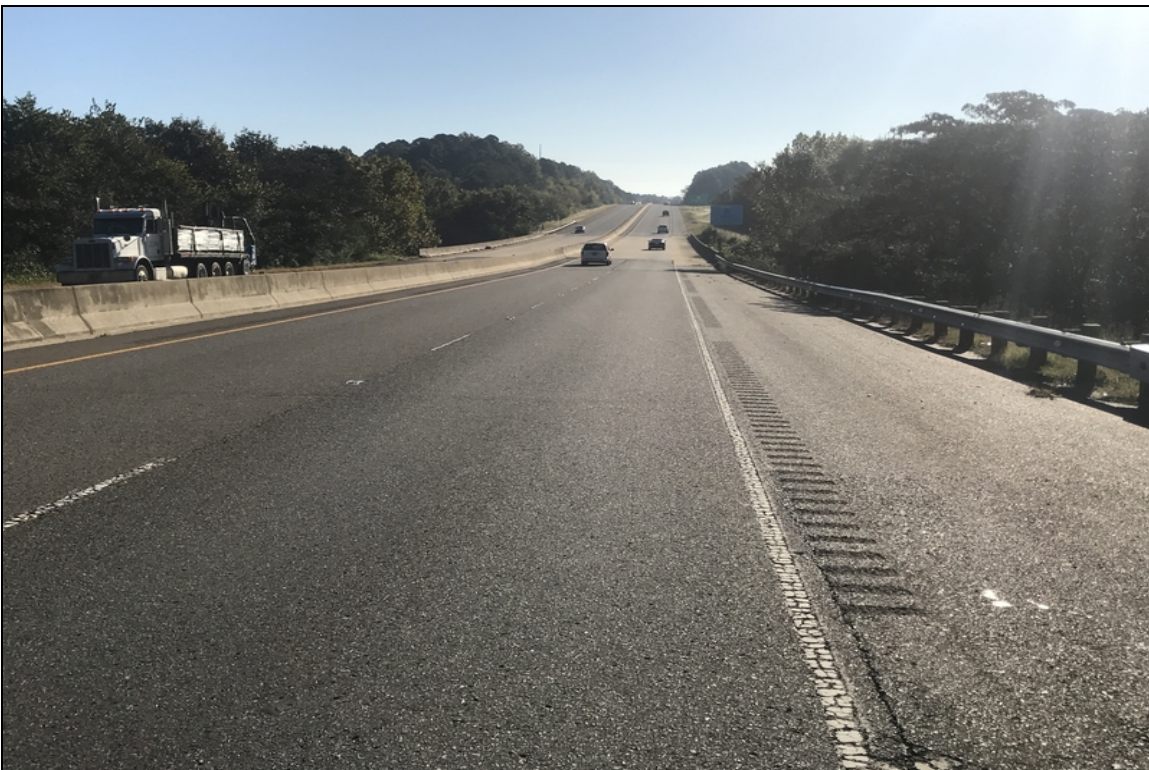
Approach Eastbound.

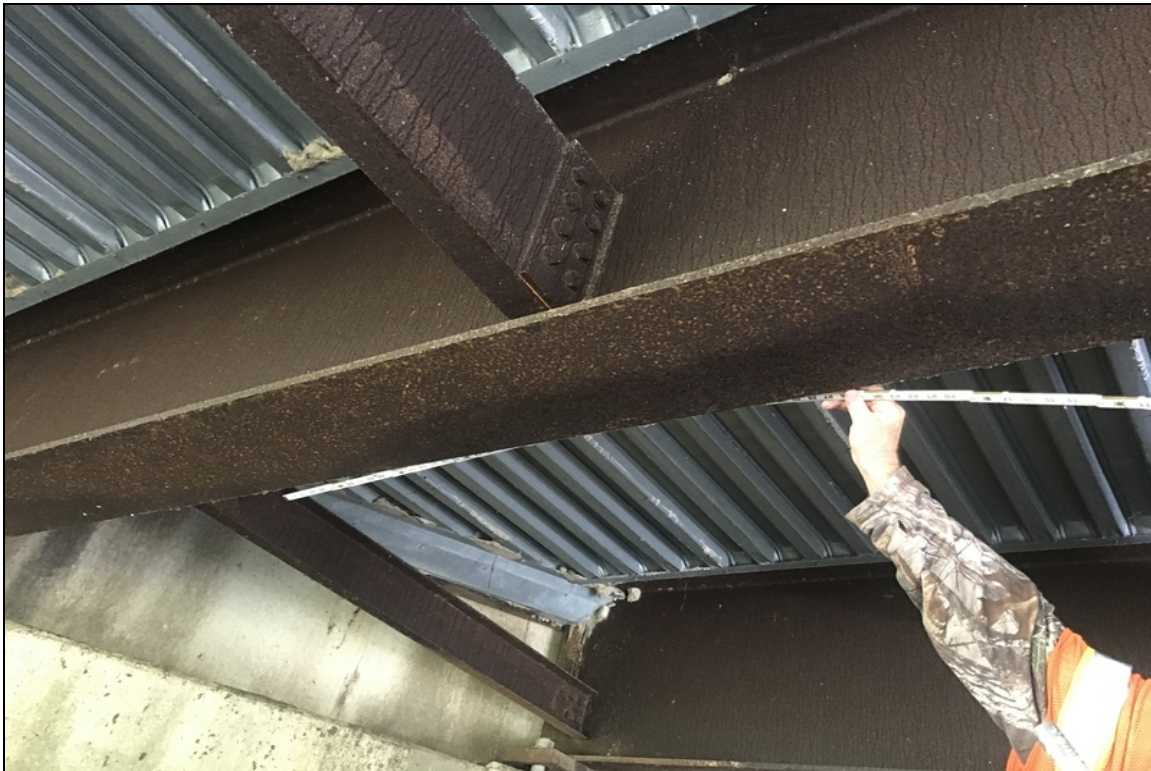
(107)	Span 3 girder 1 first splice loose bolt in bottom flange, Span 3 girder 2 and 3 2nd splice loose bolt in bottom flange and span 5 girder 3 corrosion on top flange. Span 1 girder 2, 3 and 4 flaking rust on bottom flange and lower web. No section loss.						
205	Reinforced Concrete Column	EA	8	8	0	0	0

Span 1 beam 3 has flaking rust to bottom flange.

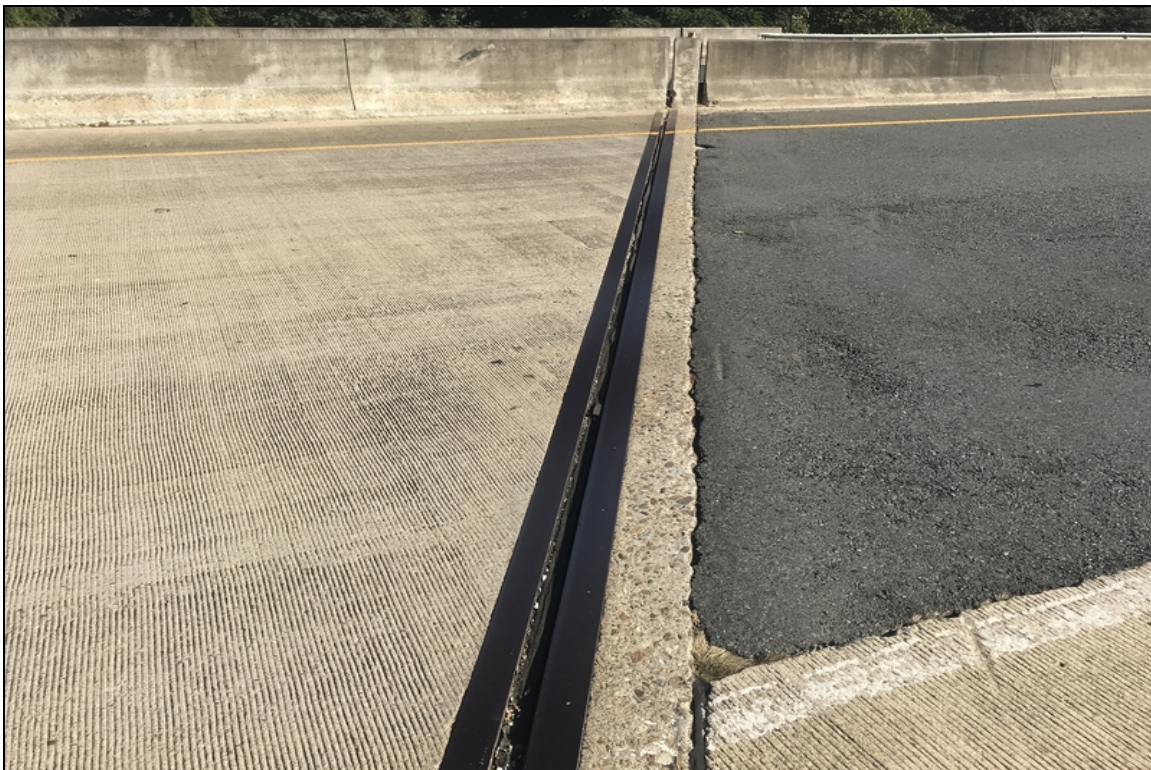
(302)	Joints at bents 1 and 6 are leaking causing debris to build up on cap.						
310	Elastomeric Bearing	EA	36	24	12	0	0

Joint seal at bent 6 has lost bond and is leaking.

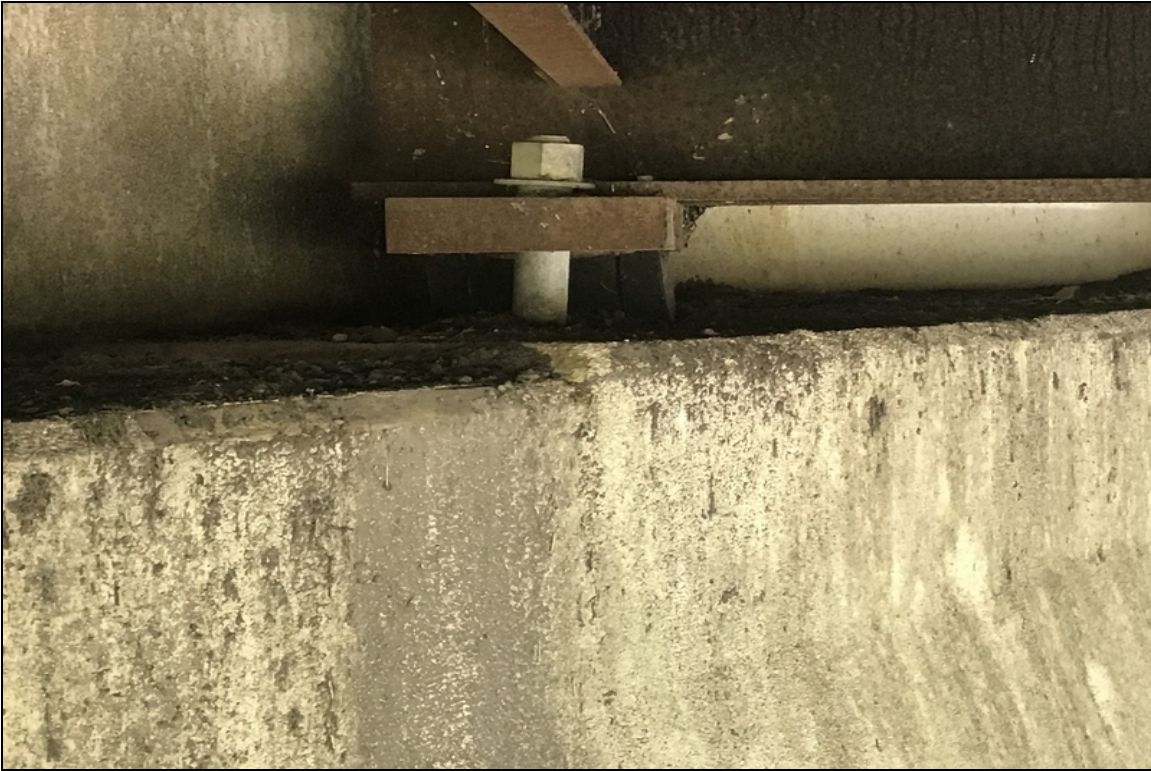
ELEM	DESCRIPTION	UNITS	TOTAL	CS1	CS2	CS3	CS4
2220 (310)	Alignment The bearings at bents 1 and 6 are leaning.	EA	12	0	12	0	0
331	Reinforced Concrete Bridge Railing	LF	695	694	0	1	0
1080 (331)	Delamination/Spall/Patched Area Span 5 right side has a spall in top of guard rail.	LF	1	0	0	1	0

Bent 1 bearing 2 is leaning.

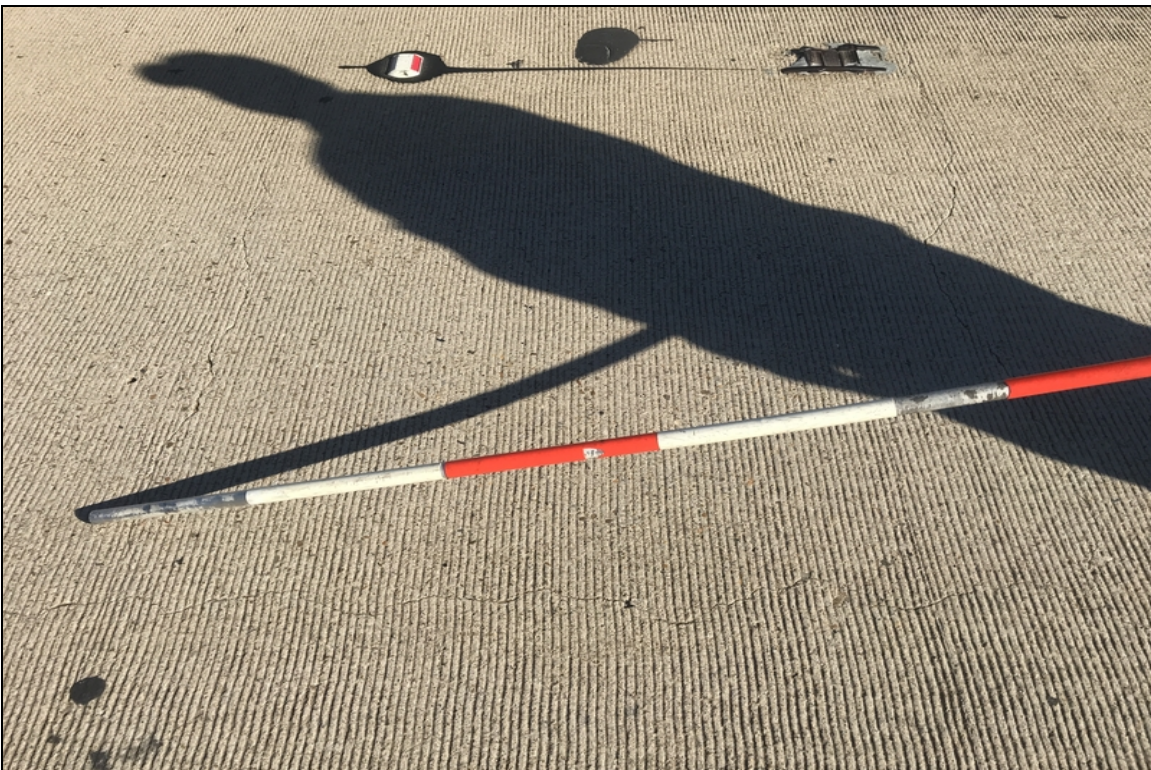
Unsealed transverse cracks in deck at span 5.

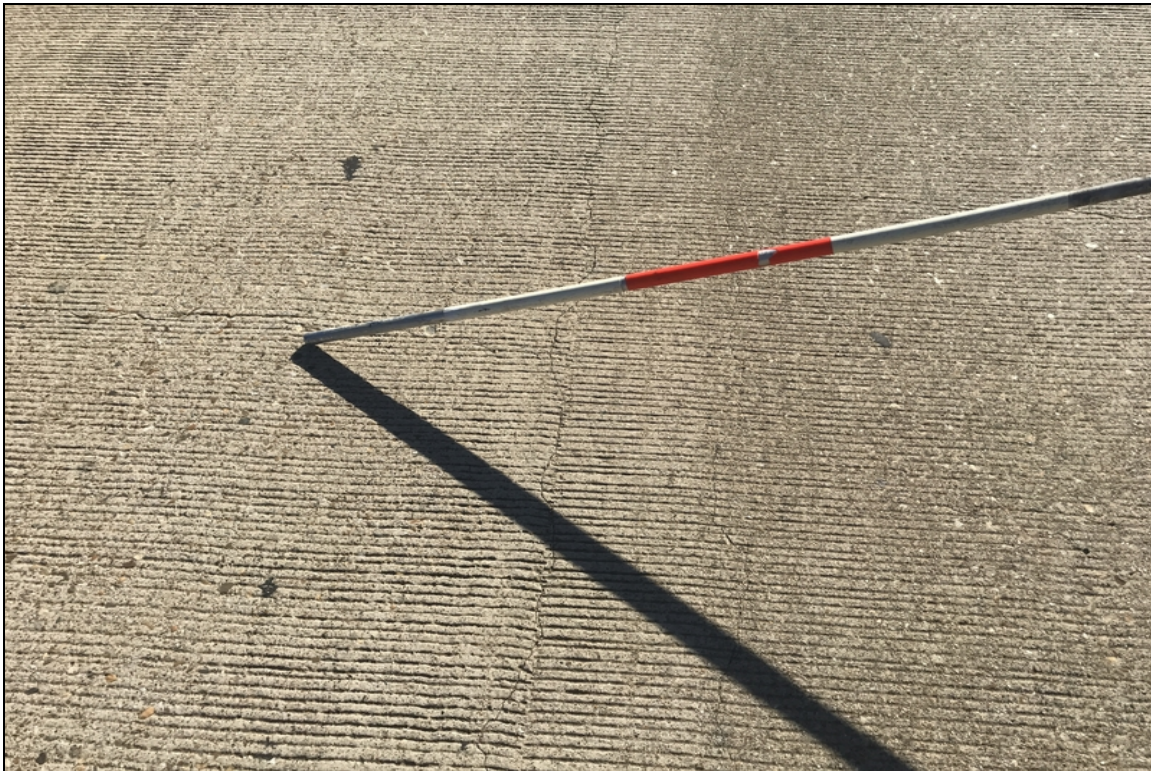
Unsealed longitudinal cracks in decal at span 2.

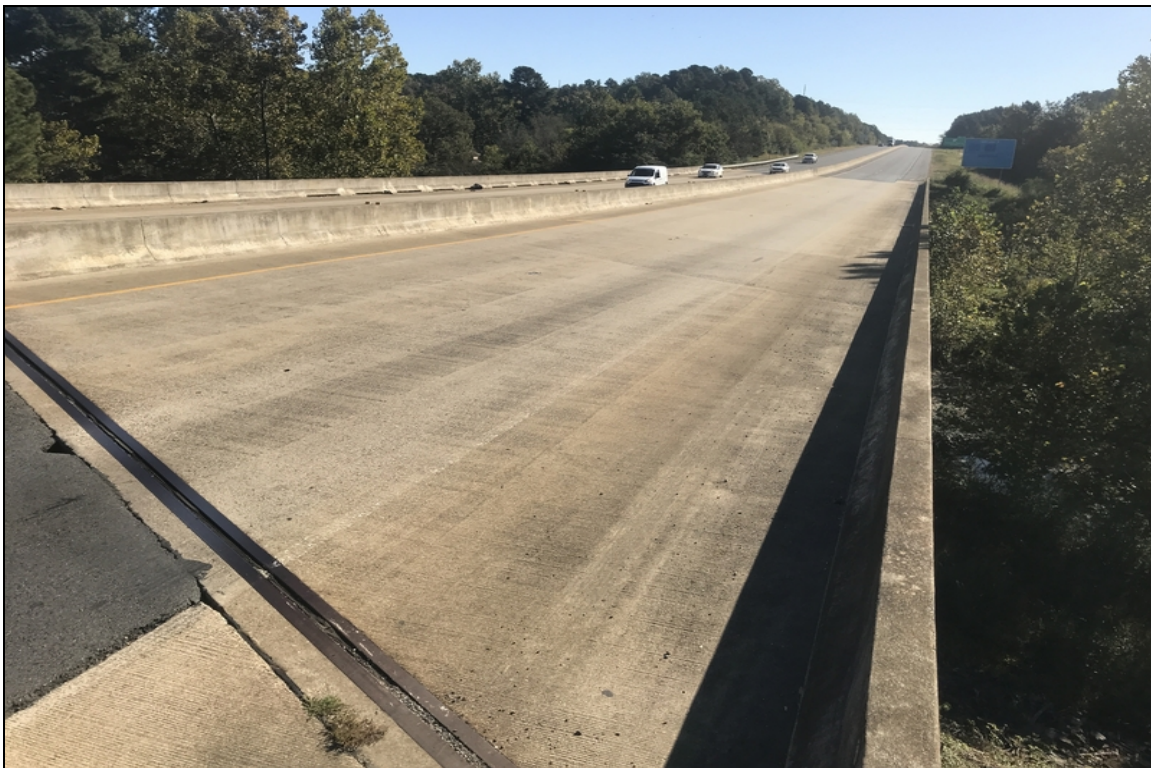
Deck overview.

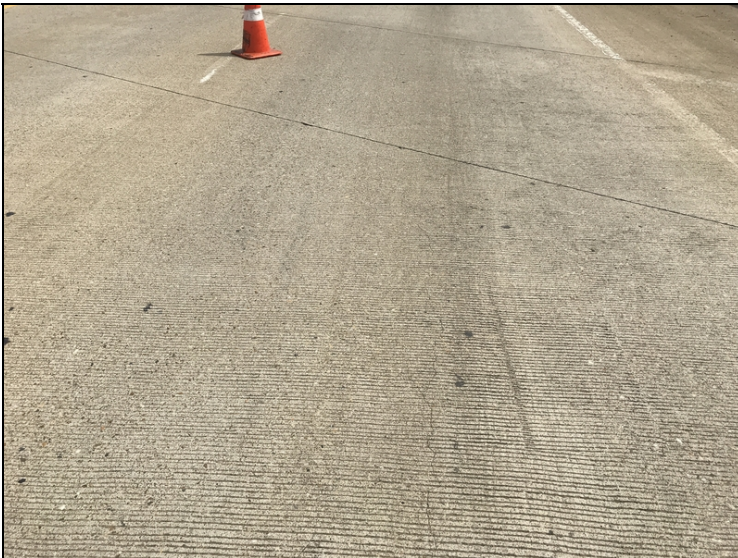
Transverse and longitudinal unsealed cracks in all spans of the deck.

Span 5 longitude crack.

Date Reported: 10/03/2016
Priority: C - Important
Type of Work: Repair
Status: Monitor
Component: Deck

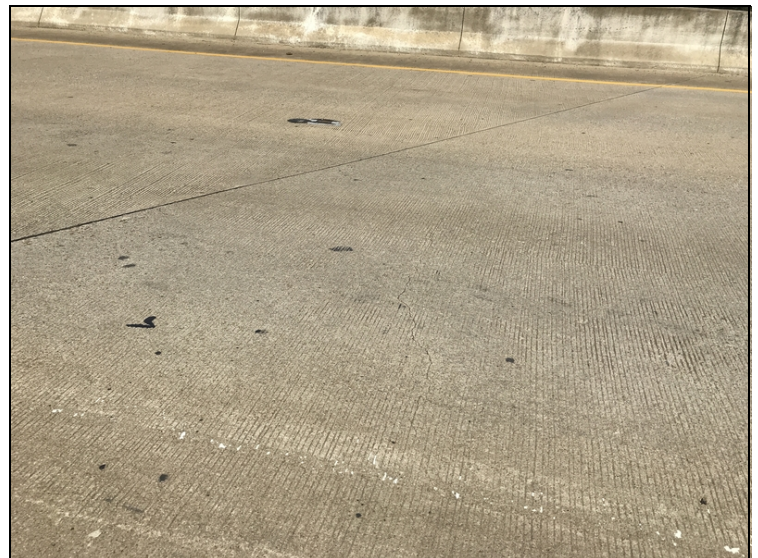
Large transverse cracks.

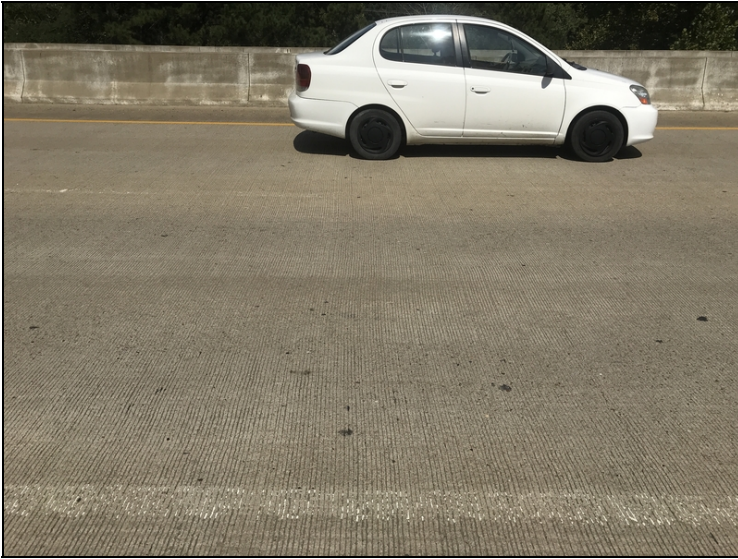
Transverse cracks in span 2.

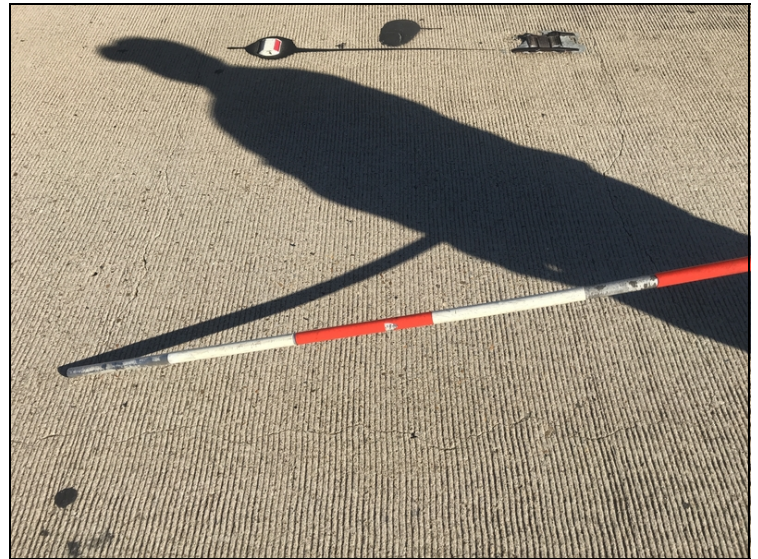
Unsealed transverse cracks in deck at span 5.

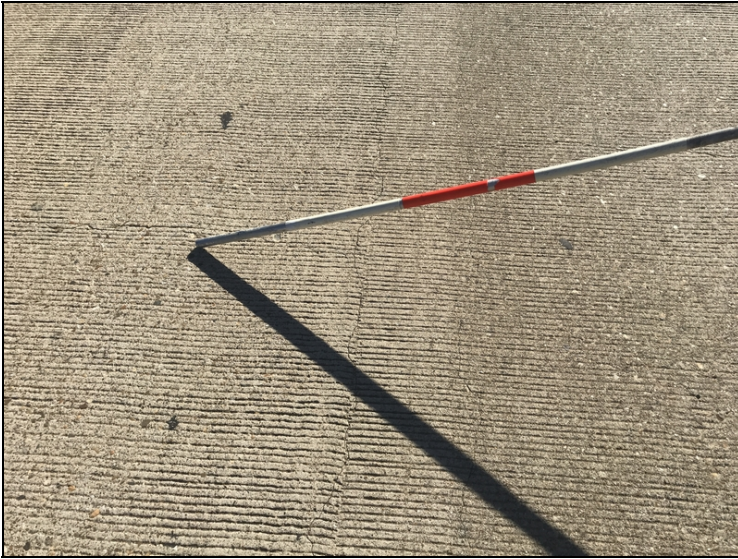
Unsealed longitudinal cracks in decal at span 2.

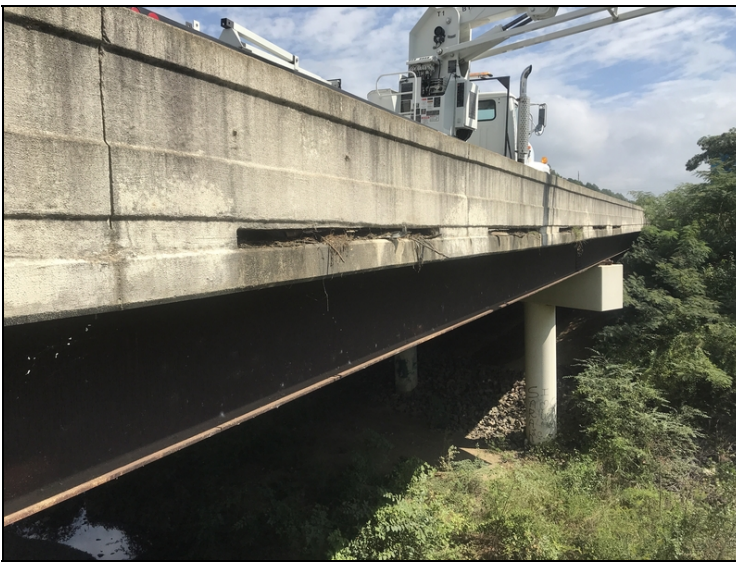
Drains are full of debris.

Span 4 drains are full of debris.

Date Reported: 10/01/2018
Priority: D- Routine
Type of Work: Clean
Status: Assigned
Component: Miscellaneous

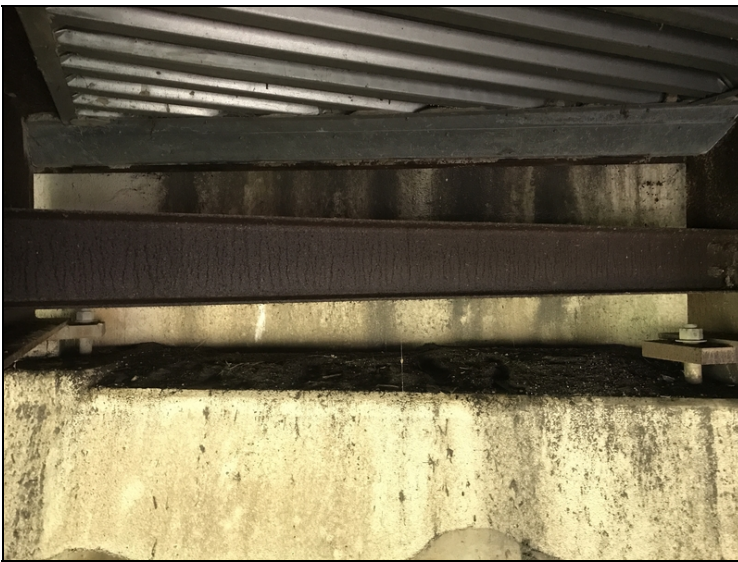
Joints are leaking at bents 1 and 6.

Bent 6 bay 3 debris on top of cap.

Date Reported: 10/01/2018
Priority: C - Important
Type of Work: Repair
Status: Monitor
Component: 302 - Compression Joint Seal

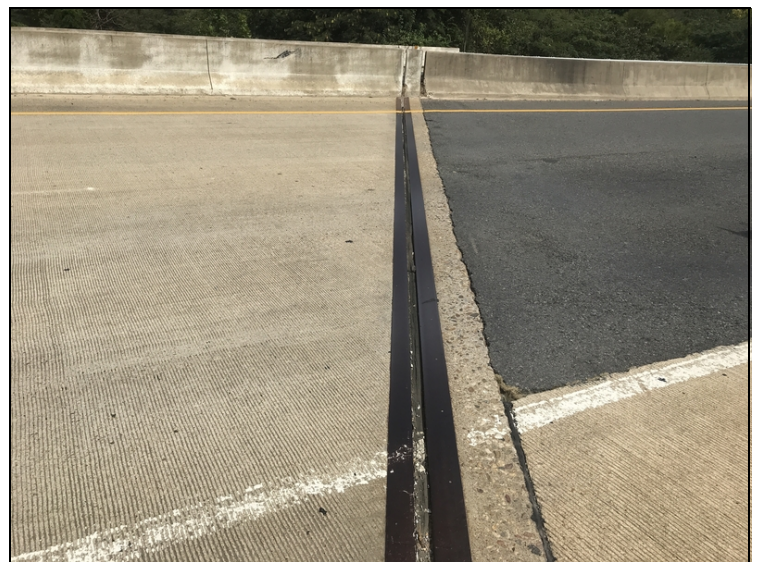
Bent 6 joint has lost adhesion and is leaking.

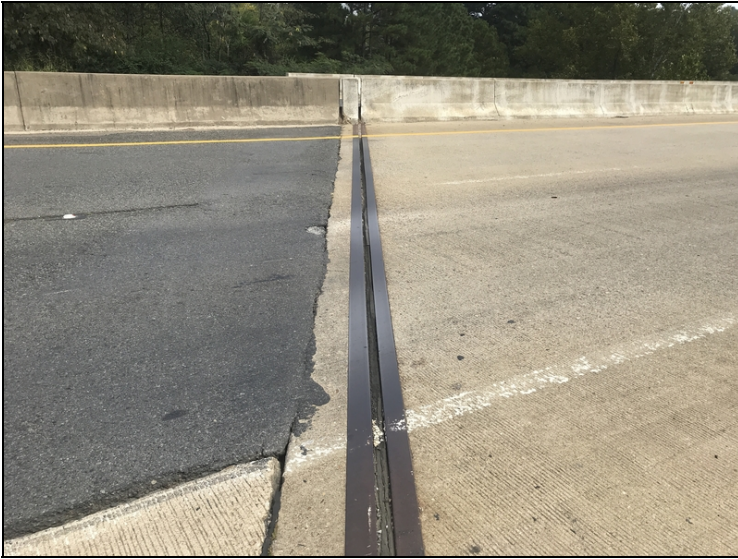
Bent 1 joint has lost adhesion.

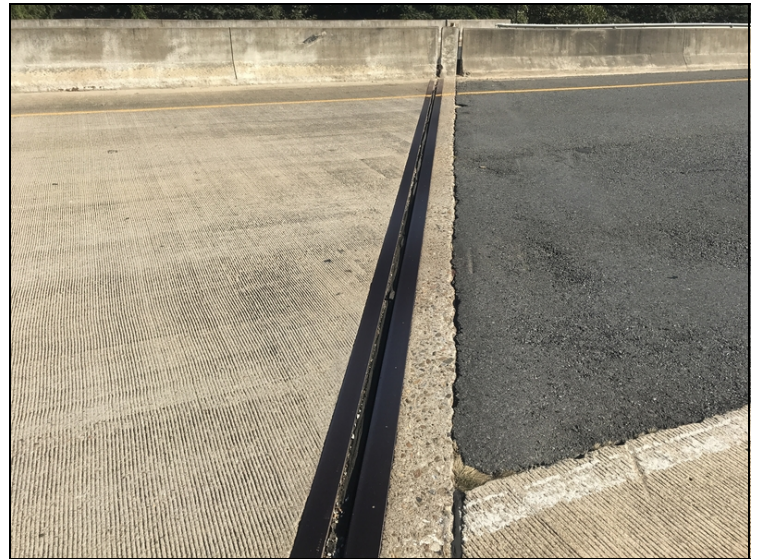
Joint seal at bent 6 has lost bond and is leaking.

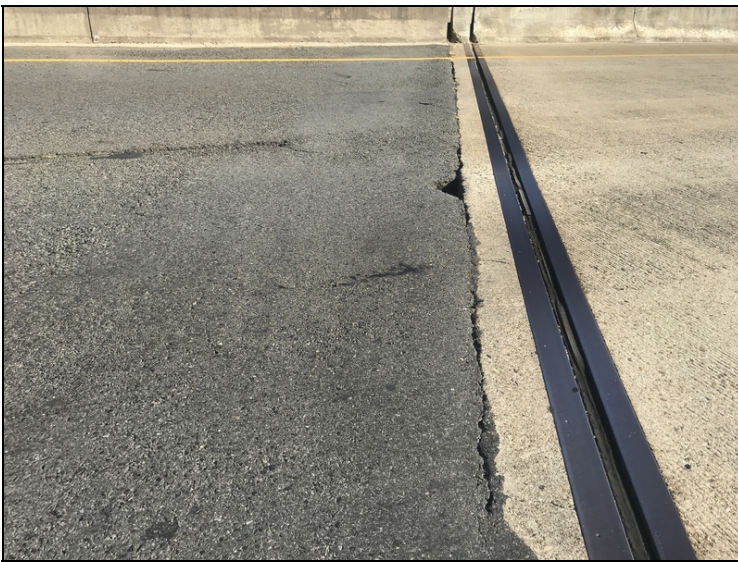
Pothole in approach roadway at bent 1, approach roadway has settled.

Date Reported: 10/14/2020
Priority: C - Important
Type of Work: Repair
Status: Open
Component: Miscellaneous
