Bridge #A6427 (Routine)

US 270, WB Log 1.88 over SHADY GROVE RD

Team Lead: Shane Byrd Inspection Date: July 08, 2020

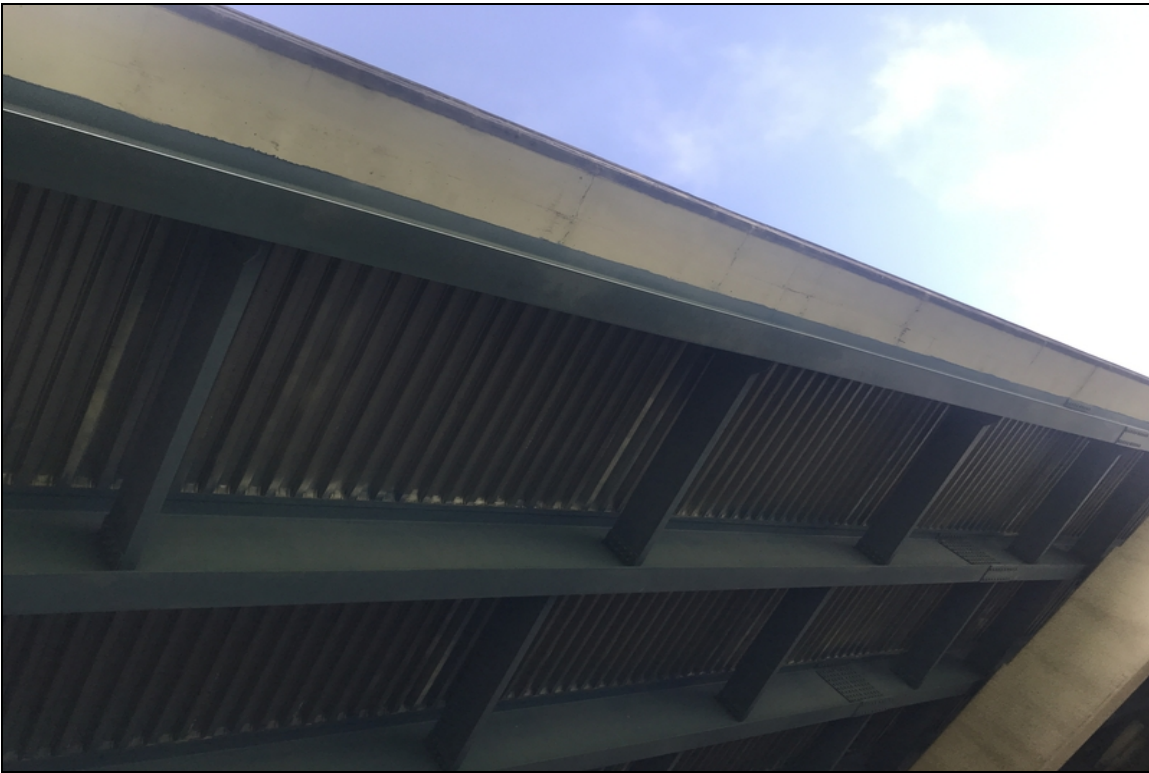
(12)	Cracks with efflorescence in the soffit overhangs. Unsealed transverse and longitudinal cracks in all spans.						
107	Steel Open Girder/Beam	LF	912	912	0	0	0
515	Steel Protective Coating	SF	6722	6162	560	0	0
3410	Chalking (Steel Protective Coatings)	SF	560	0	560	0	0

Span 2 left side soffit overhang has cracks with efflorescence.

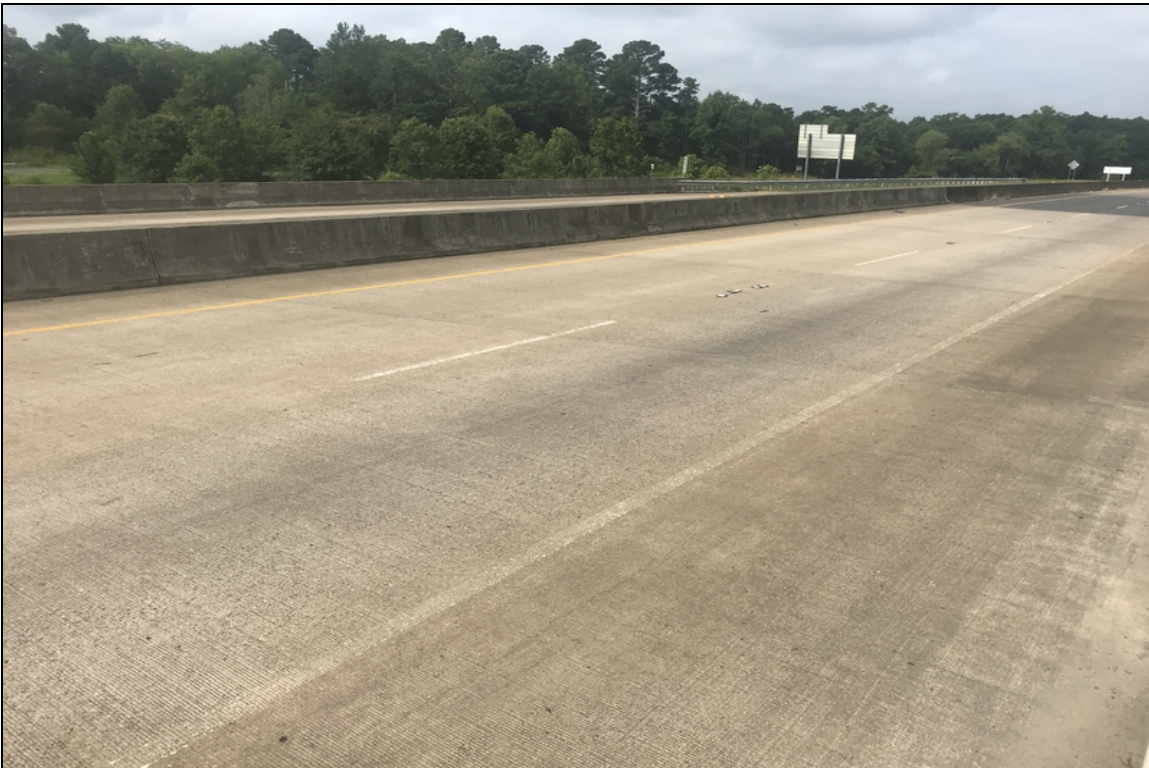
Deck overview.

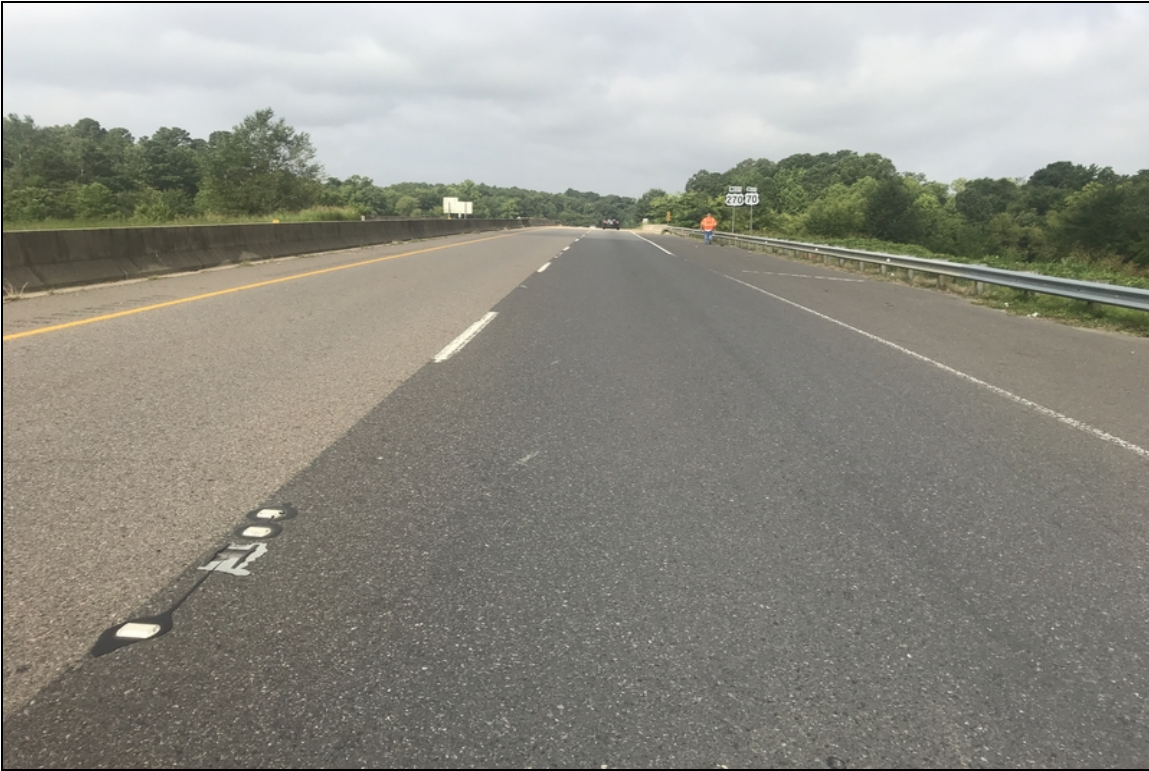
Approach Westbound.

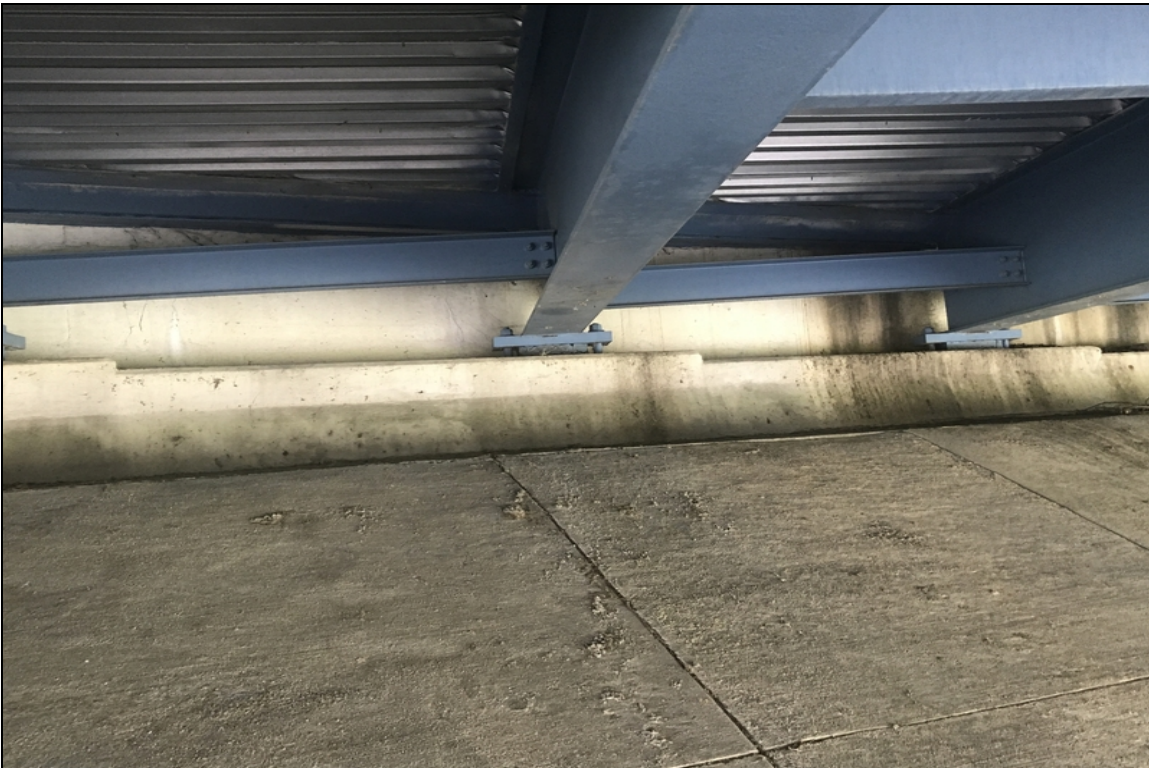
(215)	Cracks and cracks with efflorescence in both abutments.						
234	Reinforced Concrete Pier Cap	LF	84	84	0	0	0
(234)	No notable deficiencies at this inspection.						
302	Compression Joint Seal	LF	85	49	0	36	0
2310	Leakage	LF	36	0	0	36	0

Bent 1 abutment has cracks with efflorescence in the back wall.

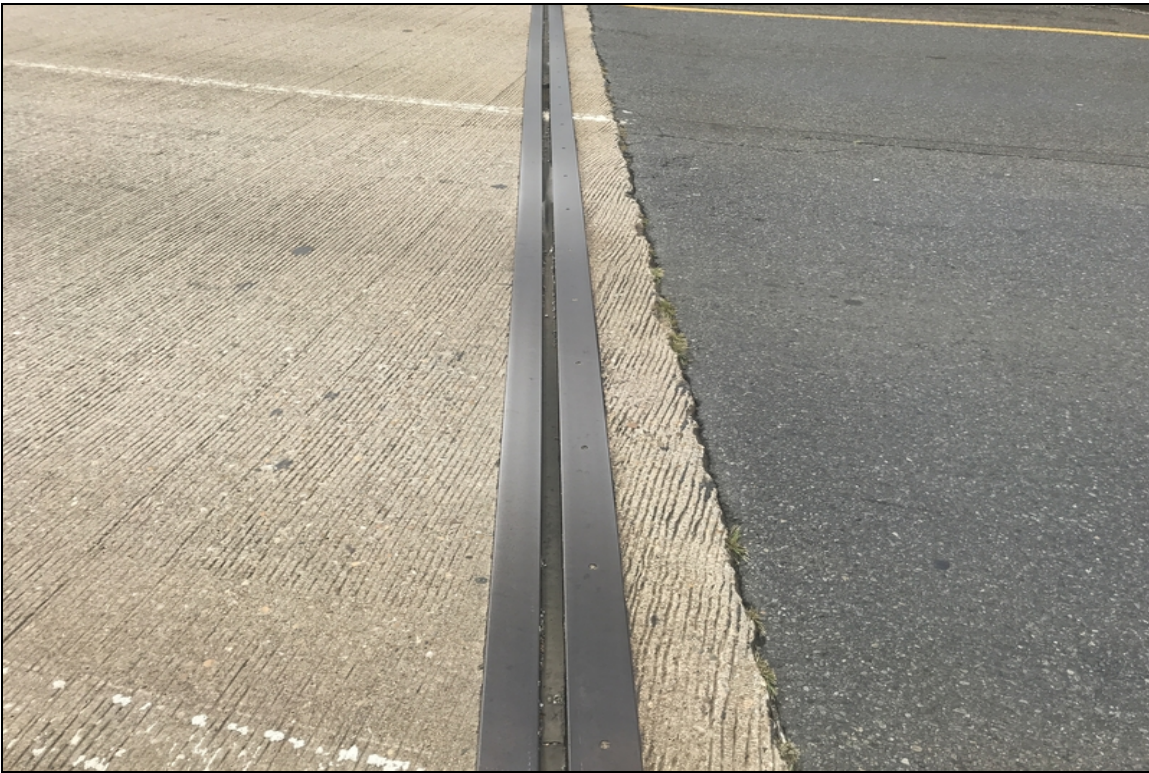
(302)	07/19/2018 - KRM & RLS - Both joints have lost adhesion and leak. (Closed cell foam joint)						
310	Elastomeric Bearing	EA	24	24	0	0	0
(310)	No notable deficiencies at this inspection.						
331	Reinforced Concrete Bridge Railing	LF	304	276	28	0	0

Bent 1 pourable joint seal has lost bond.

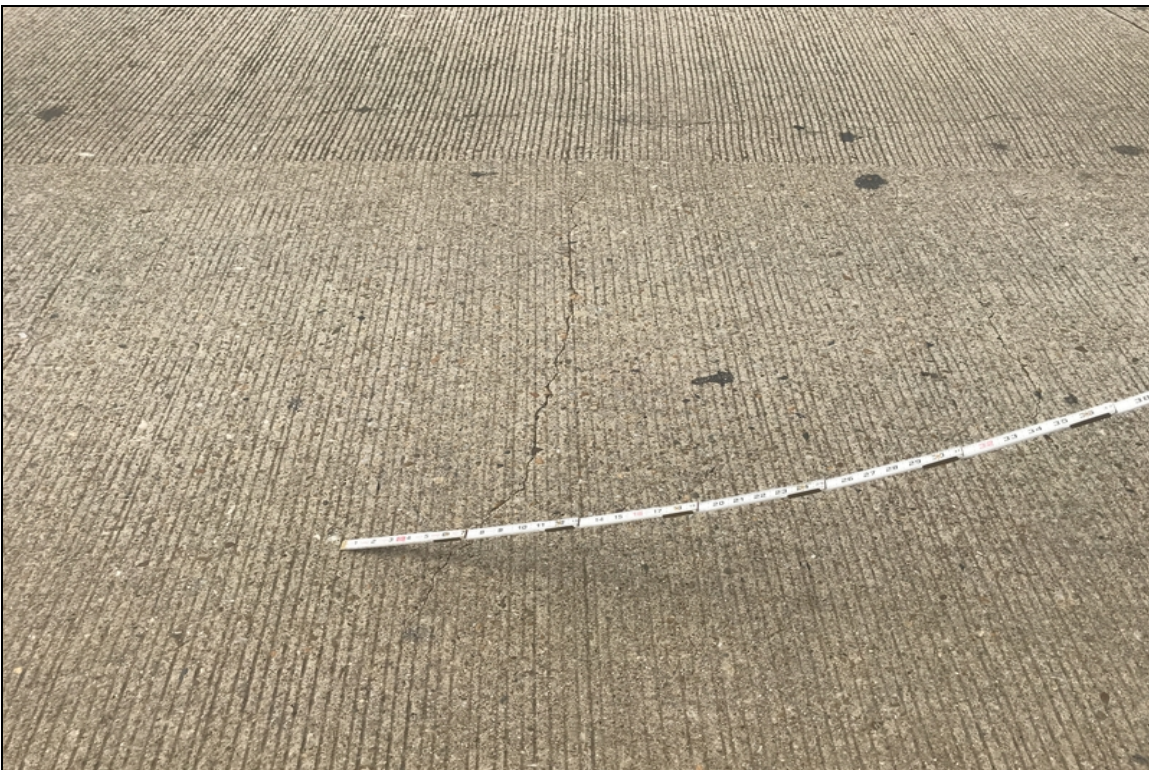
Deck span 1 has transverse cracks.

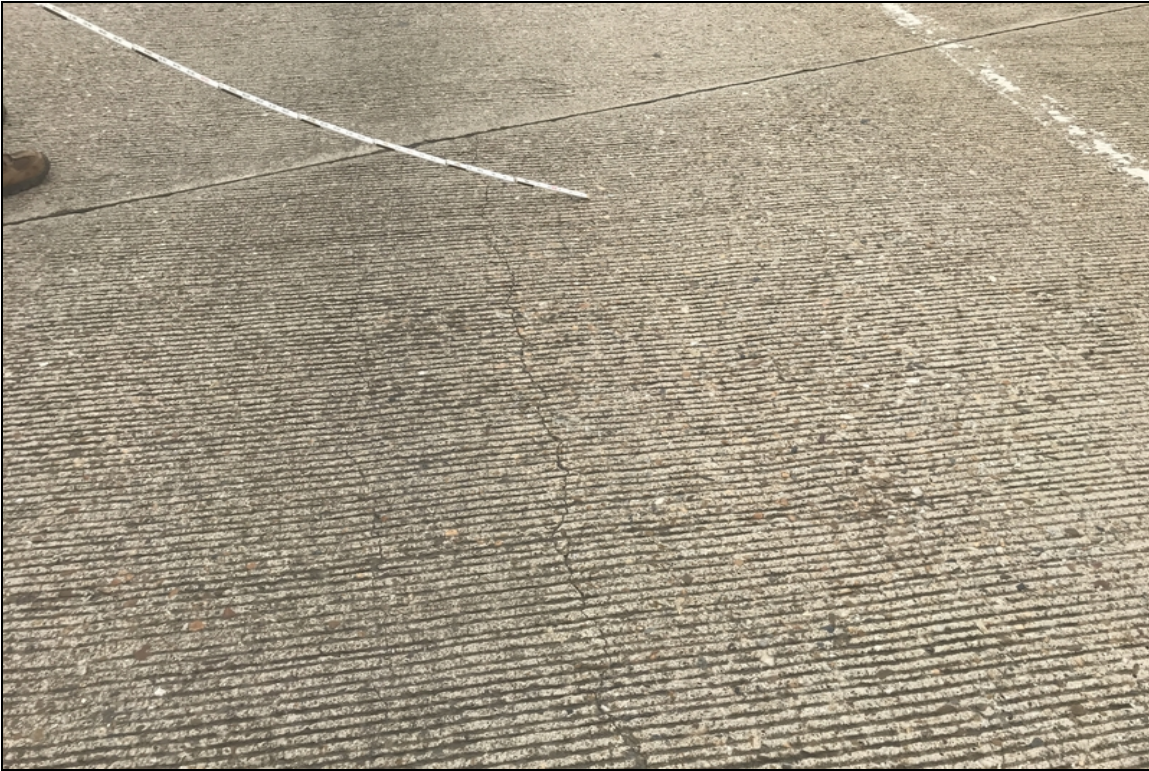
Deck span 3 has longitudinal cracks.
