Bridge #B6427 (Routine)
US 270,EB Log 1.88 over SHADY GROVE RD
Location: 1.9 MI E SH7(Bypass)

Team Lead: Shane Byrd Inspection Date: July 08, 2020

IDENTIFICATION	
(1) State Names	Arkansas
(8) Structure Number	B6427
(5) Inventory Route	270
(2) Highway Agency District	06
(3) County Code	51-Garland County, Arkansas

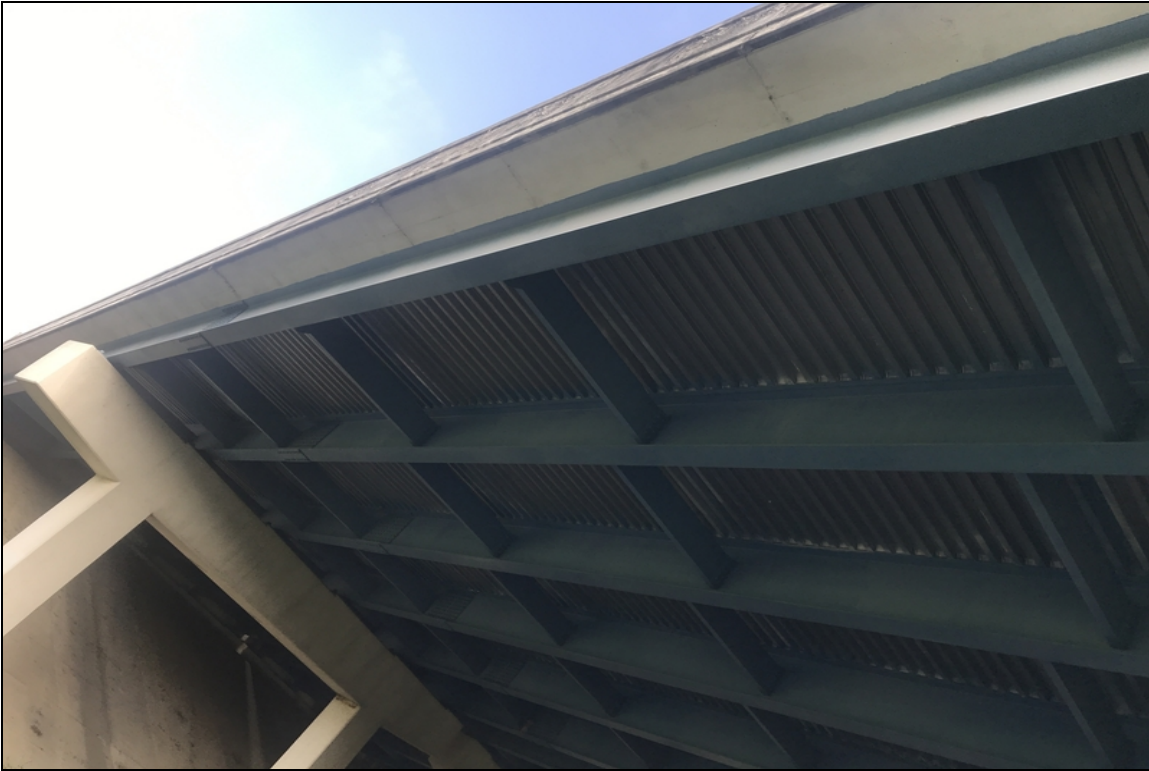
(12)	Transverse and longitudinal cracks in all spans. Soffits have cracks with efflorescence.						
107	Steel Open Girder/Beam	LF	912	911	1	0	0
1020	Connection	LF	1	0	1	0	0
515	Steel Protective Coating	SF	6722	6038	684	0	0
3410	Chalking (Steel Protective Coatings)	SF	684	0	684	0	0

Span 2 right side soffit overhang has cracks with efflorescence.

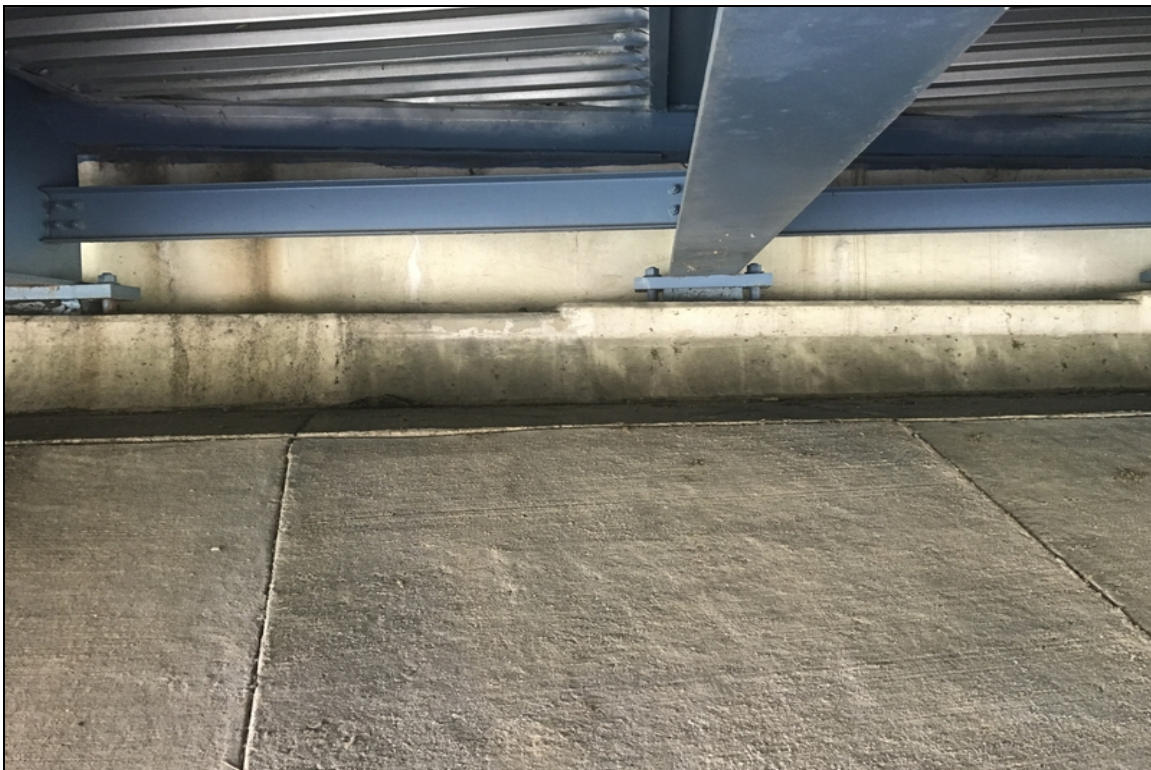
(215)	Both abutments have vertical cracks and cracks with efflorescence.						
234	Reinforced Concrete Pier Cap	LF	84	84	0	0	0
(234)	No notable discrepancies at this locations.						
302	Compression Joint Seal	LF	85	37	48	0	0
2310	Leakage	LF	24	0	24	0	0
2320	Seal Adhesion	LF	24	0	24	0	0

Bent 1 abutment has cracks with efflorescence in the back wall.

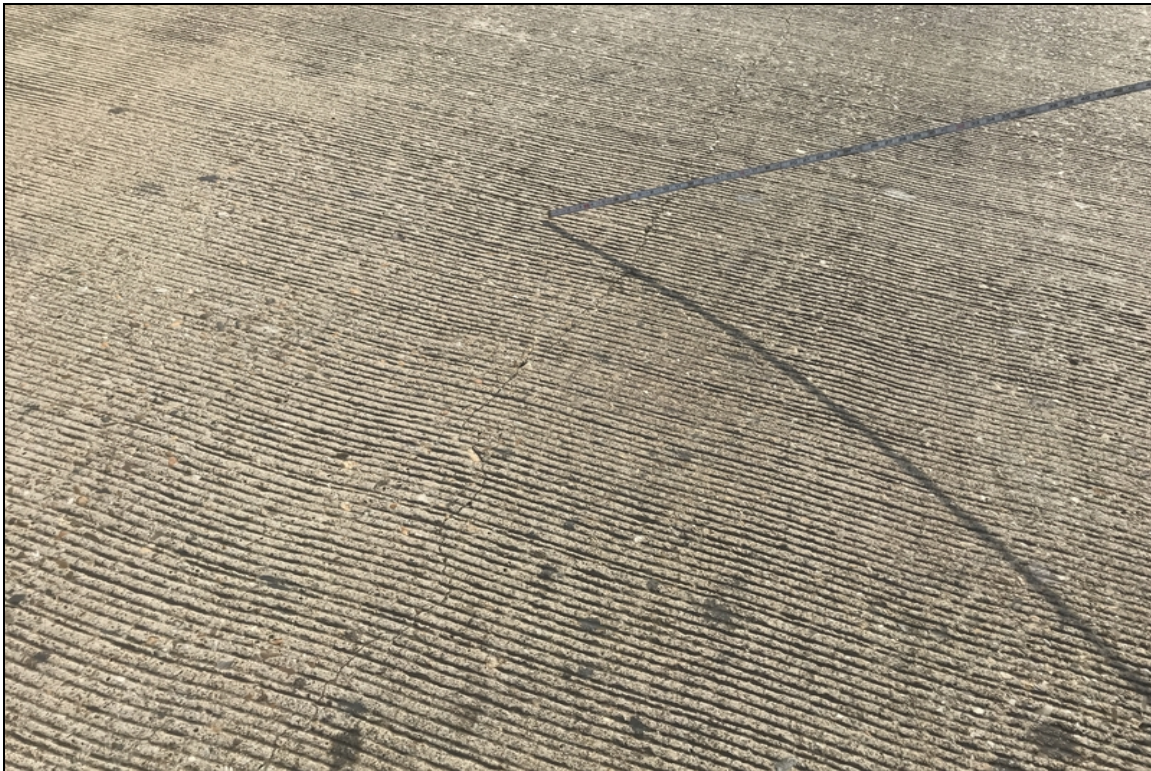
Deck span 3 has longitudinal crack.

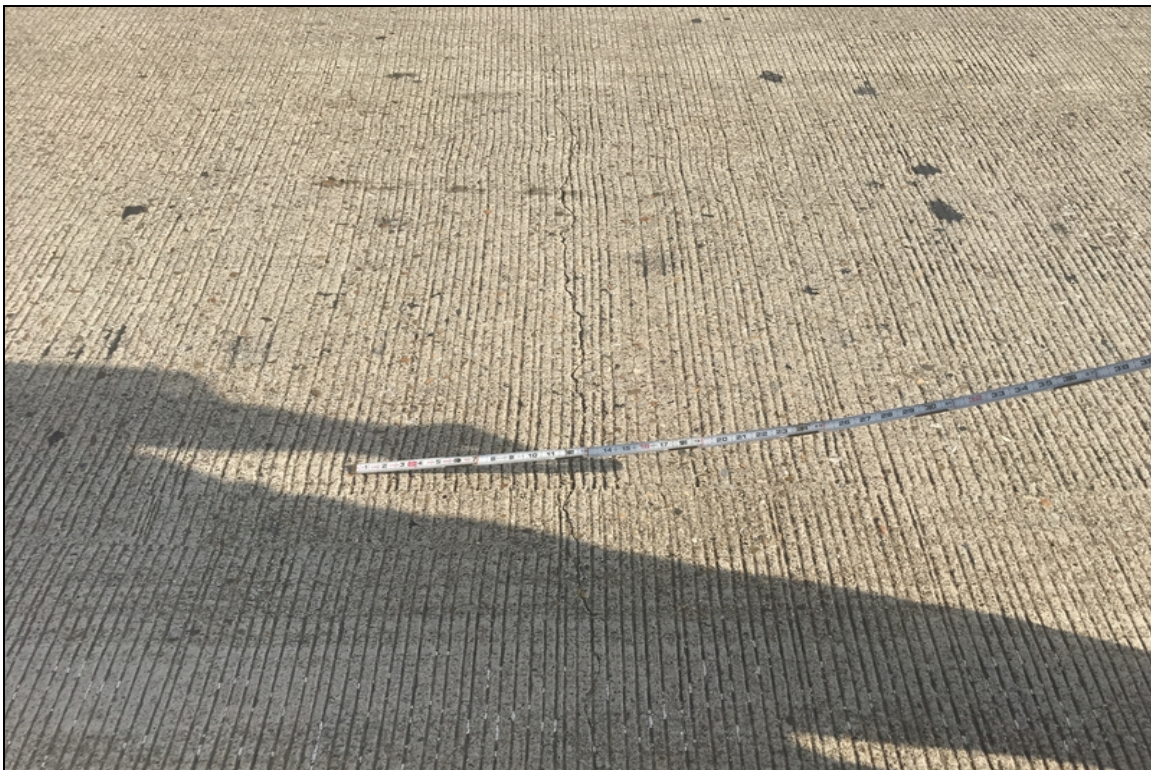
Deck span 2 has transverse cracks.

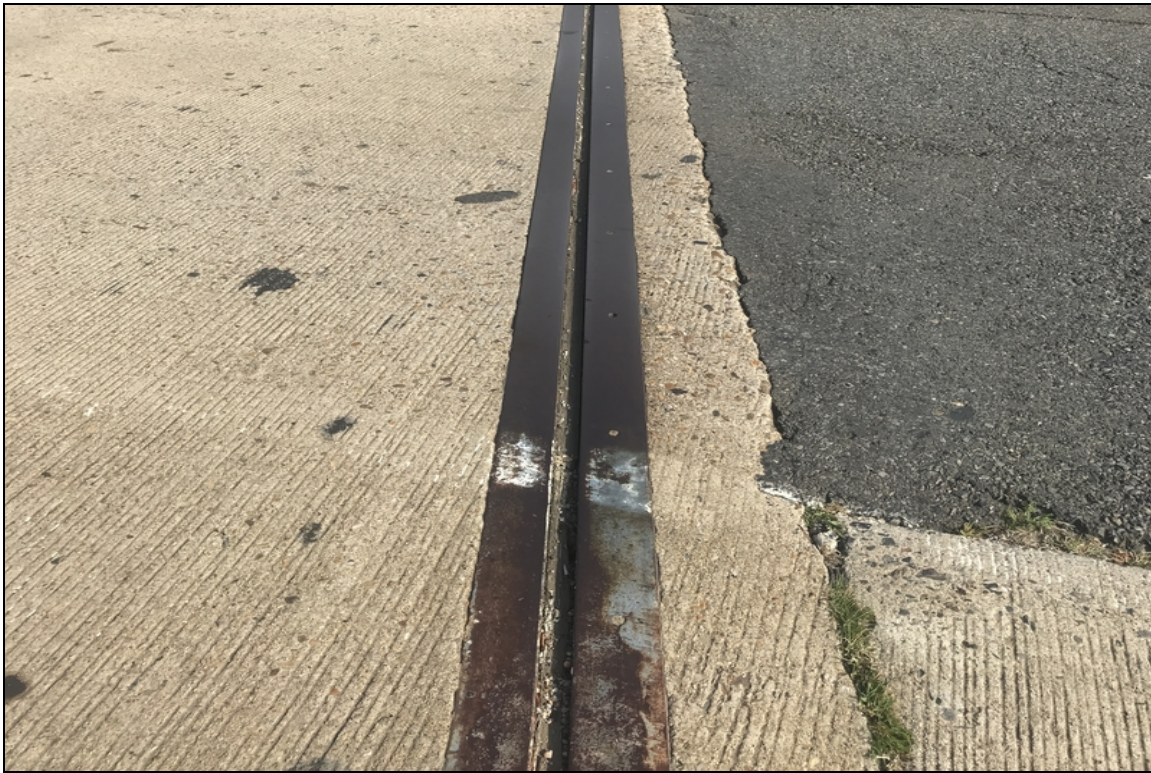
(302)	Both joints are leaking and have lost adhesion.						
310	Elastomeric Bearing	EA	24	24	0	0	0
(310)

Bent 4 joint seal has lost bond and is leaking.

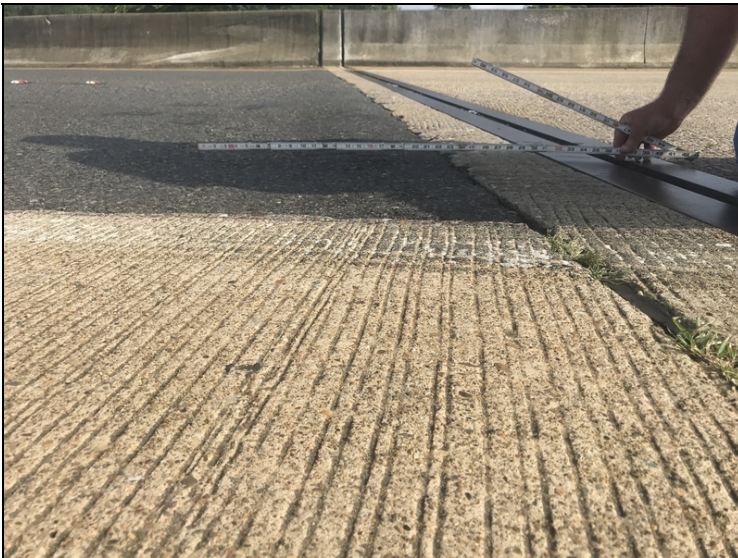
Asphalt approach at both abutments have settled.

Asphalt approach West approach has settled.

Date Reported: 07/09/2020
Priority: C - Important
Type of Work: Repair
Status: Open
Component: Approach
