Bridge #M2967(Routine)

SH 365 Log 6.30 over BR WHITE OAK BAYOU

Team Lead: Chris Doggett Inspection Date: February 22, 2021

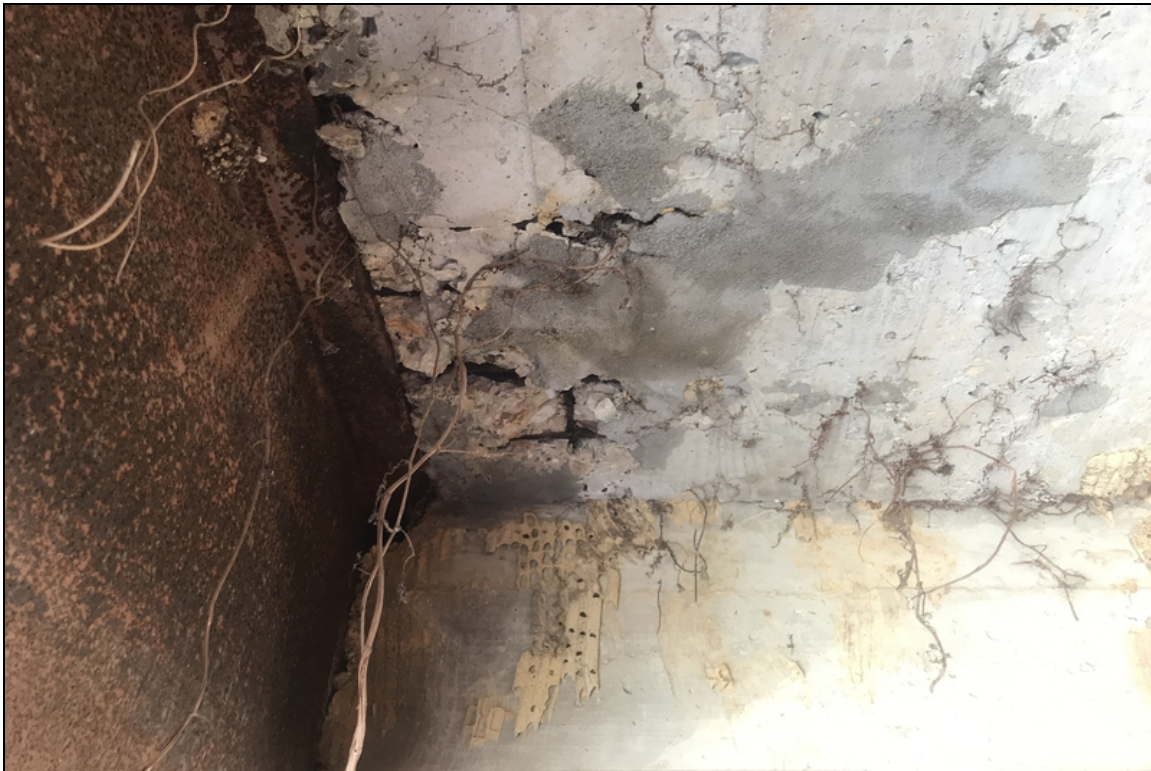
(12)							
Span 1 spall with exposed rebar between girders 6&7. Soffit near bent 2 between beams 1 & 2 with patched area beginning to deteriorate and spall exposing reinforcing steel.							
107	Steel Open Girder/Beam	LF	376	198	146	32	0
1000	Corrosion	LF	178	0	146	32	0
515	Steel Protective Coating	SF	2155	1157	0	436	562
3440	Effectiveness (Steel Protective Coatings)	SF	998	0	0	436	562

Soffit near bent 2 between beams 1 & 2 with patched area beginning to deteriorate and spall exposing reinforcing steel.

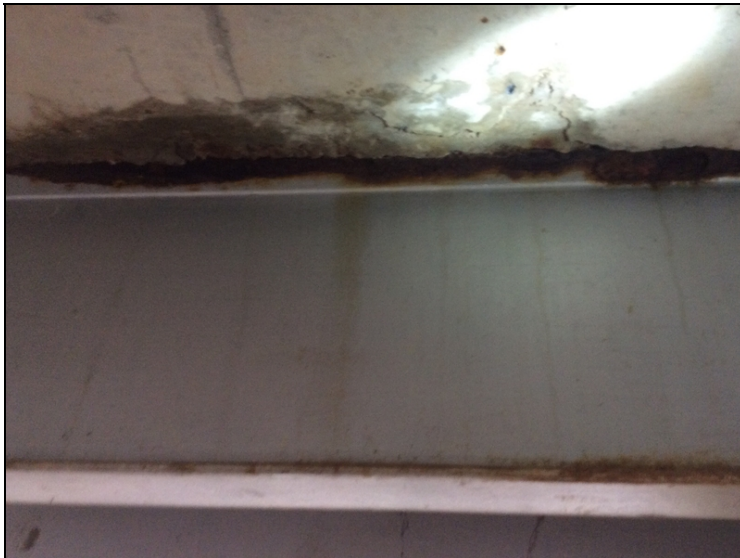
(107)							
Bent 1, beams 1,2,7,8,&9 and bent 2 beams 1,2,3,7,8&9 have surface rust with some active corrosion with pitting. Beam 6 has active rust with pitting on the upper flange. Bent 1, beam 9: measurable section loss to the lower web and bottom flange up to 2 foot from the end of the beam. Beam 8 is in similar condition.							
215	Reinforced Concrete Abutment	LF	130	98	32	0	0
1080	Delamination/Spall/Patched Area	LF	7	0	7	0	0
1130	Cracking (RC and Other)	LF	25	0	25	0	0

Beam 6 back from bent 2 active rust with moderate pitting on the upper flange. Common at bent 1.

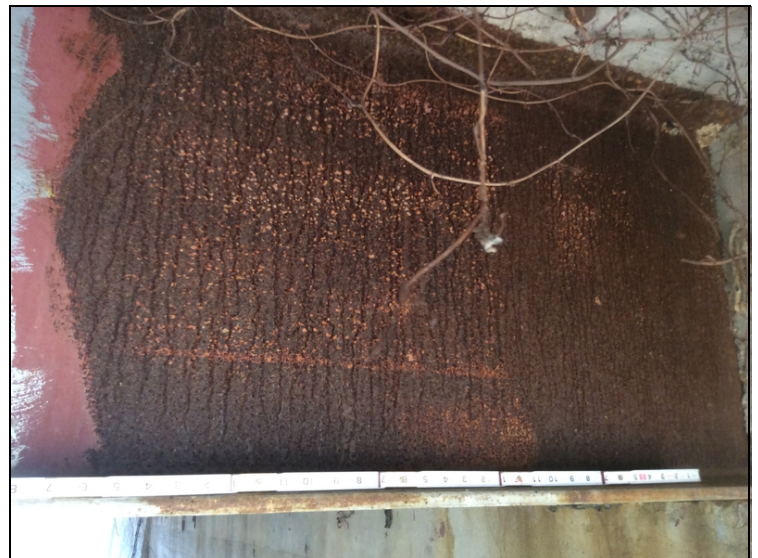
Bent 1, beam 2
Surface rust.
Beam 1 similar.

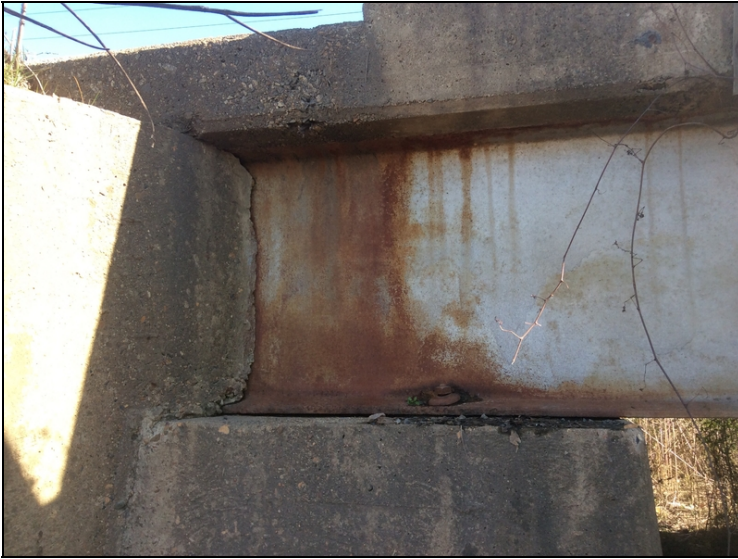
Bent 1, beam 9
Corrosion with pitting.

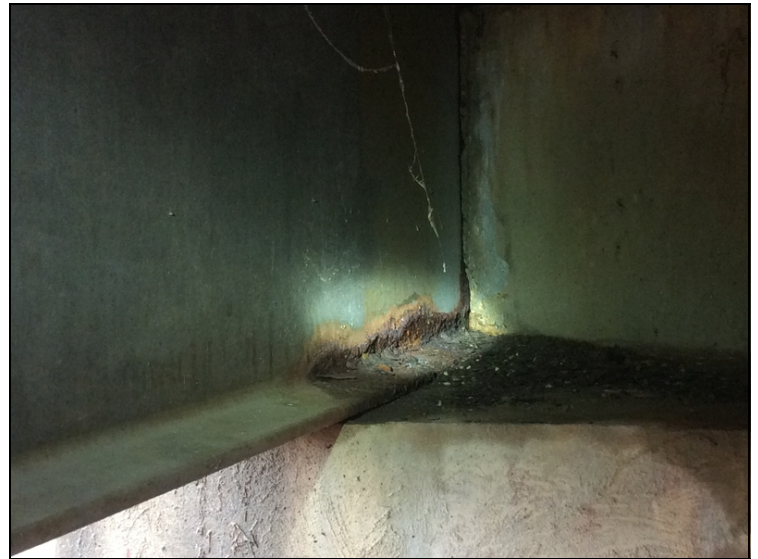
Bent 1 beam 9 has active rust with pitting on lower
web and flange common beam 8.

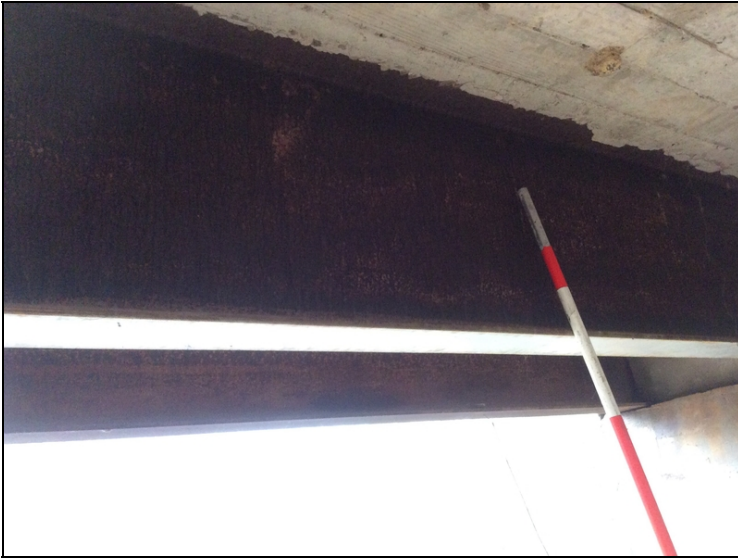
Beams 1&2 have active surface rust.

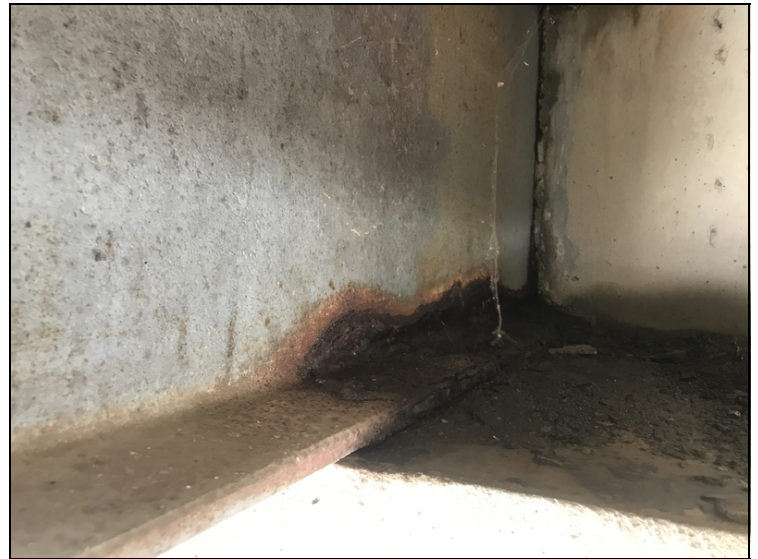
Beams 1,2,3,8&9 have unpainted sections with surface rust and pitting. Bent 1, beam 9: measurable section loss to the lower web and bottom flange up to 2 foot from the end of the beam.

Bent 1, beam 9: measurable section loss to the lower web and bottom flange up to 2 foot from the end of the beam.
