**Bridge #M2968(Routine)**  
**SH 365 Log 6.39 over WHITE OAK BAYOU**

**Location: 8.5 MI N OF I-40**

**Team Lead: Chris Doggett Inspection Date: February 03, 2020**

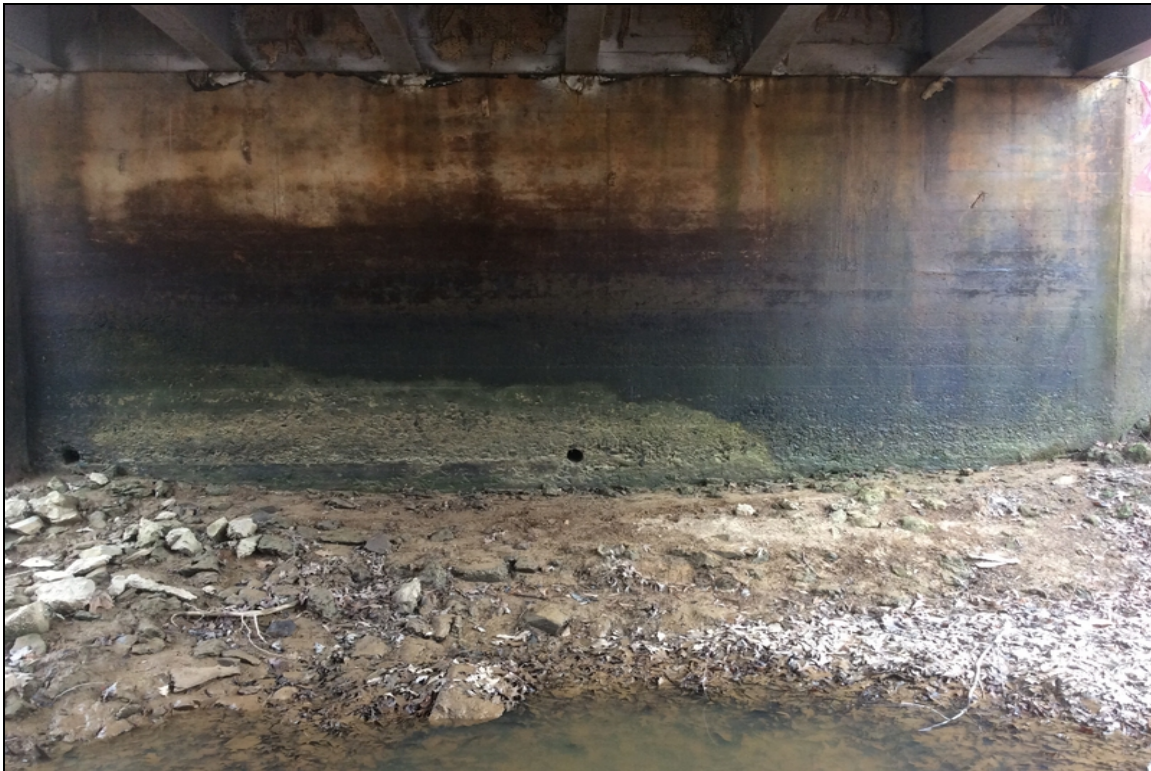
(215)	Small spalls under the beams at both abutments. Scattered small cracks in both abutments. Moderate abrasion on both abutments.						
330	Metal Bridge Railing	LF	84	84	0	0	0

Abrasion at bent 2 abutment.

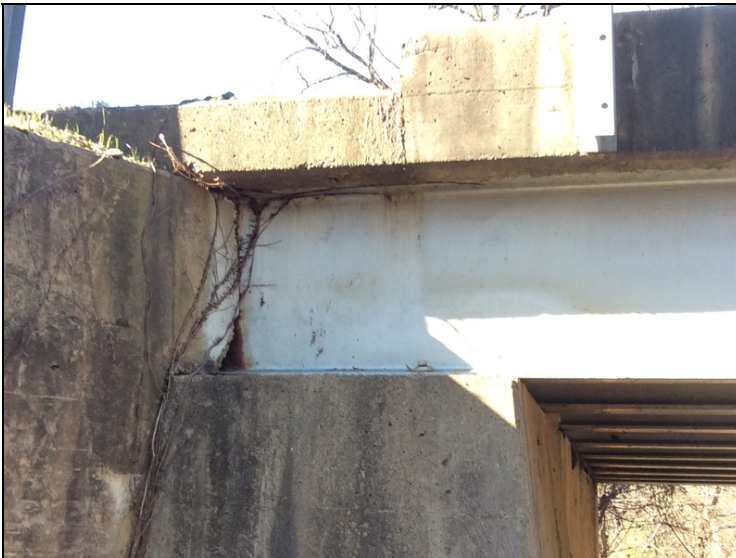
(107)	Beams 1&2 at both abutments have active rust with minor pitting. The bottom of the bottom flanges have freckled rust.						
215	Reinforced Concrete Abutment	LF	138	76	62	0	0
1080	Delamination/Spall/Patched Area	LF	7	0	7	0	0
1130	Cracking (RC and Other)	LF	15	0	15	0	0
1190	Abrasion/Wear (PSC/RC)	LF	40	0	40	0	0

Beams 1&2 at both abutments have some active rust with minor pitting. Photo attached.

Bent 2, beam 1  
Active rust with minor pitting at the end.

**Date Reported:** 02/17/2016  
**Priority:** C - Important  
**Type of Work:** None  
**Status:** Monitor  
**Component:**
