Bridge #M2969(Routine)

SH 365 Log 7.88 over WINEFREE CREEK

Team Lead: Chris Doggett Inspection Date: February 22, 2021

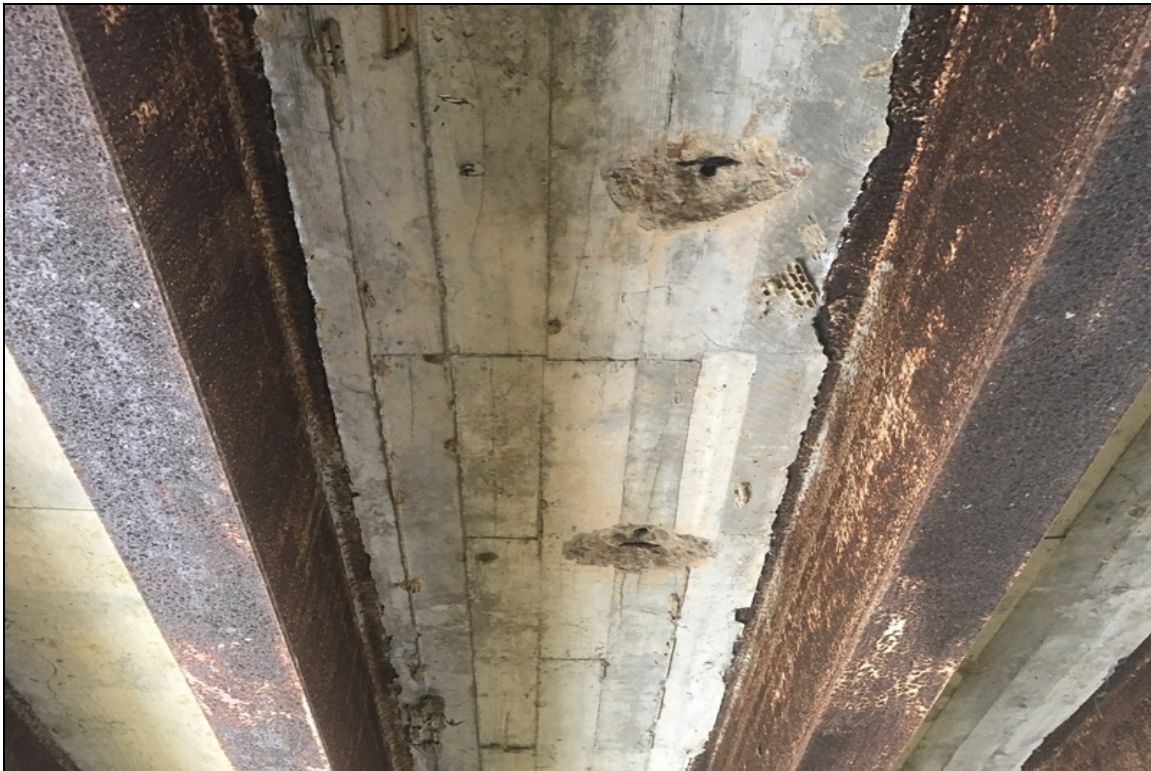
(12)	Two small spalls on the deck soffit between beams 4&5. Random cracks in the asphalt overlay.						
107	Steel Open Girder/Beam	LF	378	0	378	0	0
1000	Corrosion	LF	378	0	378	0	0
515	Steel Protective Coating	SF	2166	0	0	481	1685
3440	Effectiveness (Steel Protective Coatings)	SF	2166	0	0	481	1685

Soffit between beams 4 and 5 have spalls with exposed rebar.

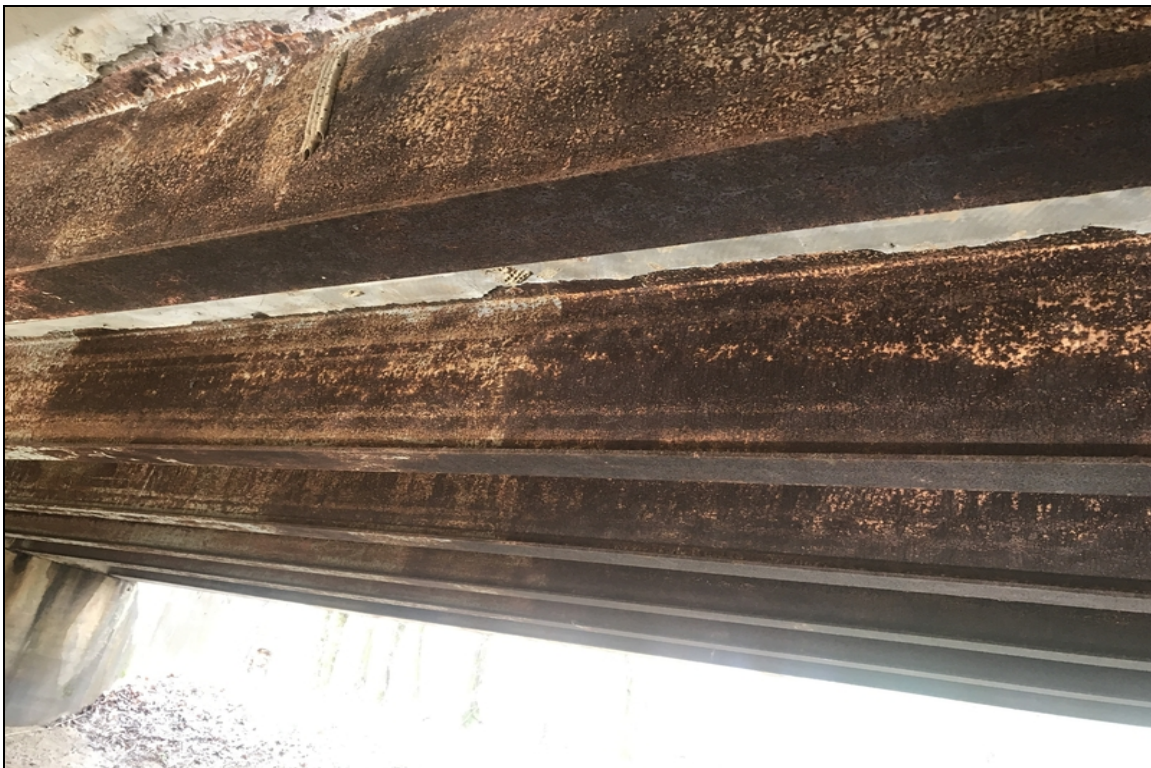
(107)	Only beams 1&9 are painted on the outside, all others have uniform surface rust. The painted surfaces of beams 1&9 have freckled rust.						
215	Reinforced Concrete Abutment	LF	130	98	30	2	0
1080	Delamination/Spall/Patched Area	LF	3	0	3	0	0
1130	Cracking (RC and Other)	LF	7	0	7	0	0
1190	Abrasion/Wear (PSC/RC)	LF	22	0	20	2	0

All beams have surface rust and light pitting.

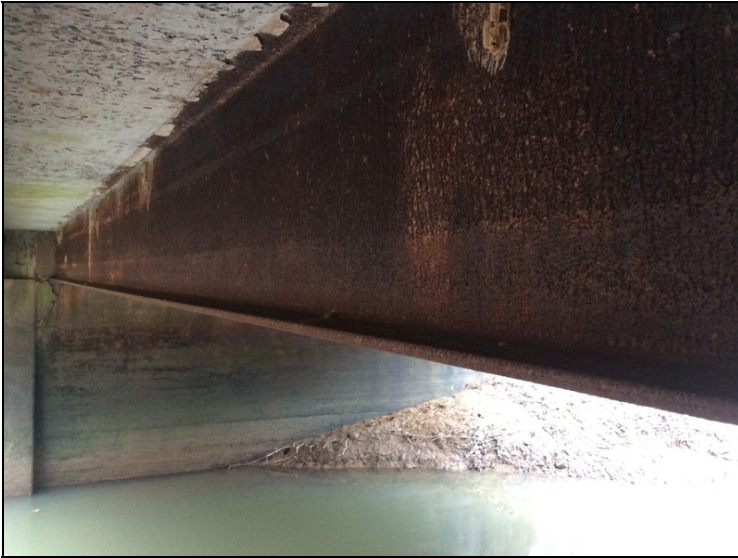
All beams have active surface rust.

Beam 3 the paint system has failed. The beam has surface rust. Common all beams 2 thru 8.

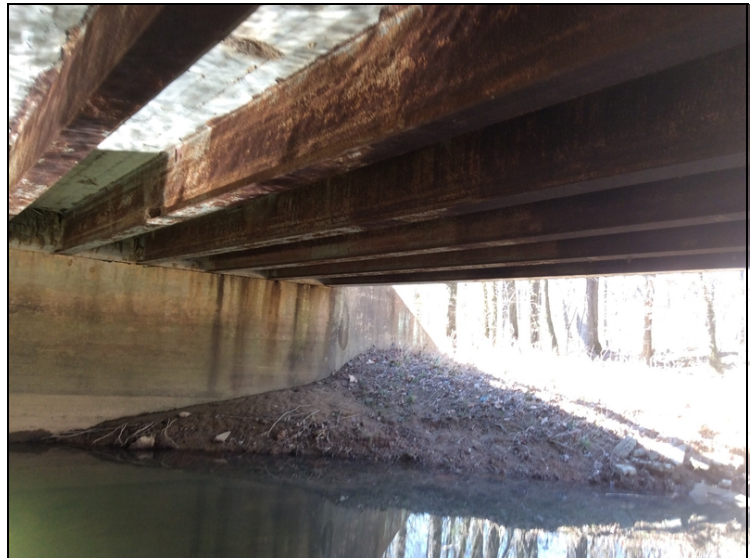
Surface rust on all beams.

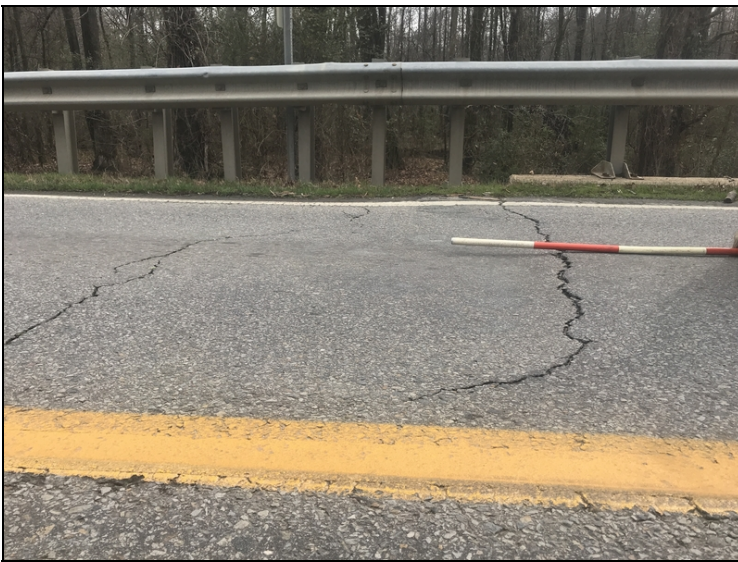
Asphalt roadway approach has settled at both abutments.

Approach roadway North end of bridge has settled, common south end.

Assigned Pulaski 1 06601 5/16/18

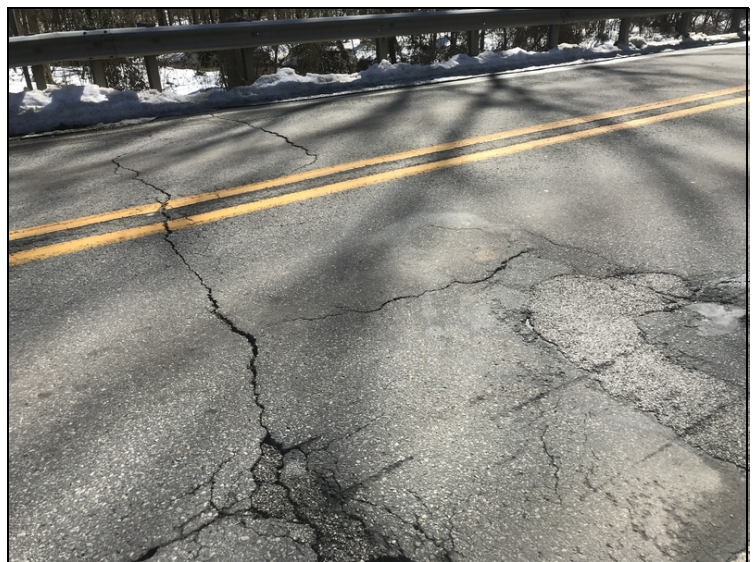
Approach roadway North end of bridge has settled.
2021
