Asset #02364(Routine)

SH 10 Log 14.94 over KINLEY CREEK

Location: 2.8 MI W SH 300

Team Lead: Chris Doggett, Inspection Date: 09/16/2021

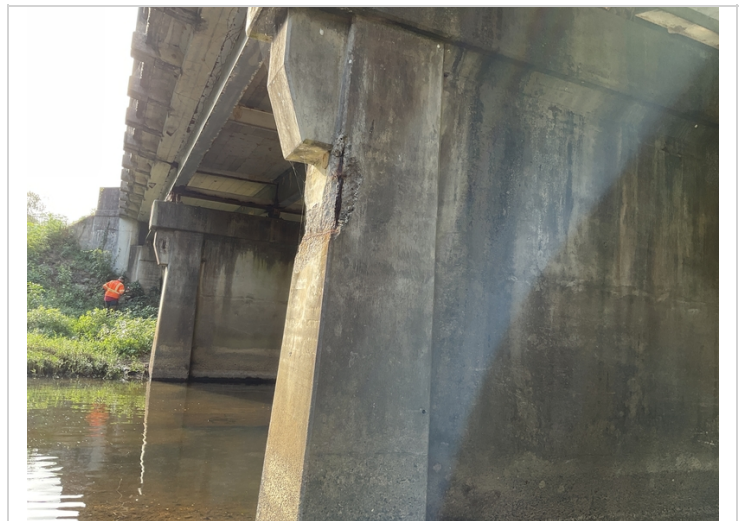
Bent 2, column 1

(205) Bent 2, columns 1 and 2, spalls with exposed rebar. Bent 3, column 2, large delamination.							
210	Reinforced Concrete Pier Wall	LF	48	0	37	11	0
1080	Delamination/Spall/Patched Area	LF	1	0	0	1	0
1090	Exposed Rebar	LF	10	0	0	10	0
1130	Cracking (RC and Other)	LF	3	0	3	0	0
1190	Abrasion/Wear (PSC/RC)	LF	34	0	34	0	0

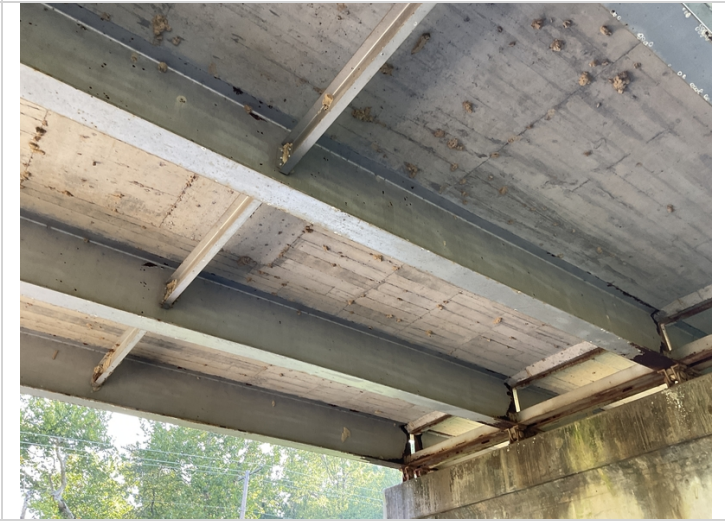
Soffit view

(12) Soffit- Small cracks with efflorescence in span 1.							
(510-12) Multiple cracks in the asphalt surface at the joints.							
107	Steel Open Girder/Beam	LF	432	276	120	36	0
1000	Corrosion	LF	156	0	120	36	0
515	Steel Protective Coating	SF	3201	0	2151	840	210
3440	Effectiveness (Steel Protective Coatings)	LF	3201	0	2151	840	210

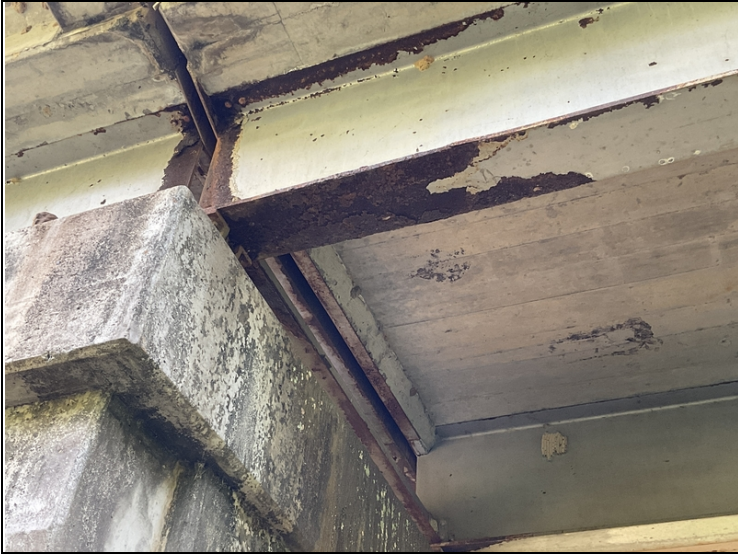
Span 1 Beams 1 & 4 at bent 1, beams 1 thru 4 at bent 2. Span 2 beams 1 & 4 at bent 2 and beams 1 thru 4 at bent 3, Span 3 beams 1 & 4 at bents 3 and 4, all have areas of corrosion with measurable section loss.

Span 3, girder 4: laminating rust and pitting to both upper and lower flange and web at the beam end.

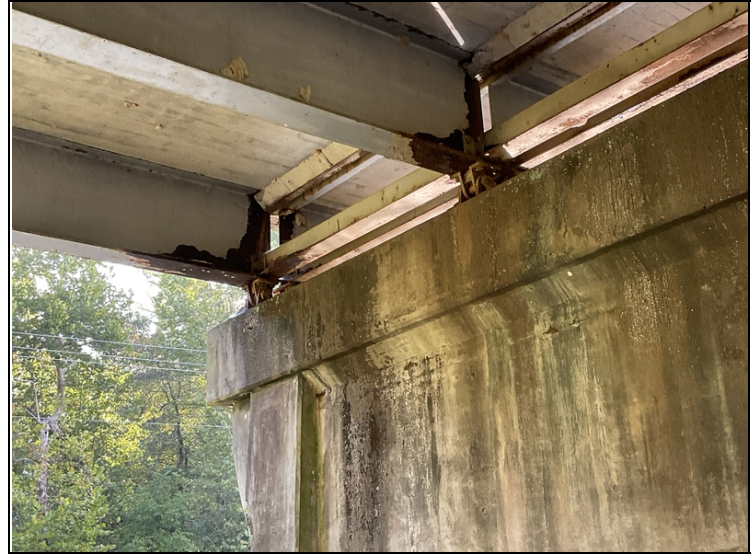
Span 1 at bent 2, girders 1&2: laminating rust and pitting to both upper and lower flange and web at the beam end.

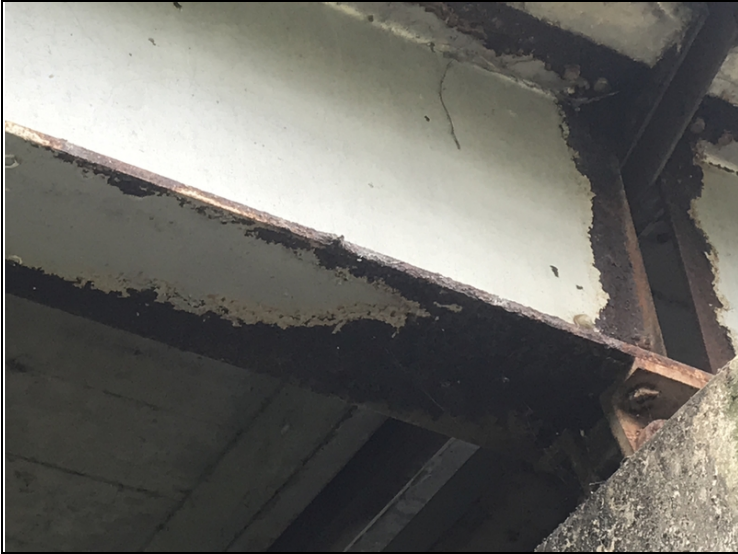
Span 3 beam 1 bent 3 active rust with moderate pitting to beam end.

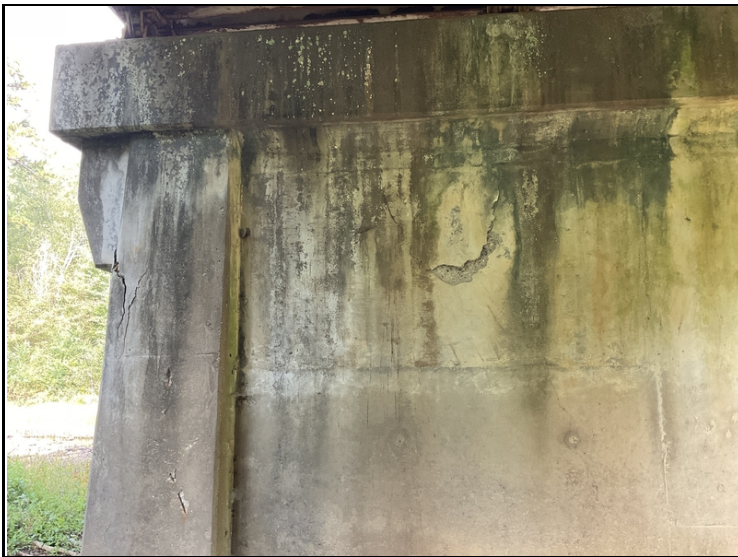
Bents 2&3 have spalls with exposed rebar on pier walls.

Ahead side of bent 3: area of delam in the pier wall

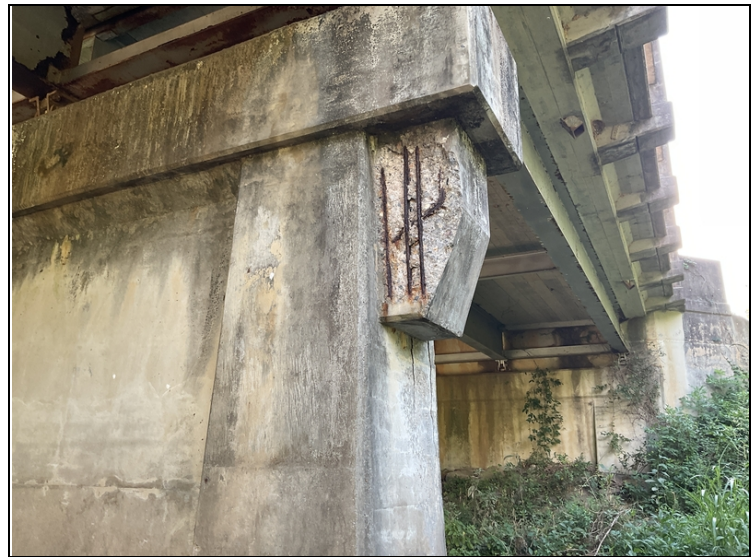
Bent 3: pier has spall with exposed rebar.

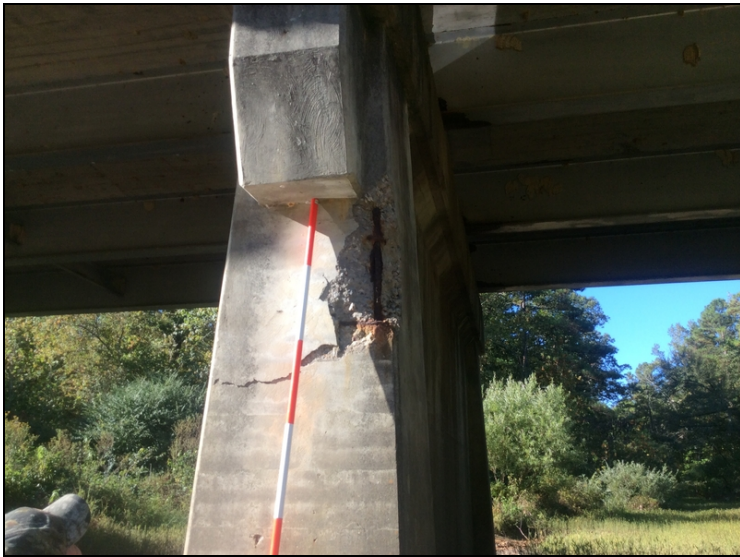
Left side of bent 2 large spall with exposed rebar.  
Common right side.

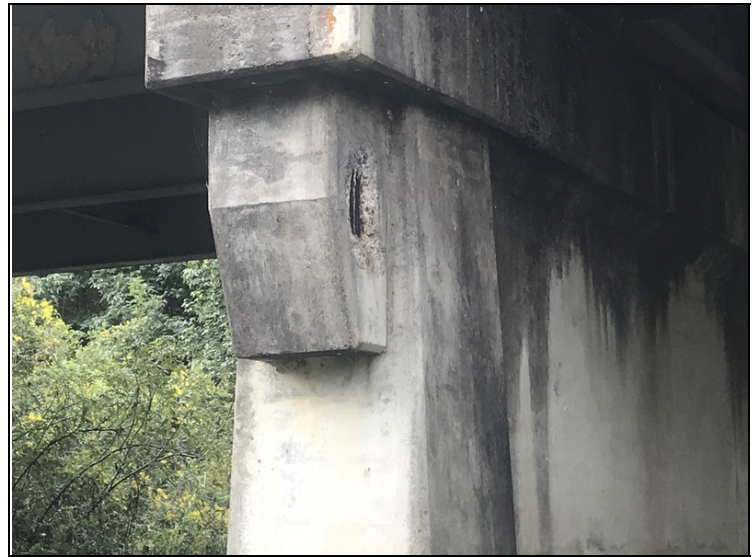
Bent 3 pier wall left end has spall with exposed  
rebar.

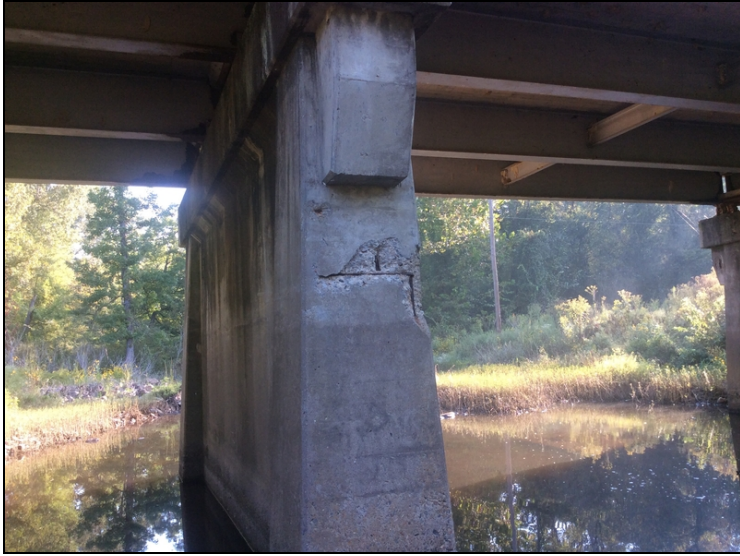
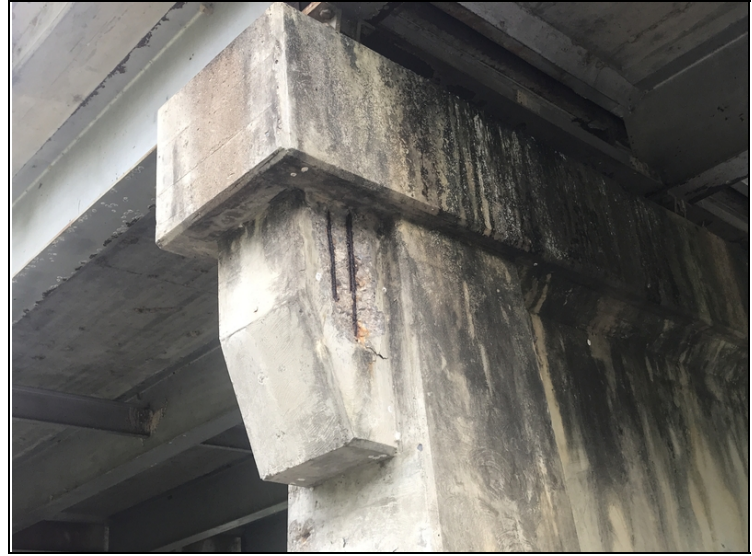
Bent 2 pier wall has spall with exposed rebar right side.

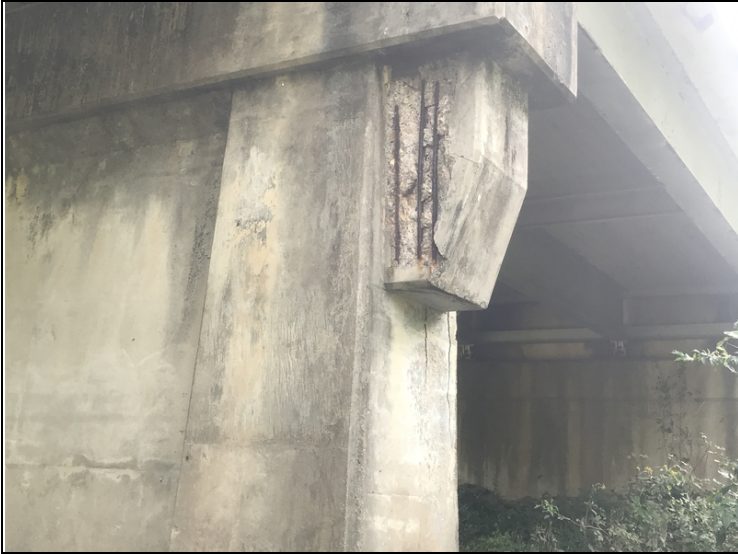
Bent 3 pier wall right side has spall with exposed rebar.
