Asset #02365(Routine)

SH 10 Log 16.24 over Little Maumelle River

Location: 1.5 MI W SH 300

Team Lead: Chris Doggett, Inspection Date: 09/16/2021

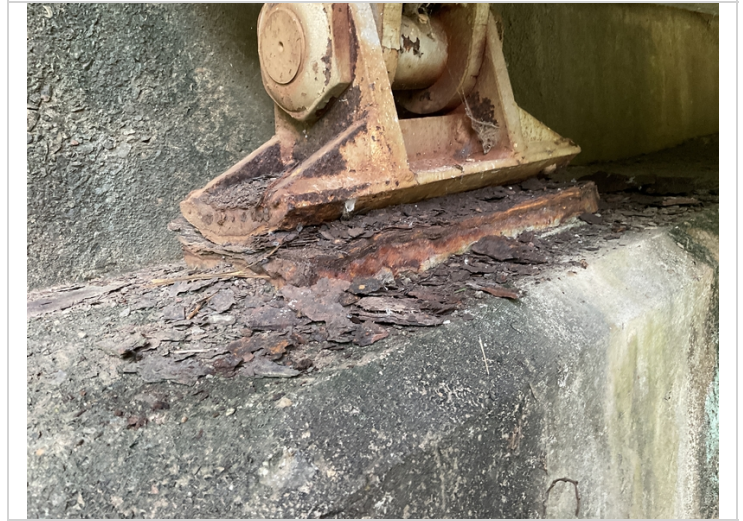
(234) Bent 2 cap ahead side 4' delam between beams 3&4.							
311	Movable Bearing	EA	12	0	0	12	0
1000	Corrosion	EA	12	0	0	12	0
(311) All bearings have measurable section loss.							
313	Fixed Bearing	EA	4	0	4	0	0

Bent 2: bearing with measurable section loss to the sole plate.

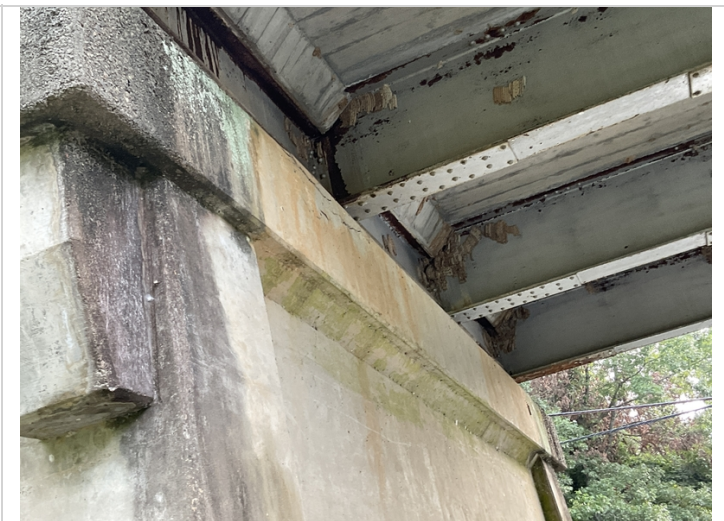
Bent 2: ahead side of cap has delma between beams 3&4.

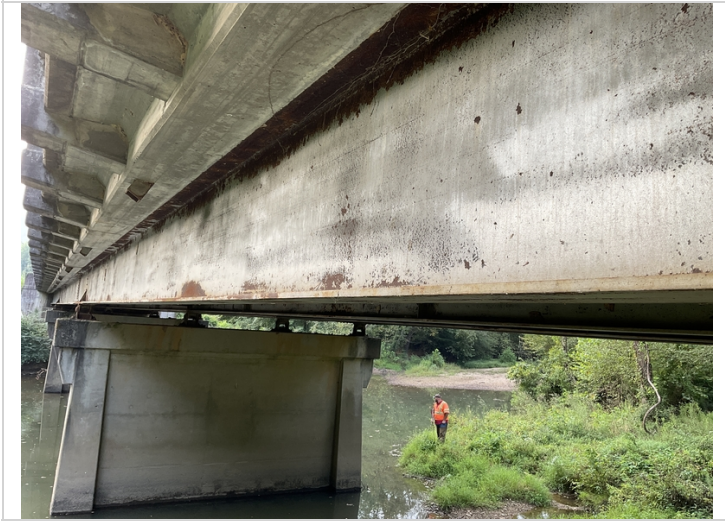
Span 1, girder 1: Typical condition of the paint condition on the girders.

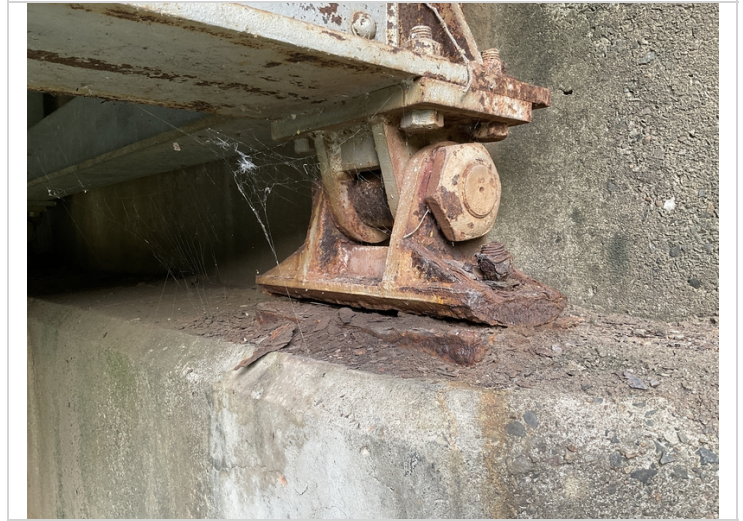
Bent 1, girder 1: bearing with section loss.

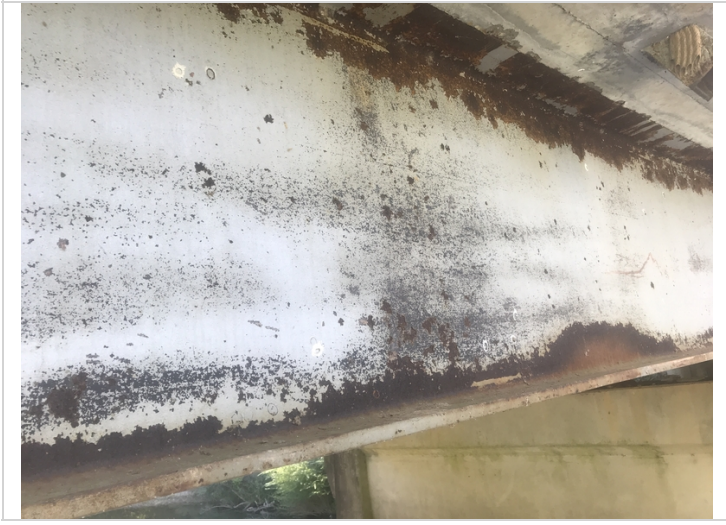
Span 2 beam 4 surface rust with minor pitting. Common all beams.

Surface rust with light to moderate pitting on all beams with peeling paint.

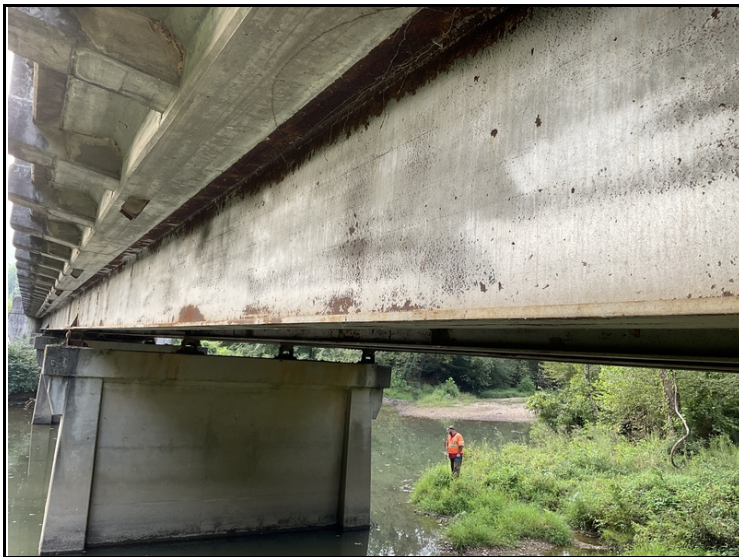
Span 1, girder 1: Typical condition of the paint condition on the girders.

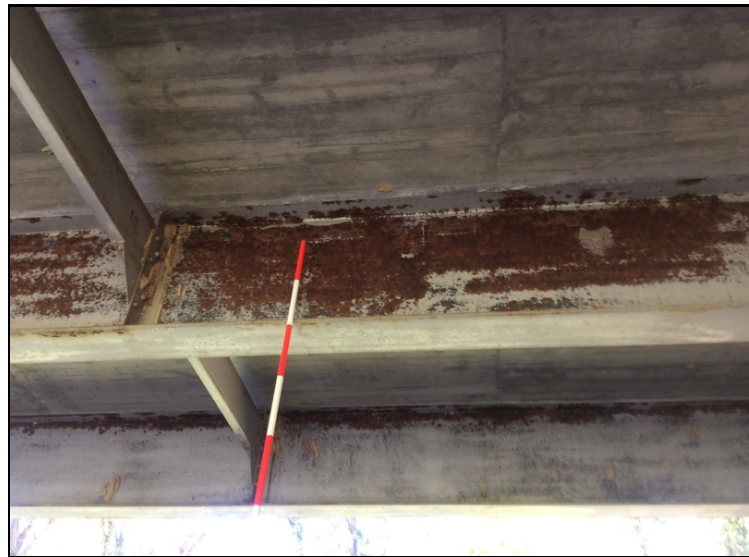
Span 1 beam 3 surface rust with light to moderate pitting. Common on all beams.

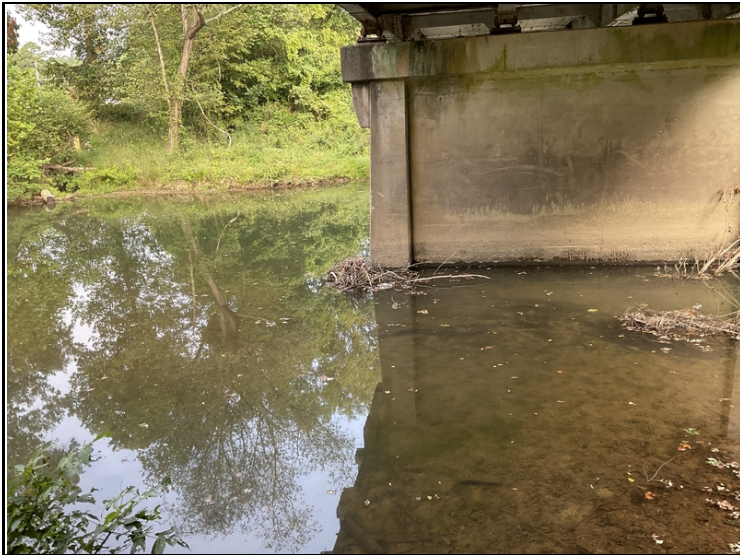
Bent 3 upstream end tree restricting water flow.

Removed tree
