Asset #05996(Routine)

SH 10-8 log 4.64 over N CHANNEL TAYLOR LOOP CR

Team Lead: Bryan Saunders, Inspection Date: 03/08/2022

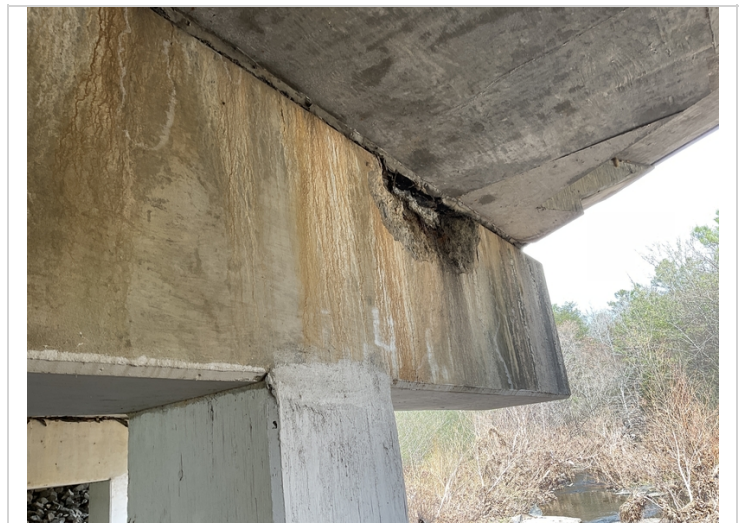
(234) Bent 3 cap back right of column 1 large delamination. See photo bent 3 ahead face above column 1 large delamination.							
301	Pourable Joint Seal	LF	120	0	0	120	0
2320	Seal Adhesion	LF	120	0	0	120	0

Bent 3 ahead side

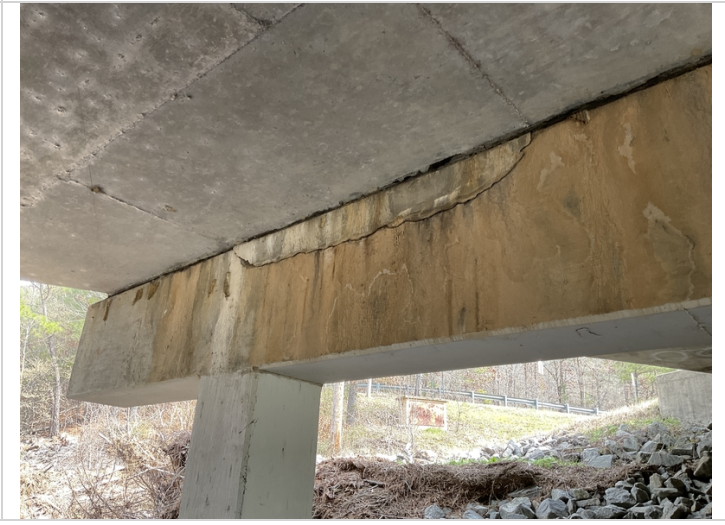
Delamination bent 3 backside

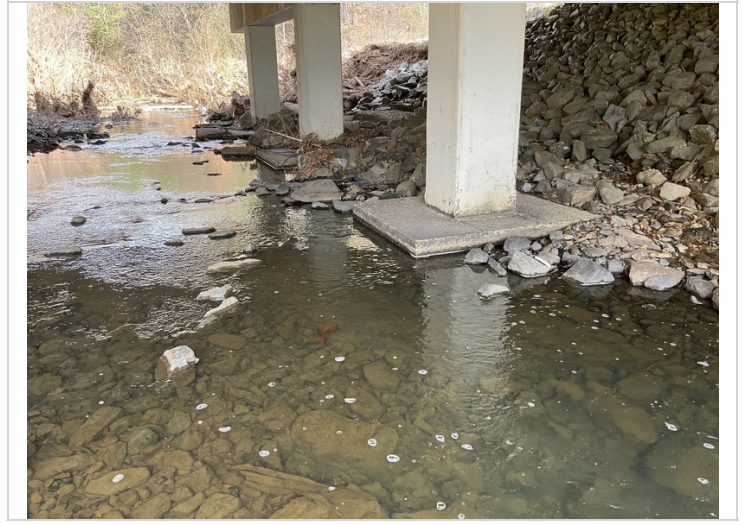
(215) Bent 4 has scattered small cracks.							
220	Reinforced Concrete Pile Cap/Footing	LF	15	15	0	0	0
(220) Bent 3 footings are exposed. Footings are keyed one foot into rock							
234	Reinforced Concrete Pier Cap	LF	128	112	5	11	0
1080	Delamination/Spall/Patched Area	LF	16	0	5	11	0

Footings at bent 3

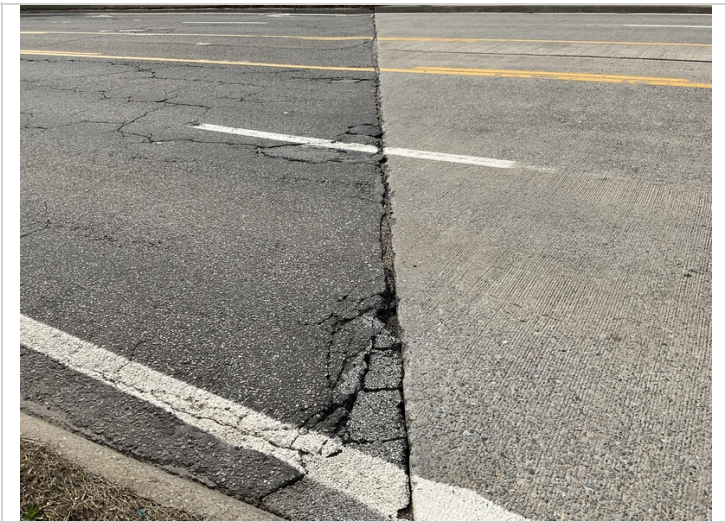
Potholes starting to form at east end of bridge

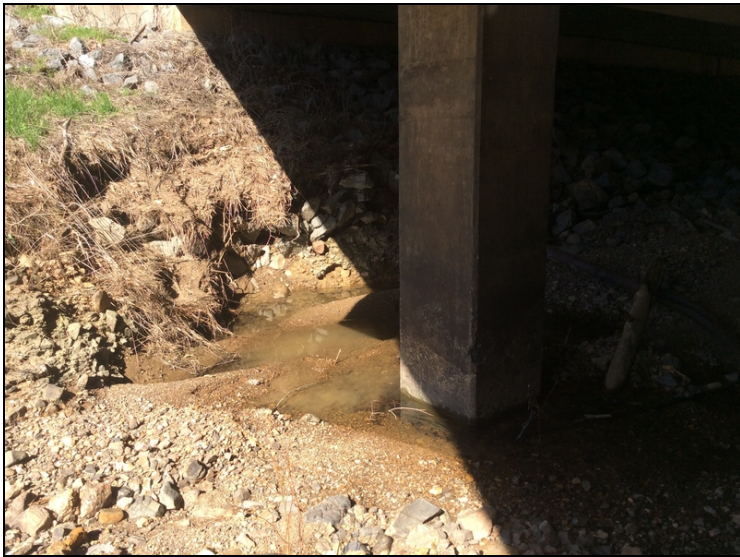
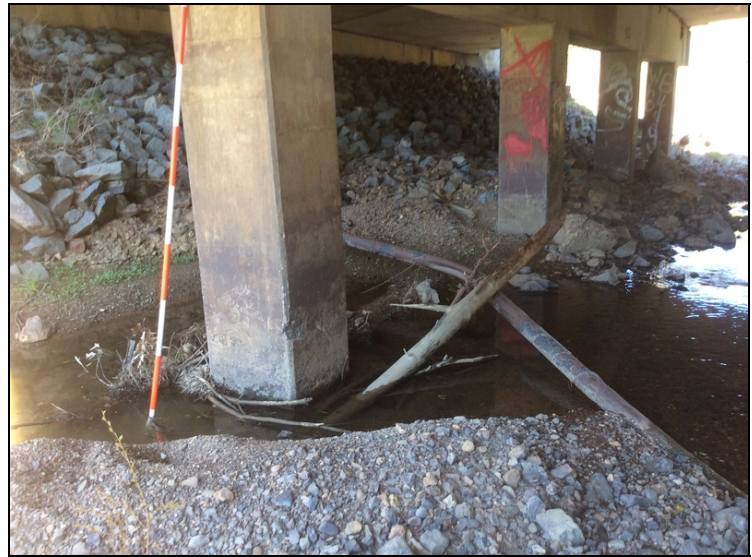
Scour has eroded embankment behind bent 2 column 4 and causing horseshoe scour at column 4. See photos

Bent 2 column 4 scour hole silted in covering top of footing. Horse scour at column at this time.

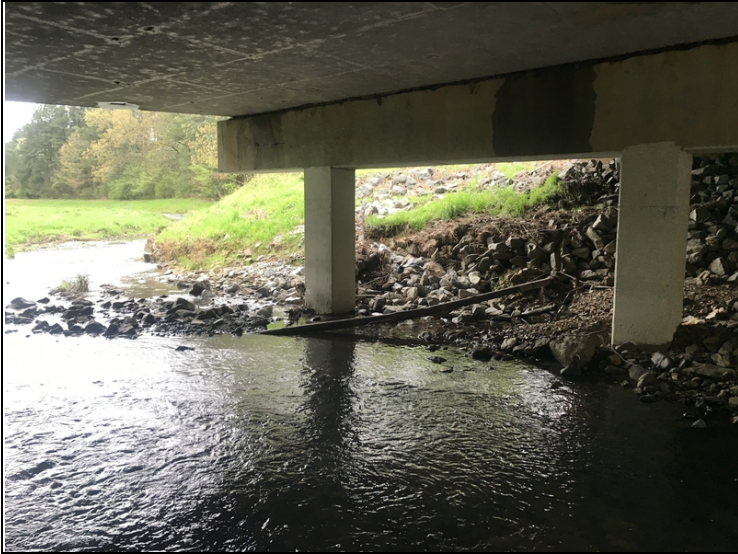
State forces have dumped rip rap in scour hole.
