Asset #06360(Routine, Underwater type 2)
SH 10 Log 4.19 over So.Ch.Taylor Loop Creek
Location: 3.69 MI EAST JCT SH 300

Team Lead: Bryan Saunders, Inspection Date: 03/08/2022

Asset **#06360**(Routine, Underwater type 2)

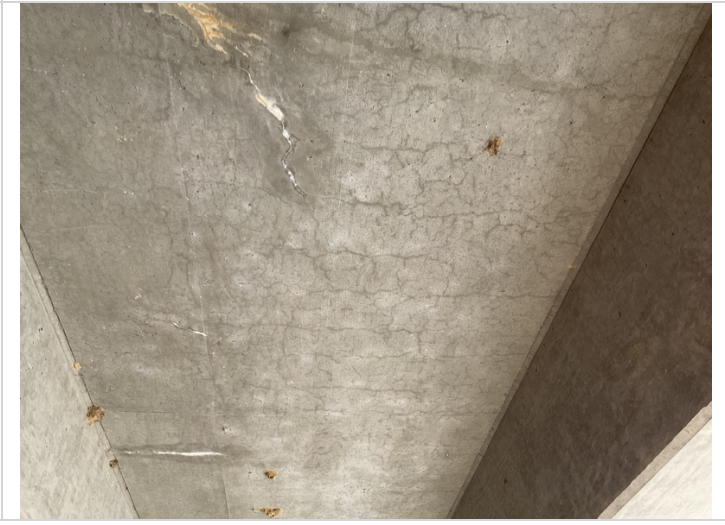
Map cracking in top flange

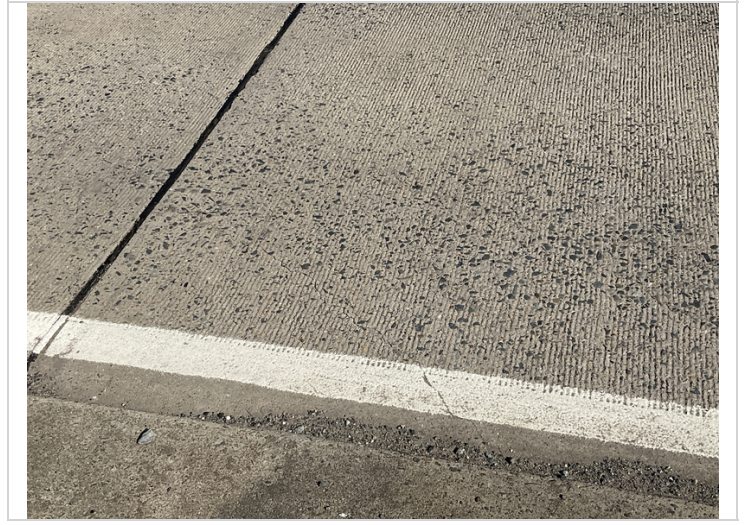
Deck cracks span 2

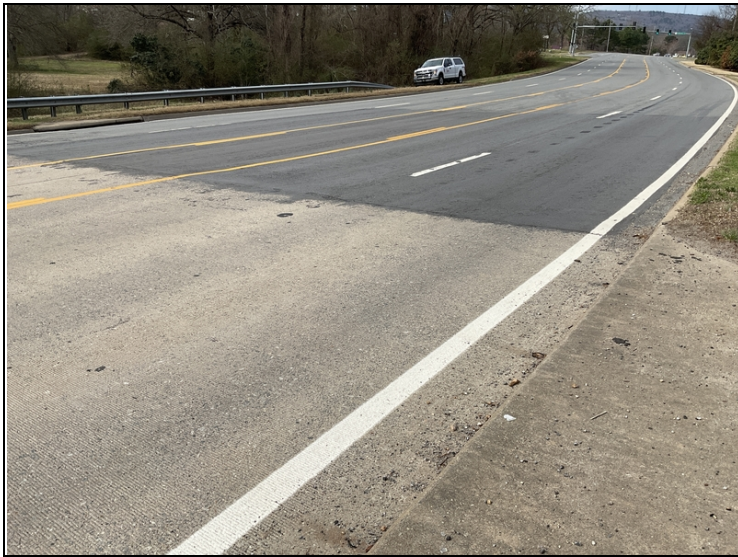
Repaired approach roadway

Approach roadway has been repaired

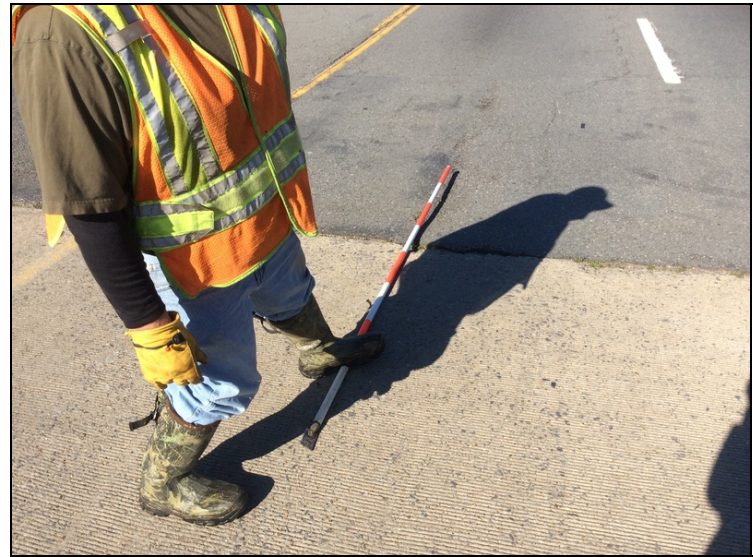
At bent 1 approach roadway has settled.

Settlement at approach roadway at west abutment.

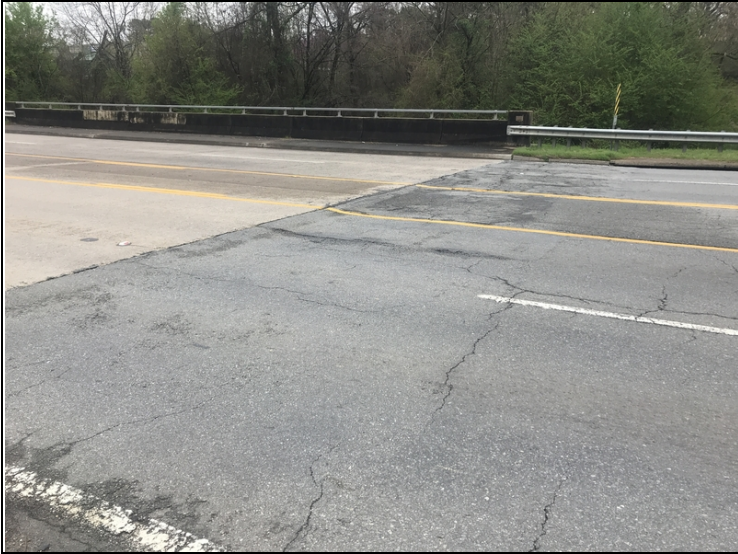
At bent 1 approach roadway has settled. 03/2020

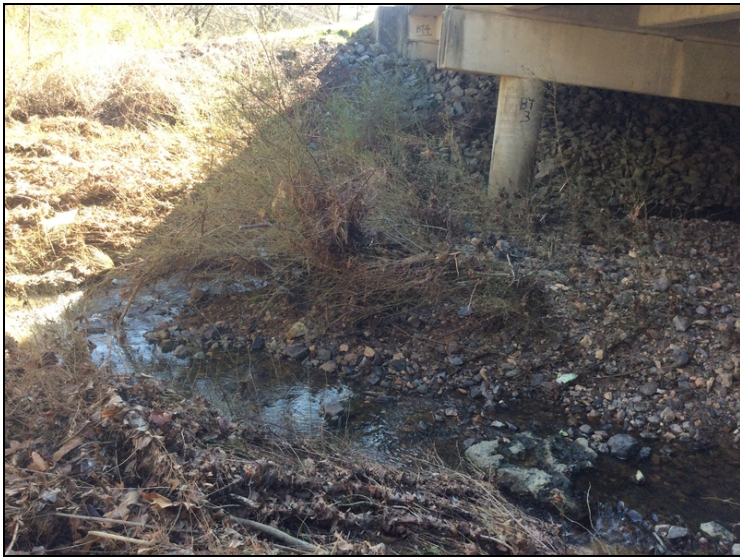
Channel between bents 2 and 3 the thalweg has split.

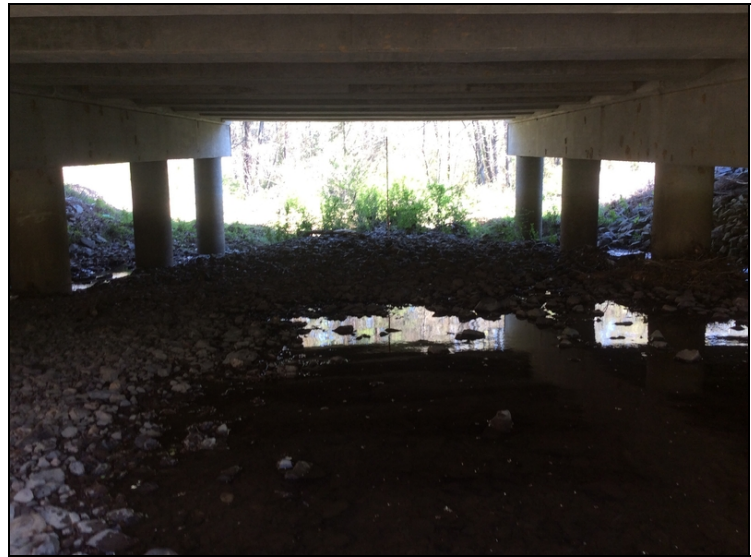
Downstream end of channel has build up of aggregation diverting stream flow to both bents 2 and 3.

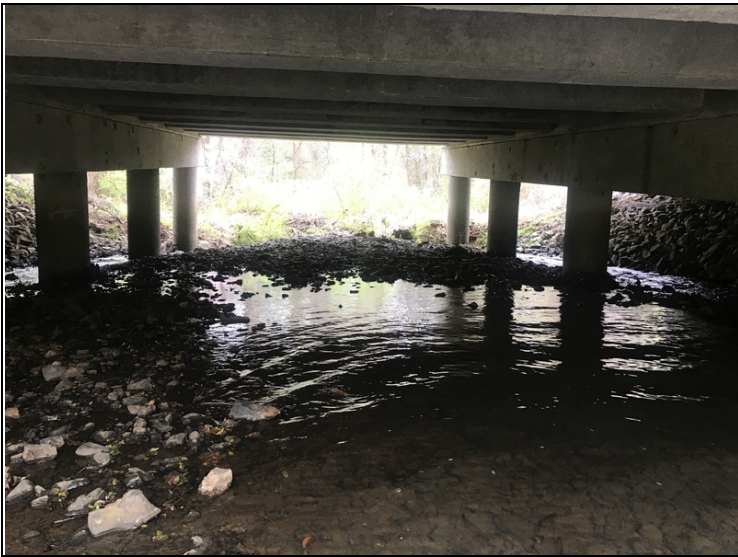
Downstream end of channel has build up of
aggregation diverting stream flow to both bents 2
and 3. 03/2020

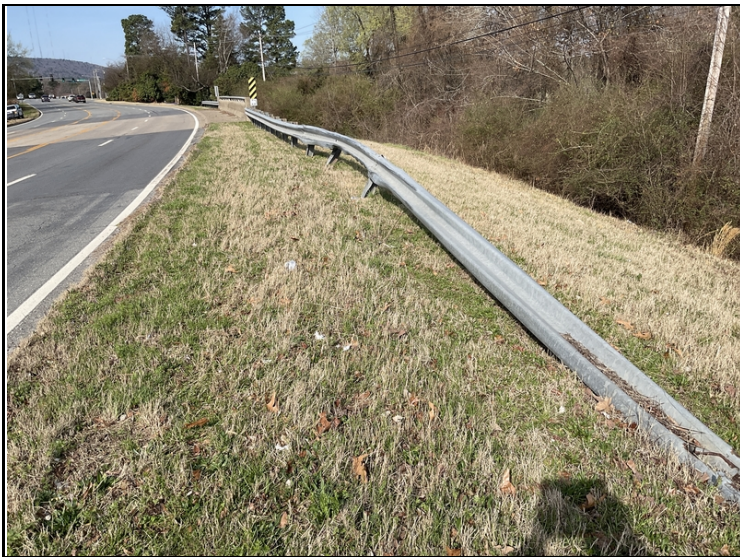
guardrail at Northeast end of bridge has damage due to traffic impact

Guardrail damage at northeast end of the bridge
