Asset #07087(Routine)

SH 35-1 Log 2.41 over U.P.R.R.

Location: 0.15 M W JCT SH 35 & 183

Team Lead: Chris Doggett, Inspection Date: 04/14/2022

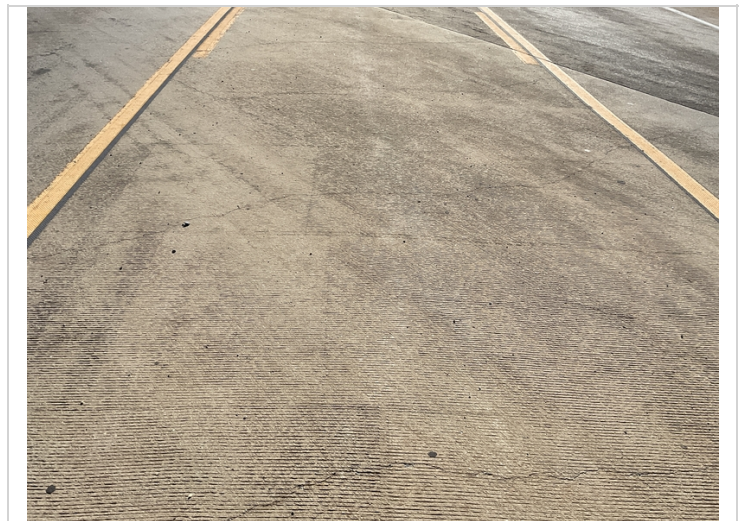
(215) Both abutments have diagonal/vertical cracks with efflorescence staining. Bent 1 bay 7 concrete ditch paving between MSE wall and abutment has settled in this area approximately 15' in length.							
301	Pourable Joint Seal	LF	256	244	7	5	0
2310	Leakage	LF	12	0	7	5	0

Sealed diagonal cracks

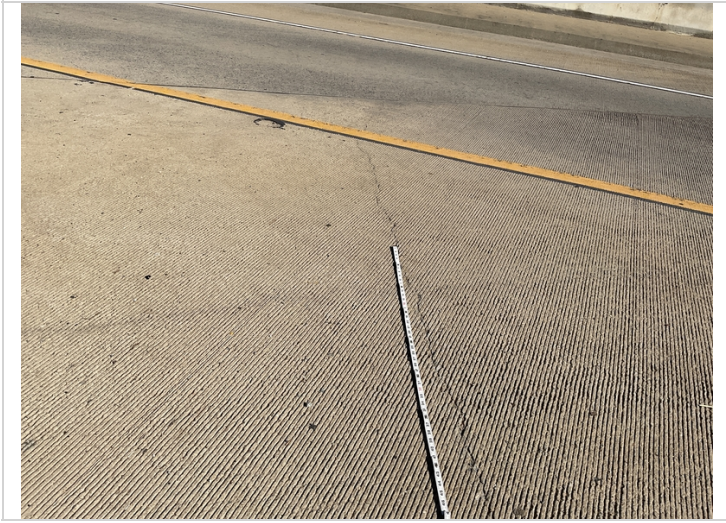
Large diagonal crack

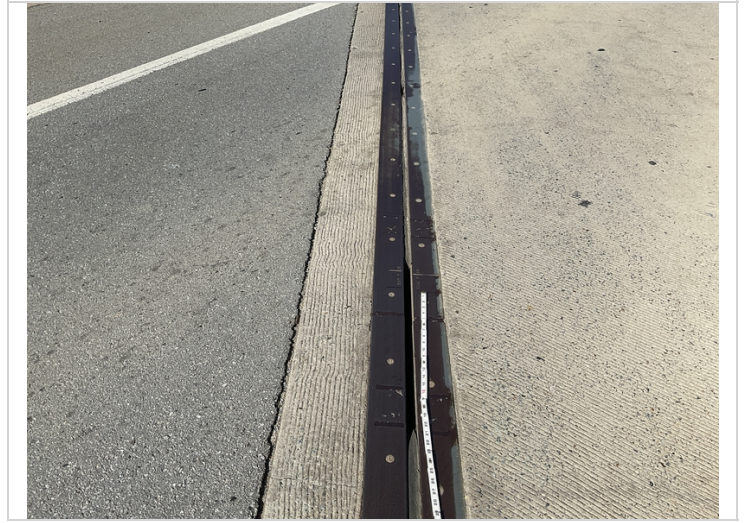
(301) Pourable joints at bent 1 and 2 have some voids							
310	Elastomeric Bearing	EA	16	16	0	0	0
(310) No apparent noteworthy defects at this inspection.							
330	Metal Bridge Railing	LF	336	336	0	0	0
515	Steel Protective Coating	SF	2016	2016	0	0	0

Bent 2, right lane: joint seal with a few holes allowing water to flow through.

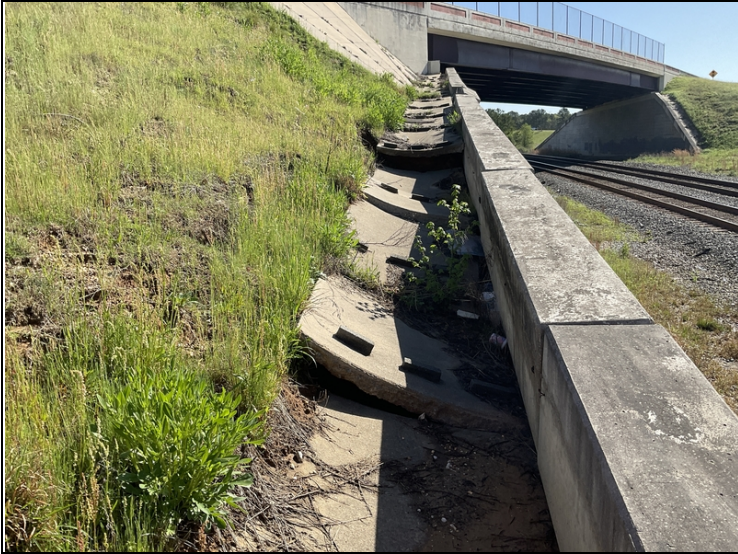
At abutment 1, South M.S.E. wall.  
Top has 10 feet of traffic damage.  
Also, the ditch paving behind the MSE wall at Bent 2 on the left side has failed causing slope erosion and multiple MSE wall anchor straps are exposed.

Bent 1, right side: slope paving is failing due to erosion.

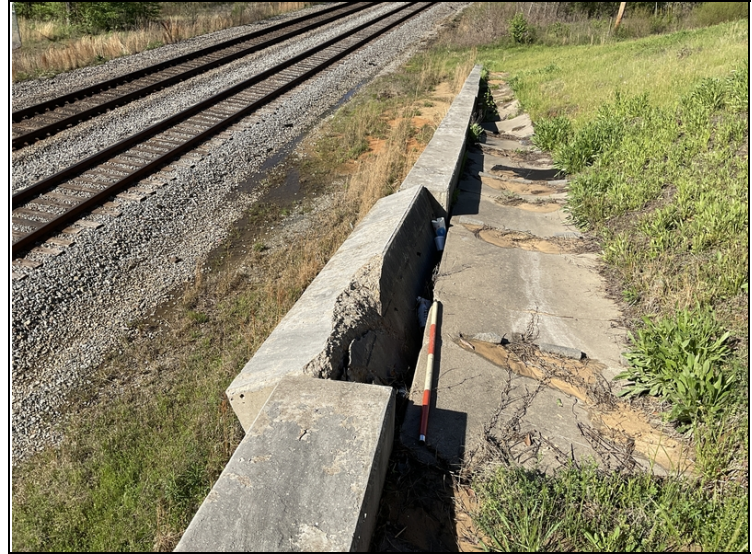
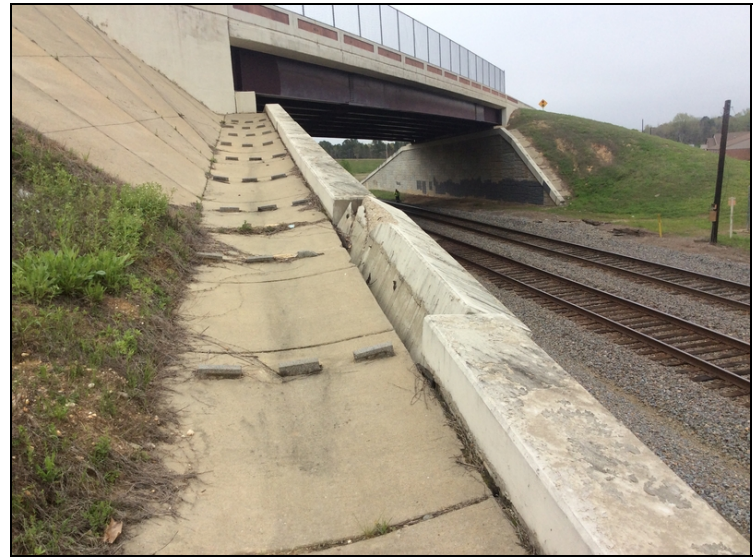
Bent 1, right side: top of MSE wall damaged due to collision.

Bent 1, right side, top of MSE wall damaged due to collision.

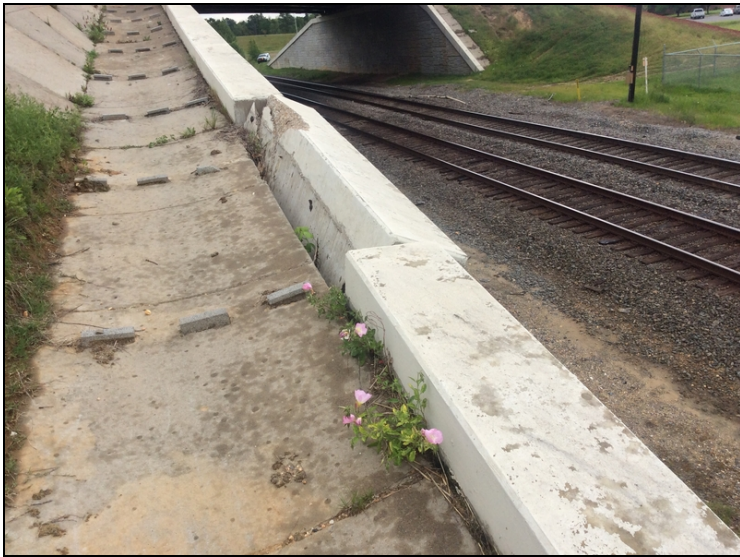
Bent 1 right side traffic impact to top of MSE wall

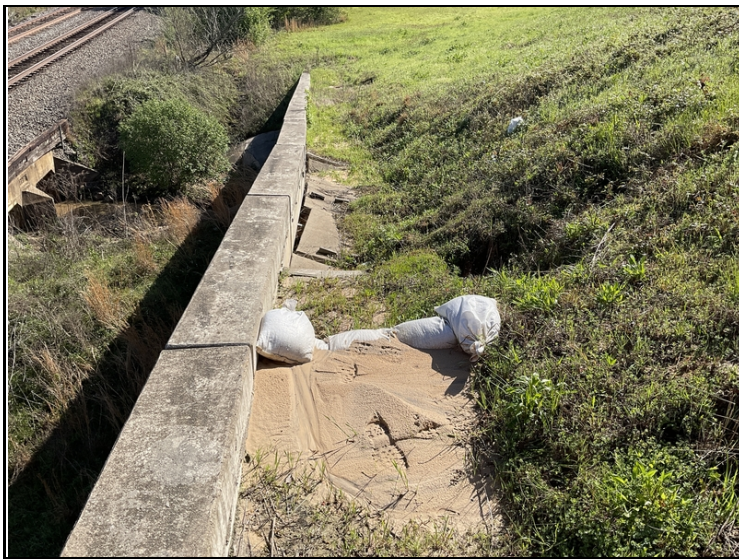
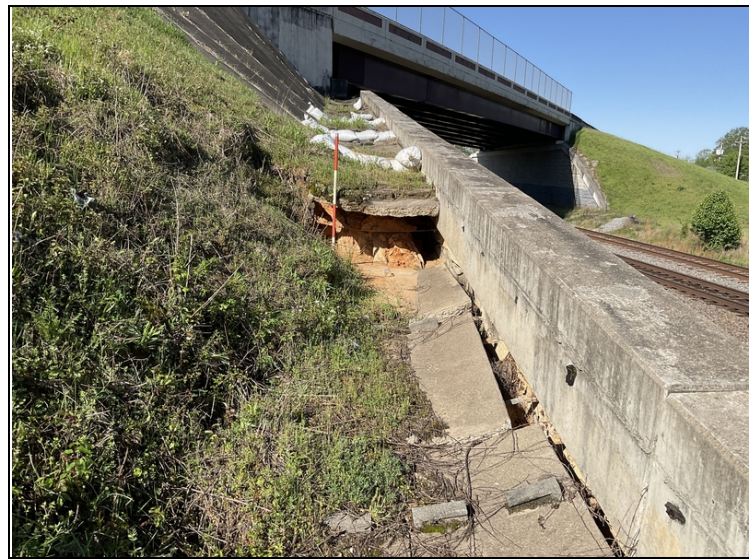
The ditch paving behind the MSE wall at Bent 2 on the left side has failed causing slope erosion and an MSE wall anchor strap is exposed.

4/14/2022 The erosion behind the MSE wall is progressing and exposing multiple anchor straps now.

The ditch paving behind the MSE wall at Bent 2 on the left side has failed causing slope erosion and multiple MSE wall anchor straps are exposed.

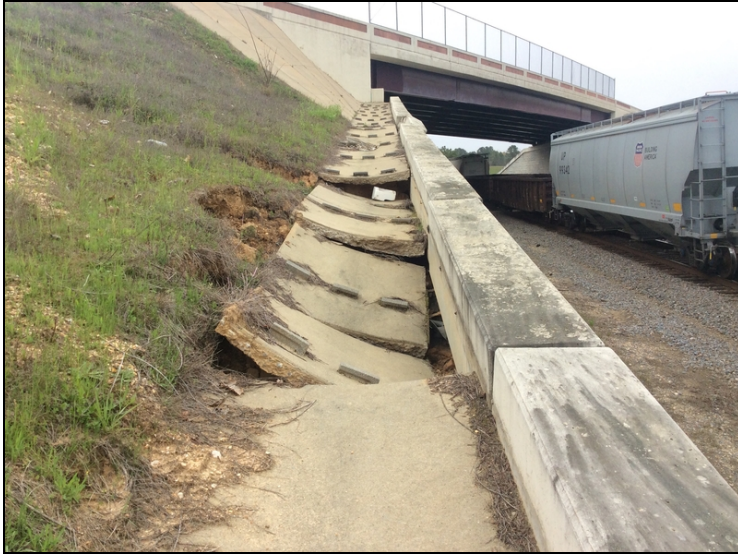
Added 4/2/2018 The ditch paving behind the MSE wall at Bent 1 on the right side has failed causing slope erosion and an MSE wall anchor strap is exposed.

Ditch paving next to MSE wall at the right side of bent one has been undermined and 20' has collapsed.

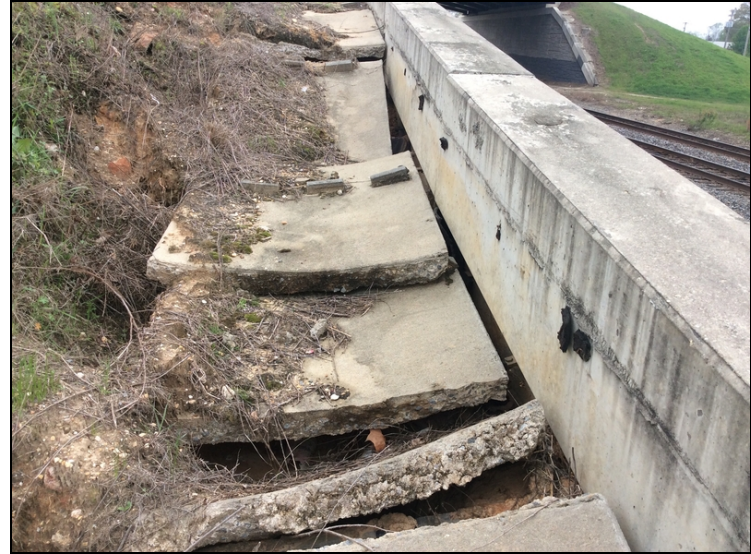
Ditch paving bent 2 left side.

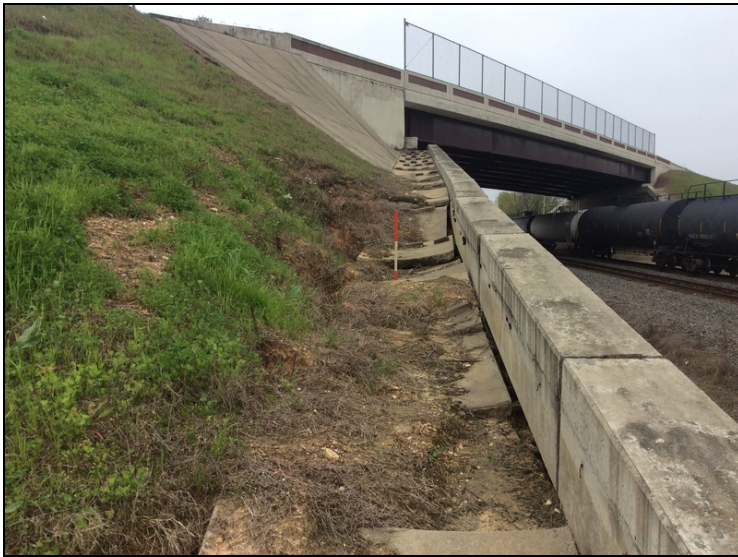
Ditch paving has failed at bent 2 left side. Approximately 35 ' has erosion and ditch paving has dropped 3'.

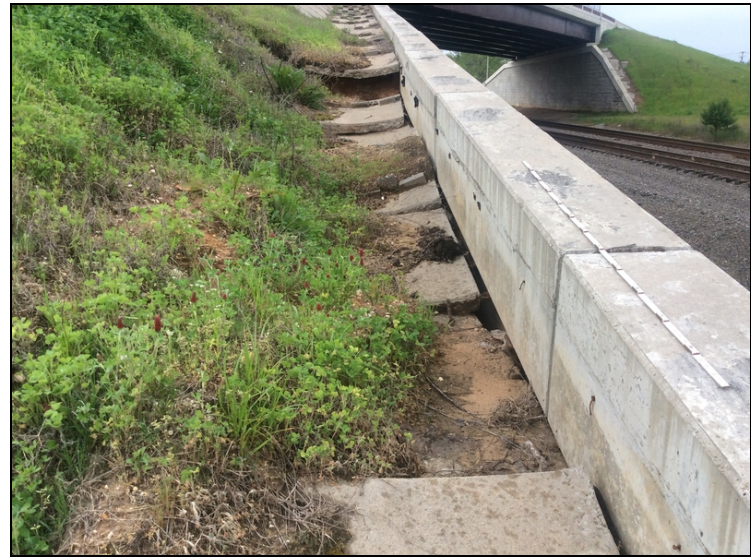
The ditch paving behind the MSE wall at Bent 2 on the left side has failed causing slope erosion and an MSE wall anchor strap is exposed. Photos attached.

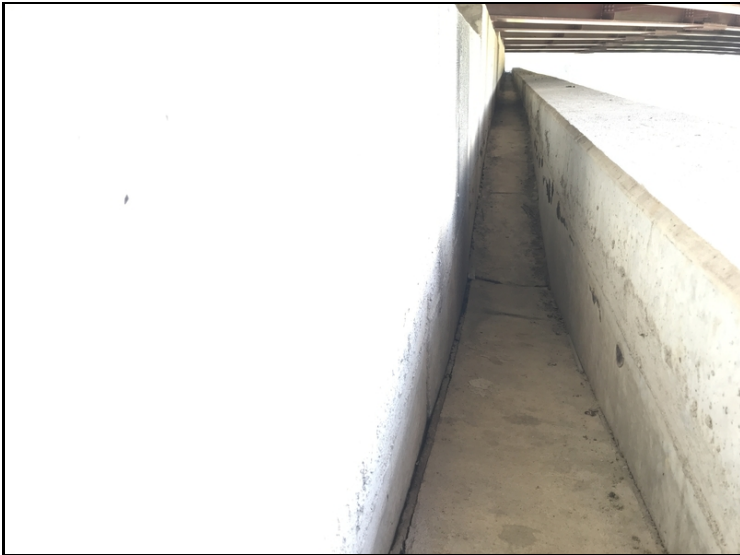
Bent 1 abutment between beams 7 & 8 the slope pavement between abutment and MSE wall has settled up to 14 inches.

Slope paving between MSE wall and abutment  
bent 1 has settled up to 14"

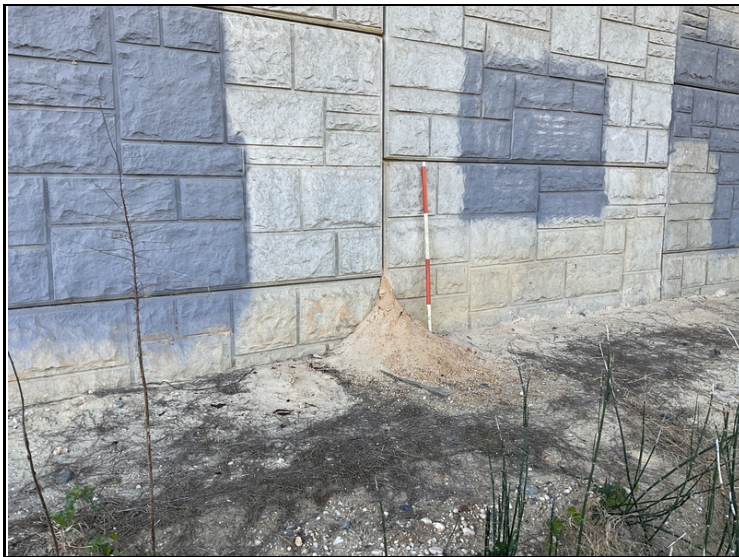
Abutment 2 is leaking dynafill at base of MSE wall.

Bent 2: backfill material is leaking through the joint of the MSE wall.  
Under girder 3

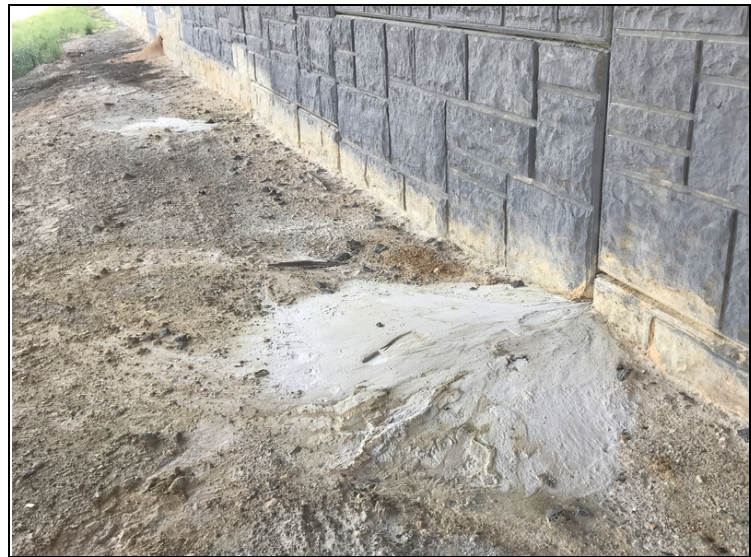
Abutment 2 is leaking dynafill at base of MSE wall.

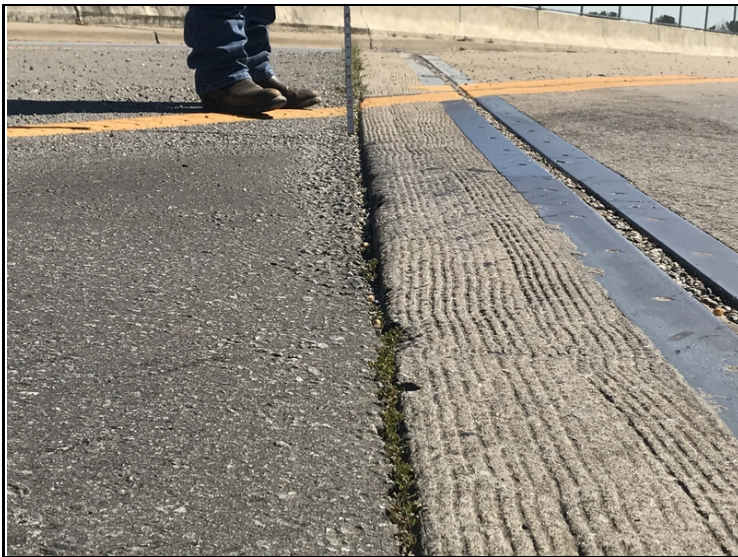
Southbound lane at north abutment, asphalt approach has settled.

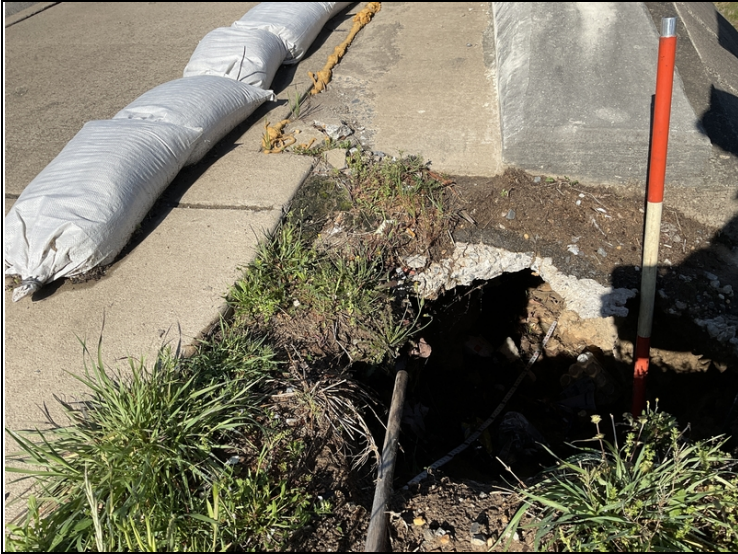
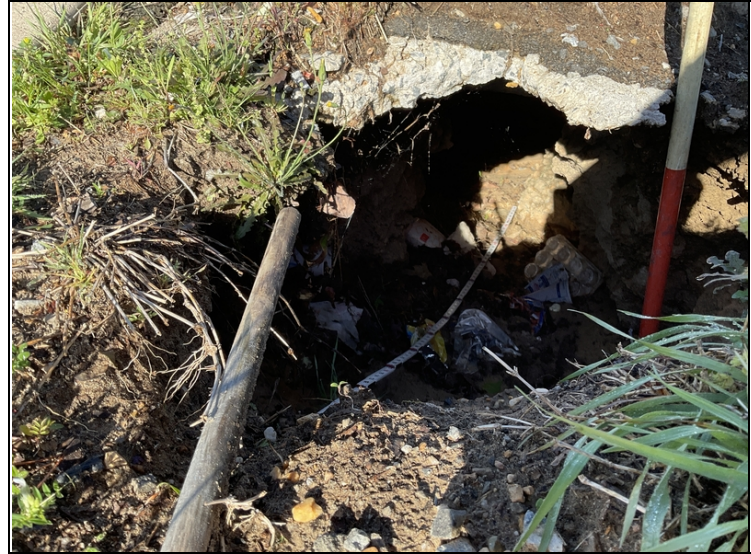
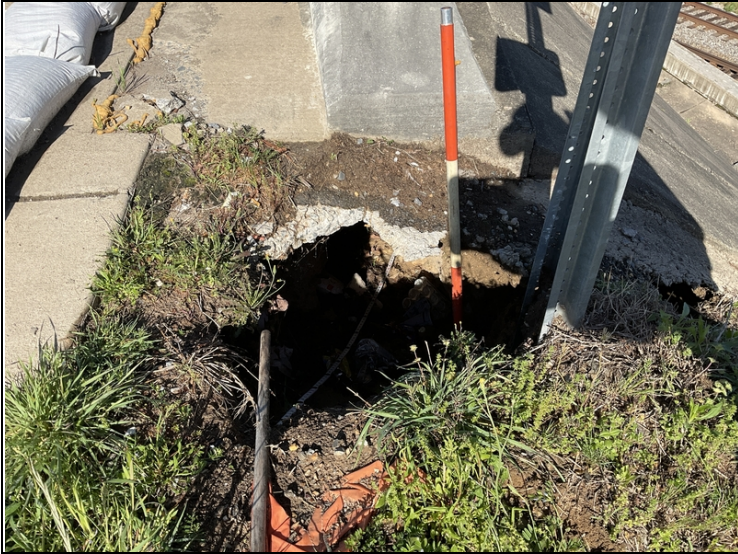
**Date Reported:** 04/15/2022  
**Priority:** A - Safety deficiency; requires prompt action  
**Type of Work:** Repair (General)  
**Status:** Open  
**Component:** Bridge

Bent 2, left side of the bridge a large void has been created at the end of the bridge railing near the side walk

Bent 2, left side of the bridge a large void has been created at the end of the bridge railing near the side walk.
