Asset #05872(Routine)

US 70 over LAKE HAMILTON

Location: 2 SW JCT SH 270

Team Lead: Shane Byrd, Inspection Date: 07/19/2021

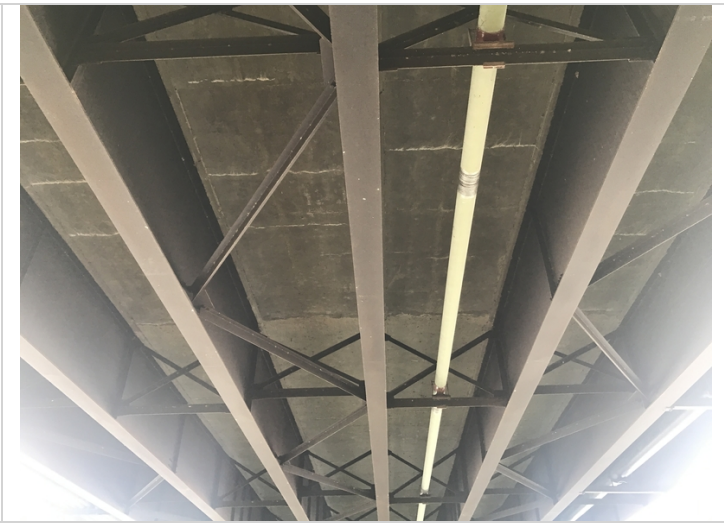
Span 2 soffit overview.

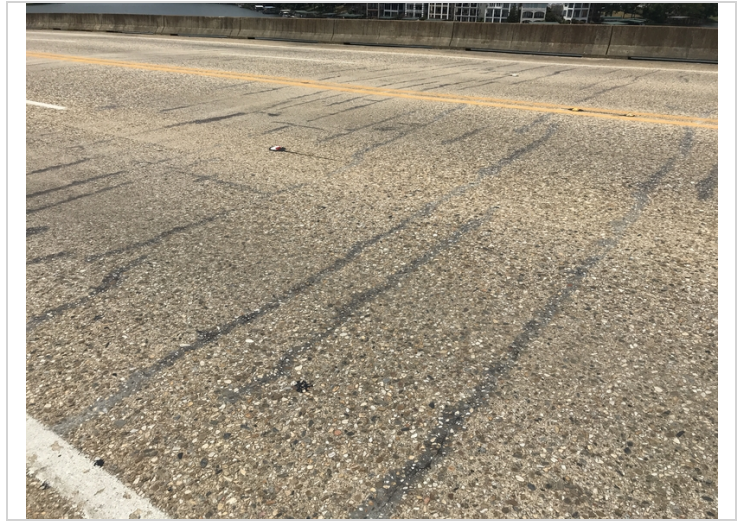
Deck has been diamond ground for smoothness

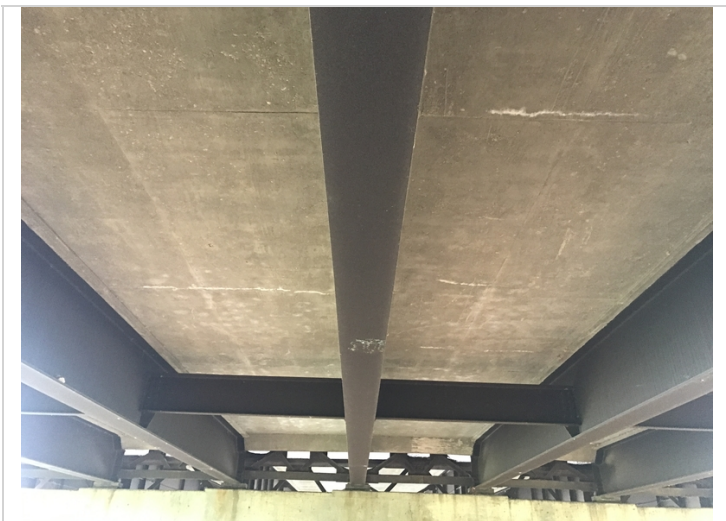
Span 1 soffit has cracks with efflorescence, common all spans.

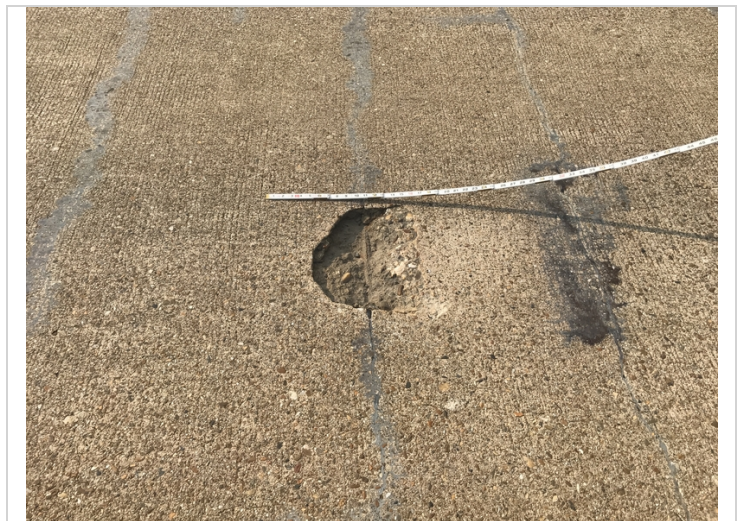
Deck span 5 spall with exposed rebar.

Spans 4 & 5 have spalls with exposed rebar.

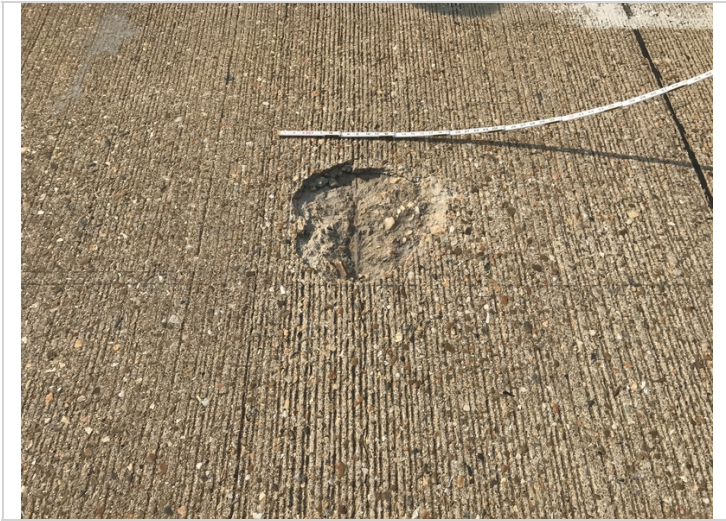
Deck spall with exposed rebar span 4.

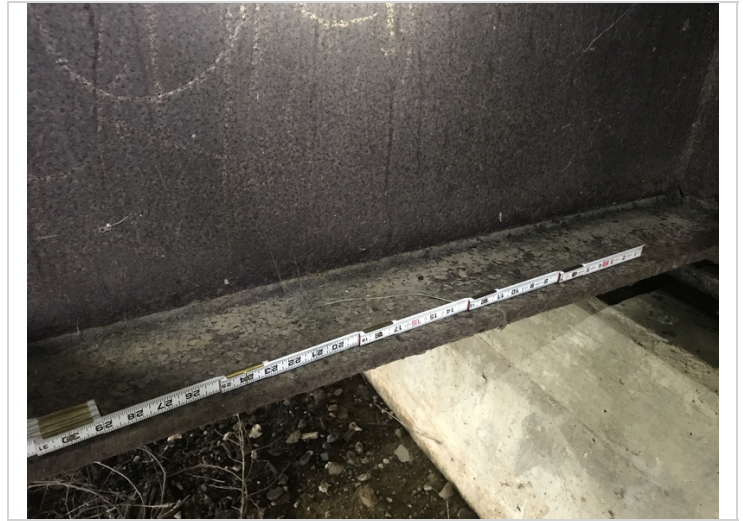
Span 9 beam 2 at bent 10 bottom flange and lower web have 3/8" diameter flakes, common girders 1,3,&4.

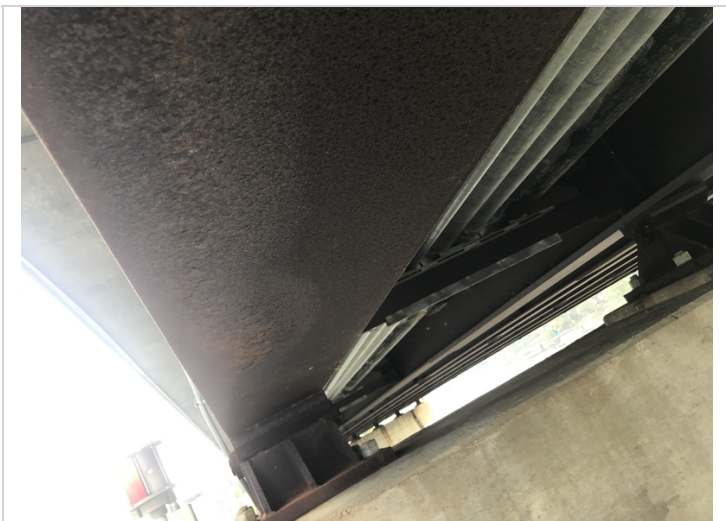
Span 5 girder 1 back of bent 6 bottom flange small flaking rust.

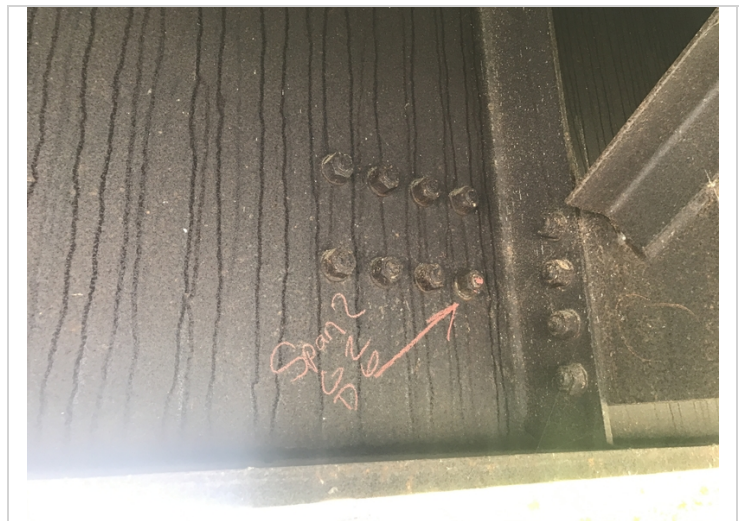
Span 2 girder 2 diaphragm 6 loose bolt.

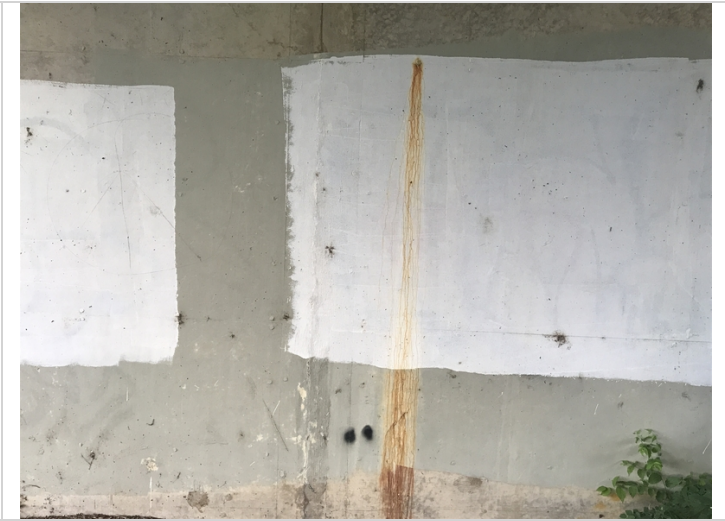
Bent 9 pier wall ahead has cracks with efflorescence and rust staining.

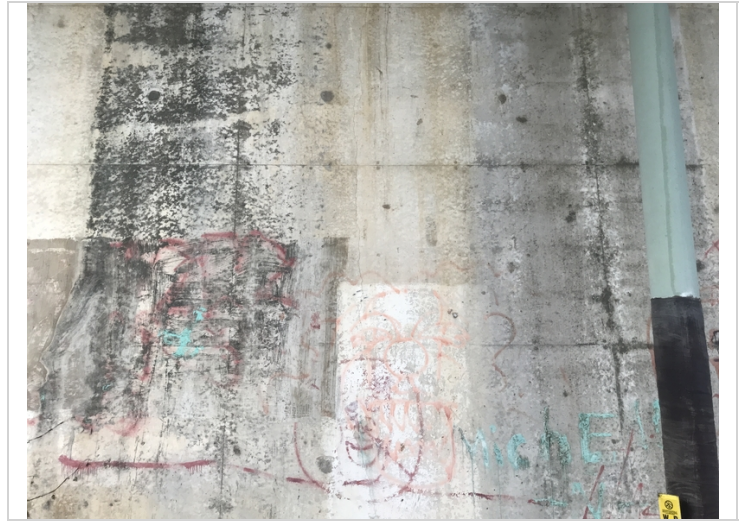
Bent 2 pier wall ahead has vertical cracks.

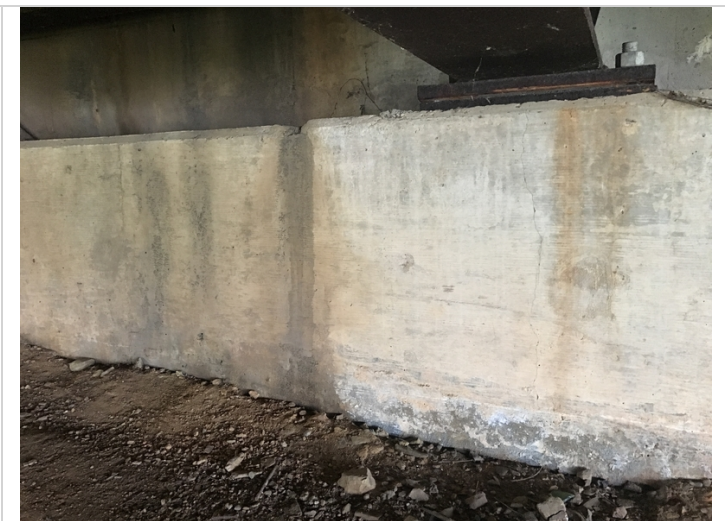
Bent 1 abutment has small scattered vertical cracks.

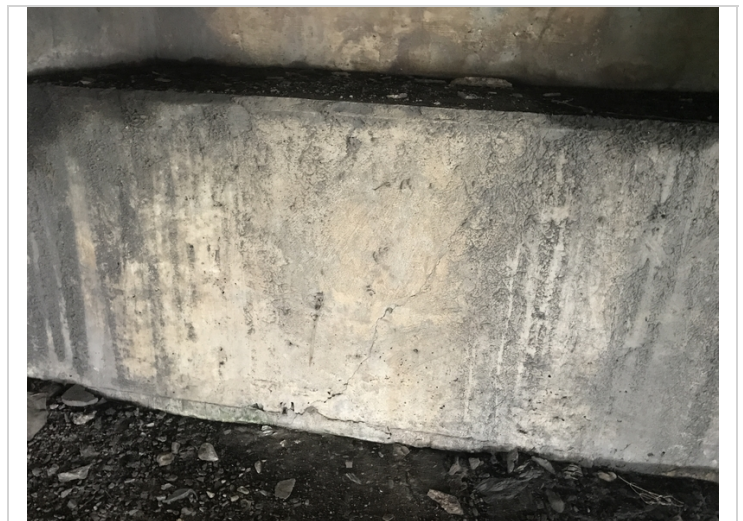
Vertical cracks in beam seat at abutment 2.

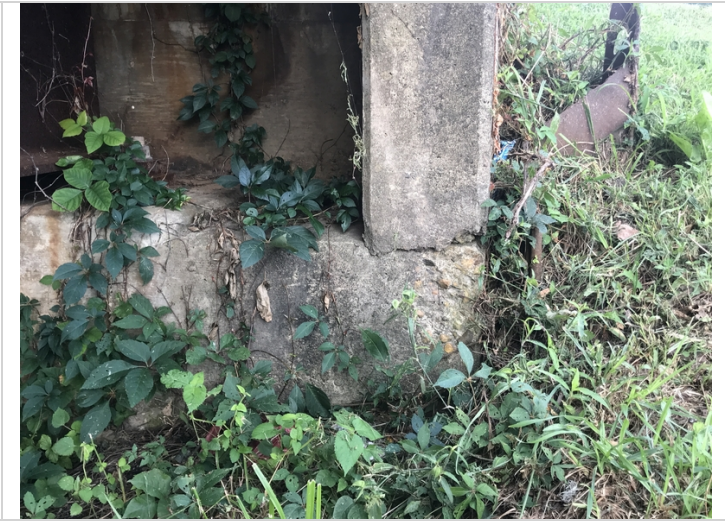
Left side bent 1 abutment has spall.

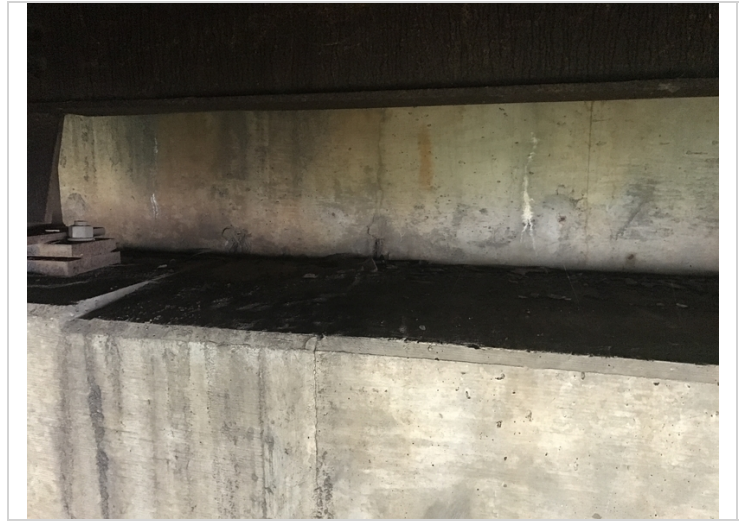
Bent 1 has scattered cracks with efflorescence in back wall.

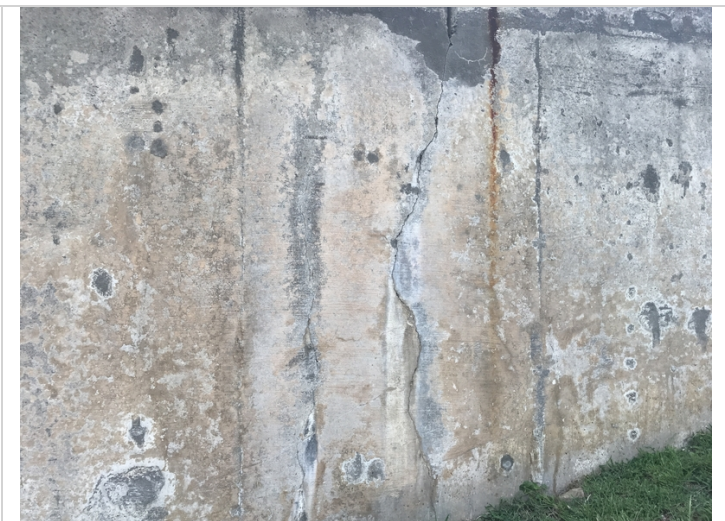
Vertical open cracks with efflorescence right wing wall at abutment 2.

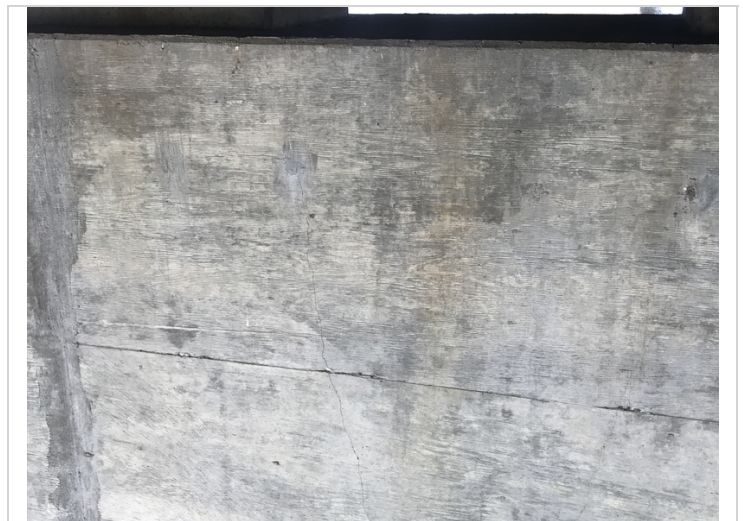
Bent 8 cap ahead vertical crack.

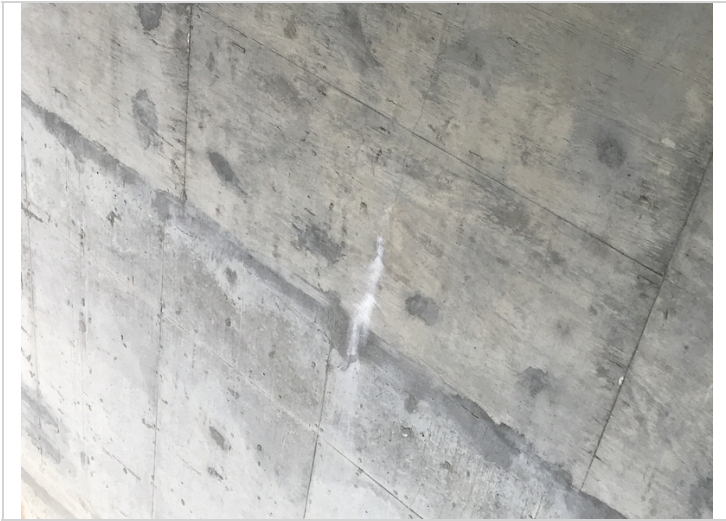
Bent 7 ahead pier cap has vertical crack with efflorescence.

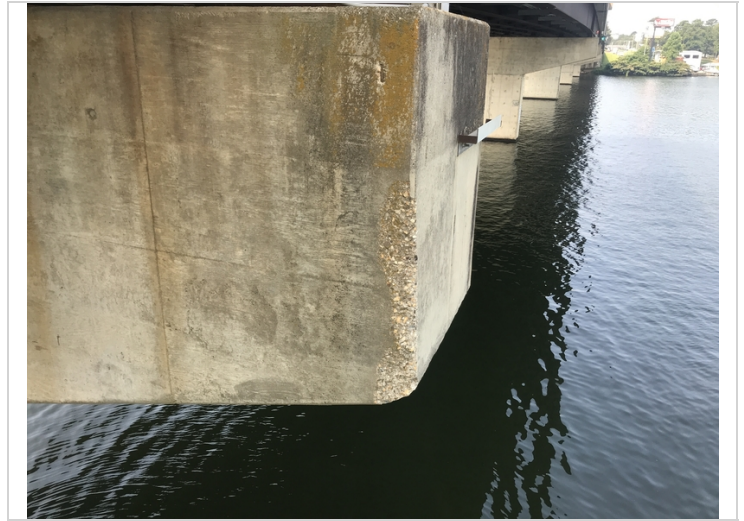
Bent 7 ahead left side pier cap has spall.

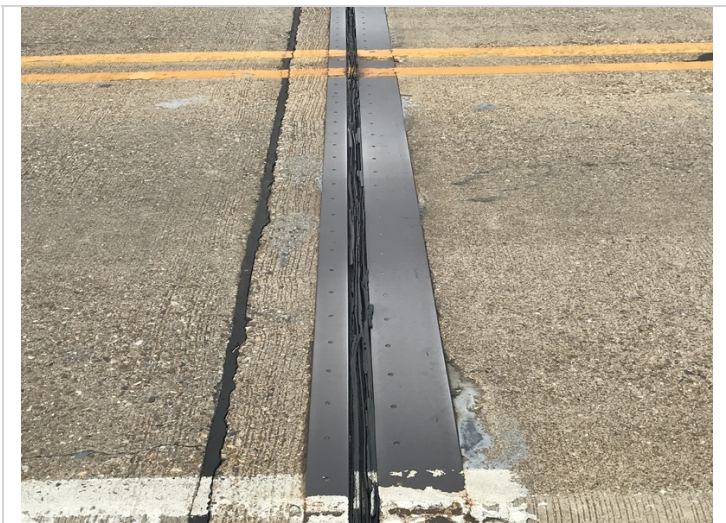
Joint seal at bent 10 are torn and split.

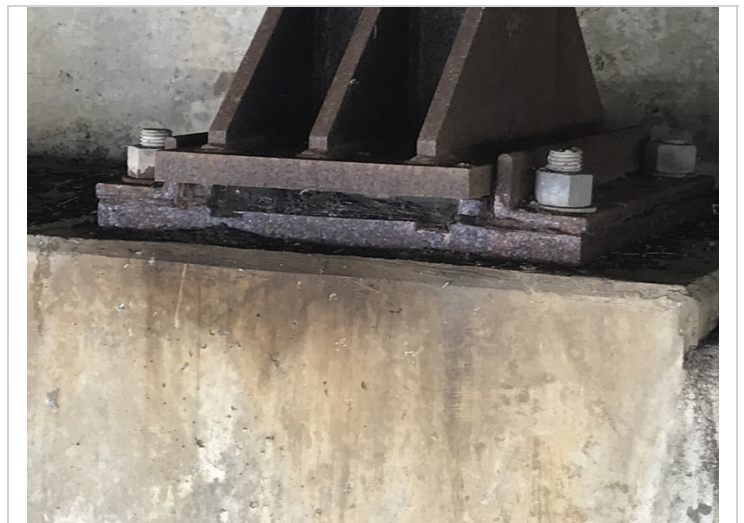
Bent 2 span 2 bearing 4 has pack rust forming between the bolted connections. Common bearing 2,3,5,6 & 7.

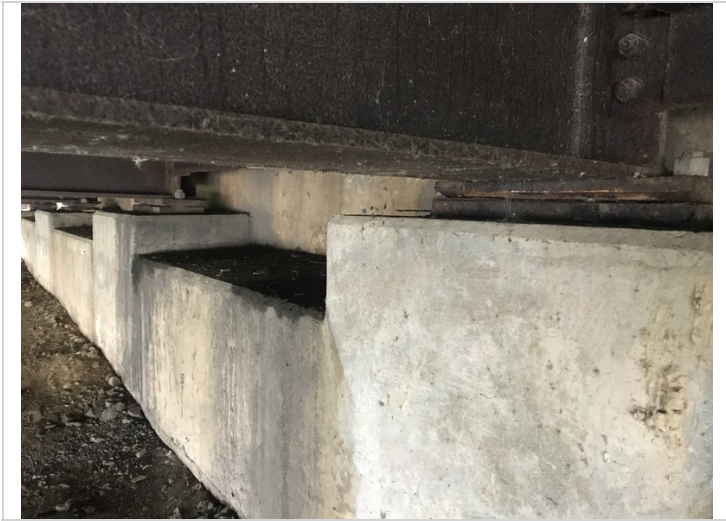
Bearings at abutment 2 have corrosion with laminating rust, common abutment 1.

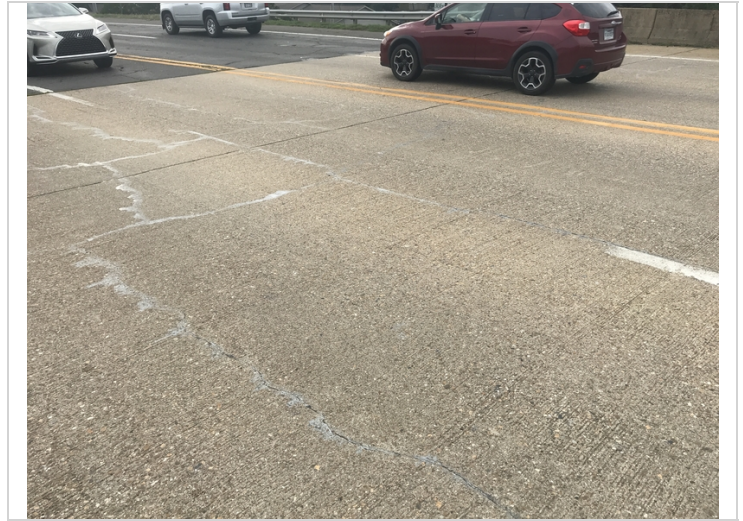
East approach slab sealed cracks.

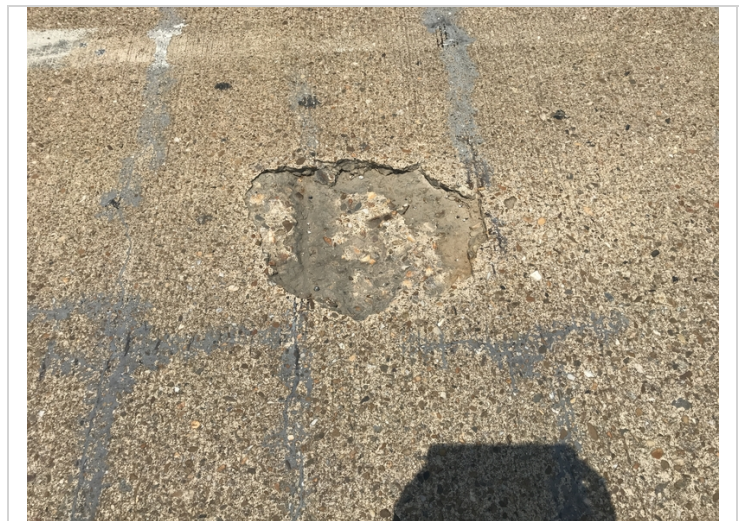
Span 5 spall with exposed rebar.

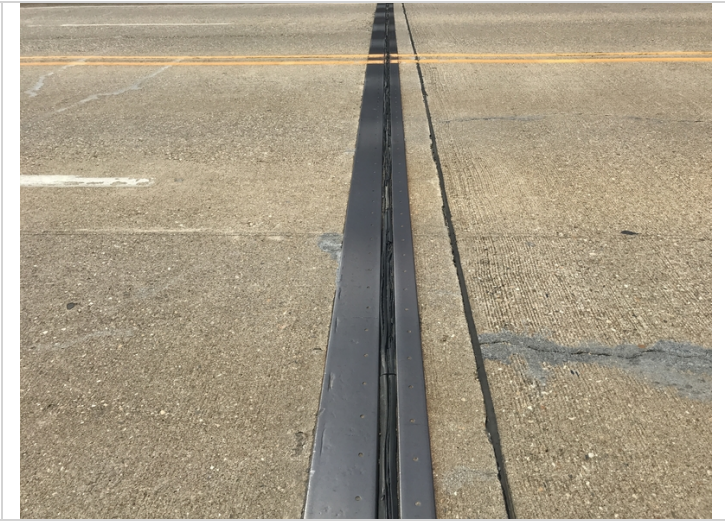
Joint seal at bent 1 are torn and split.

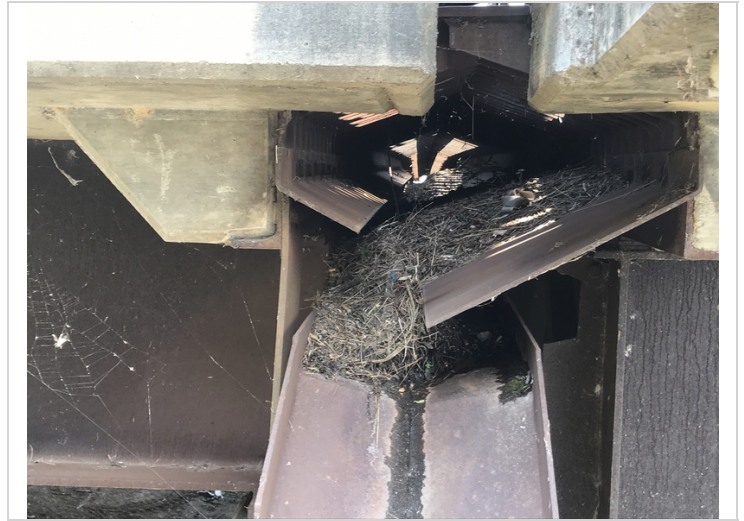
Bent 2 finger joint has debris impaction.

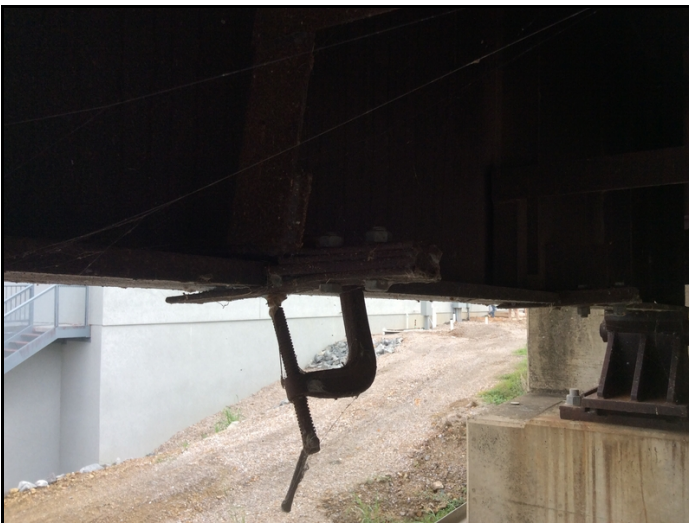
Pier 8, Back, Between G1-G2: Angle iron water line brace between girders is loose. The only support is a U bolt attaching it to the water line.

Pier 8, Back, Between G1-G2: Utility cable is separated.

Utility company has installed c-clamps on waterline bracket.

Turned over to utilities 8-8-16

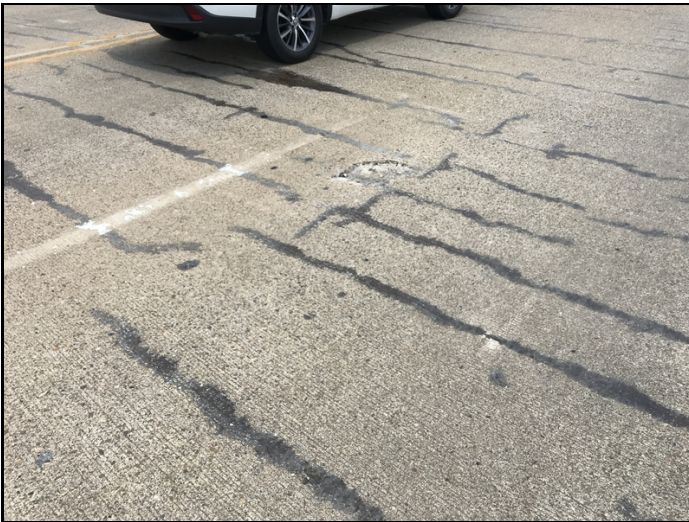
Large pothole at the east end of the bridge at the approach slab.  
Two potholes in east and westbound lanes in span 4

Spall in right lane and 1 in left lane mid span

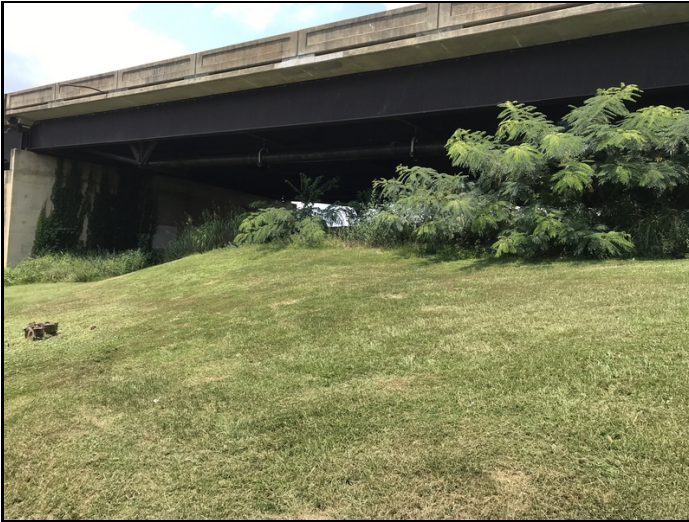
vines and trees growing on pier walls at bents 1, 2, 9 and 10

vines and trees growing at both abutments

Assigned Garland 06261 10/8/19

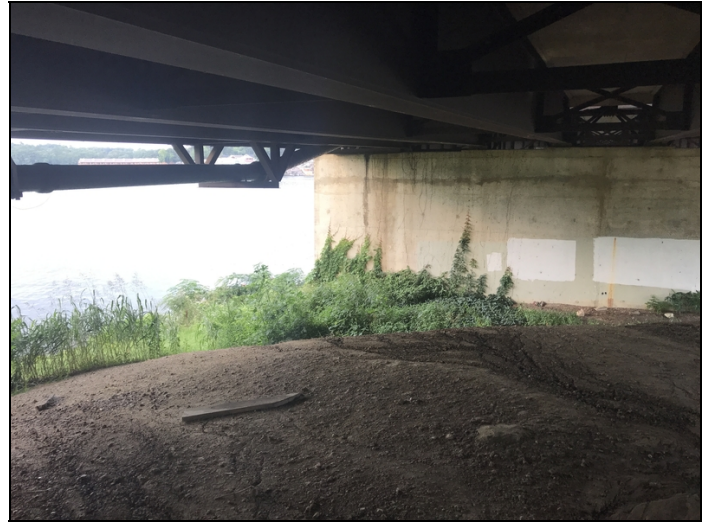
Bent 9 pier wall has vines growing on pier wall.

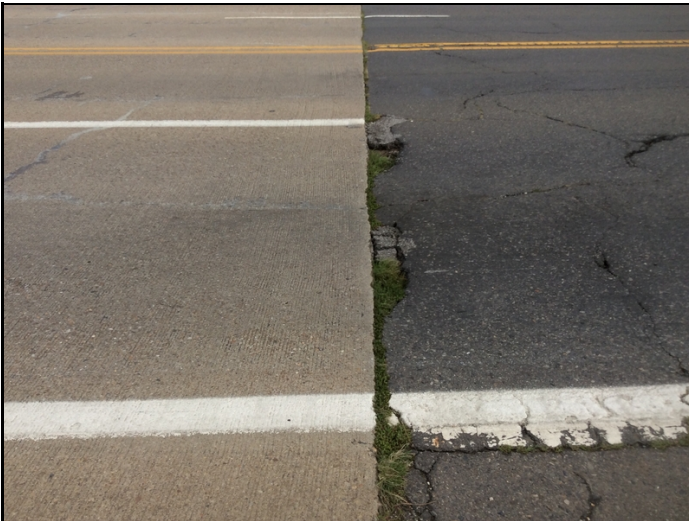
Approach slabs at both ends of the bridge have potholes in the asphalt at the beginning of the approach slabs.

Potholes in asphalt at ends of approach slabs.

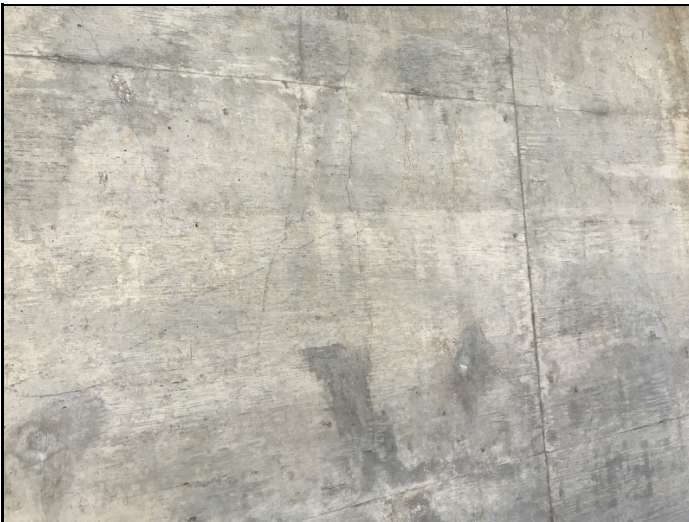
Vertical hairline cracks in all caps.

Cracks in cap at bent 7

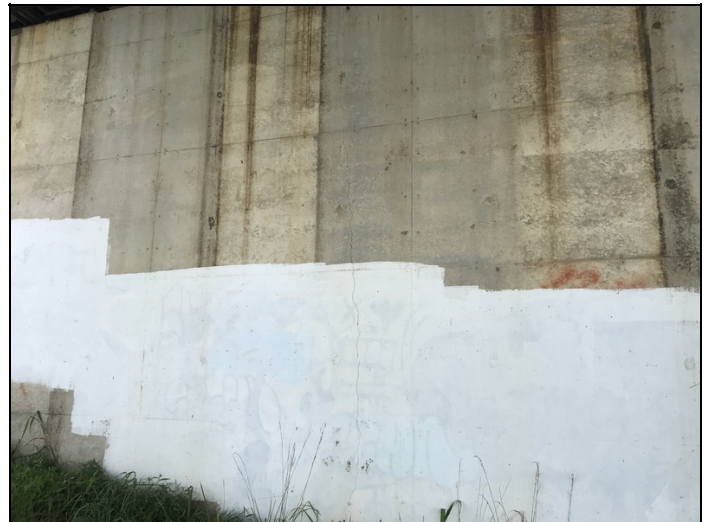
Large vertical cracks in pier walls

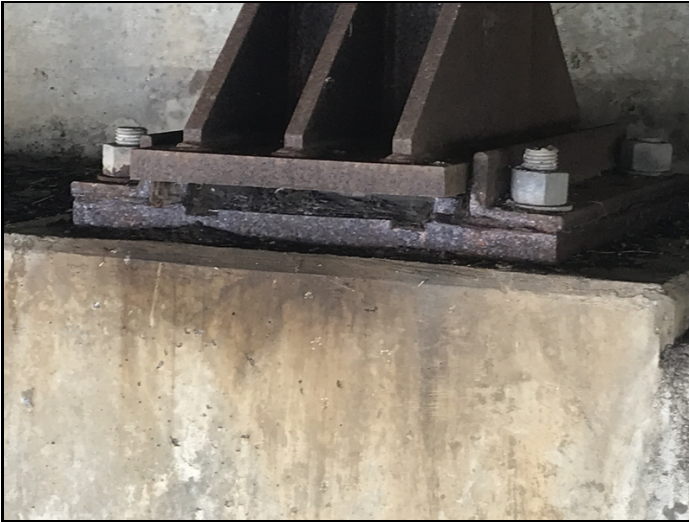
Bent 2 span 2 bearing 4 has pack rust forming between the bolted connections. Common bearing 2,3,5,6 & 7.

**Type of Work:** Repair (General)

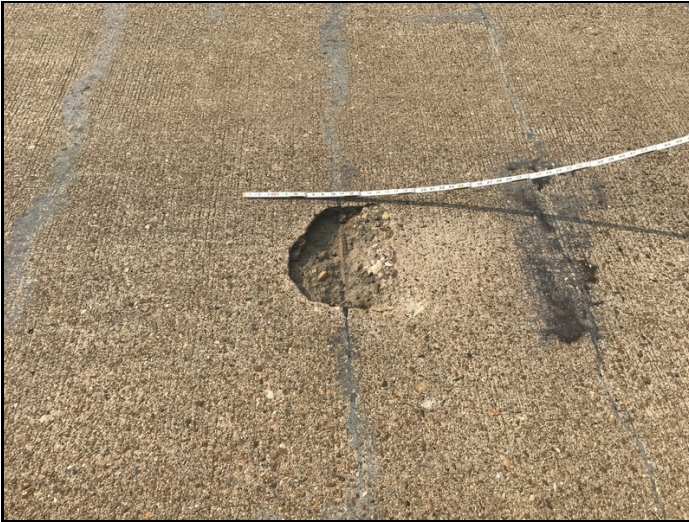
Deck span 5 spall with exposed rebar.

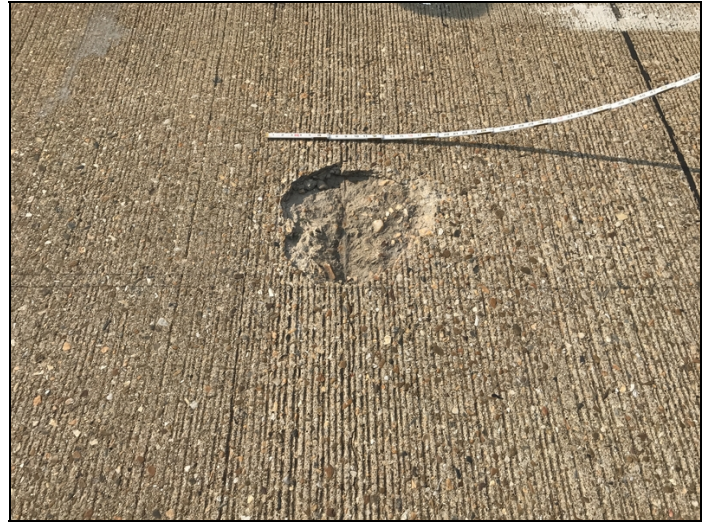
Deck spall with exposed rebar. Liver bent 4.
