**Asset #06025**(Routine, Underwater type 2)  
**US 270-7 Log 4.63 over STONE QUARRY CREEK**

**Location: 2.6 MI W JCT US270&51**

**Team Lead: Chris Doggett, Inspection Date: 12/06/2022**

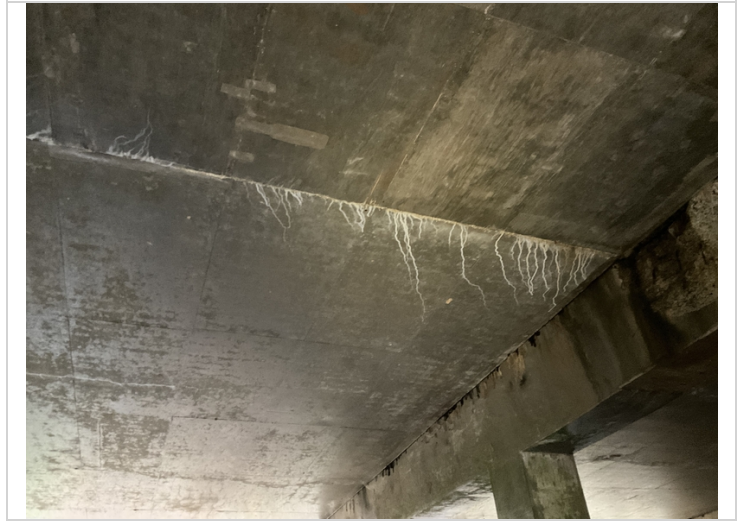
Span 2: soffit has longitudinal cracks with efflorescence staining at centerline.

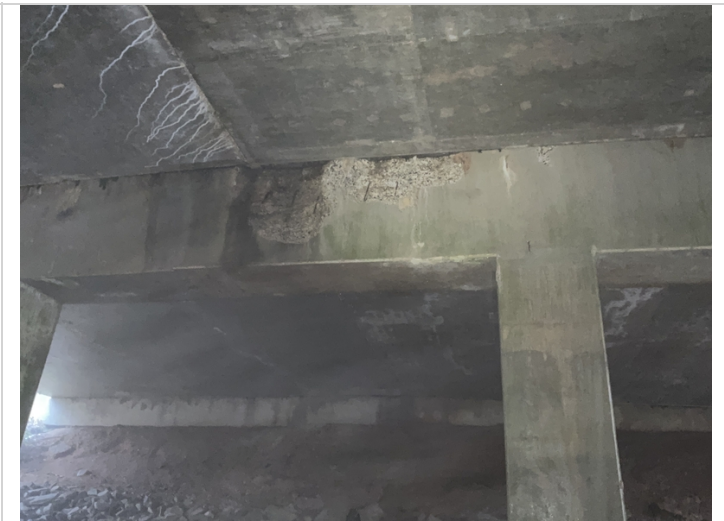
(234) Bent 2 ahead side, large spall with exposed rebar, cracks and cracks with efflorescence, small spall. Bent 3 has spalls with exposed rebar on the bottom at centerline and on the ahead face above column 4, cracks with efflorescence, small spall.

Ahead bent 2: cap has large spall with exposed rebar.

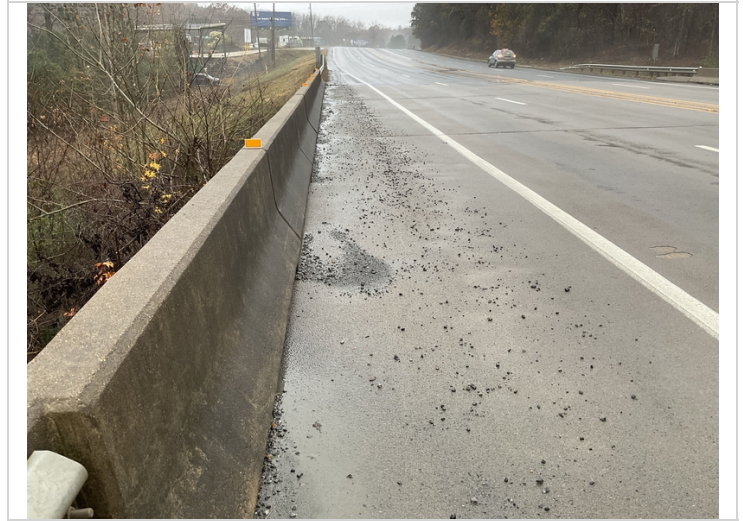
Both gutter lines are full of gravel

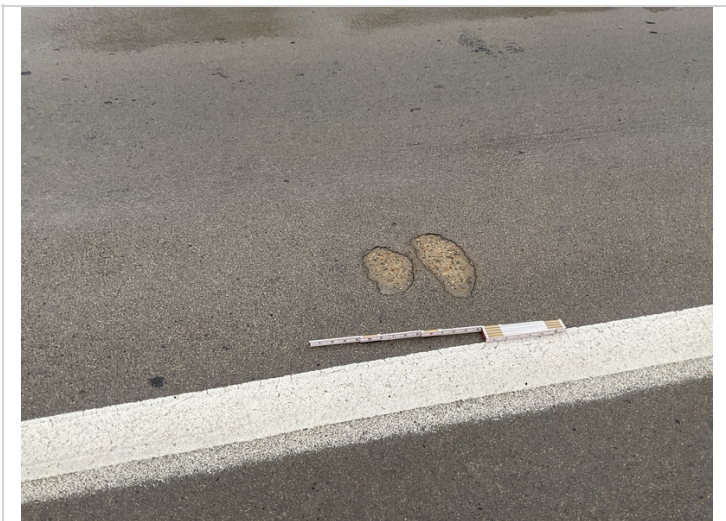
ELEMENTS	DESCRIPTION	UNITS	TOTAL	CS1	CS2	CS3	CS4
38	RC Slab	SF	7455	7286	169	0	0
1080	Delamination/Spall/Patched Area	SF	14	0	14	0	0
1090	Exposed Rebar	SF	3	0	3	0	0
1120	Efflorescence/Rust Staining	SF	152	0	152	0	0
510	Wearing Surfaces	SF	7130	7128	2	0	0
3210	Delam/Spall/Patched Area/Pothole	SF	2	0	2	0	0
(38) Span 1, spall with exposed rebar in soffit. Soffit all spans have cracks with efflorescence. Polymer overlay has been applied to deck under job# 012350							
(510-38) Span 3: the far right lane has couple of small areas where the polymer overlay has peeled away from the deck surface

Span 3: the far right lane has couple of small areas where the polymer overlay has peeled away from the deck surface

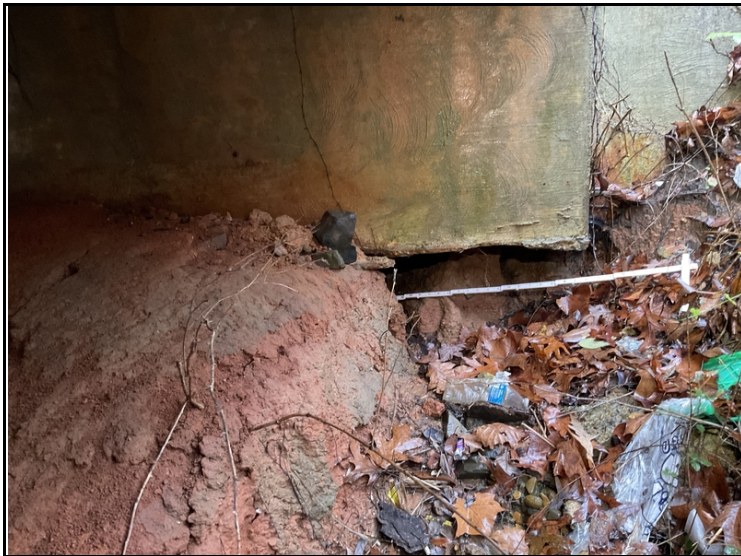
(215) Both abutments have had erosion undermine the ends, but at bent one both ends have pile exposed. Bent 4 has a crack.							
225	Steel Pile	EA	2	1	1	0	0
1000	Corrosion	EA	1	0	1	0	0

(225) Bent 1 both left and right side, pile exposed due to erosion under cap. Pile 1 has laminating rust.							
234	Reinforced Concrete Pier Cap	LF	142	125	10	7	0
1080	Delamination/Spall/Patched Area	LF	9	0	2	7	0
1090	Exposed Rebar	LF	3	0	3	0	0
1120	Efflorescence/Rust Staining	LF	3	0	3	0	0
1130	Cracking (RC and Other)	LF	2	0	2	0	0

Bent 1: left end erosion has washed material out from under abutment exposing a steel pile. 2022

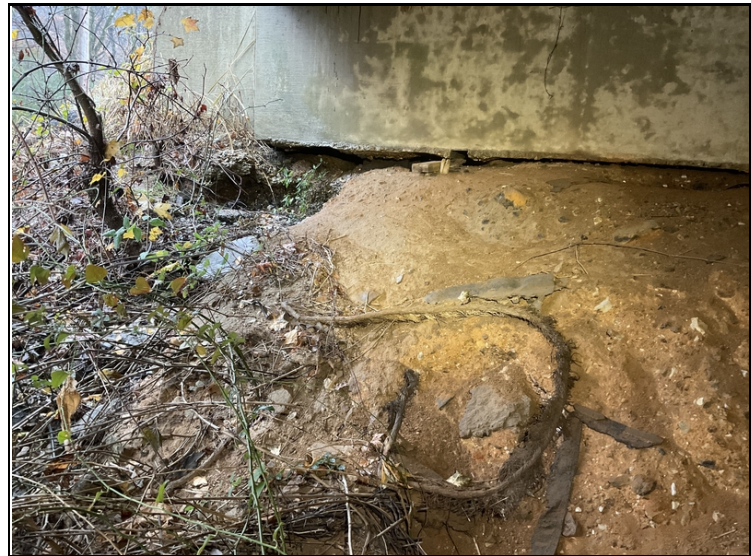
Bent 1: right end of abutment erosion has exposed pile under this bent. 2022

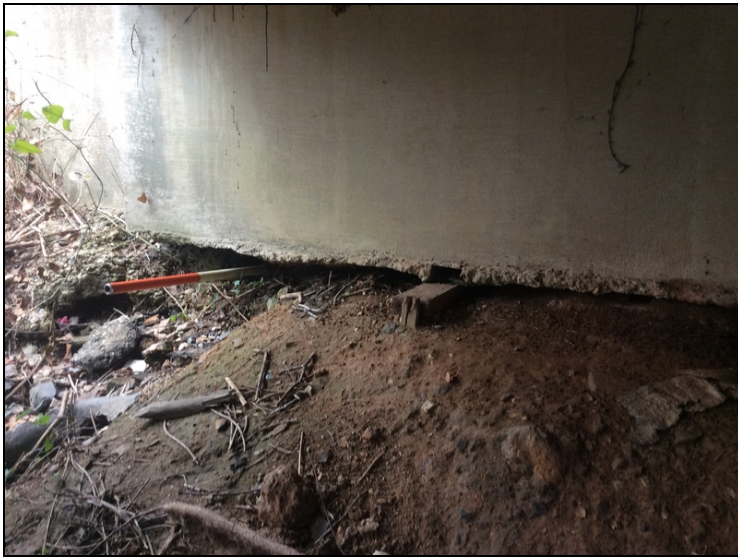
Bent 1 erosion has undermined both ends of bent. Added: 12/12/2018-KRM & RLS- The exterior pile of bent 1 are exposed due erosion.

Bent 1 right side undermined due to erosion.

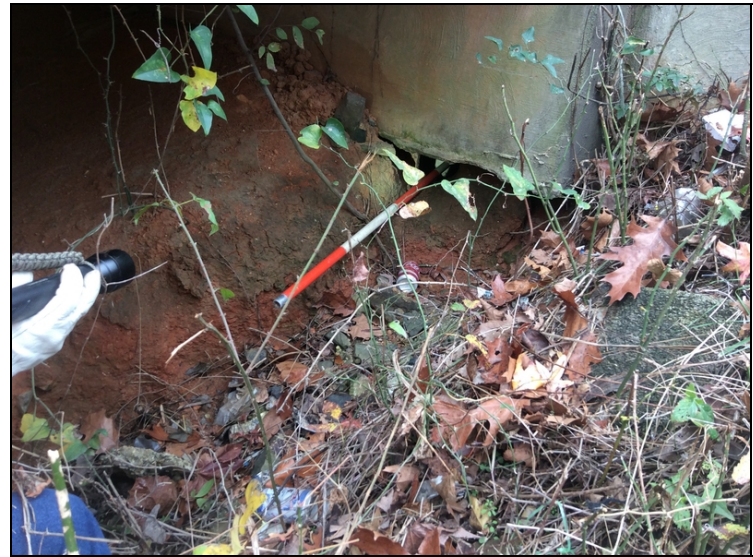
Bent 1 erosion has undermined the left end of bent.

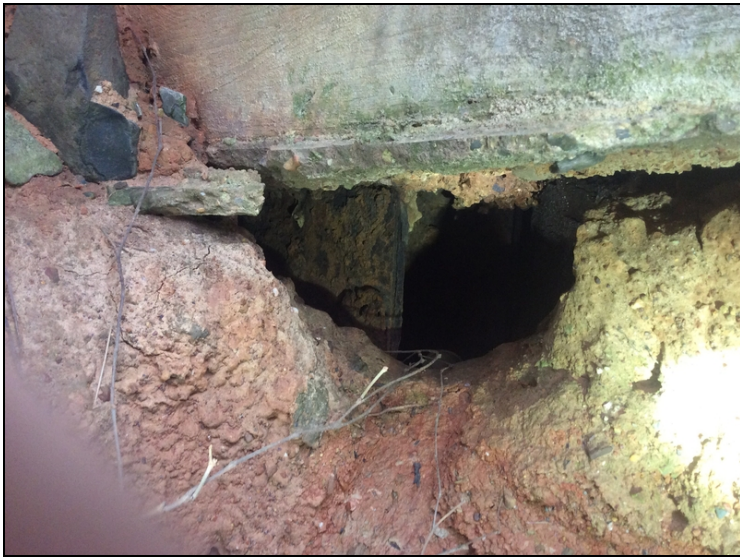
Bent 1, laminating rust on pile exposed due to erosion on the left side.

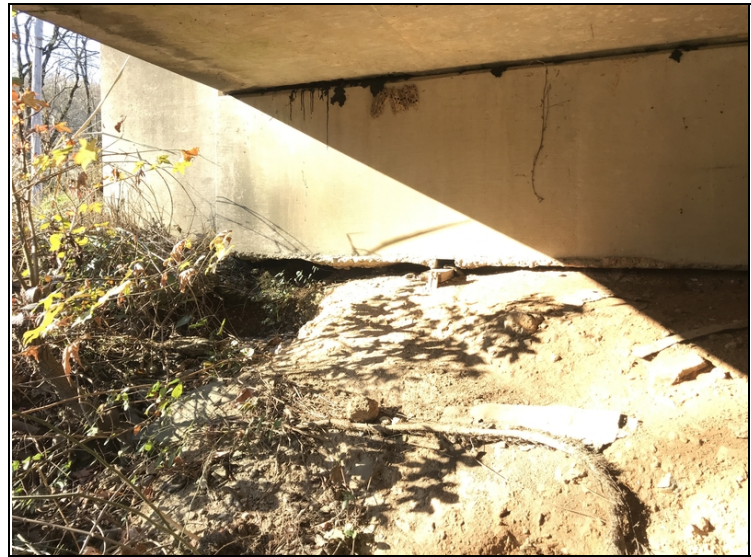
Bent 1 abutment right side undermined due to erosion.

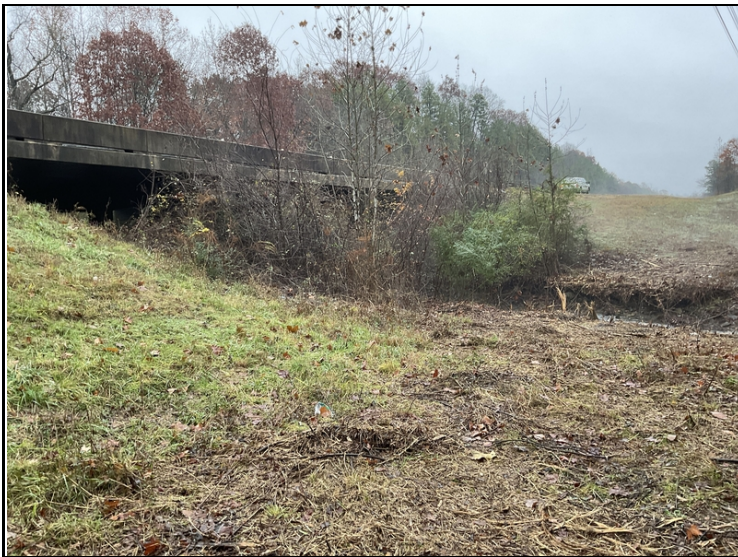
Heavy growth of vegetation at both sides of bridge.
