Asset #M2413(Routine, Underwater type 2)
SH 227 Log 6.04 over HALLMAN CREEK RELIEF
Location: 1.4 MI S US 270

Team Lead: Chris Doggett Inspection Date: 08/16/2023

Asset #M2413(Routine, Underwater type 2)
SH 227 Log 6.04 over HALLMAN CREEK RELIEF

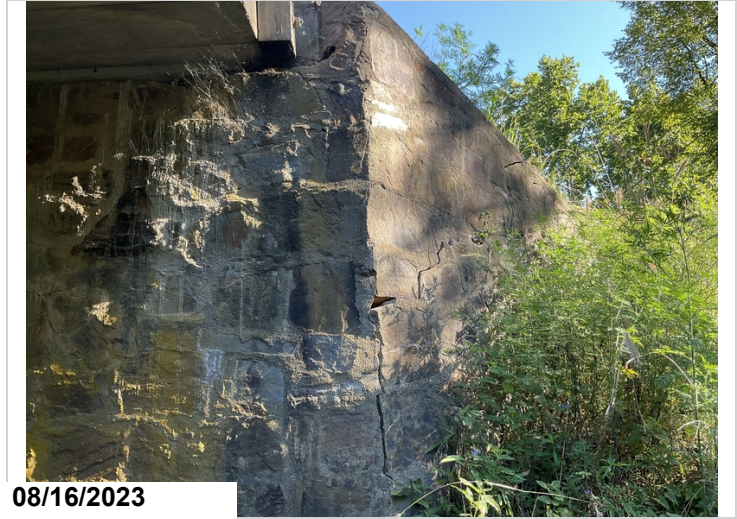
Bent 4: right wing wall is cracked.

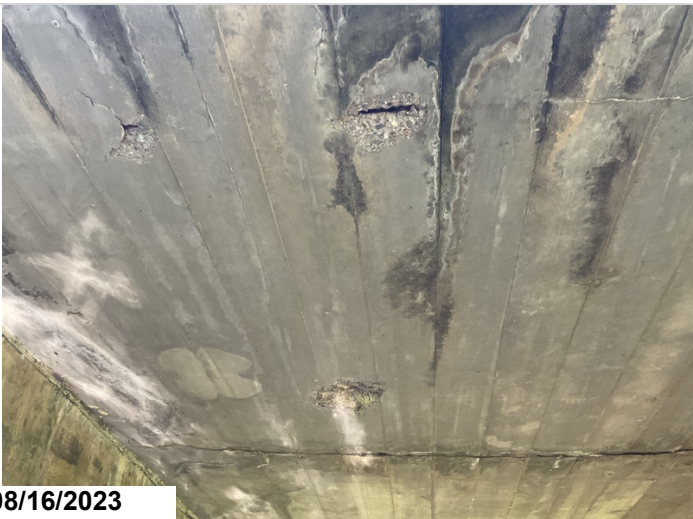
Span 3 multiple spalls to the soffit

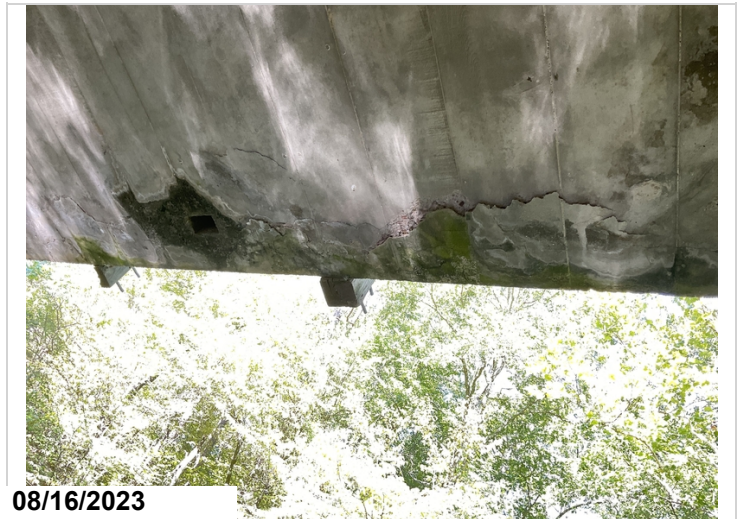
Span 2: left edge of slab has 9' delam.

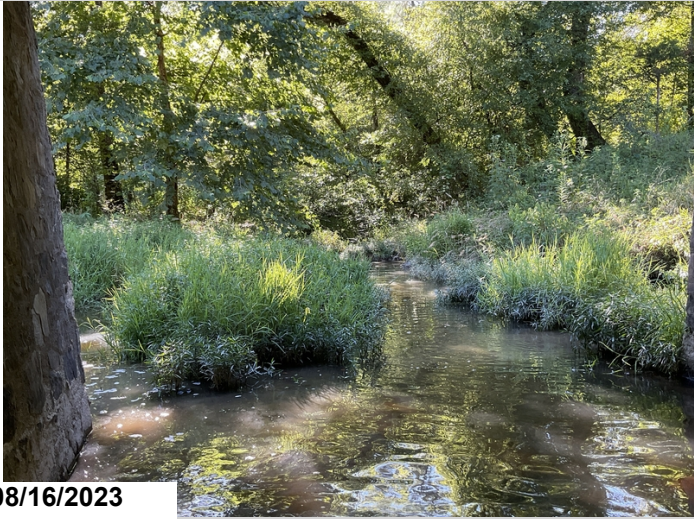
Channel looking down stream

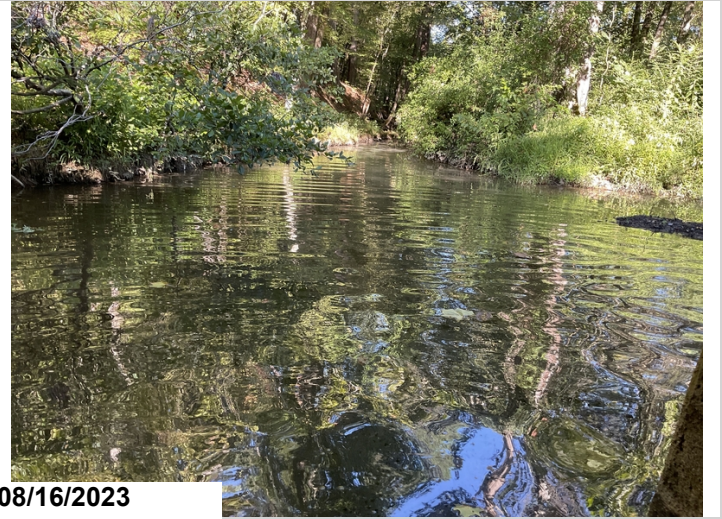
Channel looking upstream

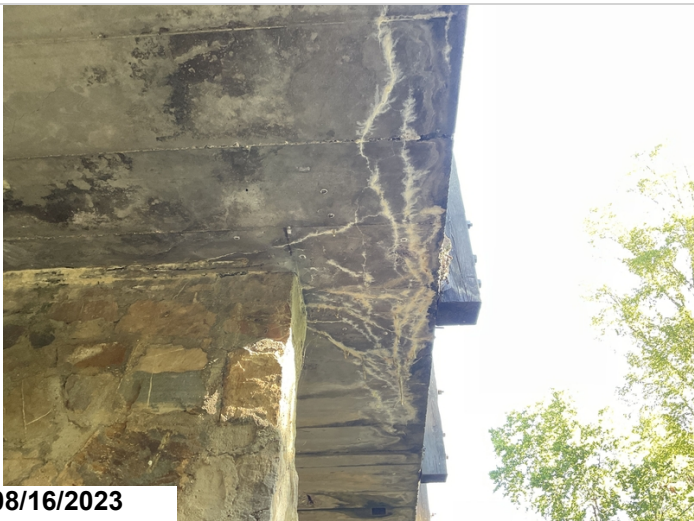
58 - Deck (5 - FAIR CONDITION - all primary structural elements are sound but may have minor section loss, cracking, spalling or scour.)
Deck with an asphalt overlay. The soffit with multiple cracks and cracks with efflorescence staining.

Spans 2&3: right side of slab is cracked with efflorescence staining

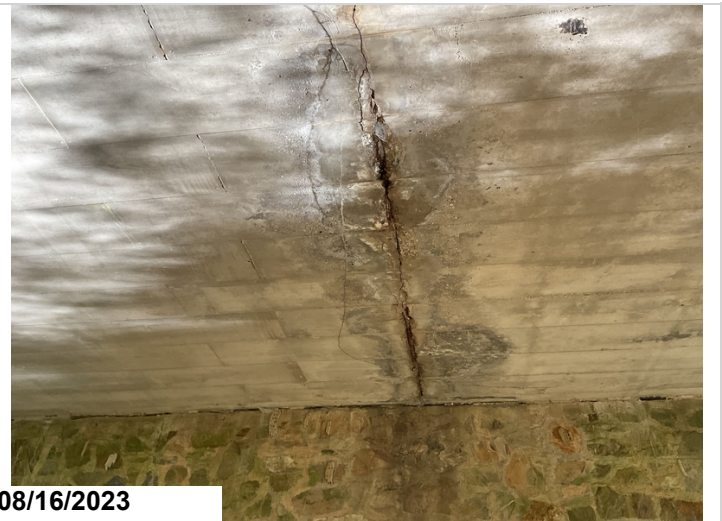
Span 1: large crack at center line.

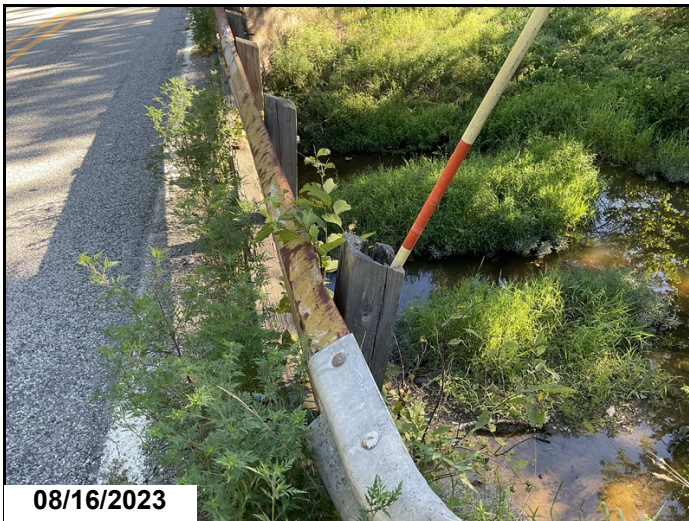
Wooden bridge rail posts are rotten and hollowing.

First post is rotten

Type of Work: Repair (General)

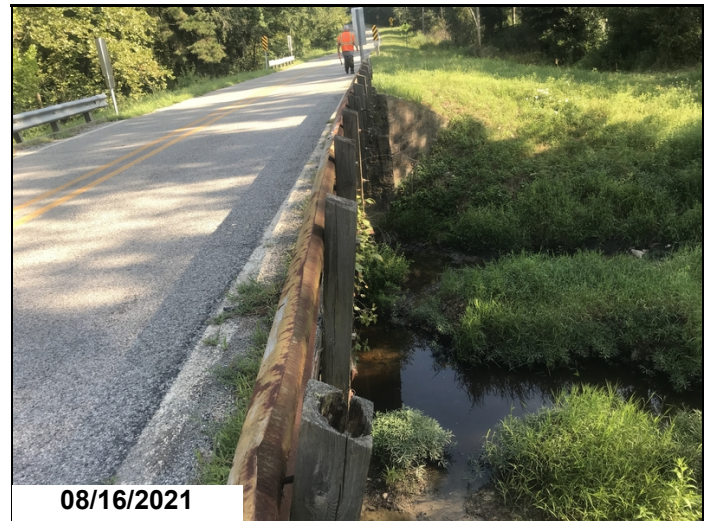
Wooden bridge rail posts are rotten and hollowing.

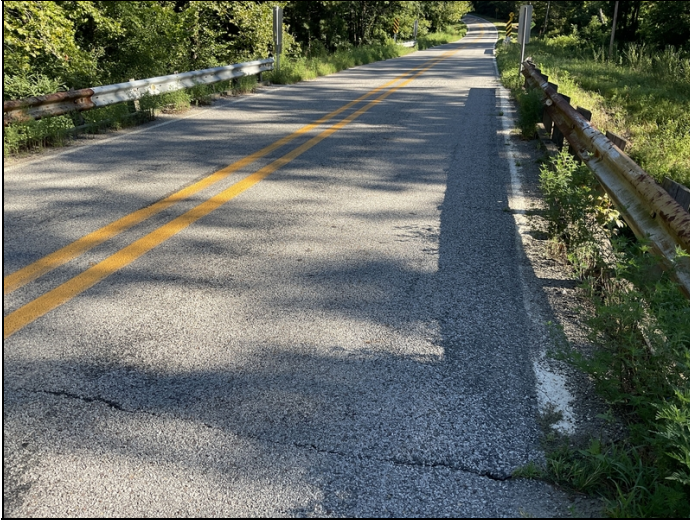
Deck view

A-55 - Deck Washing Needed (Yes)
