Asset #M2414(Routine, Underwater type 2)

SH 227 Log 6.06 over HALLMAN CREEK

Location: 1.4 MI S OF US 270

Team Lead: Chris Doggett Inspection Date: 08/16/2023

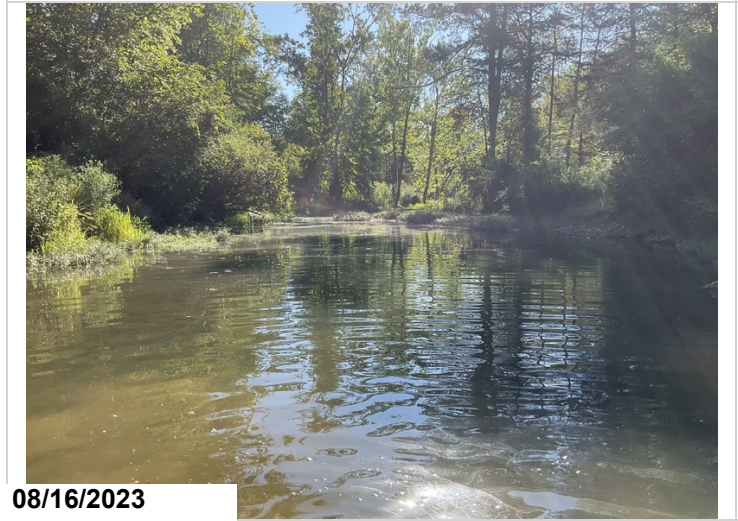
Channel looking down stream

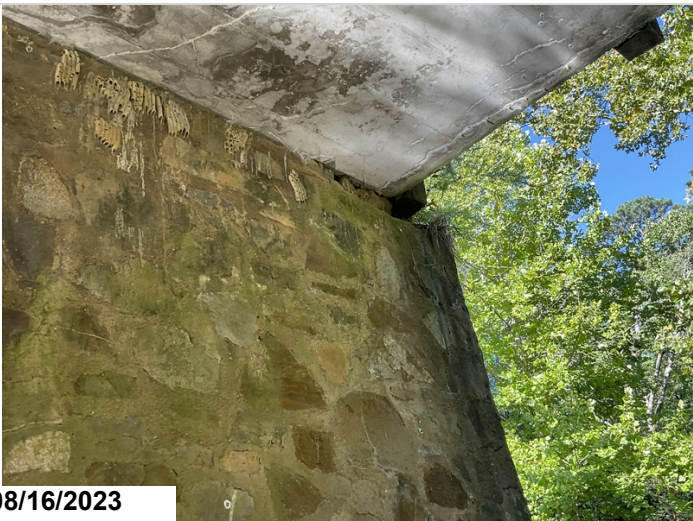
(213) Footing is exposed down to solid rock formation.							
217	Masonry Abutment	LF	88	50	36	2	0
1610	Mortar Breakdown (Masonry)	LF	30	0	30	0	0
1620	Split/Spall (Masonry)	LF	8	0	6	2	0

Bent 1: left side at the slab is missing some stone

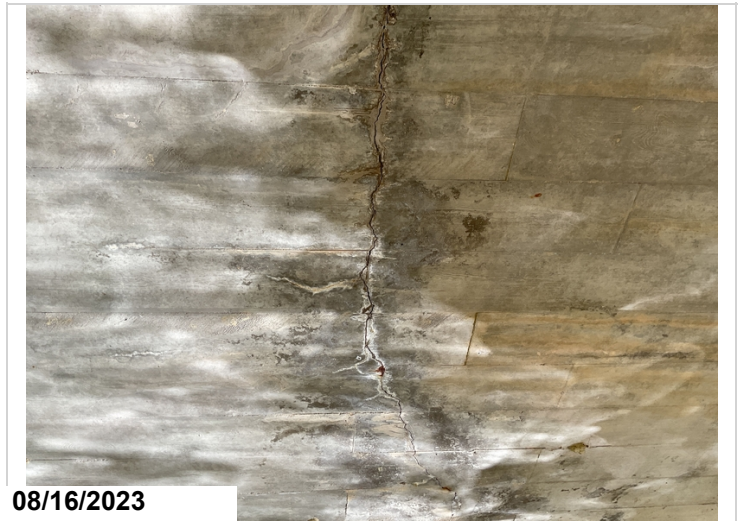
(38) One exposed rebar in span 1. Edges of the slab are deteriorating & have spalls. Scattered cracks on the soffit in both spans. With 1 large crack in the center the whole length							
213	Masonry Pier Wall	LF	19	0	19	0	0
1610	Mortar Breakdown (Masonry)	LF	19	0	19	0	0

Span 1: soffit with a large longitudinal crack down the centerline.

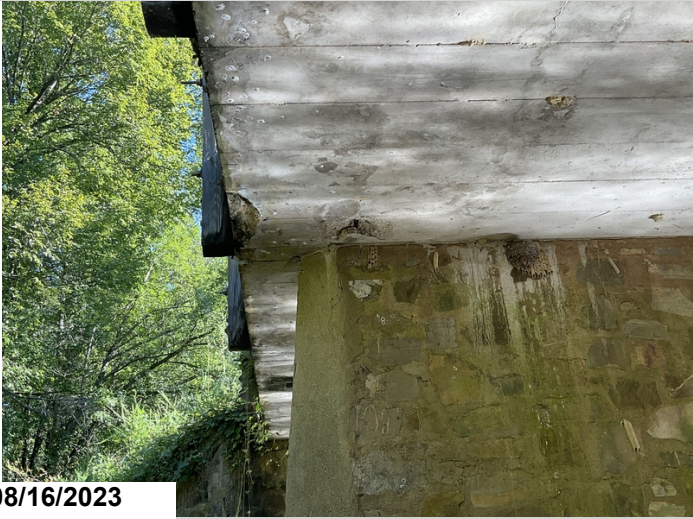
Span 1 at bent 2: couple small spalls in the slab.

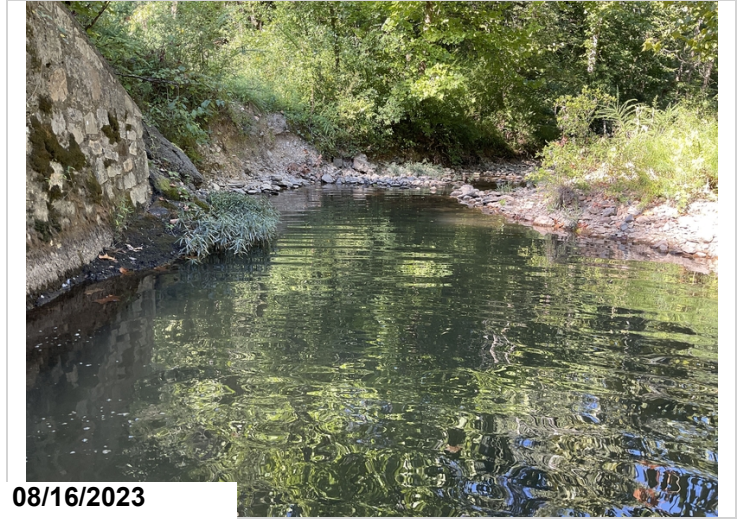
61 - Channel/Channel Protection (5 - Bank protection is being eroded. River control devices and/or embankment have major damage. Trees and brush restrict the channel.)
Soundings taken
The left embankment upstream is beginning to erode.

Channel looking upstream. The left embankment is beginning to erode.

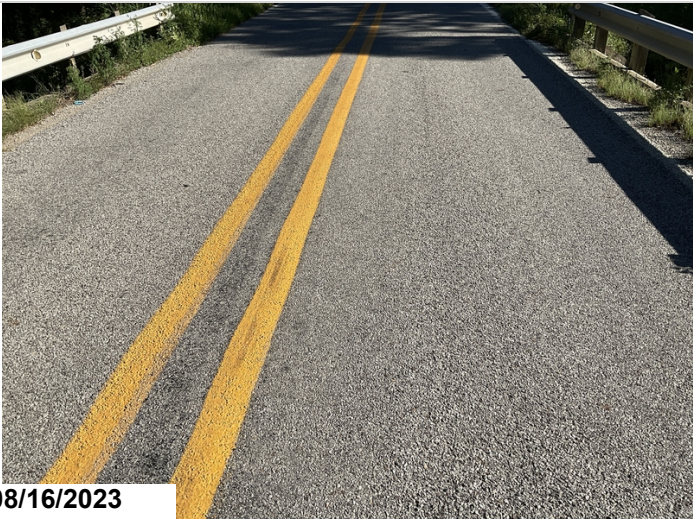
Deck view

58 - Deck (6 - SATISFACTORY CONDITION - structural elements show some minor deterioration.)
Deck with an asphalt overlay

A-55 - Deck Washing Needed (Yes)
