**Asset #M2415**(Routine, Underwater type 2)

**SH 227 Log 7.28 over MAYBERRY CREEK**

**Location: 0.2 MI S US 270**

**Team Lead:** Chris Doggett **Inspection Date:** 08/16/2023

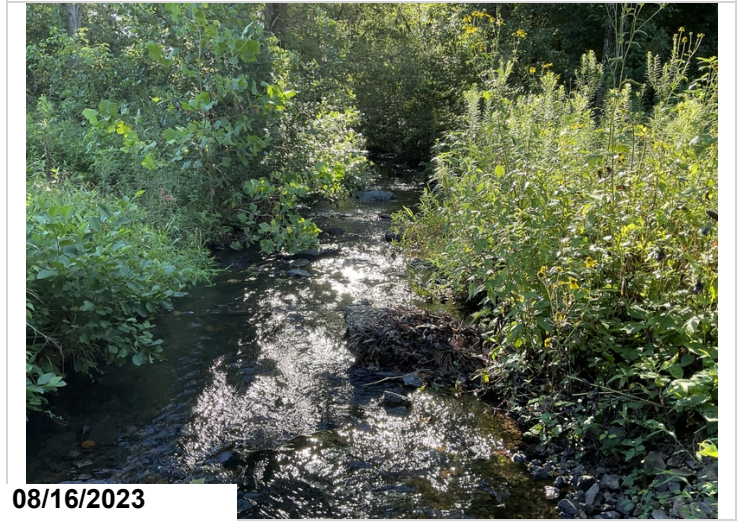
Channel looking down stream.

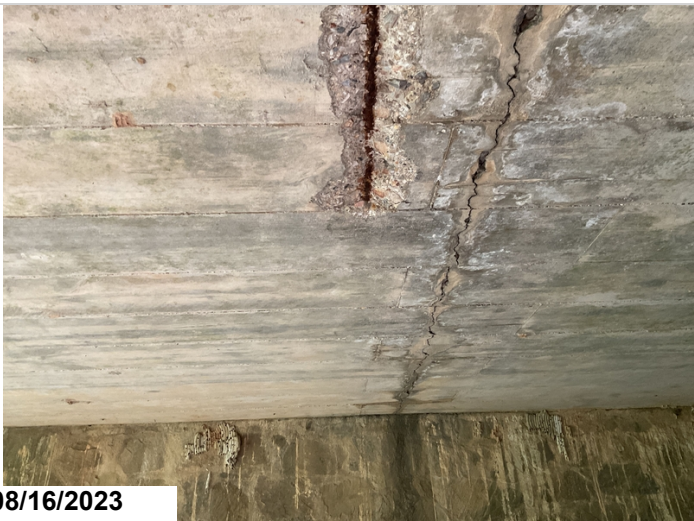
(38) Slab is cracked down centerline: span 1 has 1 spall & 1 exposed rebar, span 2 has 5 exposed rebars.							
107	Steel Open Girder/Beam	LF	128	0	64	64	0
1000	Corrosion	LF	128	0	64	64	0
515	Steel Protective Coating	SF	480	0	0	0	480
3440	Effectiveness (Steel Protective Coatings)	LF	480	0	0	0	480

Span 1: spall with exposed rebar and crack in the soffit near center line

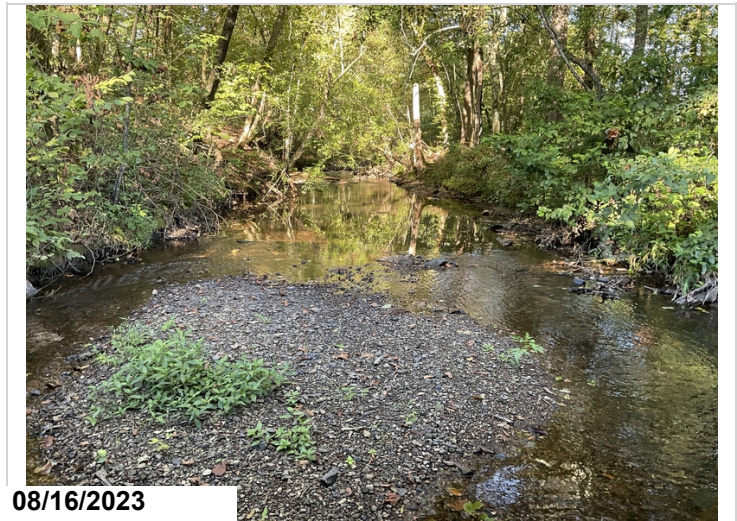
Channel looking up stream

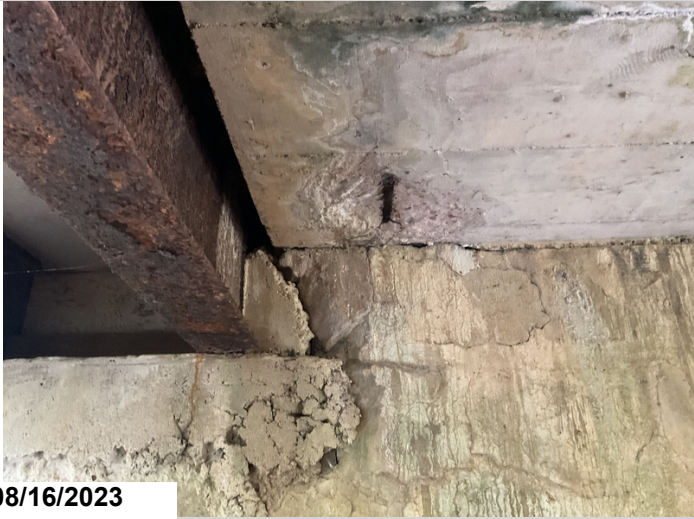
Span 2: small spall with exposed rebar in the soffit

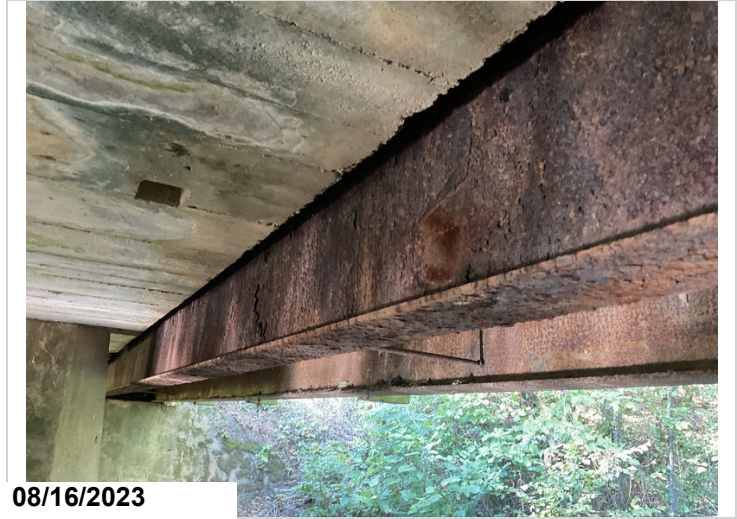
(107) All beams have active corrosion due to failed protective coating. Beams 2 and 3 have heavy laminating to bottom flanges and webs. Beam 2 has pitting up to 1/8" deep in areas of the web. Beams 2 & 3 have pitting on the bottom flange up to 1/8". (515-107) No paint on any beam.							
213	Masonry Pier Wall	LF	19	19	0	0	0

Beam 2: active rust with moderate pitting.

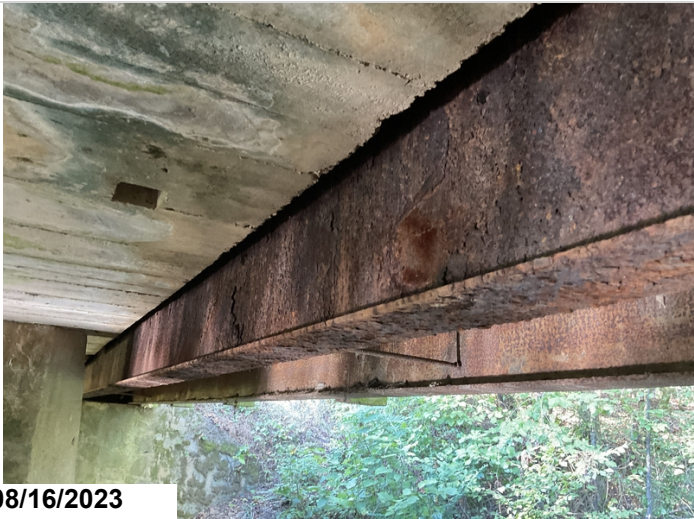
Beam 2: active rust with moderate pitting.

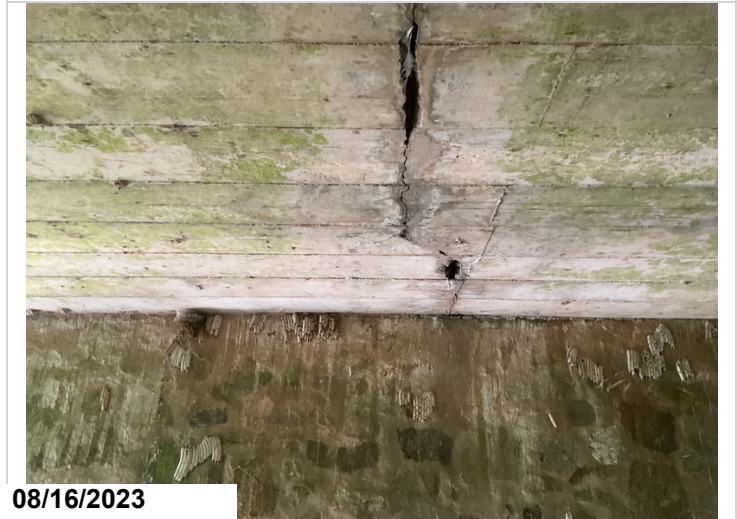
Span 2: crack at centerline with spall exposing rebar.

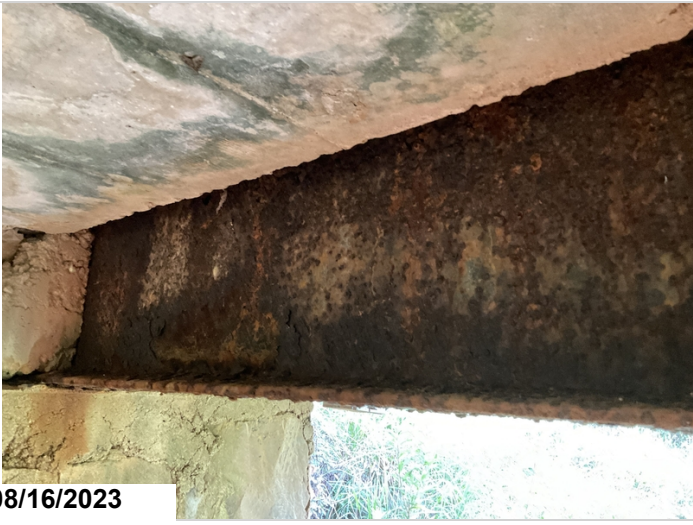
Beam 3: active rust with moderate pitting.

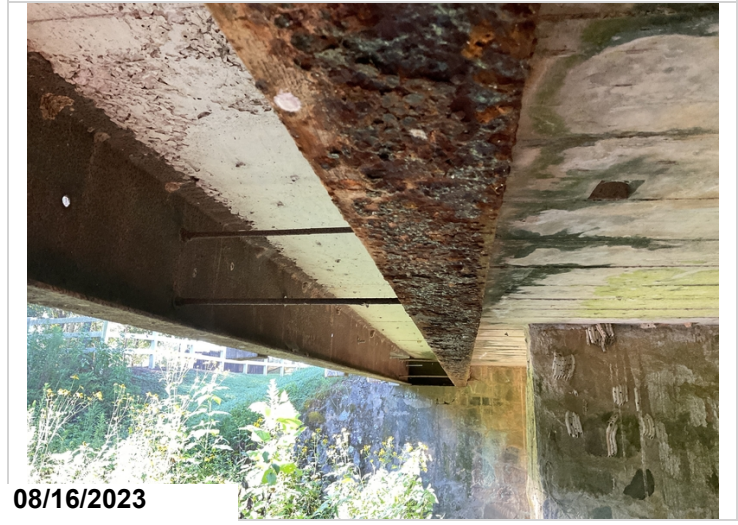
Beam 3: active rust with moderate pitting.

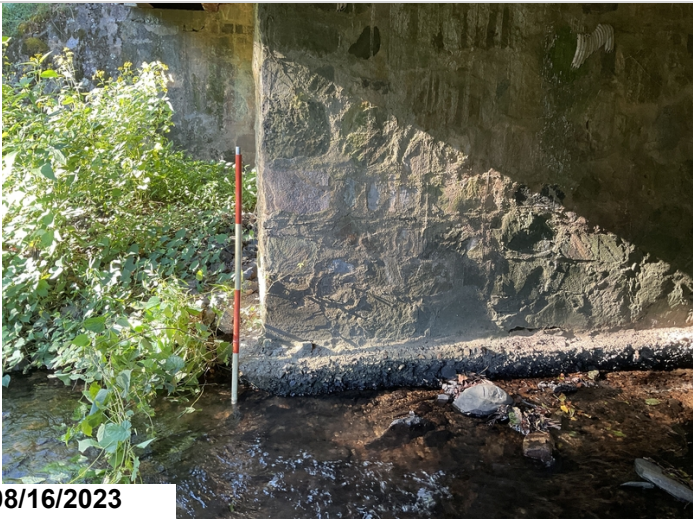
(220) The footings are exposed at all three bents with bent 2 bottom of footing exposed.							
330	Metal Bridge Railing	LF	64	64	0	0	0
515	Steel Protective Coating	SF	128	0	128	0	0
3440	Effectiveness (Steel Protective Coatings)	LF	128	0	128	0	0

Bent 2: footing exposed and has minor undermining.

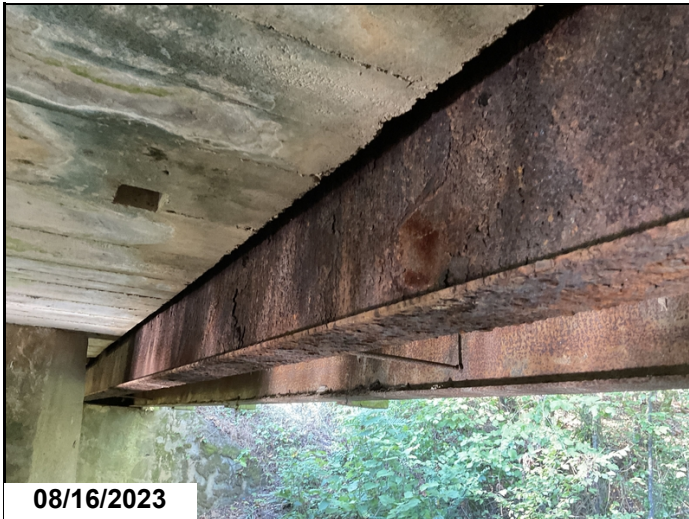
All four beams have moderate pitting the entire length.  
Due to failed paint system.

Beam 2: active rust with moderate pitting.

Type of Work: Superstructure Repair

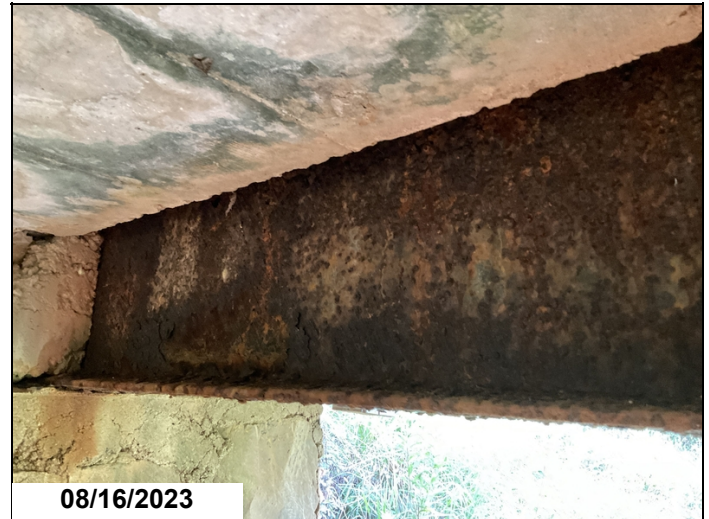
Beam 3: active rust with moderate pitting.

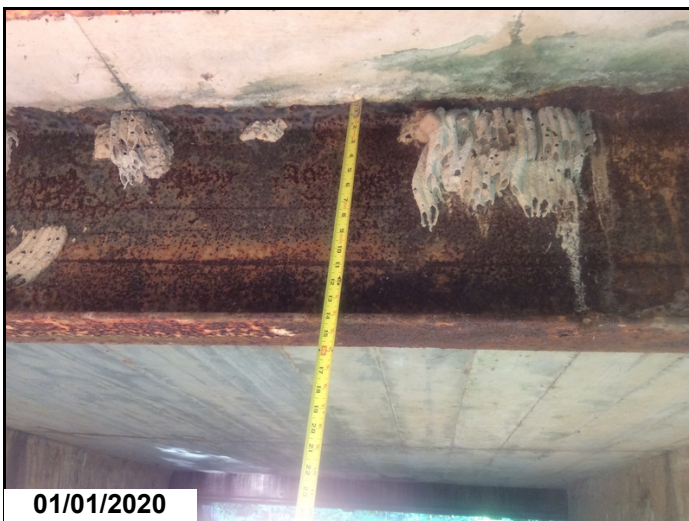
Active corrosion on all of beams.

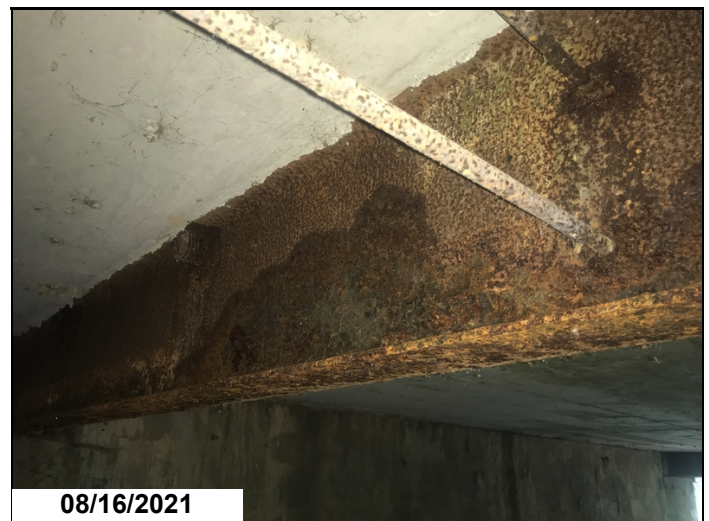
Span 2 beam 2 has active corrosion with pitting to bottom flange and web. Common beam 3.

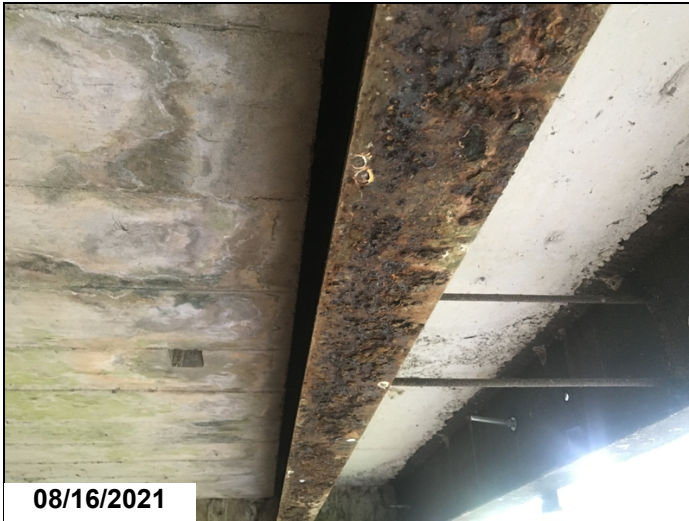
Beam 3 span 2 active corrosion with moderate pitting.

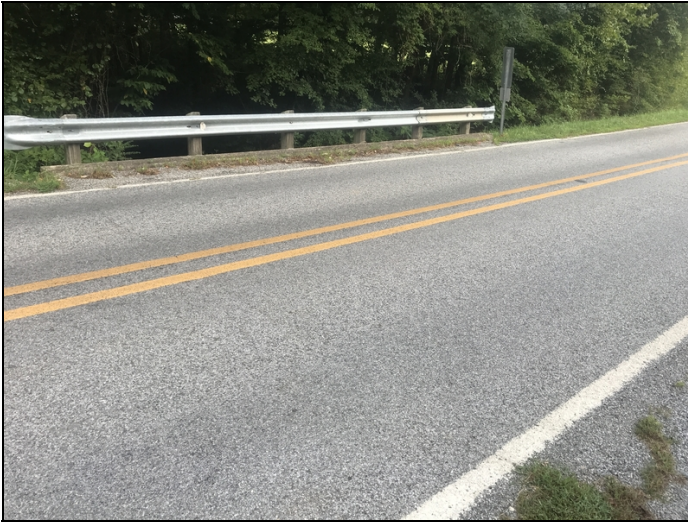
Deck overview.

**A-55 - Deck Washing Needed (Yes)**

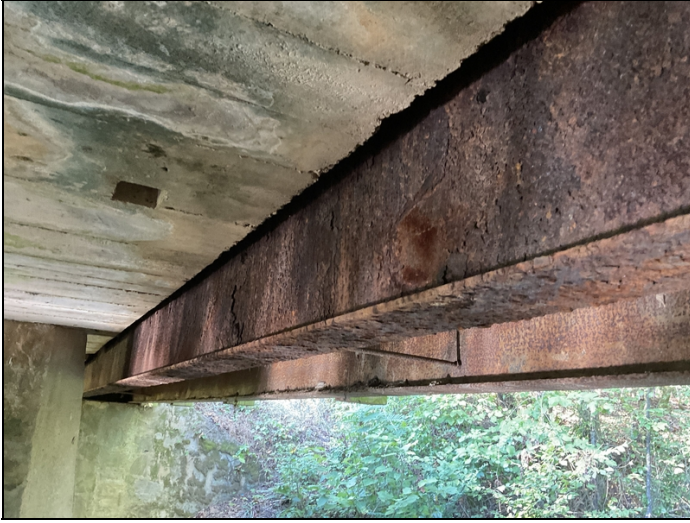
Beam 2: active rust with moderate pitting.

**A-60 - Full Girder Painting Needed (Yes)**
