Asset #01432(Routine)

US 67-8 Log 6.10 over FRANCOIS CREEK

Location: 3.50 MI NE JCT OF US 270

Team Lead: Chris Doggett Inspection Date: 09/20/2023

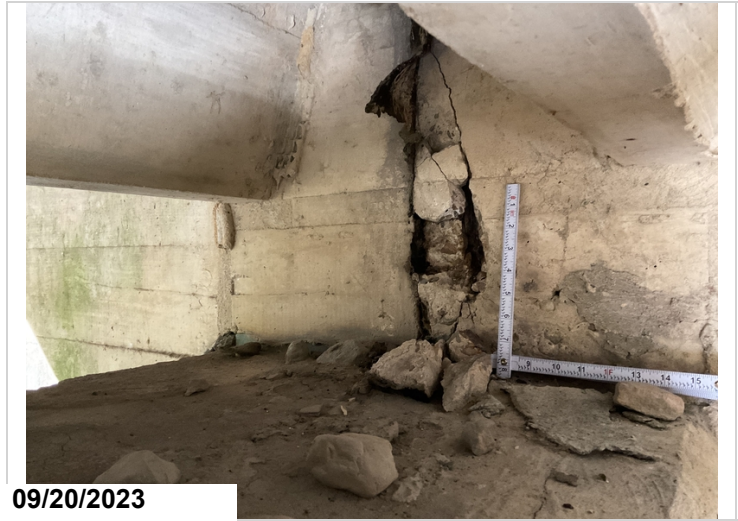
(110) Span 1, girders 1, 2 & 4 have exposed rebar. Span 2, Girders 2, 3, & 4 have exposed rebar. Bent 2, span 2, girder 2: spall with exposed rebar at the bearing area.							
205	Reinforced Concrete Column	EA	2	0	2	0	0
1190	Abrasion/Wear (PSC/RC)	EA	2	0	2	0	0

Bent 2, span 2, girder 2: spall with exposed rebar at the joint.

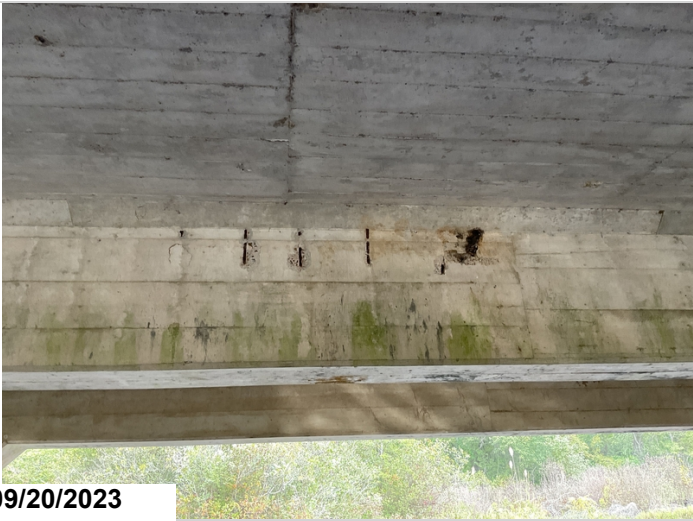
Span 2: right side of girder 2 small spalls with exposed rebar. Similar condition at girder 4.

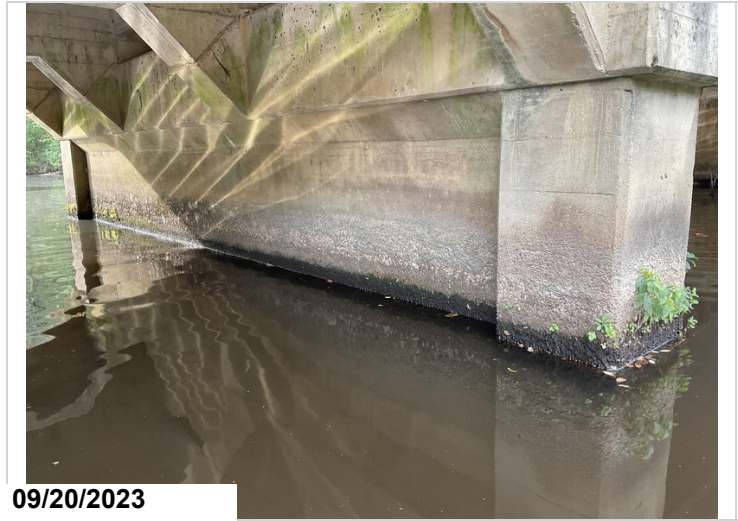
Bent 2: the columns and pier wall with abrasion near the water line.

(205) Both columns have some light abrasion.							
210	Reinforced Concrete Pier Wall	LF	24	0	24	0	0
1190	Abrasion/Wear (PSC/RC)	LF	24	0	24	0	0
(210) Light abrasion entire length of the pier wall.							
215	Reinforced Concrete Abutment	LF	92	0	92	0	0
1090	Exposed Rebar	LF	1	0	1	0	0
1120	Efflorescence/Rust Staining	LF	40	0	40	0	0
1190	Abrasion/Wear (PSC/RC)	LF	51	0	51	0	0

Bent 2: abrasion common to the columns and pier wall

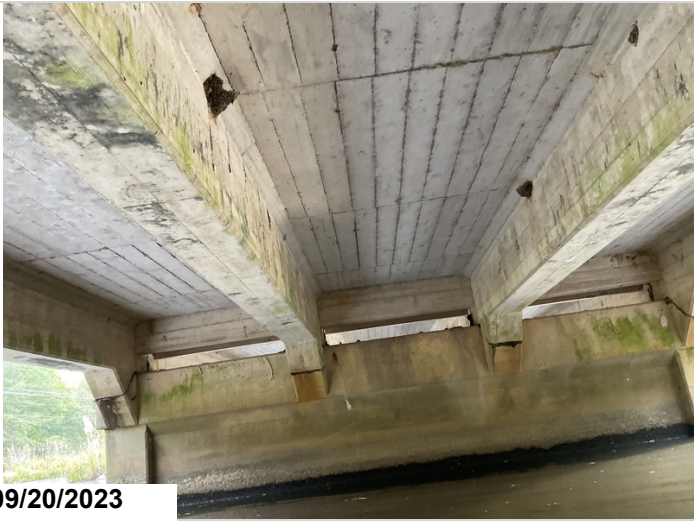
Soffit view

The deck has an asphalt wearing surface. The soffit has multiple small cracks with efflorescence staining.

(16) The soffit in both spans has small areas of exposed rebar, delams and cracks and cracks with efflorescence in the soffit overhangs. State force have milled off the old wearing surface & place a new asphalt wearing surface.							
110	Reinforced Concrete Open Girder/Beam	LF	280	257	22	1	0
1080	Delamination/Spall/Patched Area	LF	1	0	0	1	0
1090	Exposed Rebar	LF	22	0	22	0	0

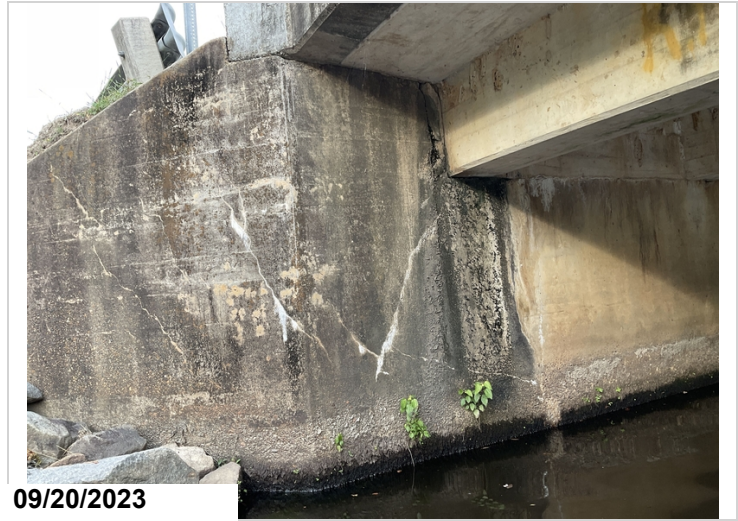
(215) Both abutments have cracks with efflorescence and light abrasion. Bent 3 has 1 small spall with rebar exposed.							
234	Reinforced Concrete Pier Cap	LF	27	27	0	0	0

Bent 1: diagonal cracking with efflorescence staining to the wing wall and abutment.
