Asset #01433(Routine)

US 67-8 Log 6.61 over RAYBURN CREEK

Location: 4.00 MI NE JCT OF US 270

Team Lead: Chris Doggett Inspection Date: 09/20/2023

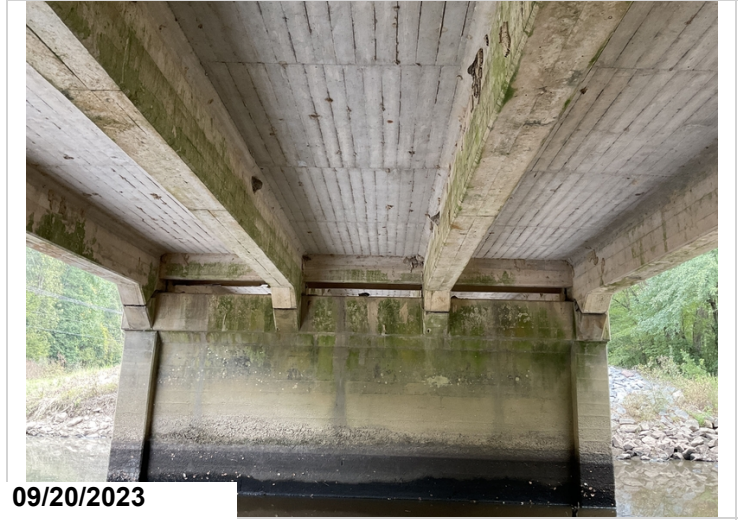
Soffit view

The soffit in both spans has exposed rebar, cracks, delam and cracks with efflorescence.

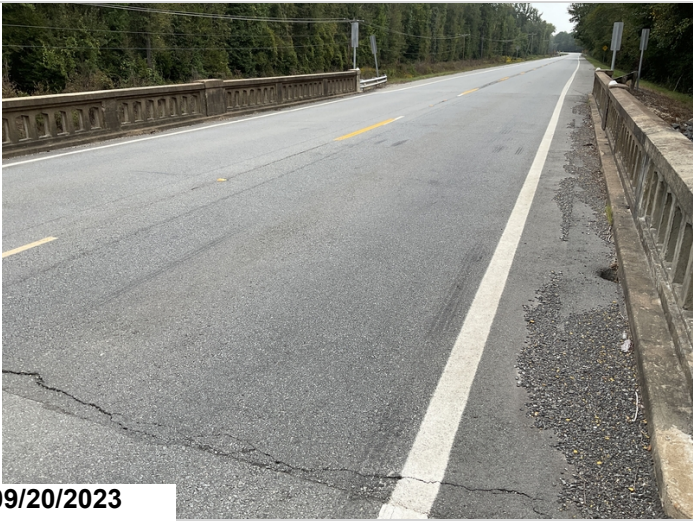
Deck view

State forces have milled up old wearing surface & place a new asphalt wearing surface.

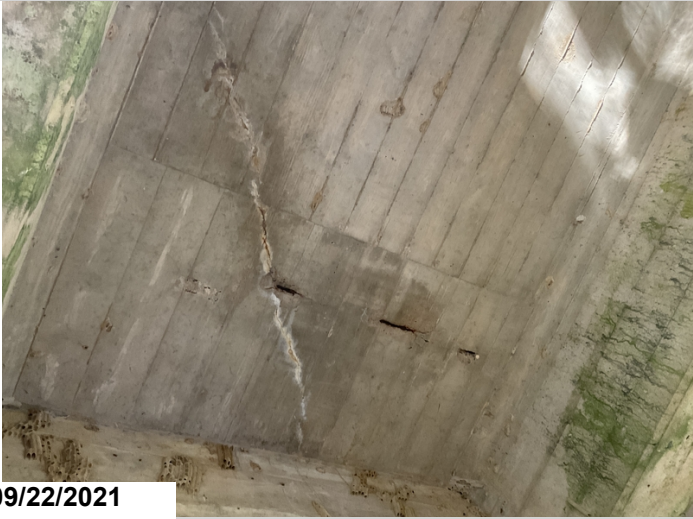
09/22/2021

Span 1 soffit has cracks with efflorescence, common span 2.
