Asset #01434(Routine)

US 67-8 Log 6.79 over NINE MILE CREEK

Location: 4.30 MI NE JCT OF US 270

Team Lead: Chris Doggett Inspection Date: 09/20/2023

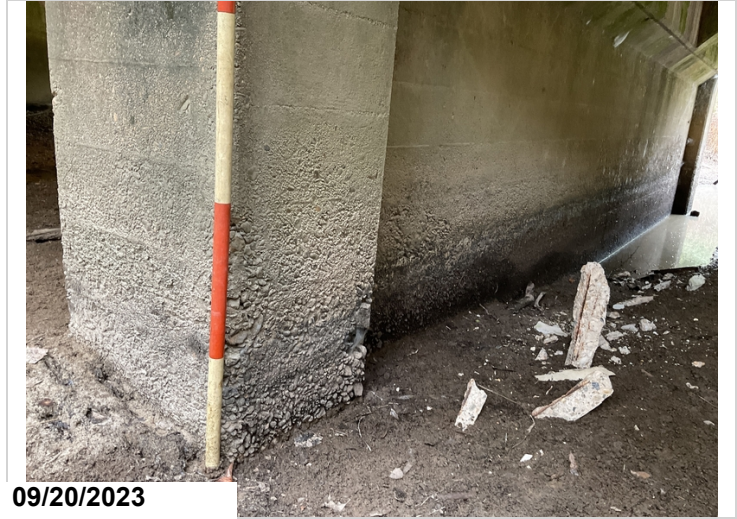
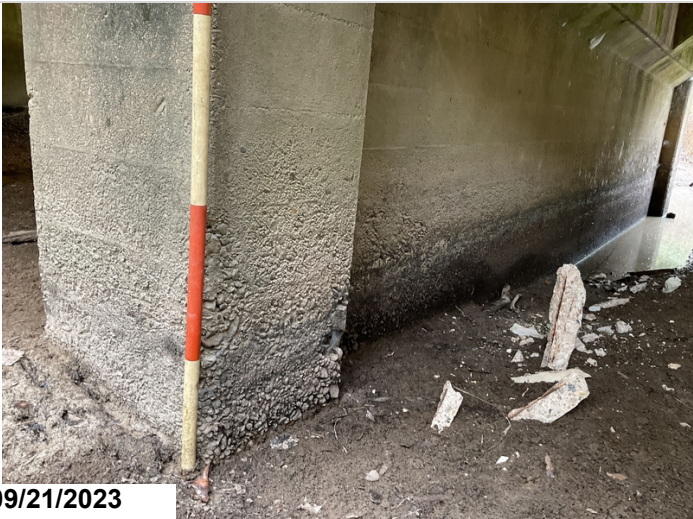
Bent 2, column 2: abrasion up to 3' from ground line typical to column 1 and the pier wall.

(205) Bent 2, both columns have severe abrasion.							
210	Reinforced Concrete Pier Wall	LF	24	0	24	0	0
1190	Abrasion/Wear (PSC/RC)	LF	24	0	24	0	0
(210) The pier wall has abrasion the entire length.							
215	Reinforced Concrete Abutment	LF	76	60	16	0	0
1130	Cracking (RC and Other)	LF	6	0	6	0	0
1190	Abrasion/Wear (PSC/RC)	LF	10	0	10	0	0

Bent 2, column 2: abrasion up to 3' from ground line typical to column 1 and pier wall.

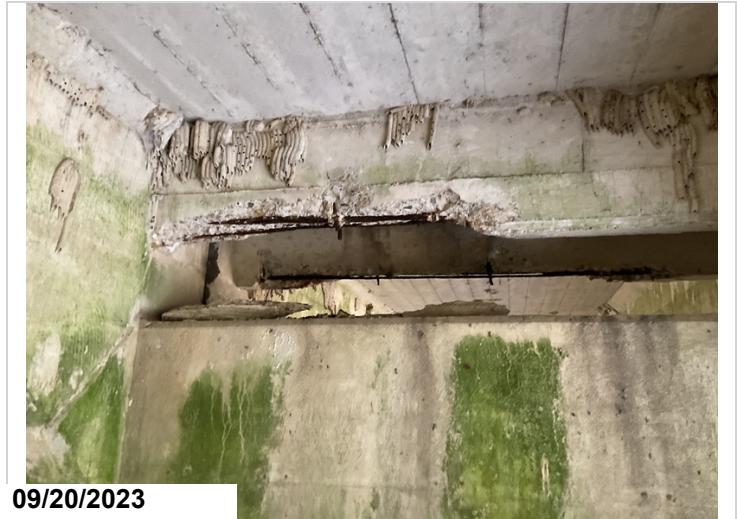
Bent 2: the concrete diaphragms are spalled with exposed rebar.

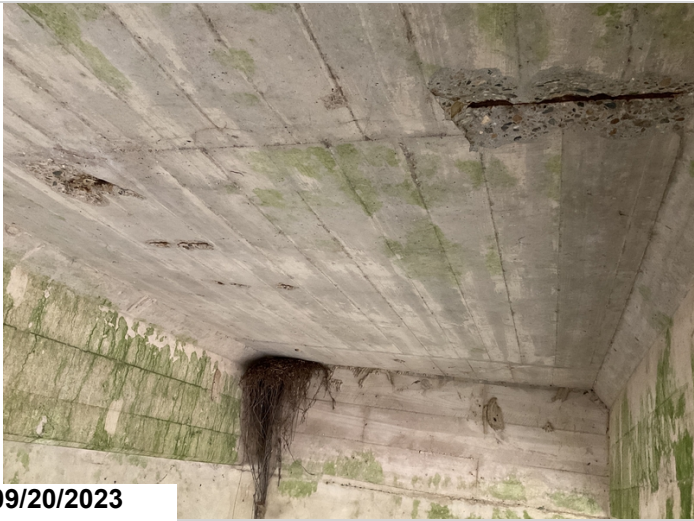
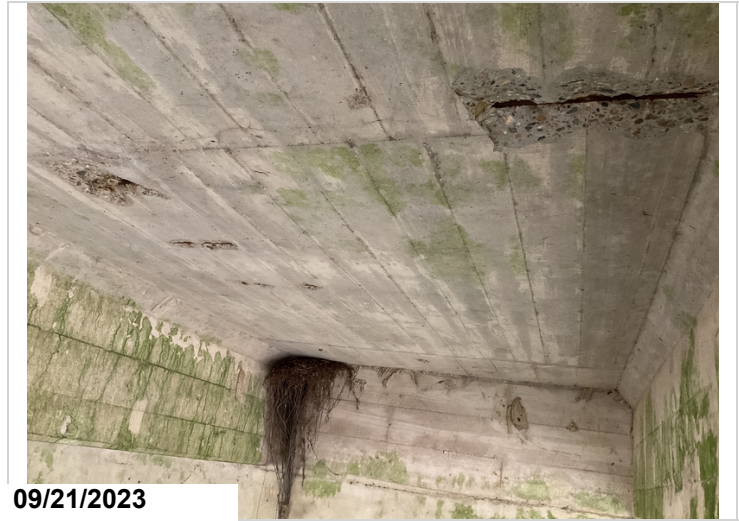
Soffit, Span 2 has exposed rebar & delams, scattered cracks in both spans.

Span 2 soffit, between girders 3&4: small spalls with exposed rebar. The largest is 5"x13".

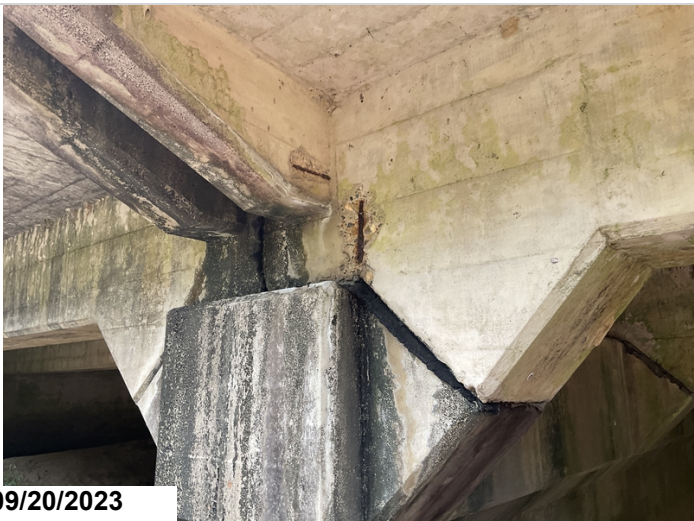
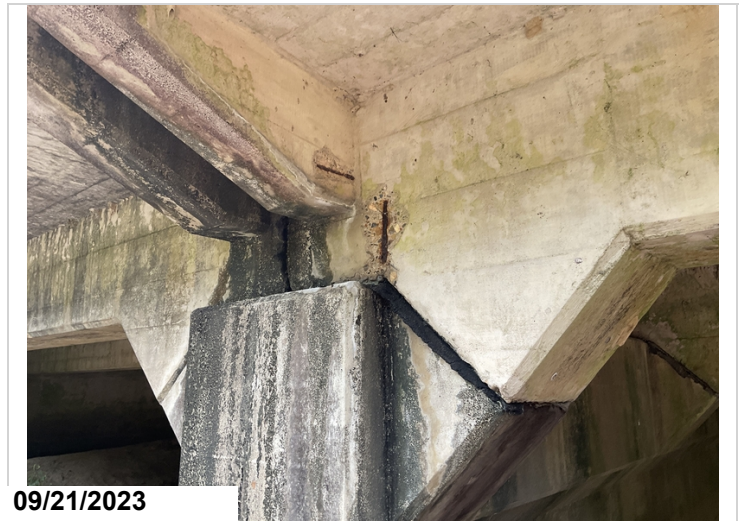
Span 1 Girder 1 has 3 exposed rebar.

Span 1, girder 1, bent 2: left side of girder has spall with exposed rebar
