Asset #01435(Routine)
US 67-8 Log 8.30 over CRI & P (Abandoned)

Team Lead: Chris Doggett Inspection Date: 06/10/2024

Asset #01435(Routine)

US 67-8 Log 8.30 over CRI & P (Abandoned)

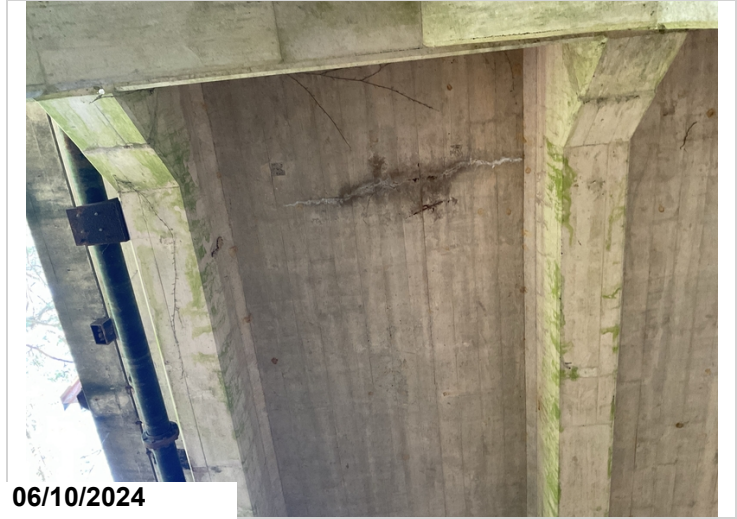
Span 3: transverse crack with efflorescence staining. CS3-8'

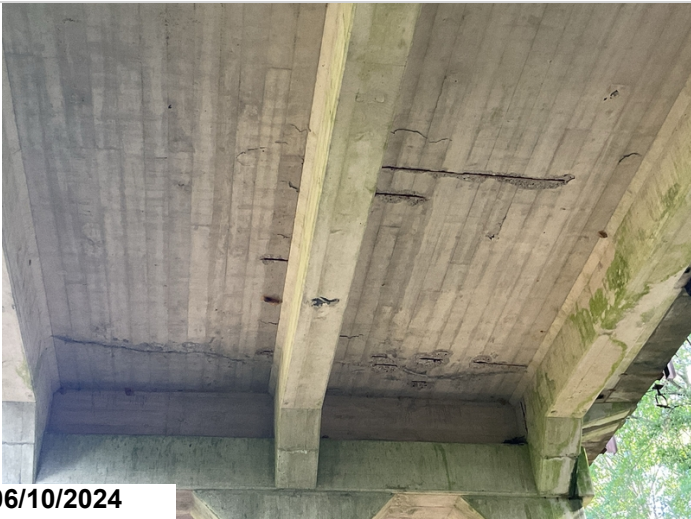
Span 2: numerous spalls with exposed rebar. CS3-33'

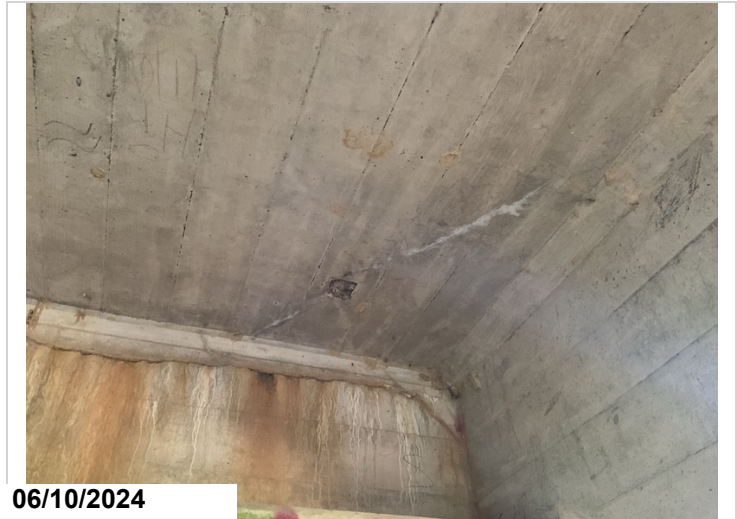
Span 1: Under surface with diagonal crack with some efflorescence staining. CS2-3'

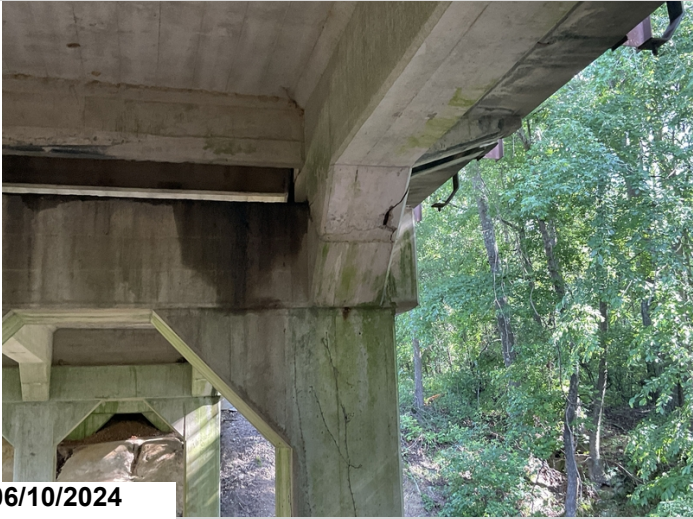
Span 1 at bent 2, girder 3: spall with exposed rebar to the bottom of the girder. CS3-1'

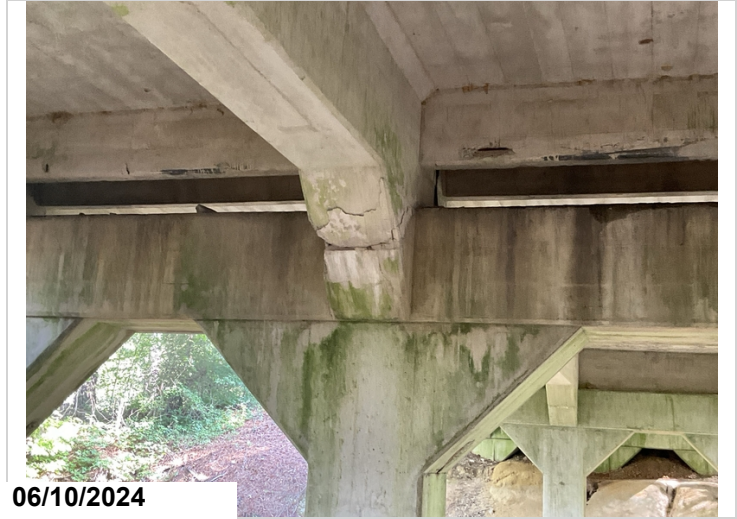
Span 1, bent 2, girder 2: the bottom of girder has a delam. CS3-2'

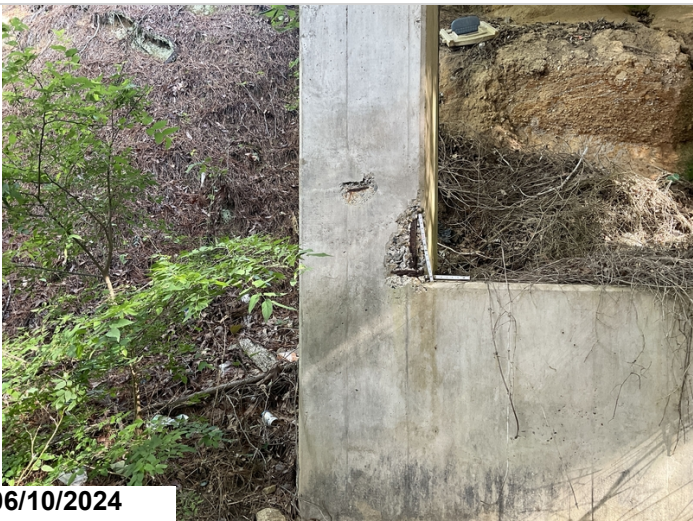
Bent 3, column 1: spall with exposed rebar. CS3-1ea

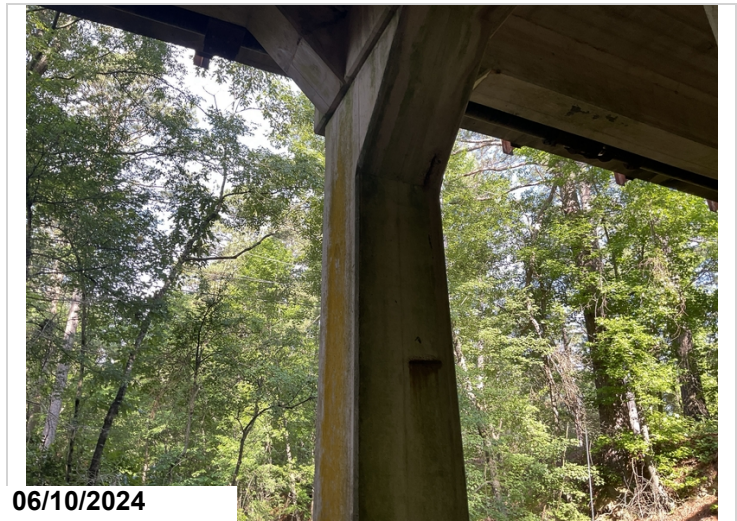
Bent 2, column 1: couple small spalls with exposed rebar. CS3-1ea

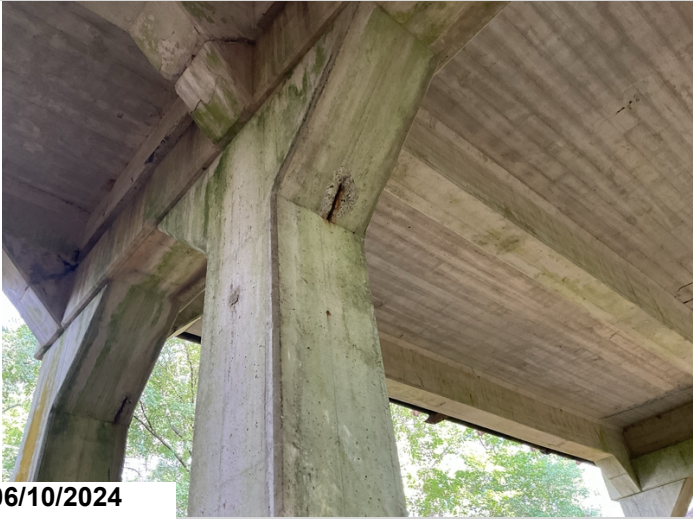
Bent 2, column 2: small spall with exposed rebar. CS3-1ea

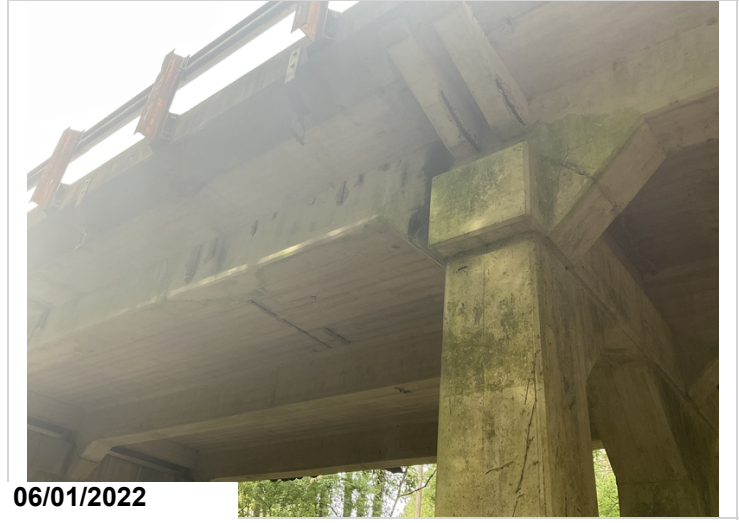
Spalls with exposed rebar in girder 3 right side span 2.

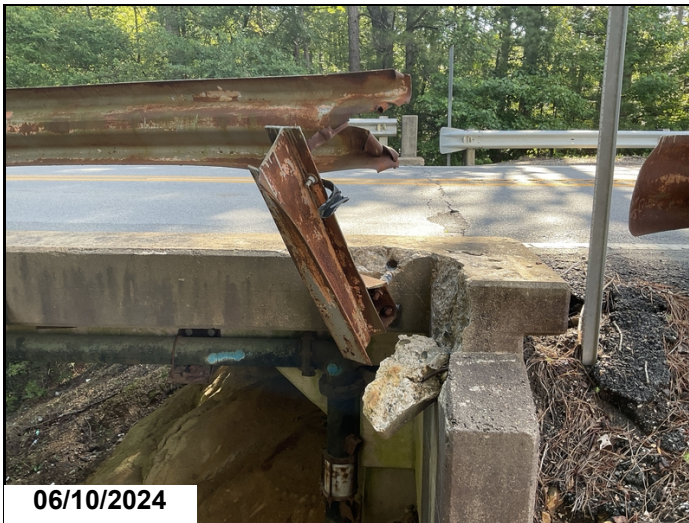
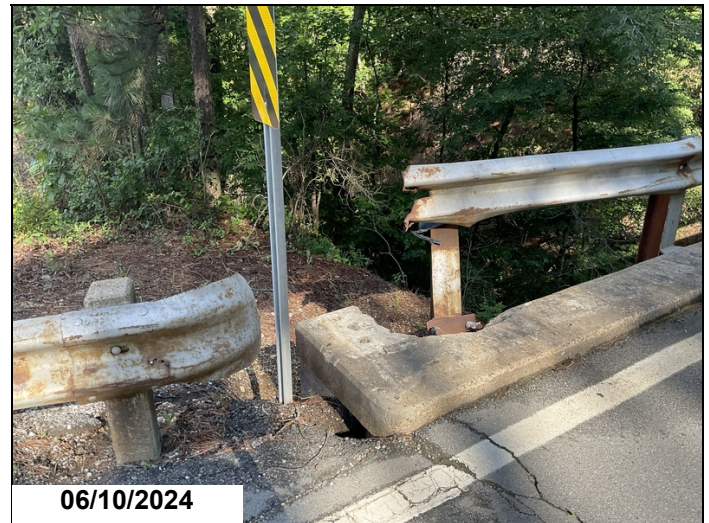
South west guardrail has been damaged. 2024

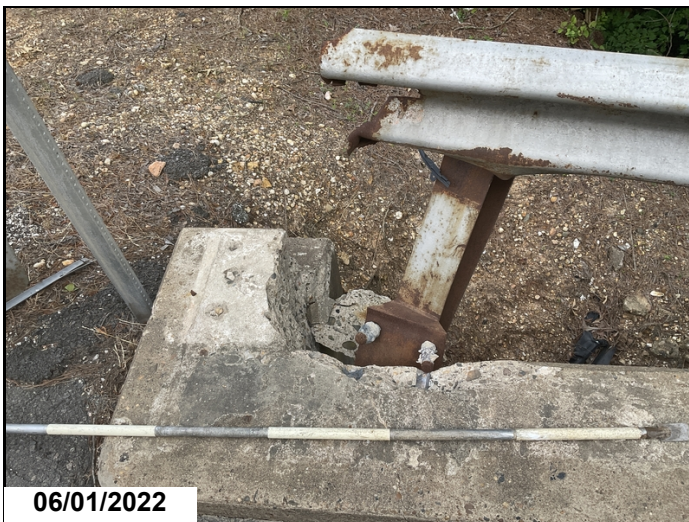
ELEMENTS	DESCRIPTION	UNITS	TOTAL	CS1	CS2	CS3	CS4
1000	Corrosion	LF	172	172	0	0	0
7000	Damage	LF	18	0	0	18	0
515	Steel Protective Coating	SF	380	380	0	0	0
(330) Span 1: left bridge rail and end post damaged due traffic impact. Span 3: right bridge rail and end post damaged due to traffic impact.

Span 1 left side bridge rail and end post damaged due to traffic impact.

Type of Work: Repair (General)

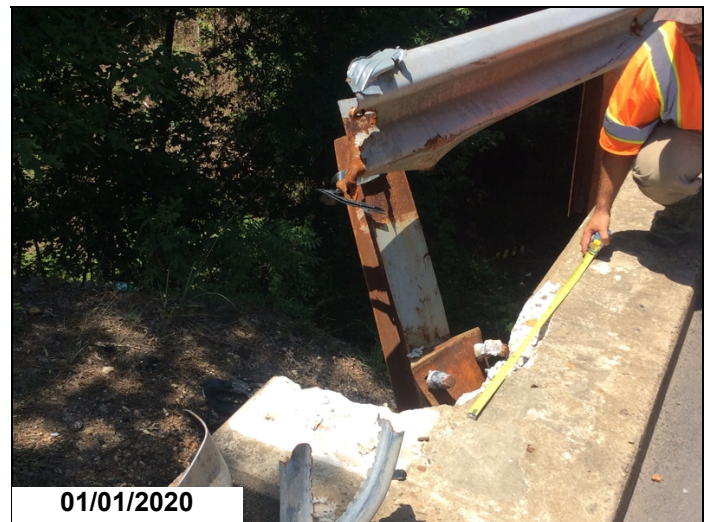
Bridge rail end post damaged left side.
