Asset #01436(Routine)

US 67-8 Log 10.2 over TEN MILE CREEK

Location: .93 MI S OF SALINE CO LIN

Team Lead: Chris Doggett Inspection Date: 06/10/2024

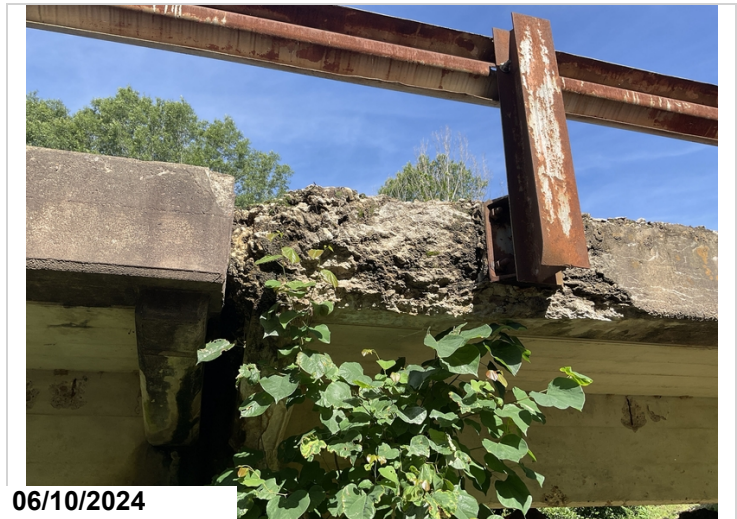
Span 3: right edge of deck is deteriorating and beginning to spall.

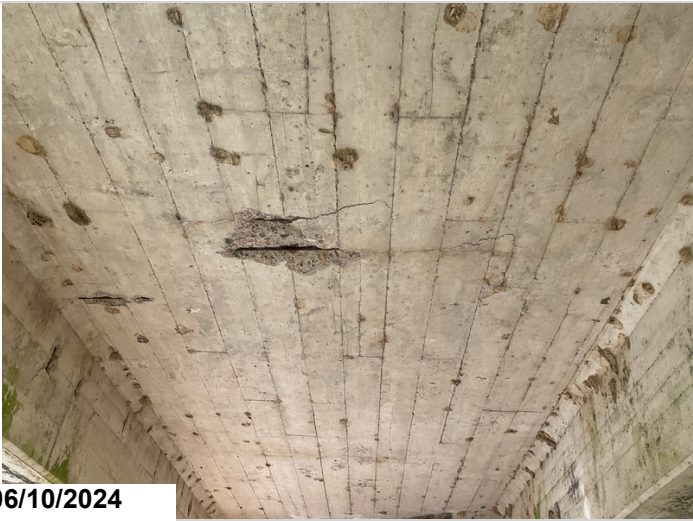
Span 2, right bay: spall with exposed rebar. CS3-3sf

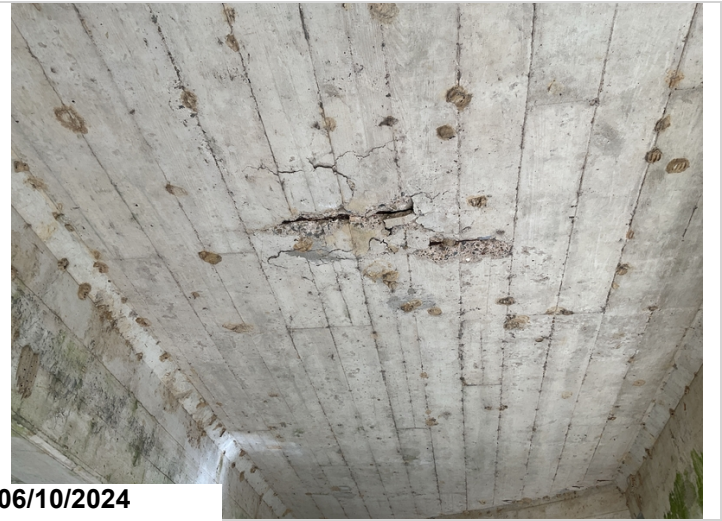
Span 1, between girders 2&3: spalls with exposed rebar.
CS3-5sf

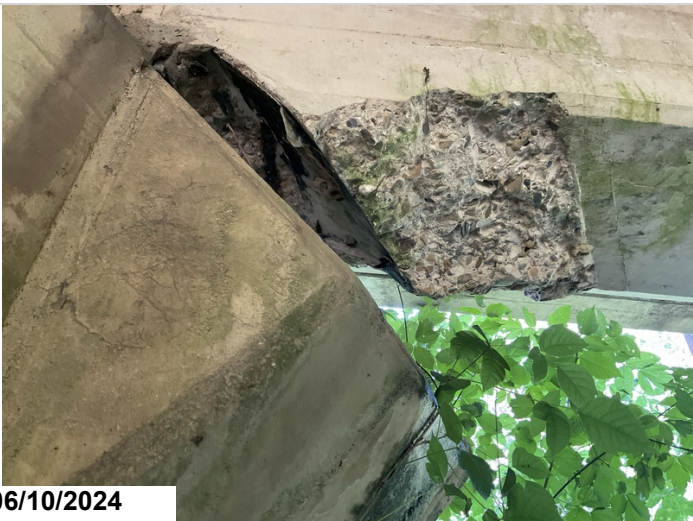
Bent 3, span 3, girder 1: spall with exposed rebar. CS3-1'

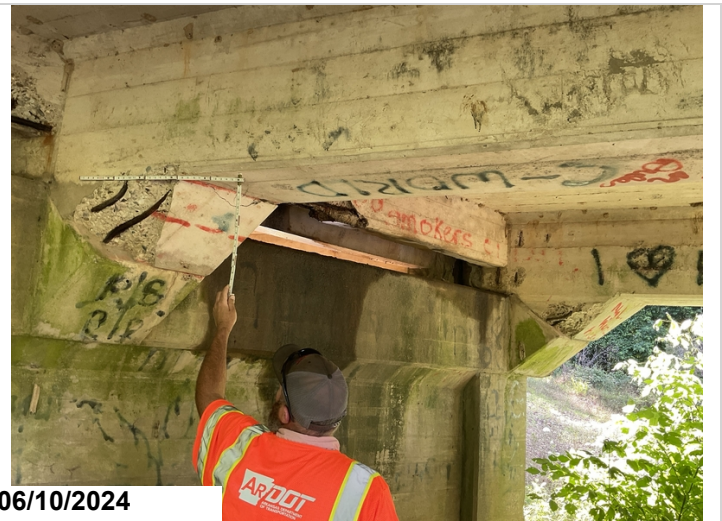
Backside bent 3, girders 2 and 3 are spalled with exposed
rebar. CS3-2'.

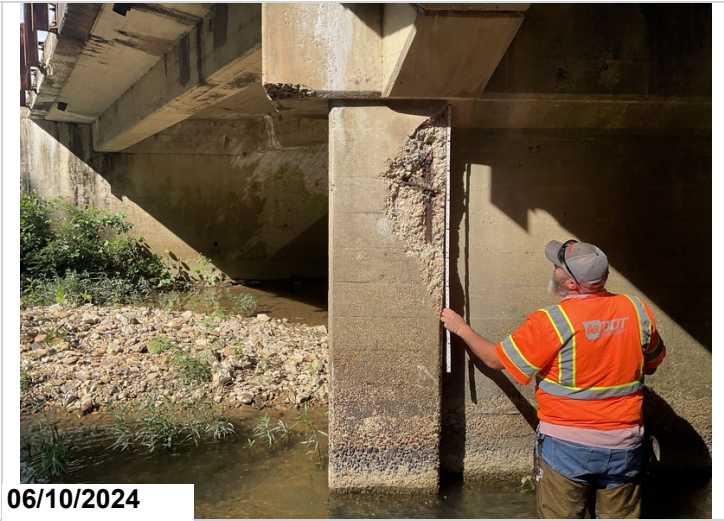
Ahead side bent 2, column 2: large spall with exposed rebar.
CS3-1ea.

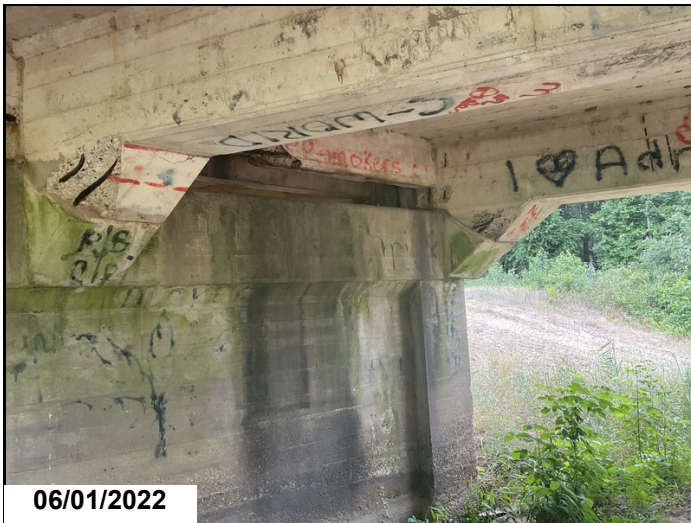
Bent 2 and 3 spalls and delams on girders.

Bent girders 2 & 3 have spalls with exposed rebar.

Type of Work: Repair (General)

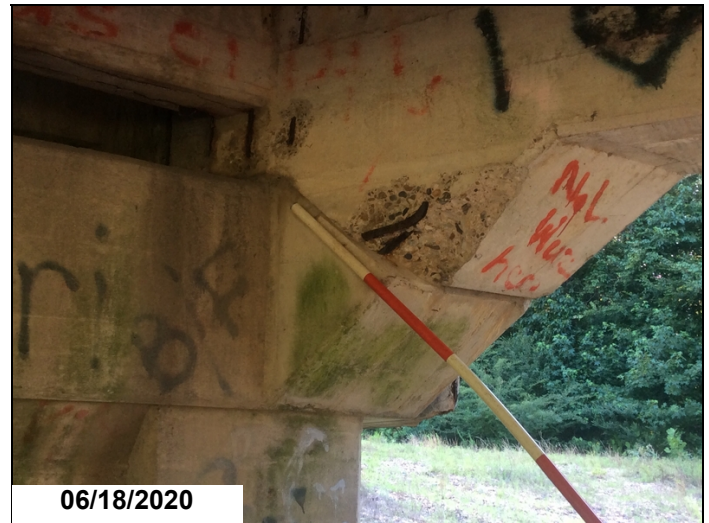
Span 2 girder 3 at bent 3 has spall with exposed rebar.

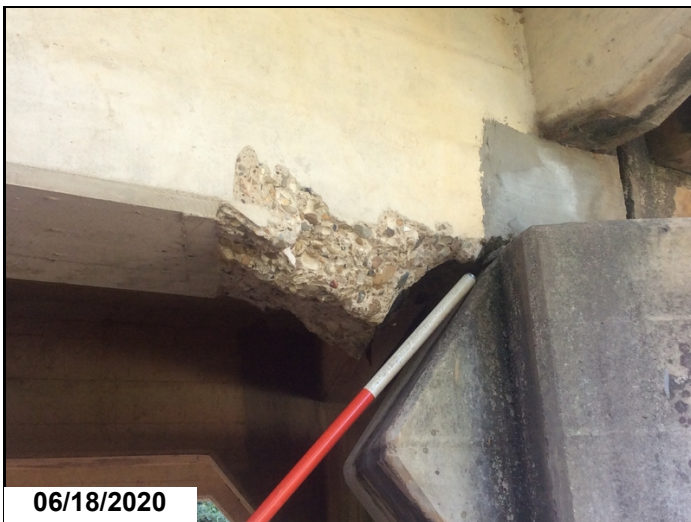
Span 3 girder 1 at bent 3 has spall.
