Asset #05481(Underwater)

SH 15 Log 0.36 over BAYOU METO

Location: 0.36 MI N OF US 70

Team Lead: Victoria Elliott, **Inspection Date:** 11/27/2023

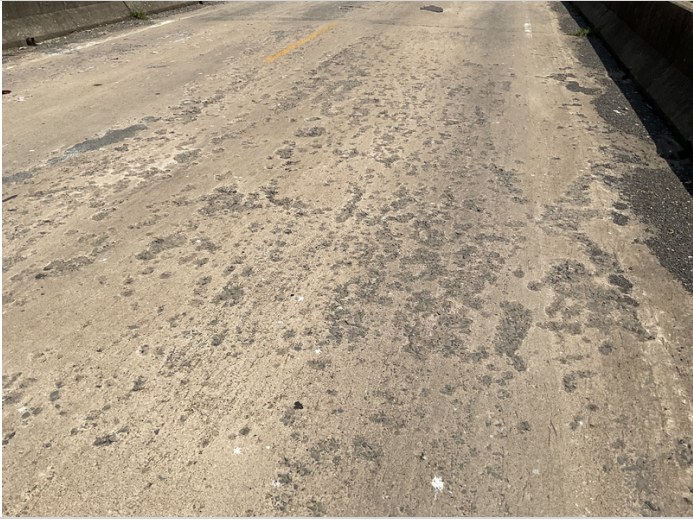
Scaling

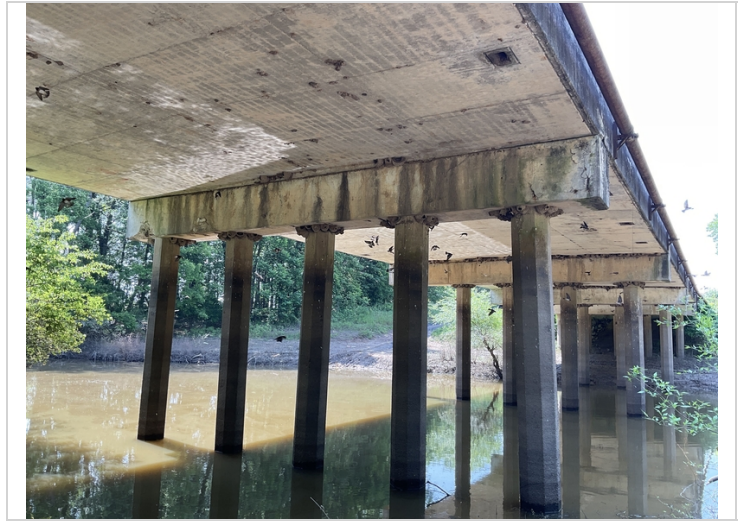
Bent 5 cap has spalls with rebar on both left and right end ahead side

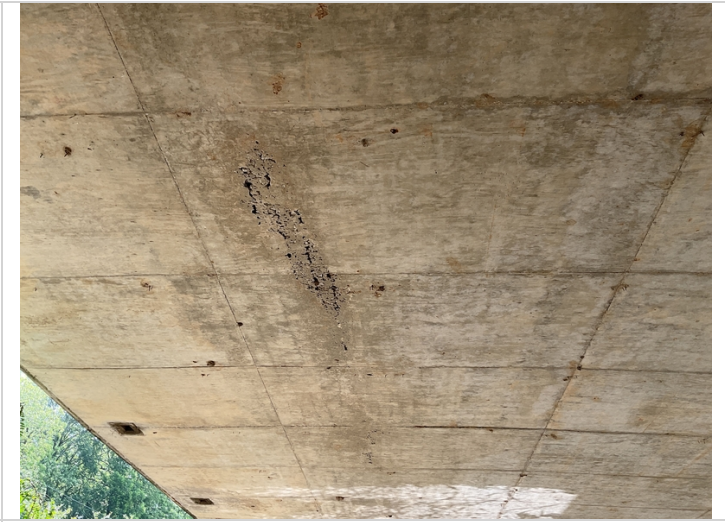
Honeycomb in the soffit span 6

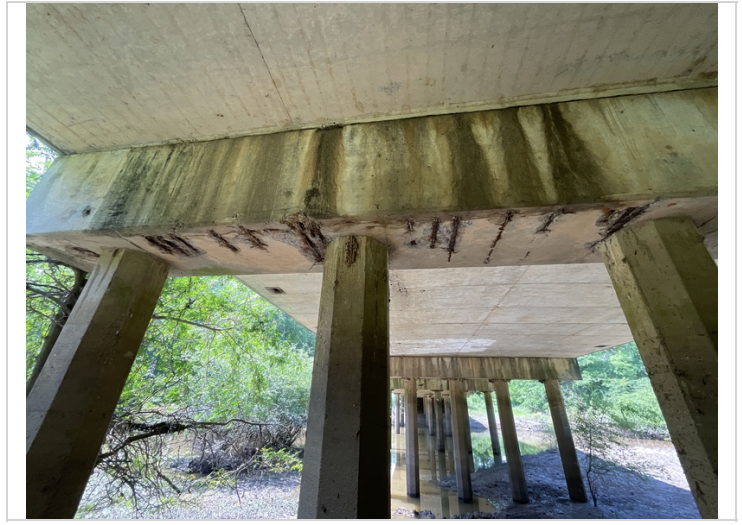
Bent 7 exposed rebar

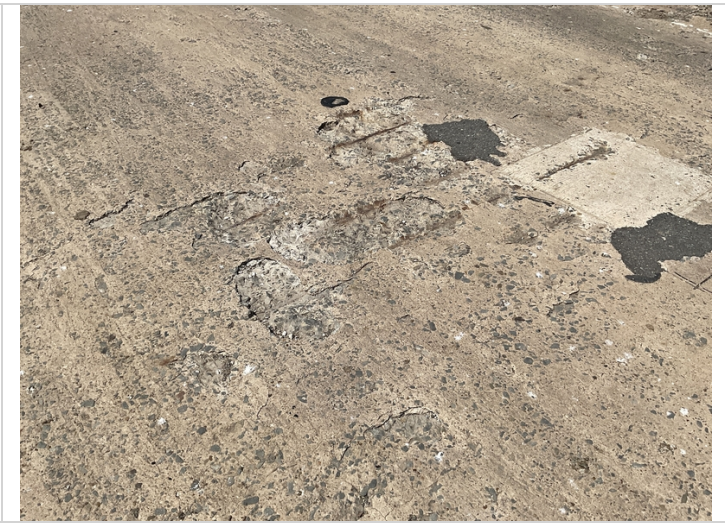
Rebar exposed in the deck

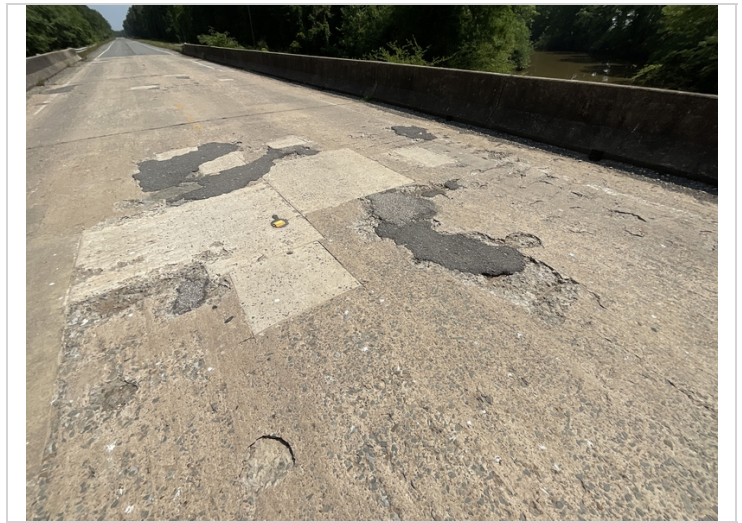
Spalls with rebar span 4

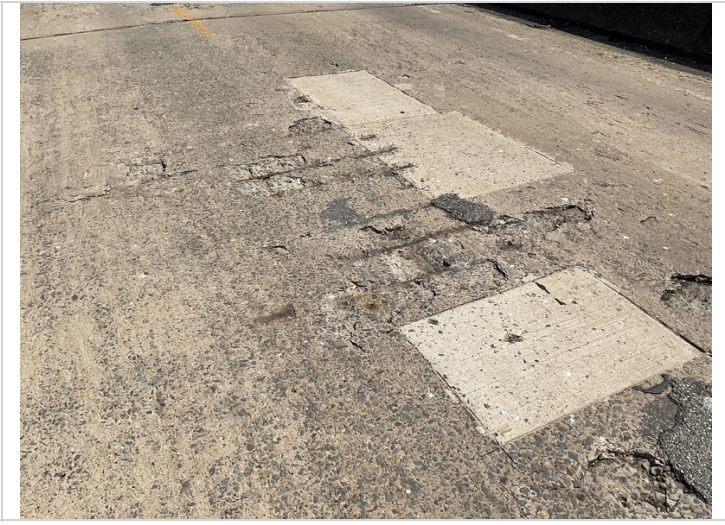
Spalls with rebar span 3

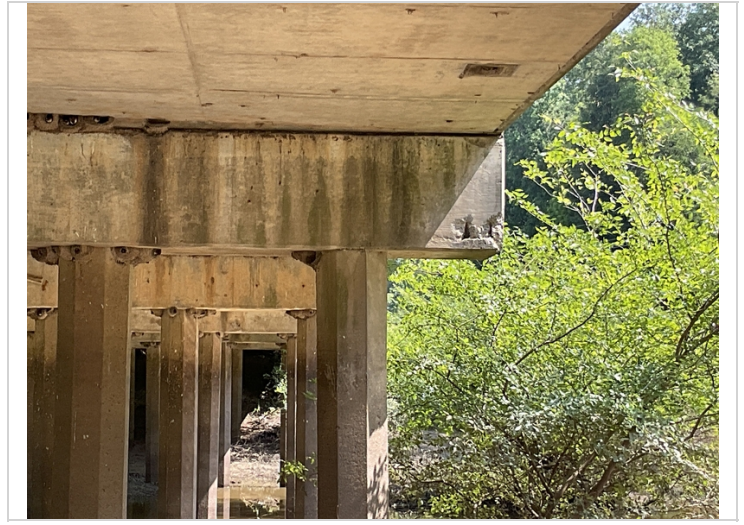
Spall with rebar bent 3

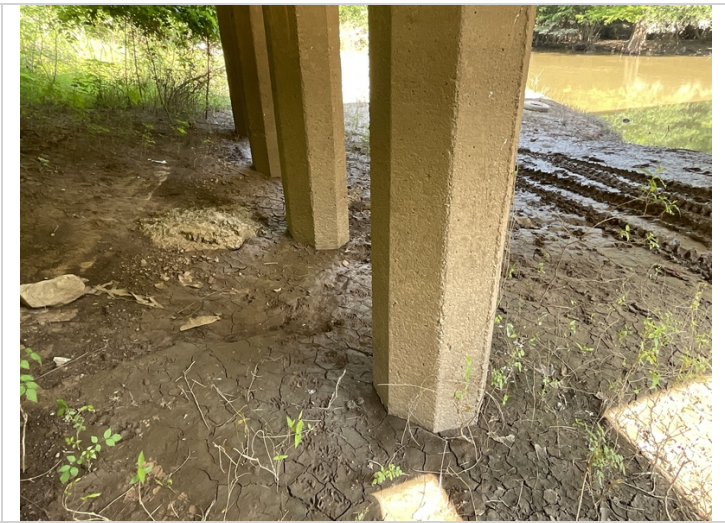
Abrasion to the columns

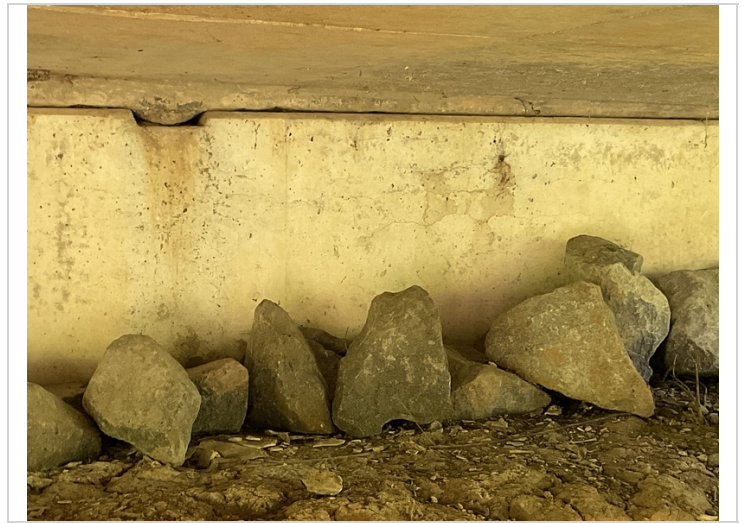
Cracks at bent 1

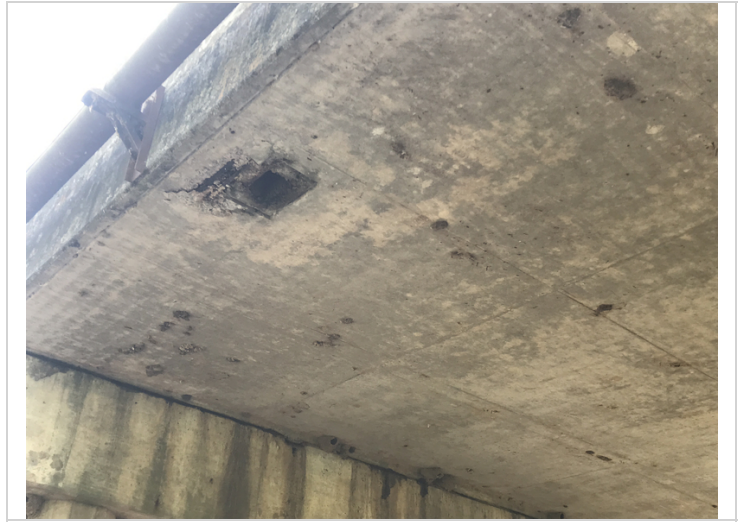
Span 2 left side has exposed rebar around drain.
