Asset #06463(Routine)

S.H. 89 Log 8.39 over BAYOU TWO PRAIRIE

Team Lead: Bryan Saunders, Inspection Date: 07/27/2023

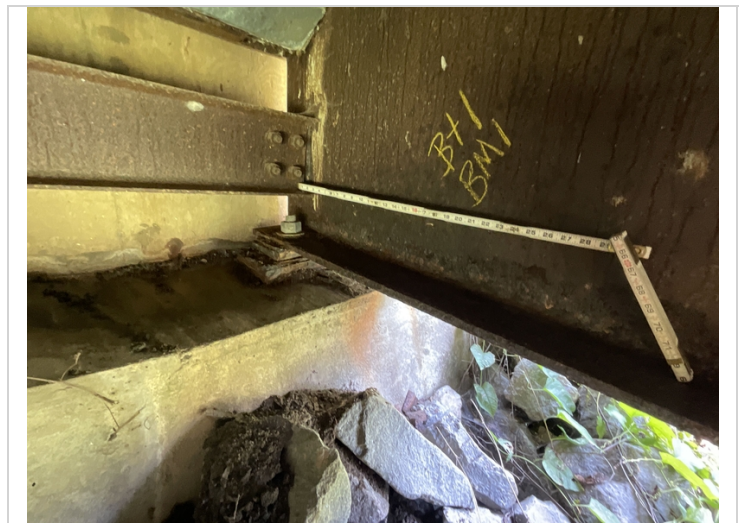
bent 1 beam 1 has corrosion at beam end

(107) Bent 1 beam 1 has 2' of flaking rust on bottom flange and lower web							
(515-107) Bent 1 beam 1 has 3' of flaking rust on bottom flange and lower web							
215	Reinforced Concrete Abutment	LF	70	54	16	0	0
1130	Cracking (RC and Other)	LF	16	0	16	0	0

Corrosion at bent 1 beam 1

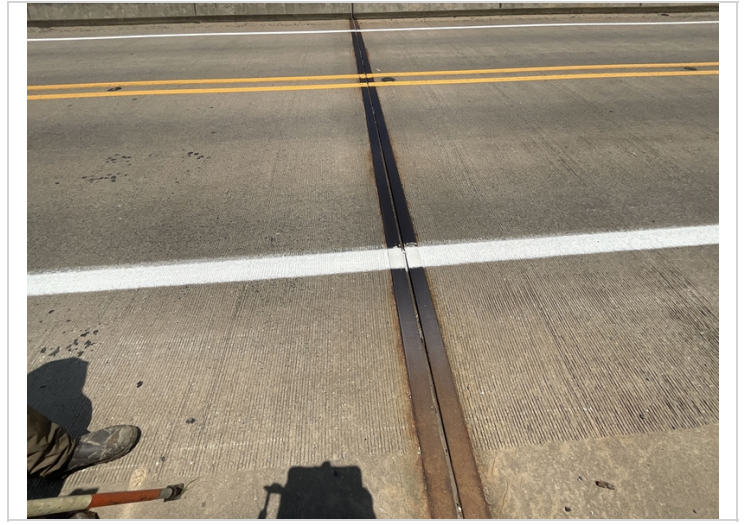
Bent 5 joint

joint at bent 5 has lost bond

(302) Closed cell foam material, glued in place.							
Joint seal at bent 5 has lost adhesion							
311	Movable Bearing	EA	35	35	0	0	0
313	Fixed Bearing	EA	35	34	0	1	0
1000	Corrosion	EA	1	0	0	1	0

A-59 - Joint Repair Needed (Yes)

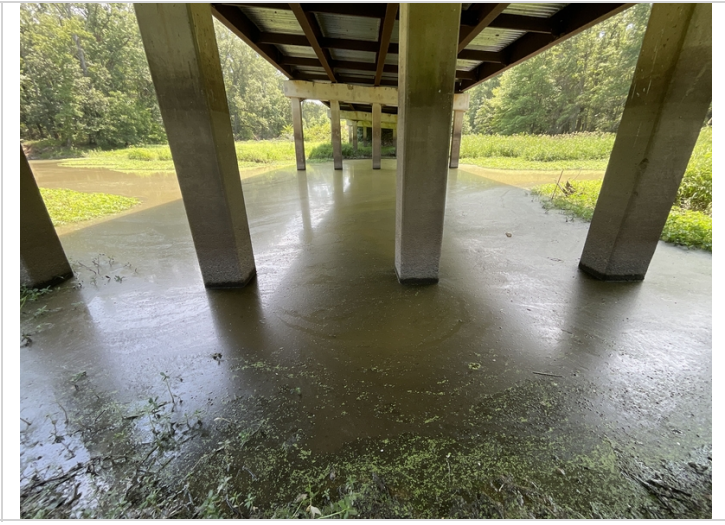
(215) Scattered cracks in back wall of both abutment.							
227	Reinforced Concrete Pile	EA	25	0	25	0	0
1190	Abrasion/Wear (PSC/RC)	EA	25	0	25	0	0
(227) All of the pile have some minor abrasion on the bottom three feet above the channel bottom.							
234	Reinforced Concrete Pier Cap	LF	165	165	0	0	0
302	Compression Joint Seal	LF	244	132	112	0	0
2320	Seal Adhesion	LF	12	0	12	0	0
2350	Debris Impaction	LF	100	0	100	0	0

Abrasion to bottom of piles

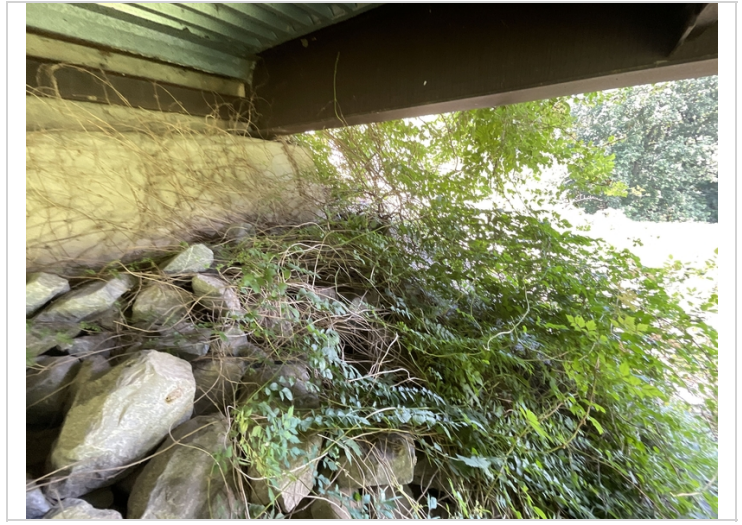
Vines growing at abutments

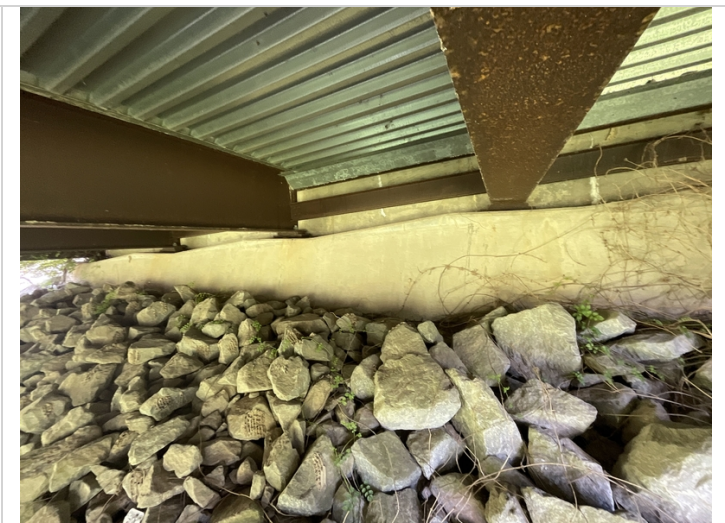
Both abutments backwalls have vertical cracks with efflorescence.
pile have abrasion at lower 5'.

Bent 7 abutment vertical cracks with efflorescence

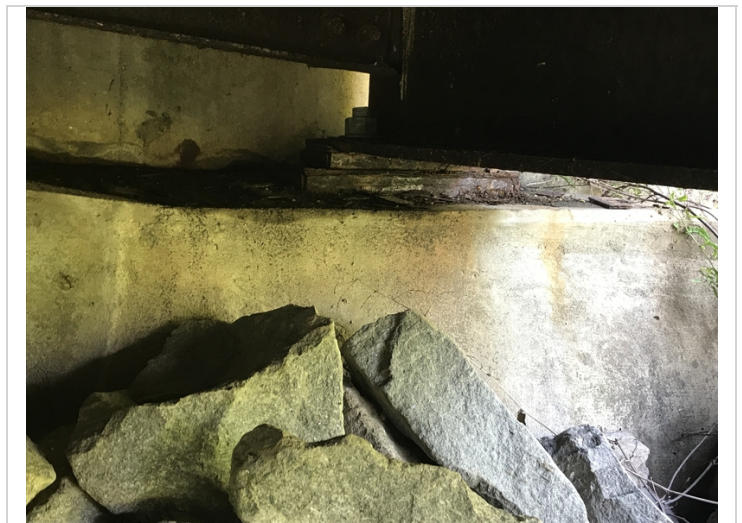
(313) Laminating rust on bearing 1 at bent 1							
331	Reinforced Concrete Bridge Railing	LF	604	576	28	0	0
1130	Cracking (RC and Other)	LF	28	0	28	0	0

Laminating rust on bearing 1 at bent 1
