Asset #06463(Routine)

S.H. 89 Log 8.39 over BAYOU TWO PRAIRIE

Team Lead: Bryan Saunders, Inspection Date: 07/27/2023

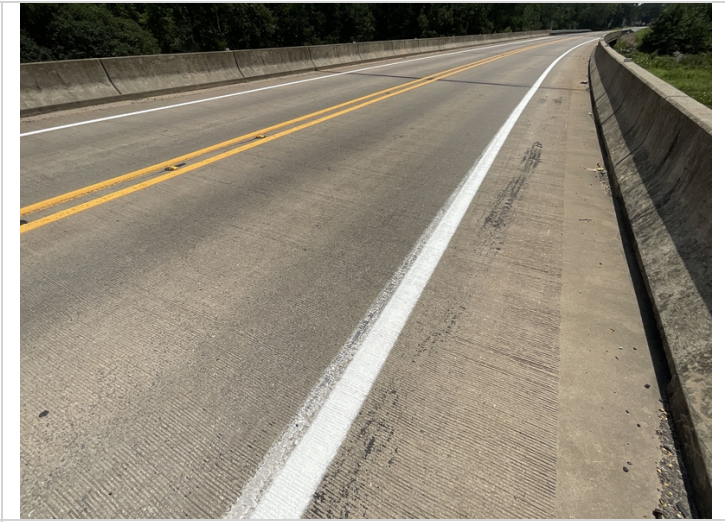
deck is in overall good shape

deck has map cracking at joints

Deck view

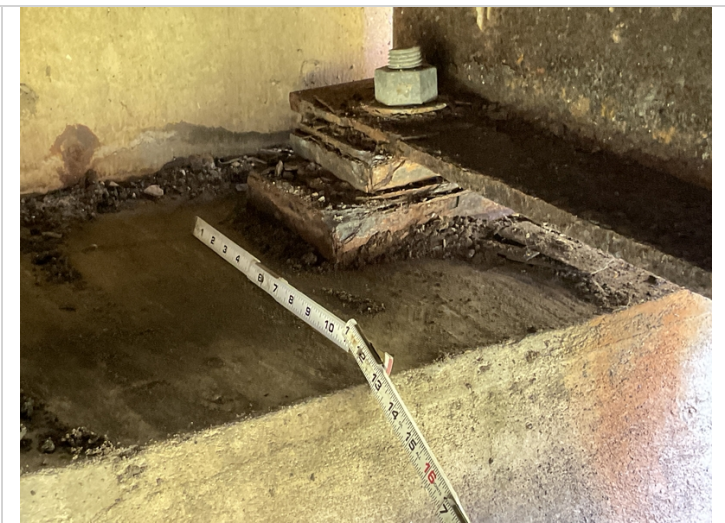
Bent 1 beam 1 bearing

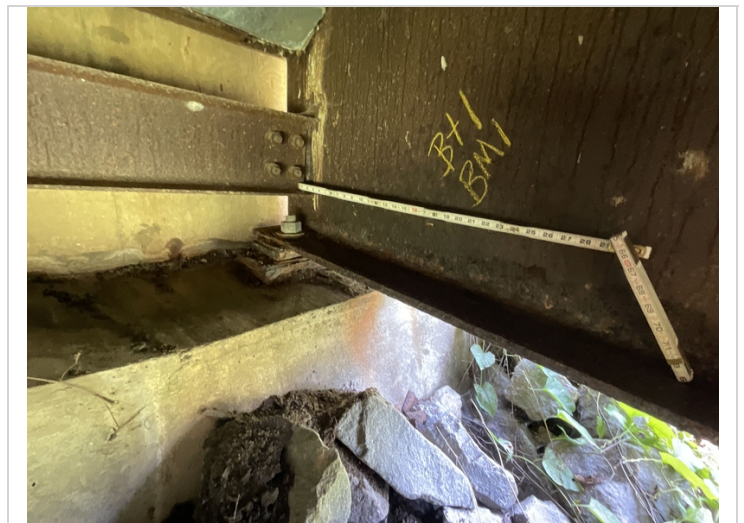
bent 1 beam 1 has corrosion at beam end

ELEMENTS	DESCRIPTION	UNITS	TOTAL	CS1	CS2	CS3	CS4
107	Steel Open Girder/Beam	LF	1500	1497	2	1	0
1000	Corrosion	LF	3	0	2	1	0
515	Steel Protective Coating	SF	10230	0	10227	3	0
3440	Effectiveness (Steel Protective Coatings)	LF	10230	0	10227	3	0
(107) Bent 1 beam 1 has 2' of flaking rust on bottom flange and lower web							
(515-107) Bent 1 beam 1 has 3' of flaking rust on bottom flange and lower web

Corrosion at bent 1 beam 1

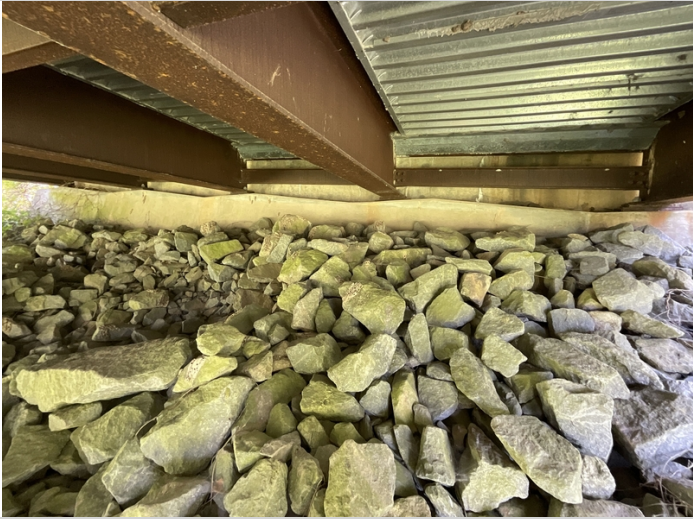
Both abutments backwalls have vertical cracks with efflorescence.
pile have abrasion at lower 5'.

Bent 1 abutment

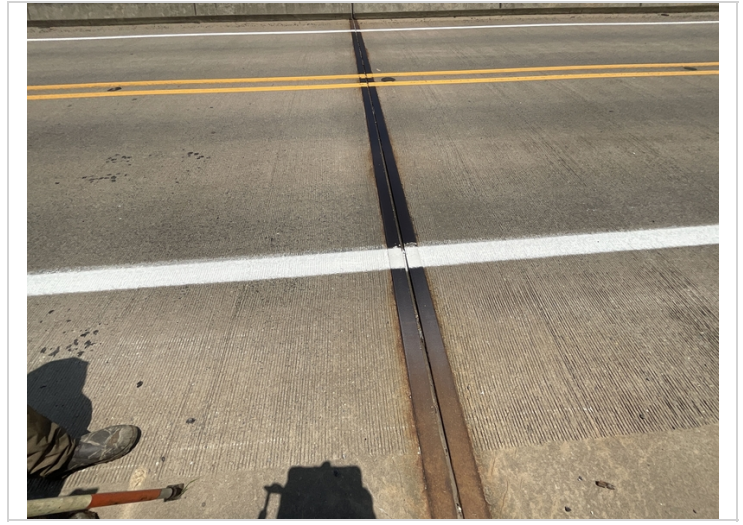
joint at bent 5 has lost bond

(302) Closed cell foam material, glued in place.							
Joint seal at bent 5 has lost adhesion							
311	Movable Bearing	EA	35	35	0	0	0
313	Fixed Bearing	EA	35	34	0	1	0
1000	Corrosion	EA	1	0	0	1	0

Bent 5 joint

A-59 - Joint Repair Needed (Yes)

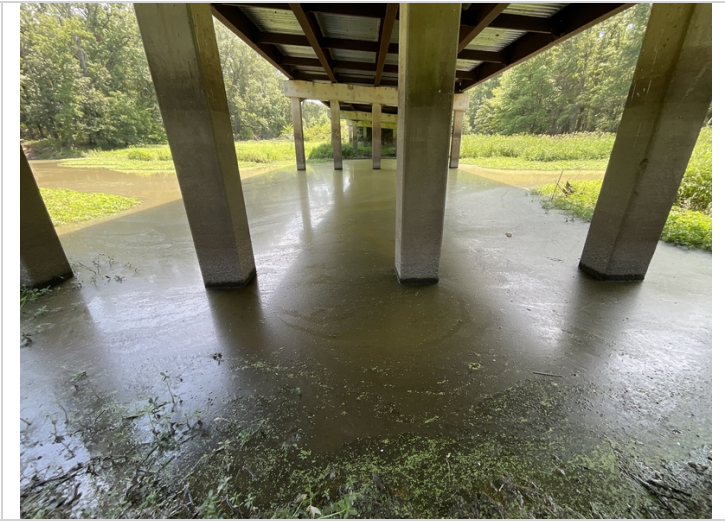
(215) Scattered cracks in back wall of both abutment.							
227	Reinforced Concrete Pile	EA	25	0	25	0	0
1190	Abrasion/Wear (PSC/RC)	EA	25	0	25	0	0
(227) All of the pile have some minor abrasion on the bottom three feet above the channel bottom.							
234	Reinforced Concrete Pier Cap	LF	165	165	0	0	0
302	Compression Joint Seal	LF	244	132	112	0	0
2320	Seal Adhesion	LF	12	0	12	0	0
2350	Debris Impaction	LF	100	0	100	0	0

Abrasion to bottom of piles

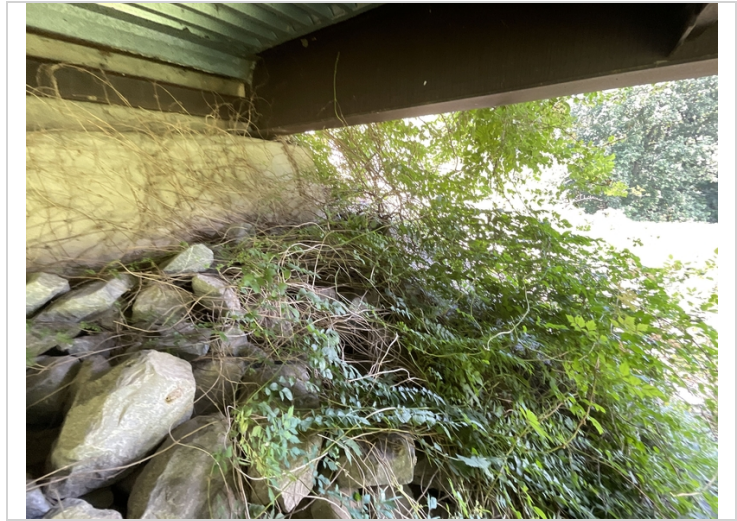
Vines growing at abutments

Type of Maintenance	Is recommended?
A-54 - Sealable Deck Cracks	Yes
A-55 - Deck Washing Needed	No
A-56 - Joint Cleaning/Flushing Needed	Yes
A-57 - Beam End and Bearing Paint Needed	No
A-58 - Cap Cleaning/Flushing Needed	No
A-59 - Joint Repair Needed	Yes
A-60 - Full Beam Painting Needed	No
A-61 - Polymer Overlay Advised	Yes
A-62 - Hydro and LMC Advised	No
A-63 Missing/Incorrect Log Mile Signage	No
A-64 - Vegetation Removal Requested	Yes

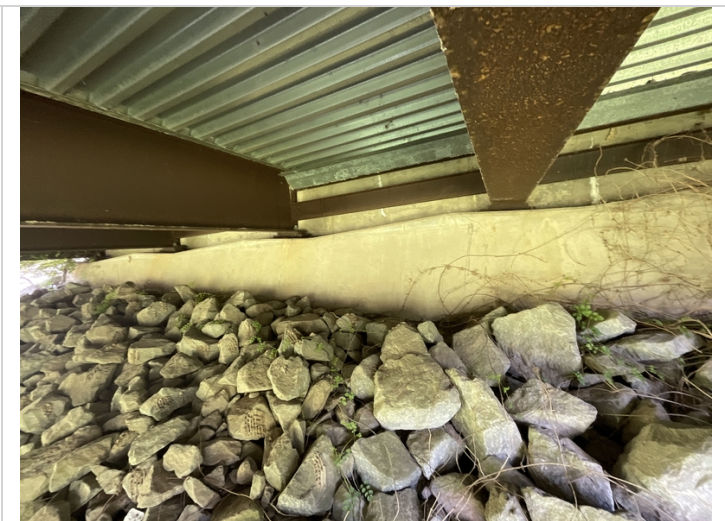
Bent 7 abutment vertical cracks with efflorescence

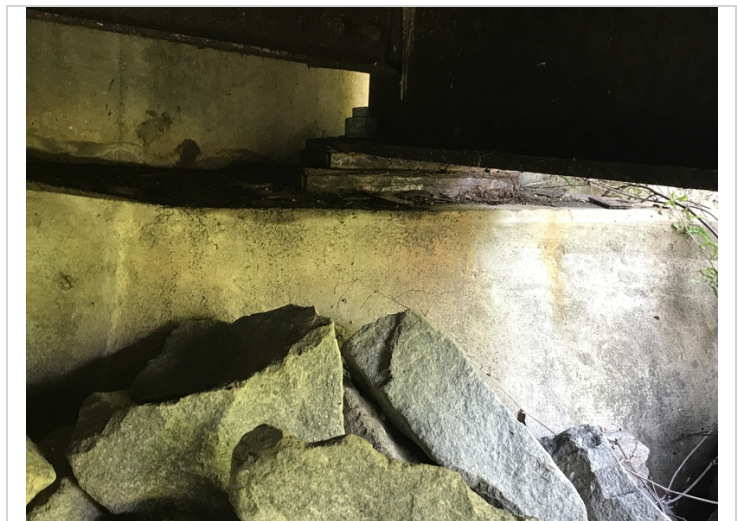
(313) Laminating rust on bearing 1 at bent 1							
331	Reinforced Concrete Bridge Railing	LF	604	576	28	0	0
1130	Cracking (RC and Other)	LF	28	0	28	0	0

Laminating rust on bearing 1 at bent 1
