Asset #05868(Routine, Underwater type 2)

SH 381 Log 10.98 over BIG DITCH

Location: 11 SO JCT US 70 & SH 381

Team Lead: Bryan Saunders, Inspection Date: 09/20/2022

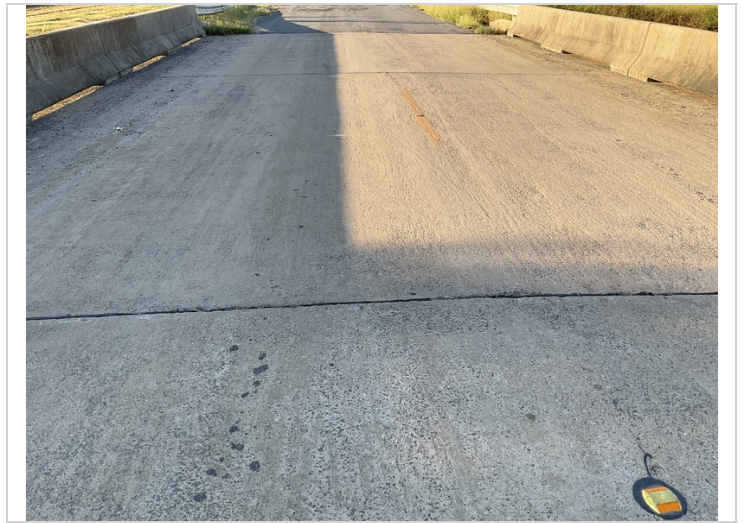
ELEMENTS	DESCRIPTION	UNITS	TOTAL	CS1	CS2	CS3	CS4
38	RC Slab	SF	2310	1935	375	0	0
1130	Cracking (RC and Other)	SF	125	0	125	0	0
1190	Abrasion/Wear (PSC/RC)	SF	250	0	250	0	0
(38) Deck all spans have small longitudinal crack at center line and scattered areas of minor wear deck has abrasion from farm machinery

Deck view

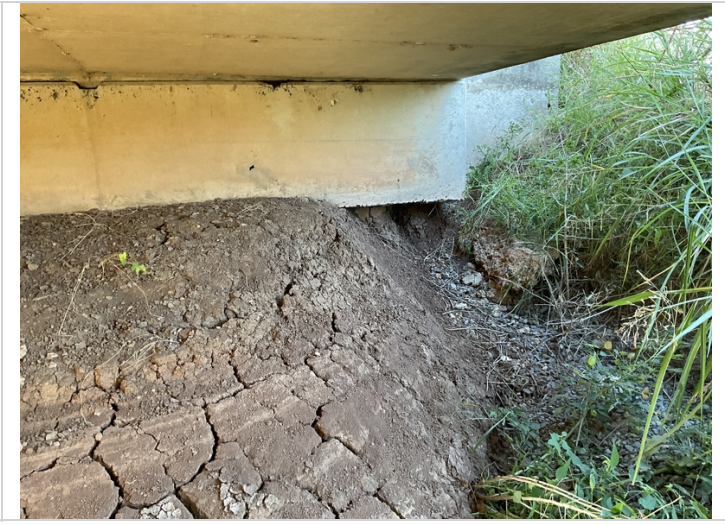
ELEMENTS	DESCRIPTION	UNITS	TOTAL	CS1	CS2	CS3	CS4
215	Reinforced Concrete Abutment	LF	80	80	0	0	0
(215) Both abutments have minor erosion.							
227	Reinforced Concrete Pile	EA	11	4	7	0	0
1190	Abrasion/Wear (PSC/RC)	EA	7	0	7	0	0
(227) Exposed pile at bent 1 both side Exposed pile at bent 4 right side side							
234	Reinforced Concrete Pier Cap	LF	60	58	2	0	0
1130	Cracking (RC and Other)	LF	2	0	2	0	0
(234) Bent 3 cap has small cracks.

Bent 4 right side exposed pile

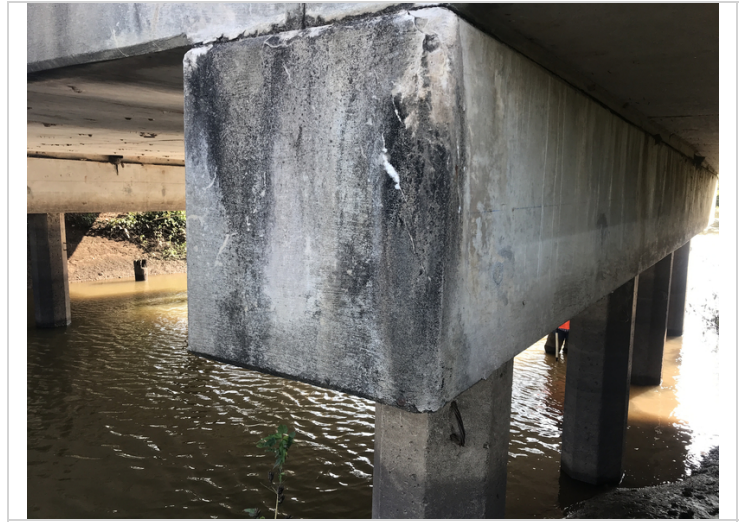
Right end of bent 3 cap has small cracks with efflorescence

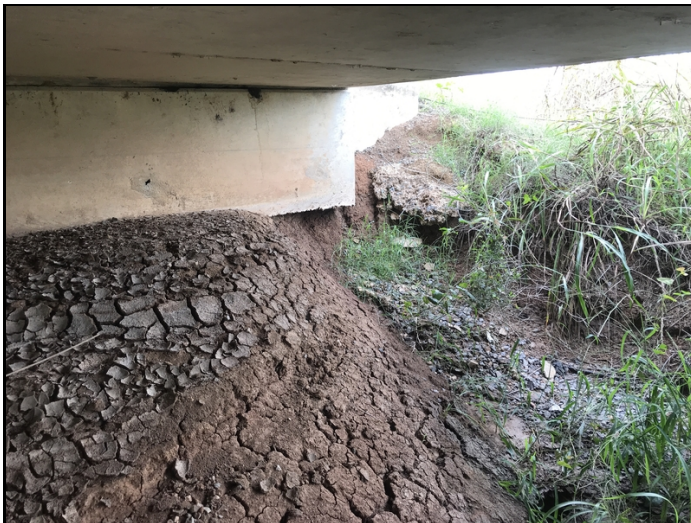
Both abutments are undermined due to erosion.

Bent 4: left end of abutment, the embankment is eroding

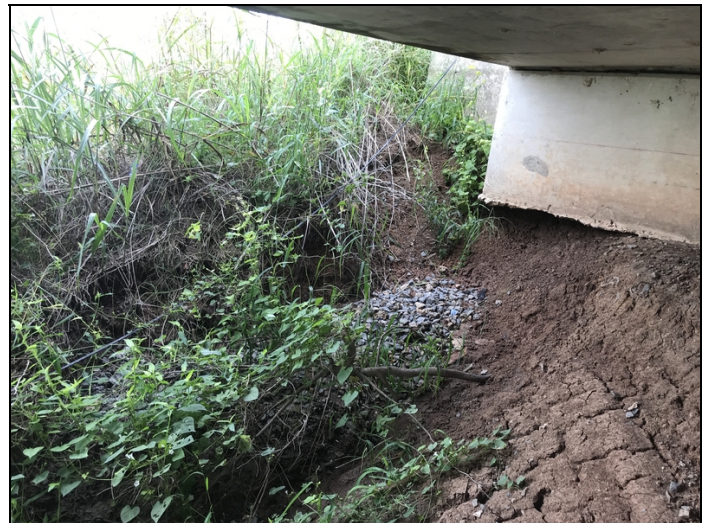
Bent 1: the embankment is eroding and undermining the abutment

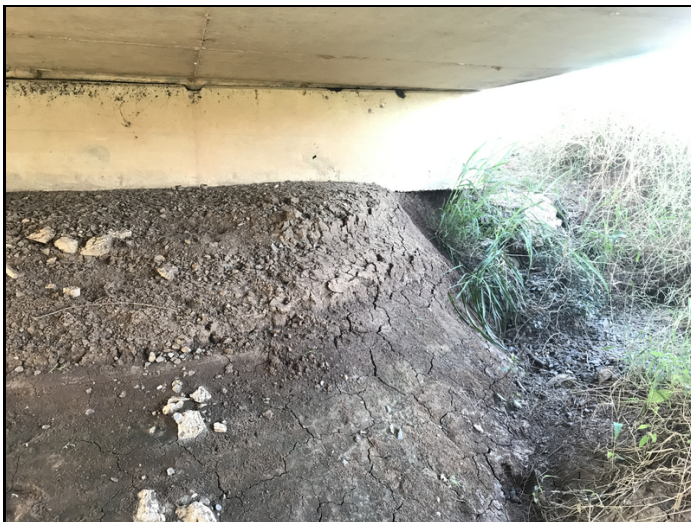
Bent 4: left end of abutment, the embankment is eroding
