Asset #05869(Routine, Underwater type 2)

SH 381Log 9.73 over BUFFALO DITCH

Location: 9.7MI SO JCT US 70

Team Lead: Bryan Saunders, Inspection Date: 09/19/2022

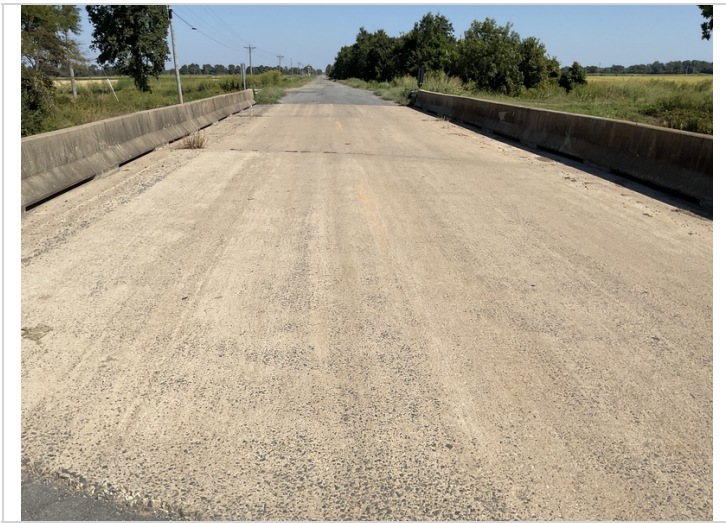
Deck view

ELEMENTS		DESCRIPTION	UNITS	TOTAL	CS1	CS2	CS3	CS4
38	RC Slab	SF	3234	2569	665	0	0	
1130	Cracking (RC and Other)	SF	265	0	265	0	0	
1190	Abrasion/Wear (PSC/RC)	SF	400	0	400	0	0	
(38) All spans have shear cracks at bents 1,2 and 3. All spans have up to 13/16 inch creep. Creep measured with string line 09/10/14. abrasion to deck from farm machinery

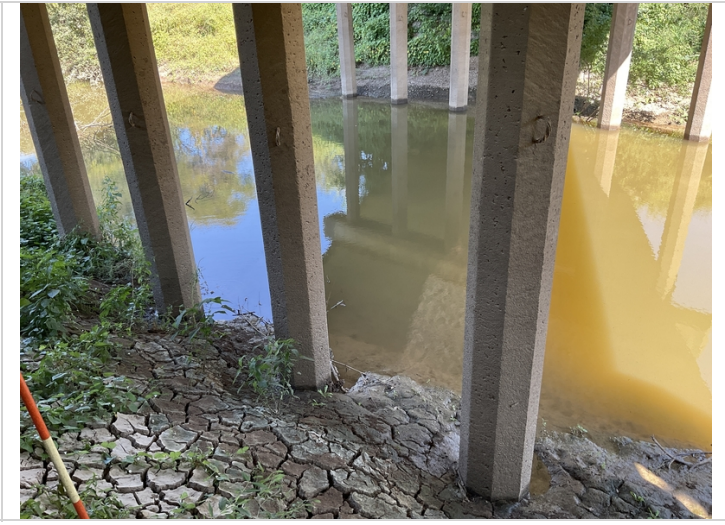
(215) Small scattered cracks in both abutments.							
227	Reinforced Concrete Pile	EA	12	0	12	0	0
1190	Abrasion/Wear (PSC/RC)	EA	12	0	12	0	0
(227) All piles have light abrasion							
234	Reinforced Concrete Pier Cap	LF	68	66	1	1	0
1080	Delamination/Spall/Patched Area	LF	1	0	0	1	0
1090	Exposed Rebar	LF	1	0	1	0	0

Abrasion to the piles

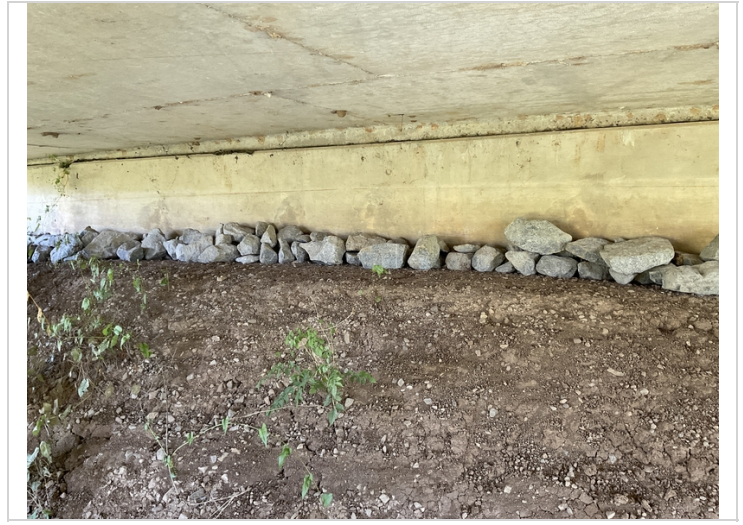
Bent 1 abutment

ELEMENTS	DESCRIPTION	UNITS	TOTAL	CS1	CS2	CS3	CS4
215	Reinforced Concrete Abutment	LF	88	85	3	0	0
1130	Cracking (RC and Other)	LF	3	0	3	0	0
(215) Small scattered cracks in both abutments.							
227	Reinforced Concrete Pile	EA	12	0	12	0	0
1190	Abrasion/Wear (PSC/RC)	EA	12	0	12	0	0
(227) All piles have light abrasion							
234	Reinforced Concrete Pier Cap	LF	68	66	1	1	0
1080	Delamination/Spall/Patched Area	LF	1	0	0	1	0
1090	Exposed Rebar	LF	1	0	1	0	0
(234) Bent 3 cap back spall at the keyway right side. Bent 3 cap exposed rebar at pile 2
