Asset #05870(Routine, Underwater type 2)
SH 381Log 8.88 over BAYOU METO SLOUGH

Location: 8.9MI SO JCT US 70

Team Lead: Bryan Saunders, Inspection Date: 09/19/2022

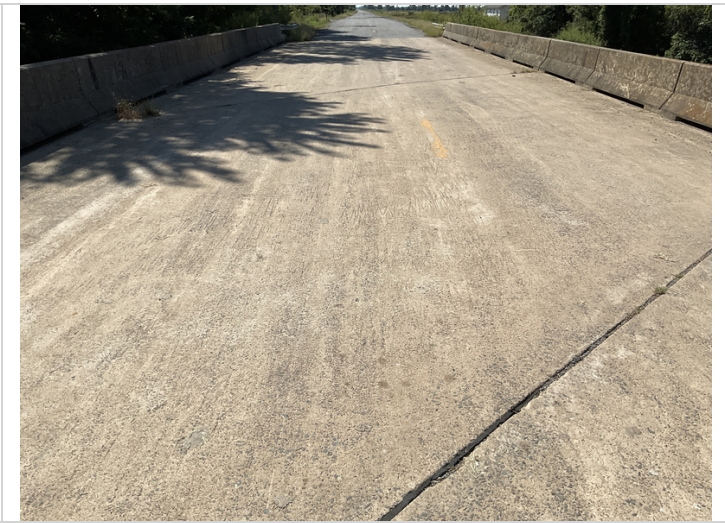
Deck view

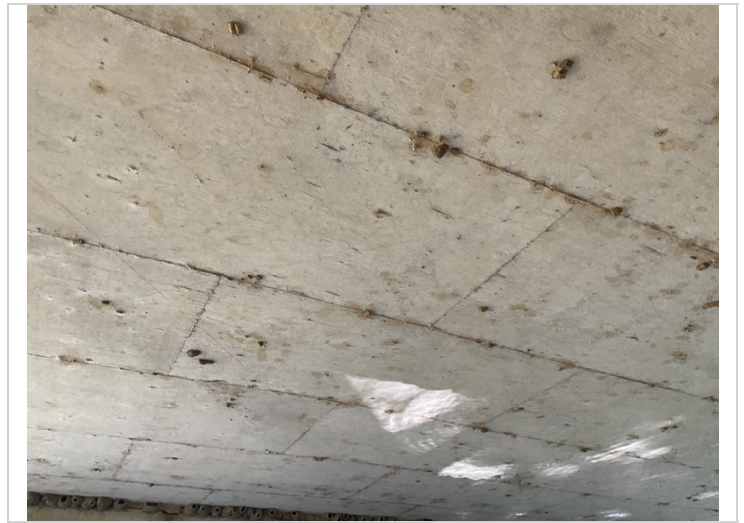
Soffit view

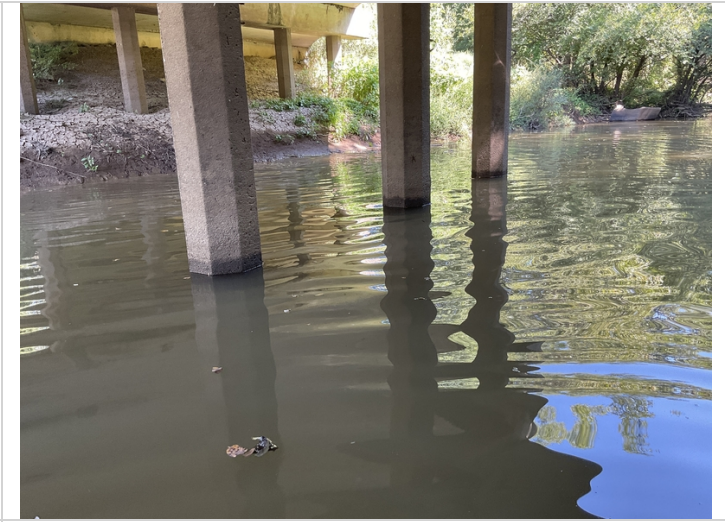
(38) Scattered small cracks in the deck with minor abrasion. honeycomb in the soffit at the backside of bent 2 abrasion due to farm machinery							
215	Reinforced Concrete Abutment	LF	100	100	0	0	0
227	Reinforced Concrete Pile	EA	18	14	4	0	0
1190	Abrasion/Wear (PSC/RC)	EA	4	0	4	0	0

Abrasion to piles at the water line

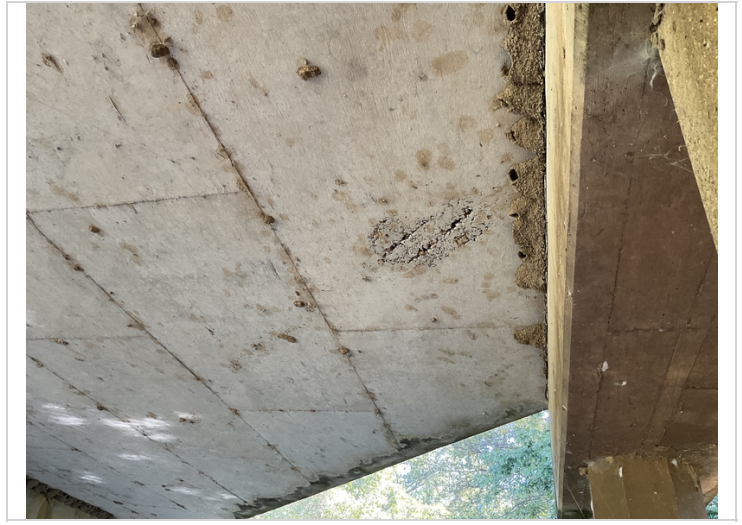
Honeycomb in soffit at bent 3
