Asset #M3141 (Routine, Underwater type 2)

SH 381 log 0.39 over WHITEOAK BRANCH

Location: .4 MI S OF US 70

Team Lead: Bryan Saunders, Inspection Date: 05/15/2023

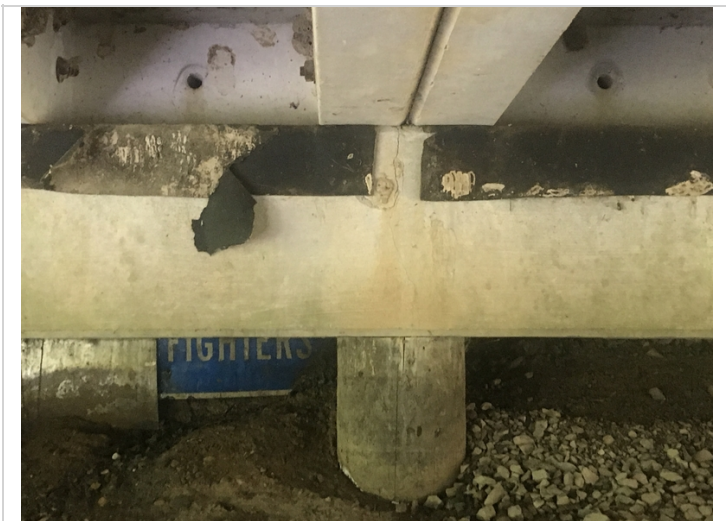
(234) Small cracks in the caps at bents 1 and 4. One spall with exposed rebar on the bottom of the cap of bent 2 between pile 3 and 4.							
330	Metal Bridge Railing	LF	138	138	0	0	0
515	Steel Protective Coating	SF	138	78	60	0	0
3440	Effectiveness (Steel Protective Coatings)	LF	60	0	60	0	0

Bent 4 cap has a vertical crack above pile 3

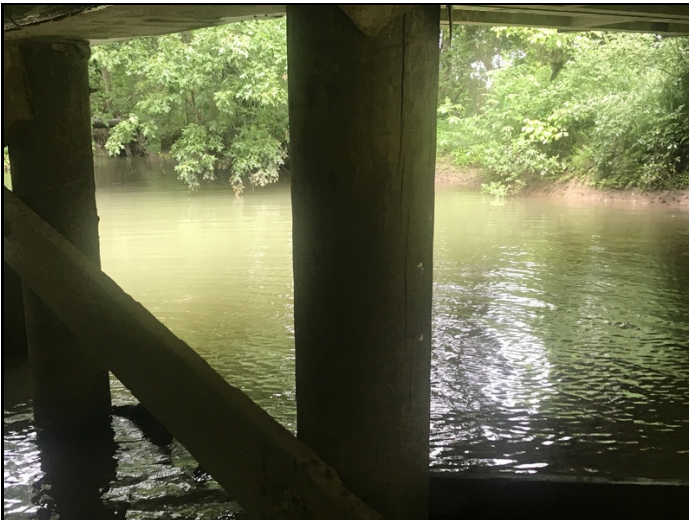
Bent 3 piles 1 and 2 have minor cracks and decay. Pile 2 hollow at cross brace. Pile 3 has 1/8 inch wide cracks, hollow at cross brace and pile 4 has 9/16 inch wide cracks at top of piles below caps.

Bent 3 pile 3 1/8" crack in pile.

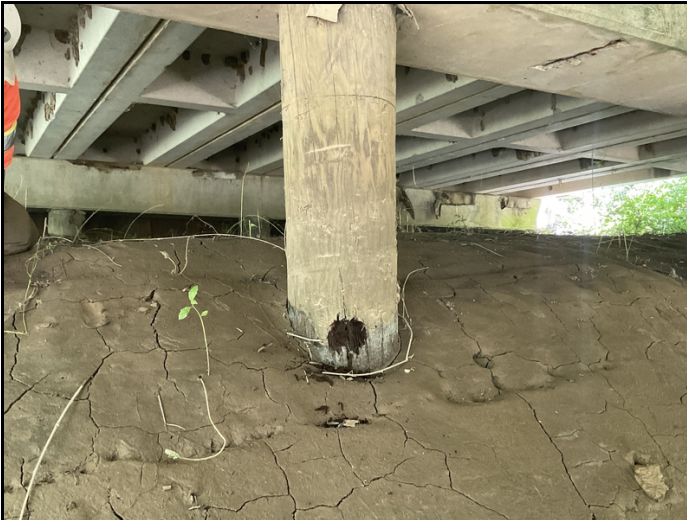
Bent 2 column 4 has a decayed section on ahead side approximately 5"x4"x 1/4" deep near bank line

Bent 2 pile 4 ahead side decay at bank line

Type of Work: Substructure Repair

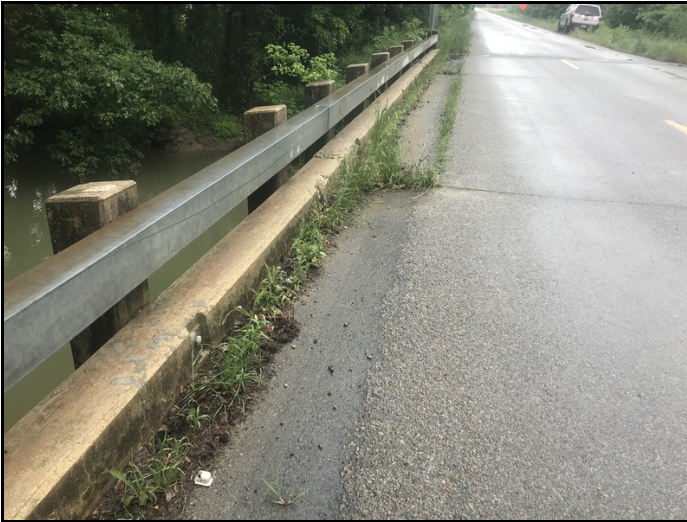
Debris and vegetation in both gutter lines.

Type of Work: (Inactive) (Inactive) 1 - Clean
