Asset #M3143(Routine, Underwater type 2)

SH 381 log 3.48 over SKINNERS BRANCH

Team Lead: Bryan Saunders, Inspection Date: 05/15/2023

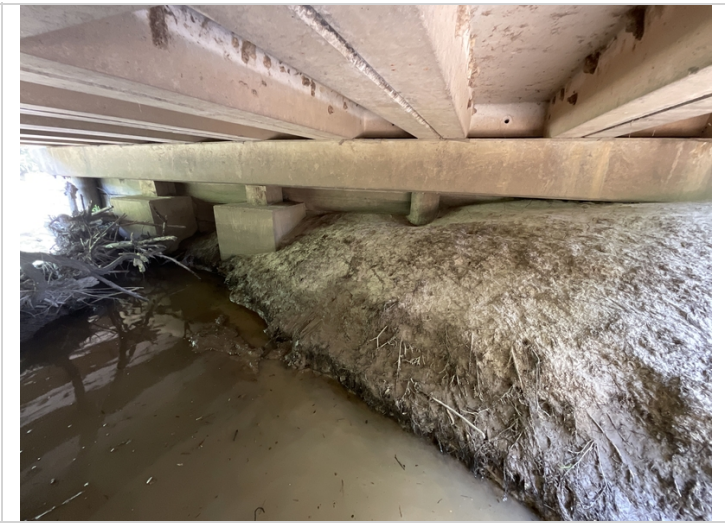
Bent 1

(234) Spalls on the right end of bent 1 and on the ahead face of bent 2.							
330	Metal Bridge Railing	LF	74	74	0	0	0
515	Steel Protective Coating	SF	74	74	0	0	0

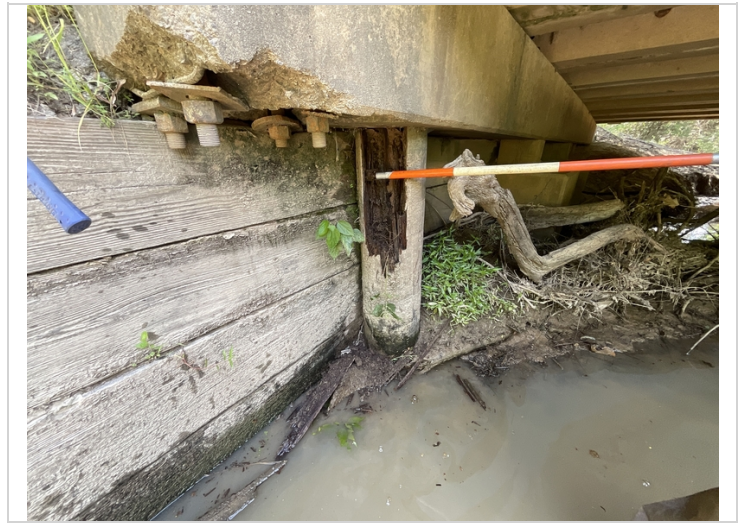
(228) State forces have repaired pile at bent 1 pile 3 & 4, bent 2 pile 1, bent 3 pile 4. Bent 1 pile 5 has a 2'x6"deep decay area at the top Bent 2 pile 2 and 3 cracks splits Bent 3 pile 2 is hollow. Concrete collar bent 2 pile 1 and 5 vertical cracks							
234	Reinforced Concrete Pier Cap	LF	91	81	4	6	0
1080	Delamination/Spall/Patched Area	LF	6	0	0	6	0
1130	Cracking (RC and Other)	LF	4	0	4	0	0

Bent 1 pile 5 2' tall 6" deep decayed section

Bent 1 pile 5, has large decayed area 2' x 6" deep

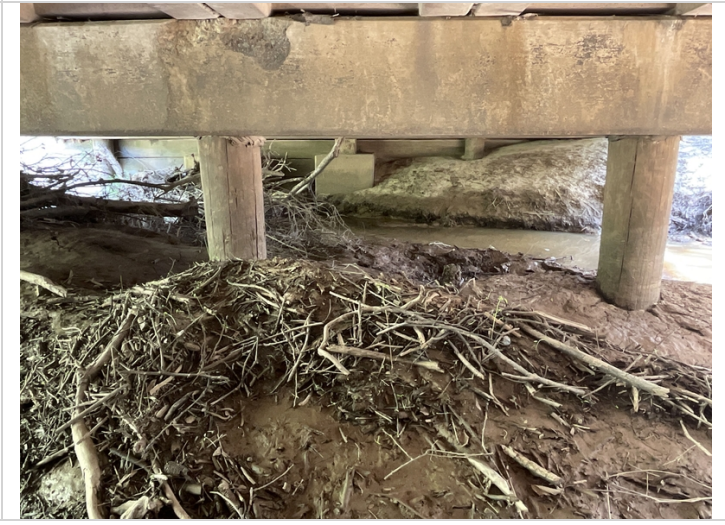
Bent 2 pile 2 and 3

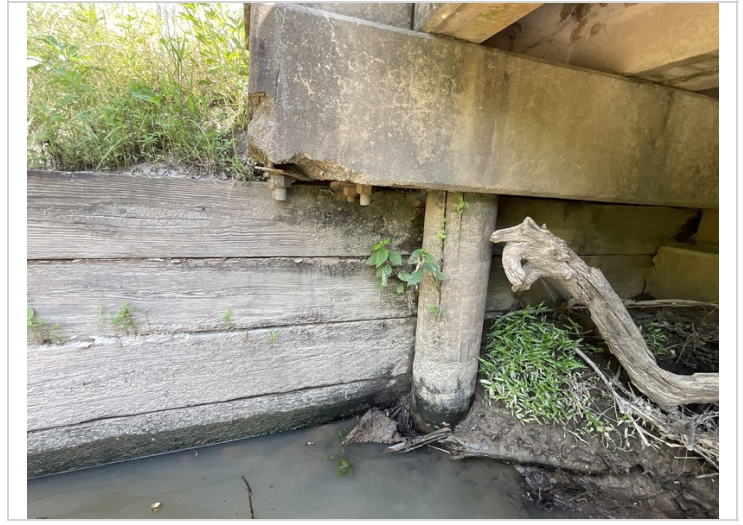
Bent 1 pile 5

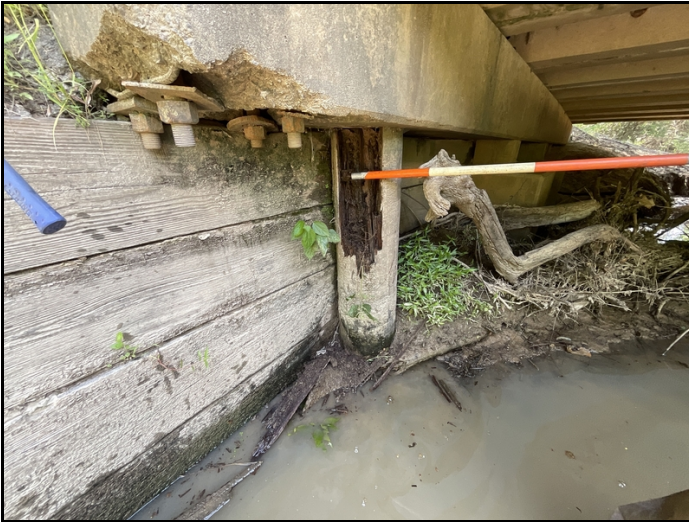
Bent 1 pile 5 2' tall 6" deep decayed section

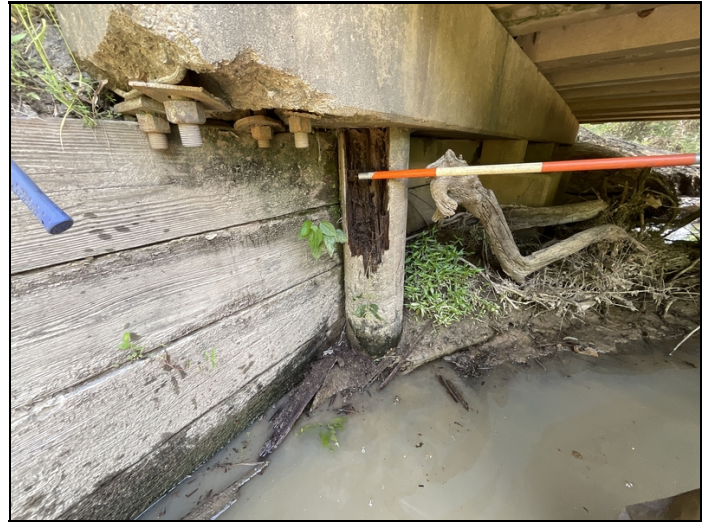
Bent 1 pile 5 2' tall 6" deep decayed section

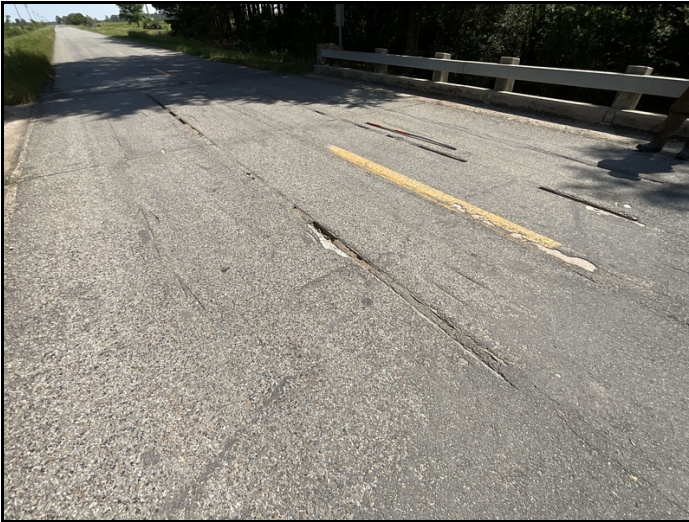
(16) Approximately 8 feet of grout between the units is missing. Bent 2: spall on unit 1 in spans 1 & 2. Similar condition to unit 8							
110	Reinforced Concrete Open Girder/Beam	LF	608	604	4	0	0
1090	Exposed Rebar	LF	4	0	4	0	0

Grout missing from between channel units

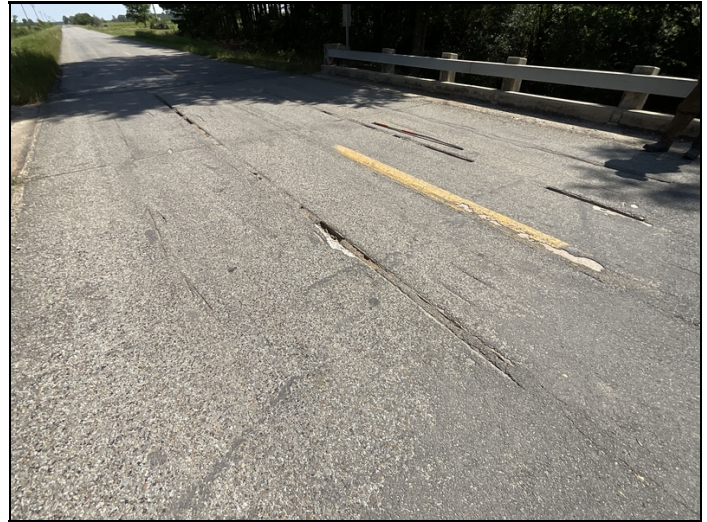
Grout missing from between channel units

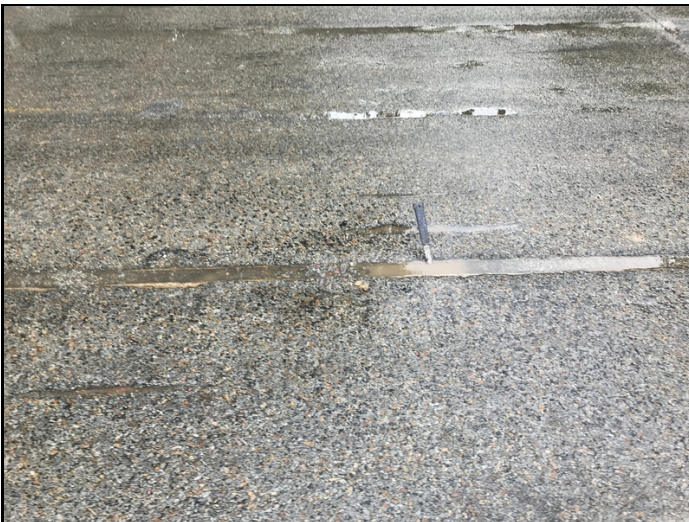
Deck has small spalls in grouted keyways between channel units.

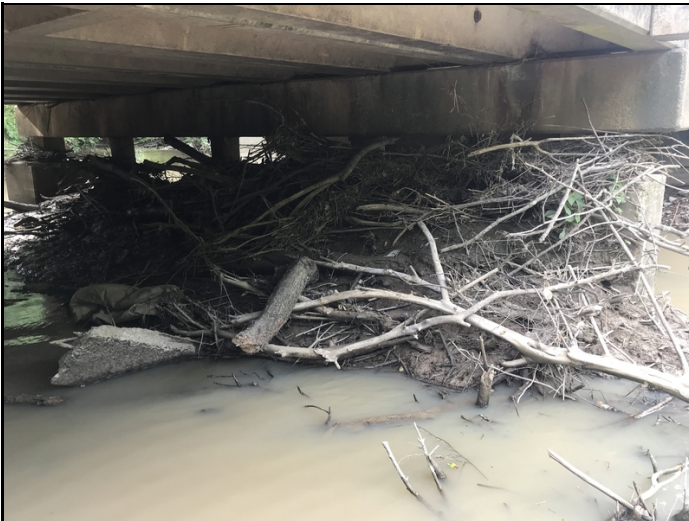
Bent 2: large amount of drift and sediment against pile.

Assigned Lonoke 06431 6/20/19

Most of the drift has been removed

Sediment mound is still in place.
