Asset #M0756(Routine)

SH 33 Log 3.15 over HONEY CREEK

Location: 5.3 MI S JCT US 70

Team Lead: Bryan Saunders Inspection Date: 03/27/2024

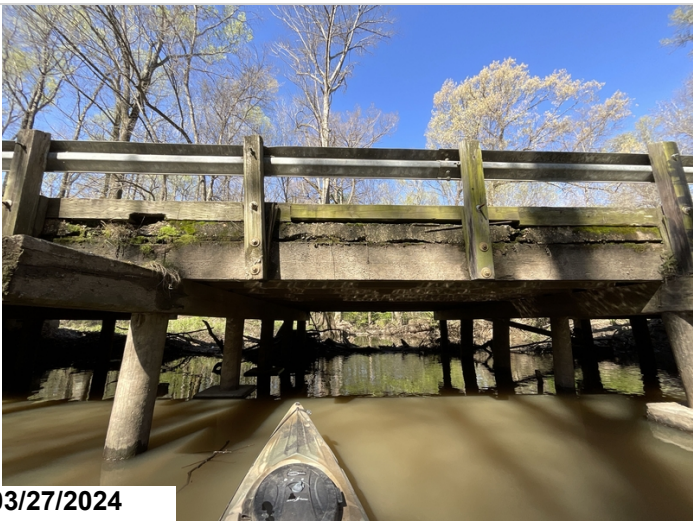
(12) Right & Left side of deck has concrete deterioration at gutter line.							
(510-12) longatudional cracks							
111	Timber Open Girder/Beam	LF	969	837	105	27	0
1140	Decay/Section Loss	LF	27	0	0	27	0
1160	Crack (Timber)	LF	105	0	105	0	0

Concrete deteriorating at both left and right sides of the deck

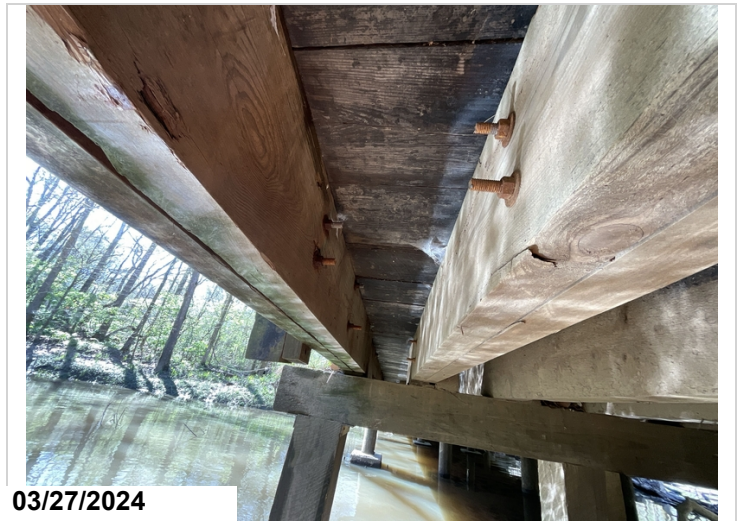
span 5 girder 12 has a split to one of the bolted together girders.

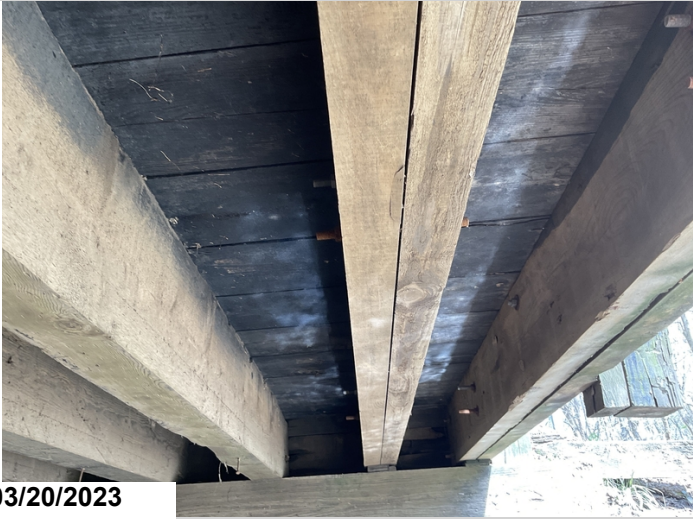
Span 5 girder 12 and 13 replaced with sandwiched beams

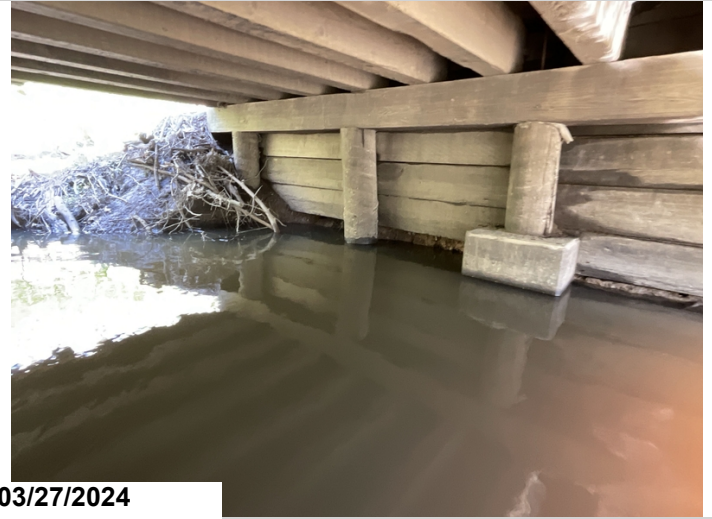
bent 6 has scour hole at west end undermining timber cribbing.

(216) The cribbing at both abutments have \ decayed sections on both ends.							
Bent 6 timber cribbing is undermined from erosion							
228	Timber Pile	EA	30	8	14	8	0
1140	Decay/Section Loss	EA	5	0	0	5	0
1160	Crack (Timber)	EA	17	0	14	3	0

Scour hole at bent 6 has undermined the cribbing at bent 6 pile 2

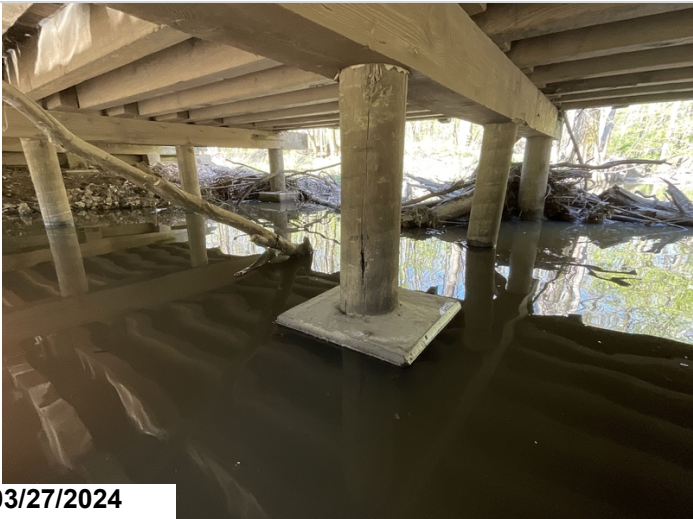
Bent 3 pile 3 cracked with decay

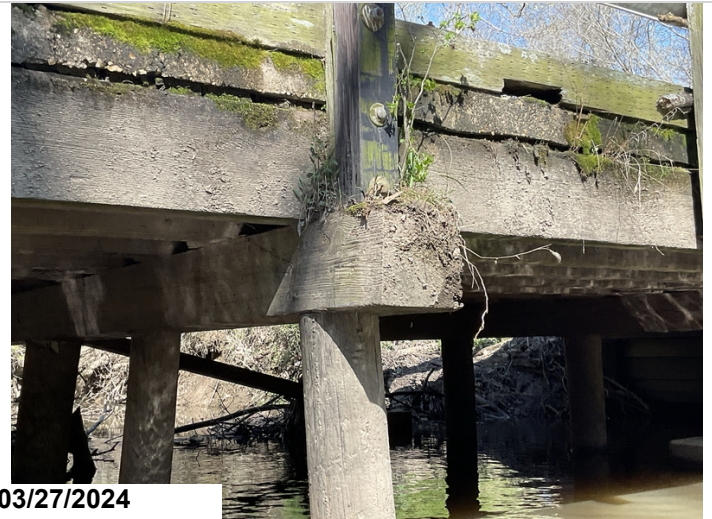
(235) The timber caps are decayed on the ends both left and right at all bents and abutments cs 3

Decay to all ends of timber caps

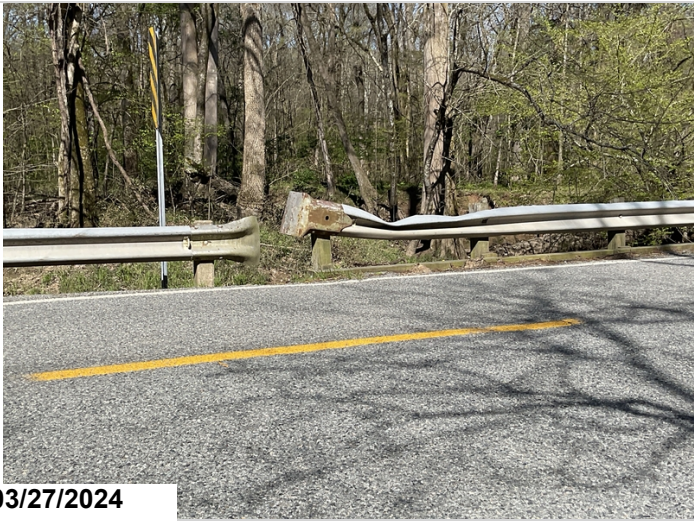
Tree has fallen on left bridge rail at bent 1 causing damage to 15'.

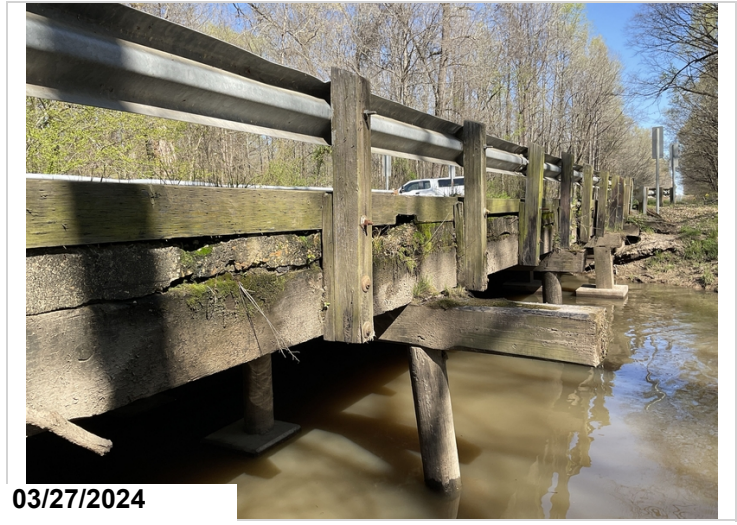
Bridge rail post are loose on both left and right sides.

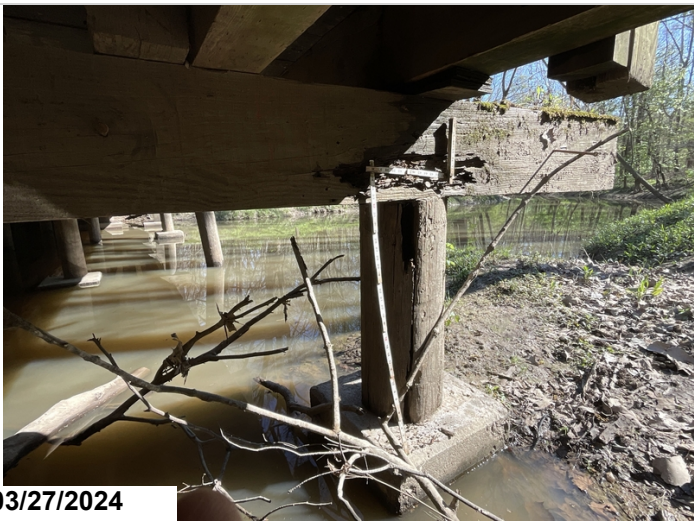
Bent 2 pile 5 is decayed and split

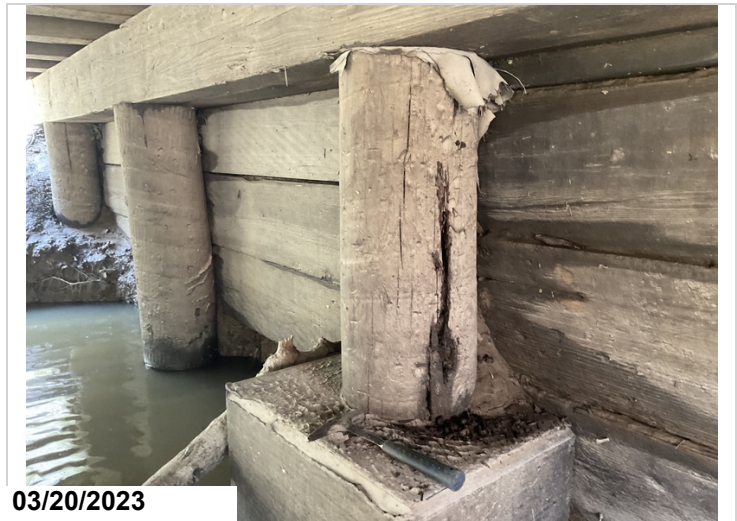
Bent 6 pile 3 has a decayed area 2' long 2" deep

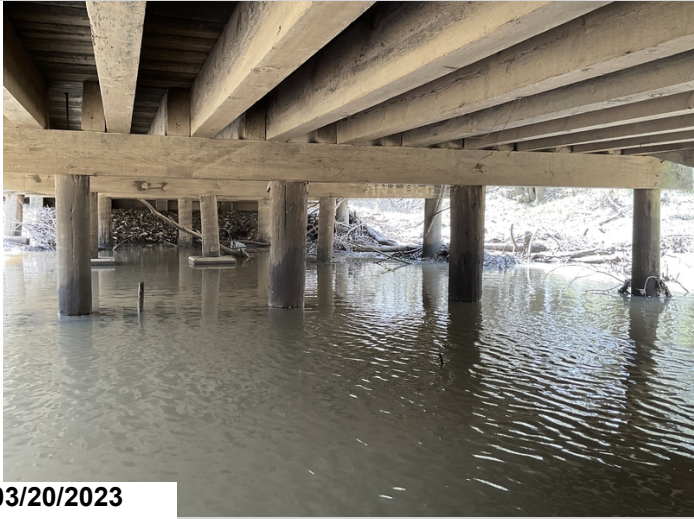
Split at bent 4 pile 3

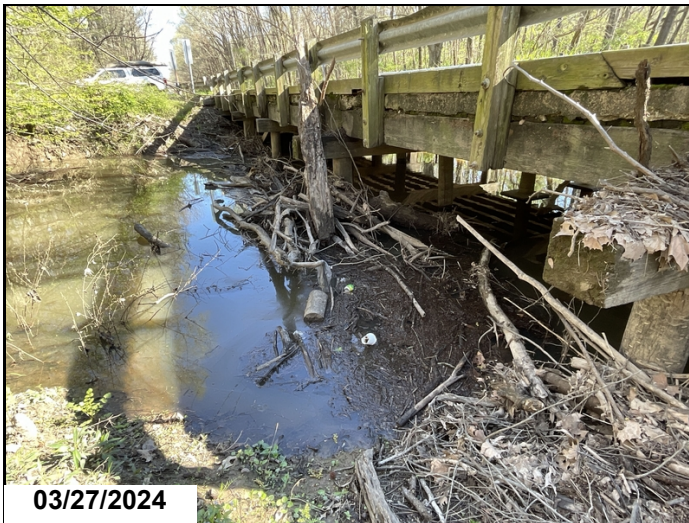
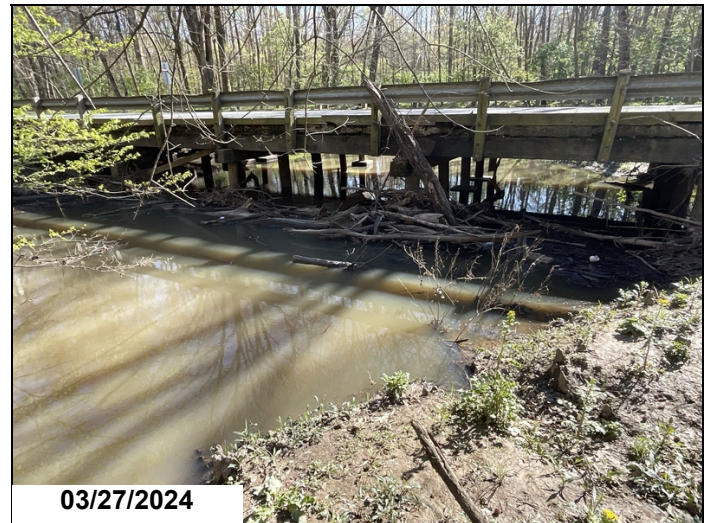
Logs and debris build up on west side of bridge restricting water flow

Logs and debris on west side

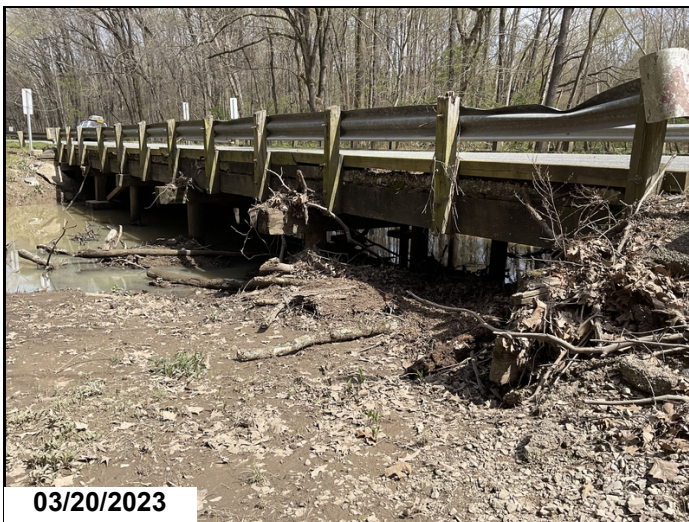
Debris at bent 2 and 3 upstream end

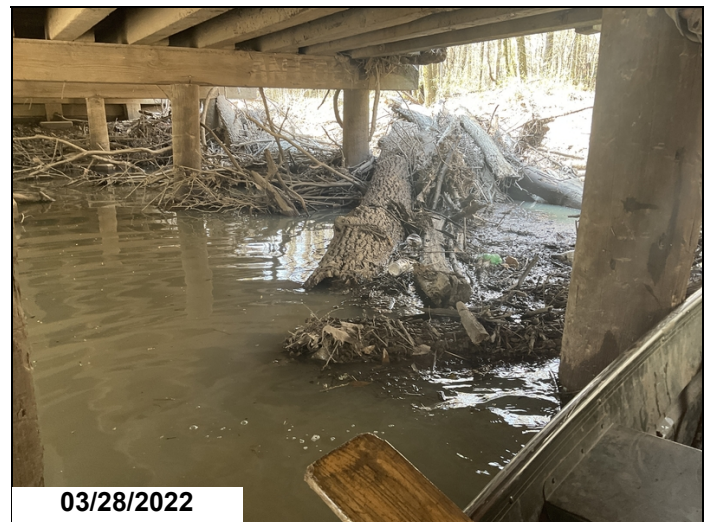
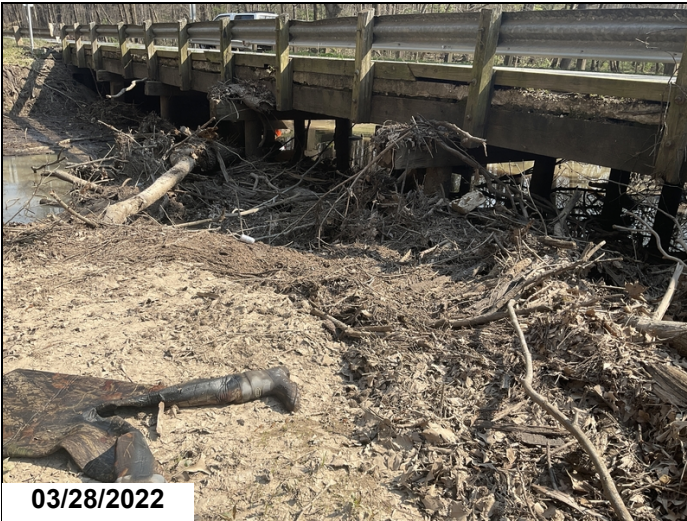
Logs and debris build up on west side of bridge restricting water flow

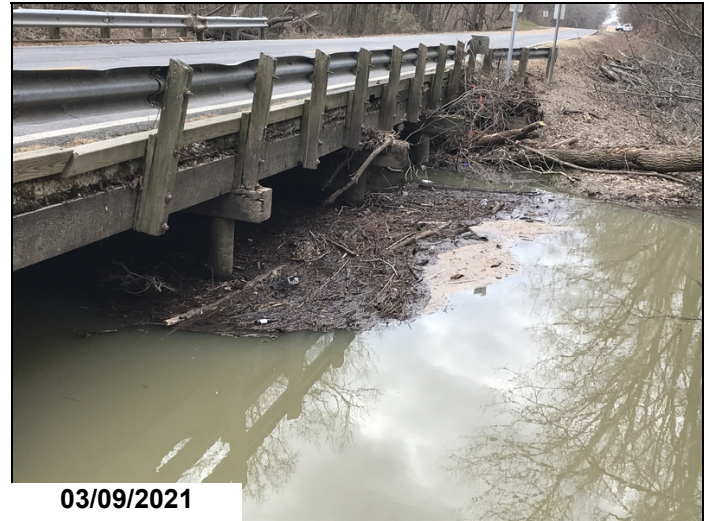
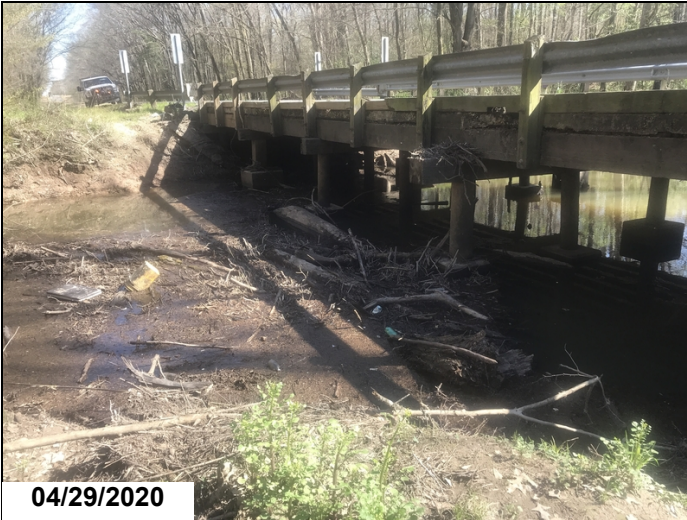
Logs and debris build up at west end of the bridge restricting water flow

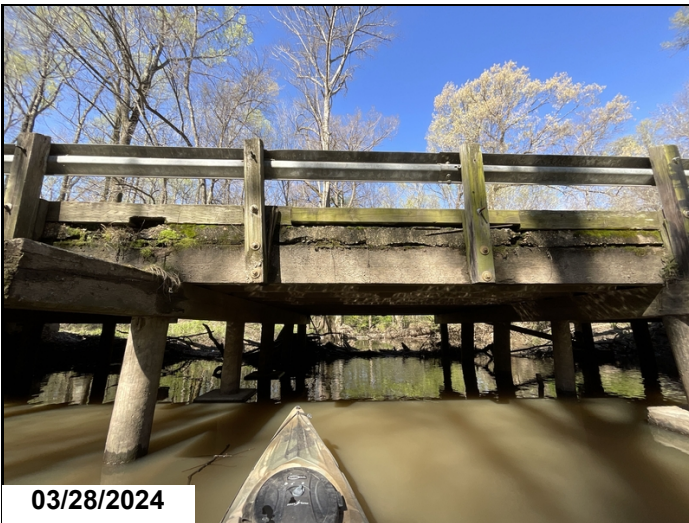
Deck both sides at gutter line have spalls due to concrete deterioration.

Concrete deteriorating at both left and right sides of the deck

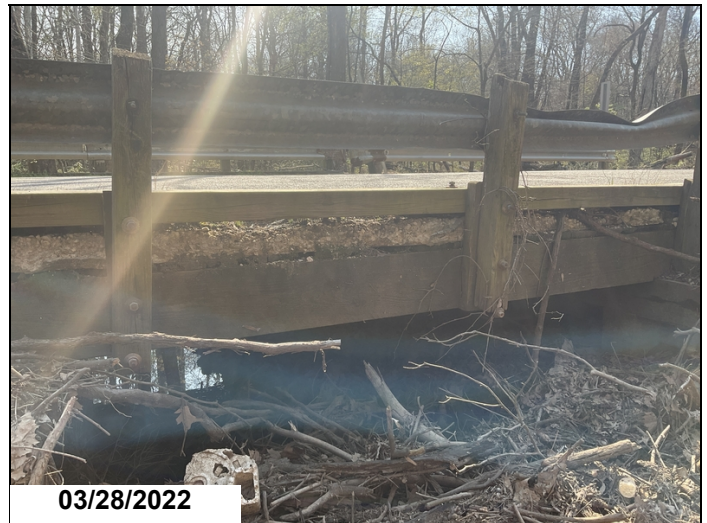
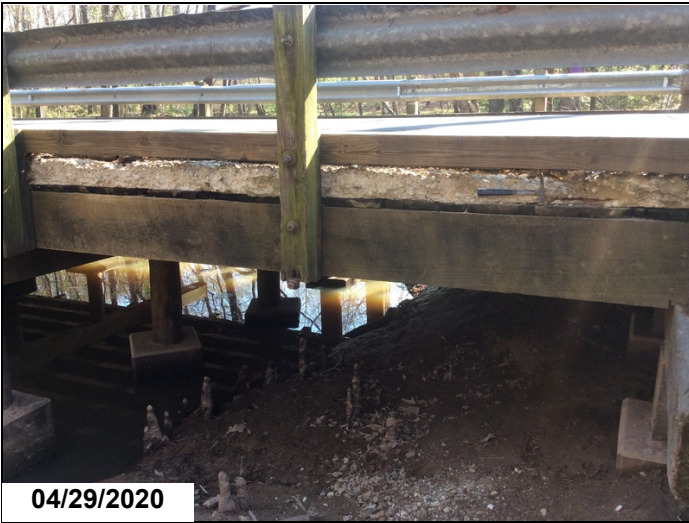
Span 1 left side spalling due to concrete deterioration.

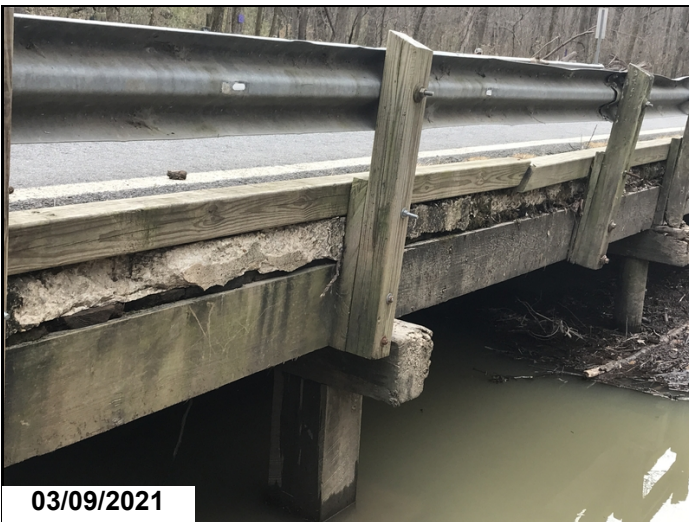
Span 2 and 3 right side of deck has spalls

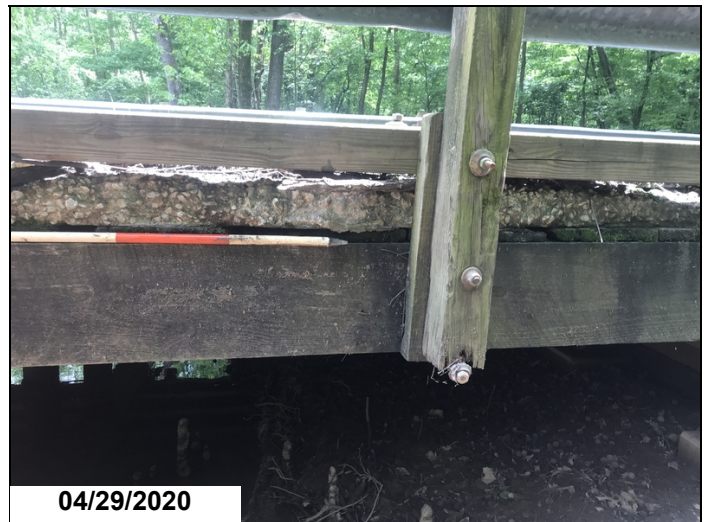
Span 1, left side of concrete deck is spalled

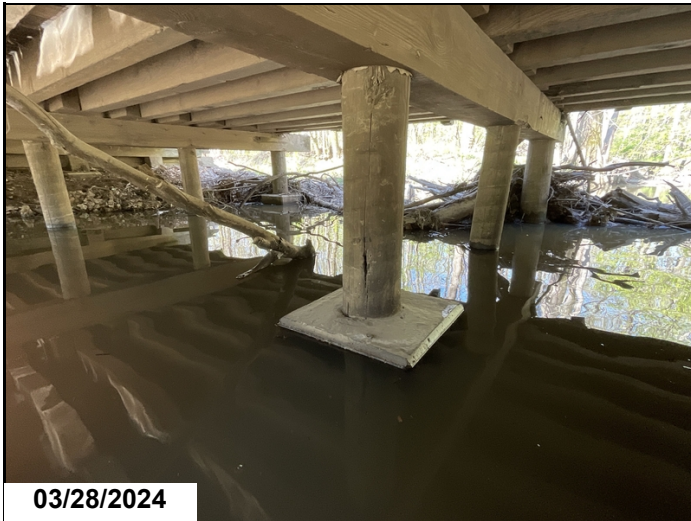
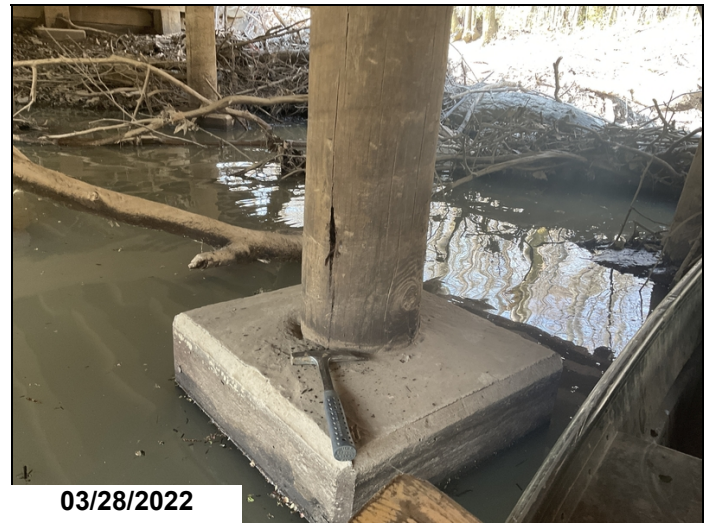
Bent 3 pile 3 is split and decayed.

Bent 3 pile 3 cracked with decay

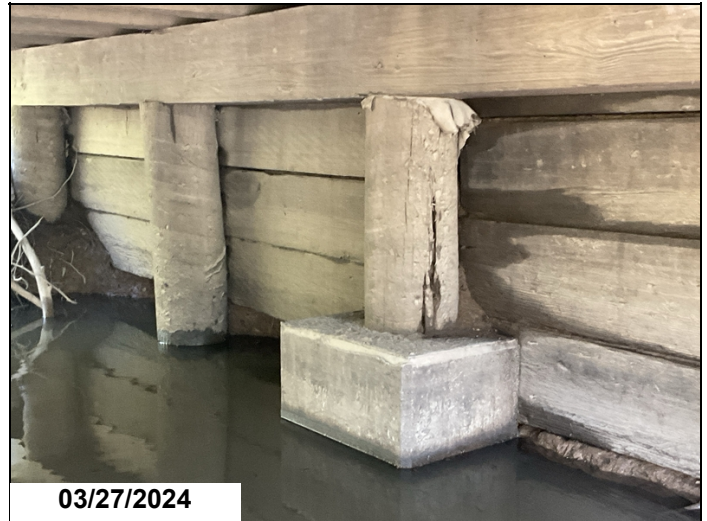
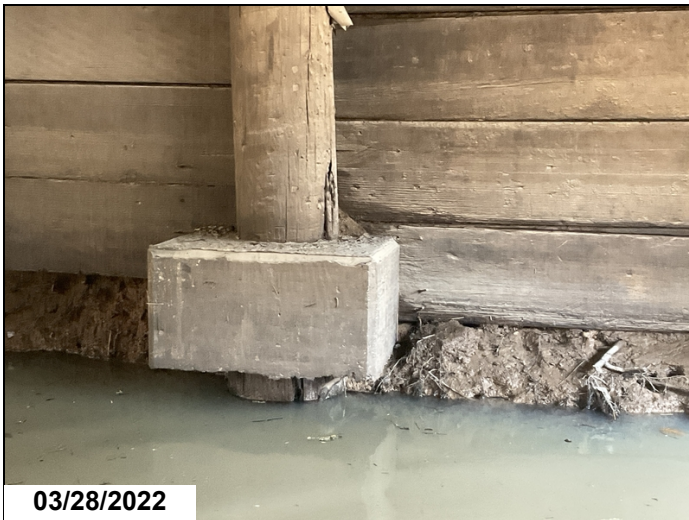
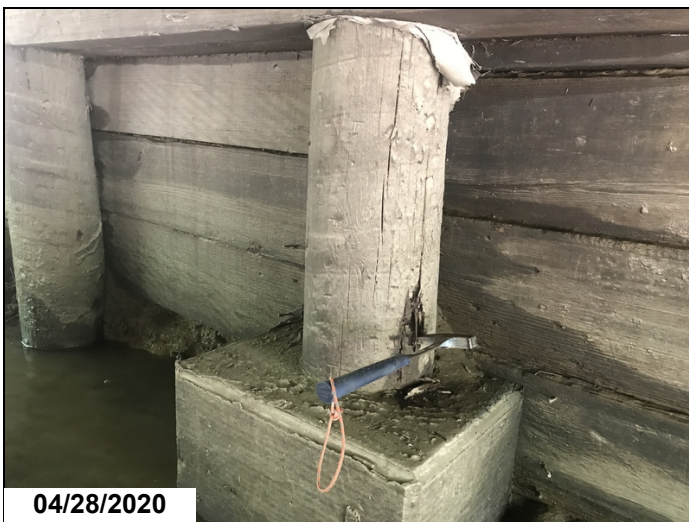
Bent 6 pile 3 is split and decayed at bottom near concrete collar

Bent 6 pile 3 split and decayed

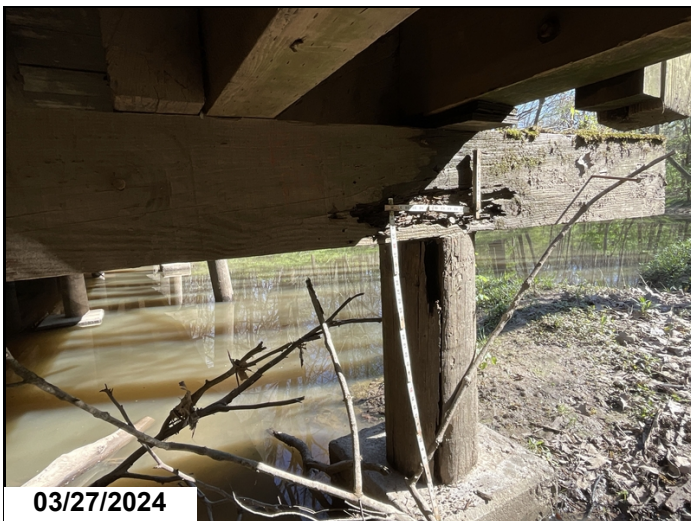
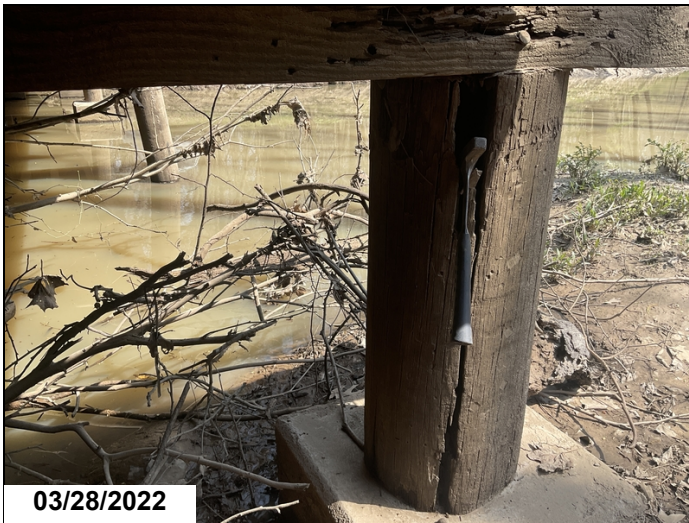
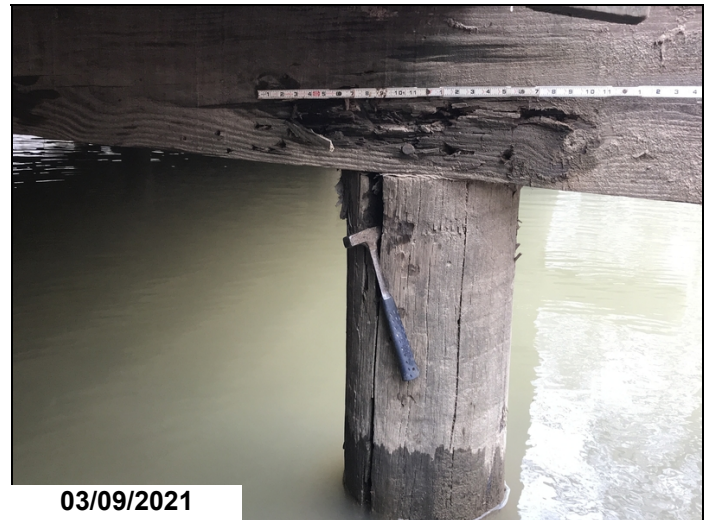
Bent 2 pile 5 is split and hollow at the top

Bent 2 pile 5 is decayed and split

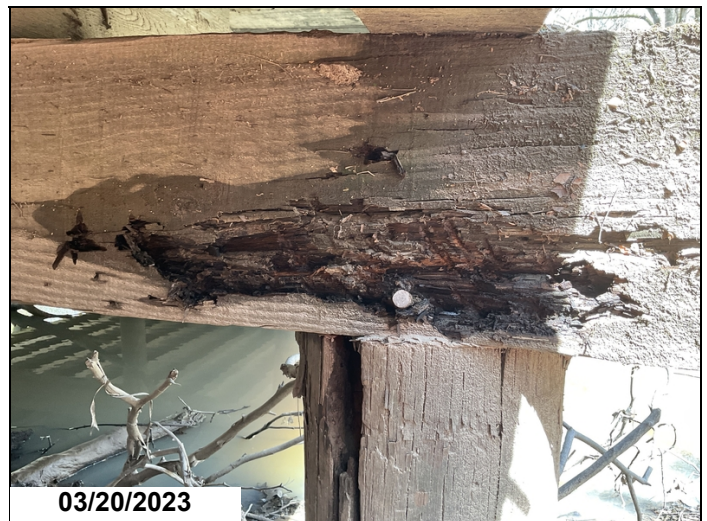
Bent 2 cap over pile 5 has a 2'x 6" x1" deep decay

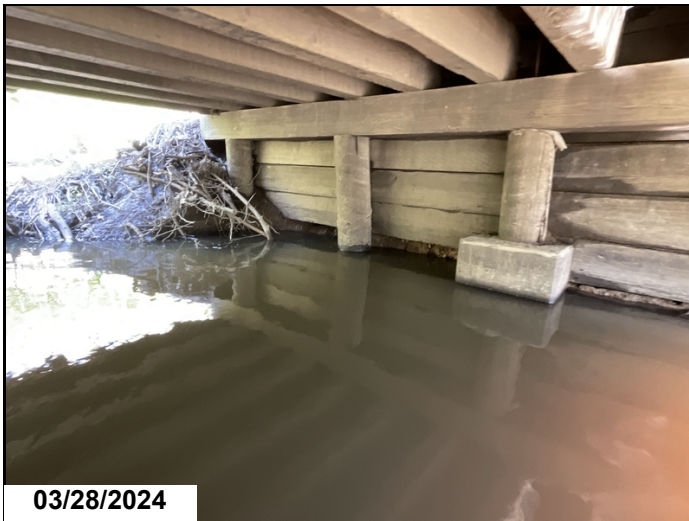
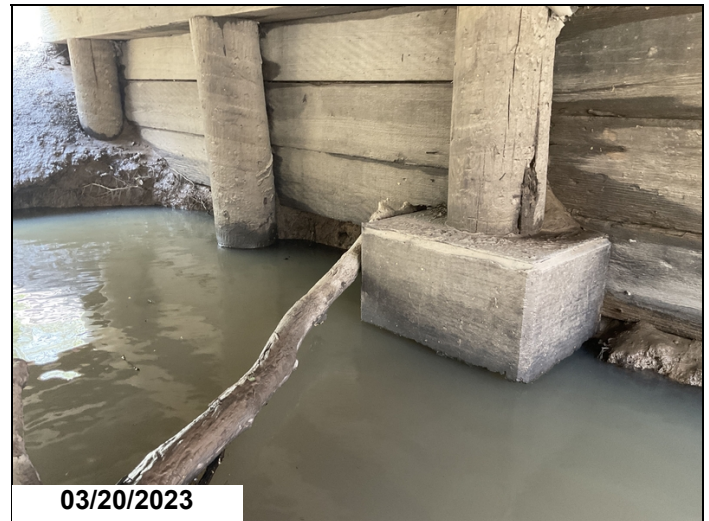
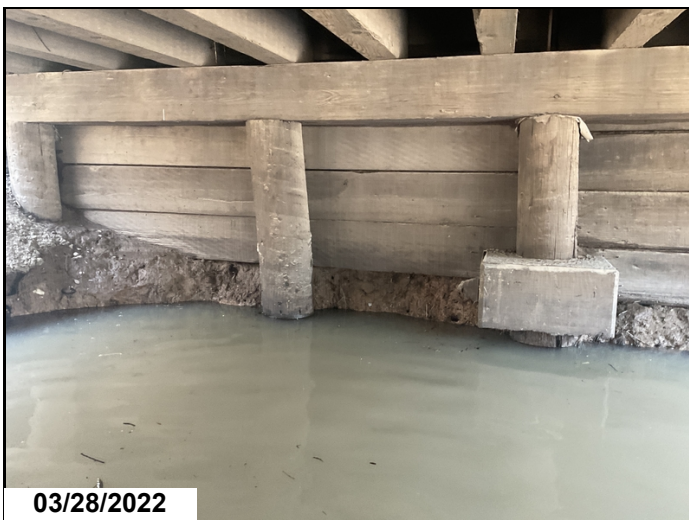
Timber cribbing at bent 6 is being undermined due to channel being block by trees and debris

Scour hole at bent 6 has undermined the cribbing at bent 6 pile 2

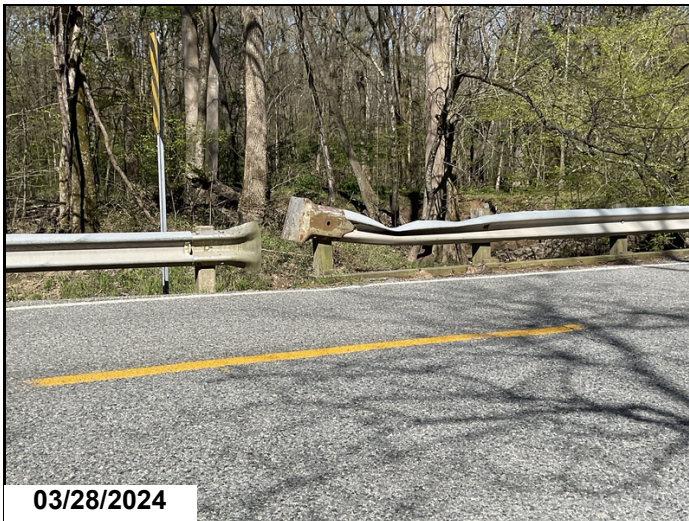
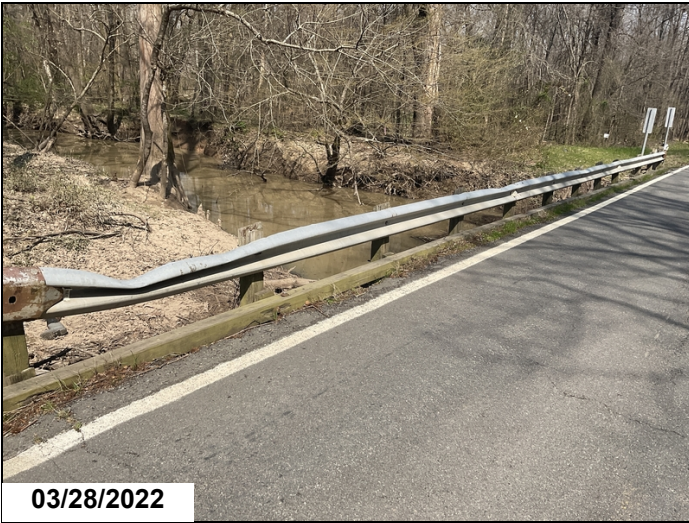
southwest bridge rail and northwest rail post is damaged from traffic impact

Tree has fallen on left bridge rail at bent 1 causing damage to 15'.

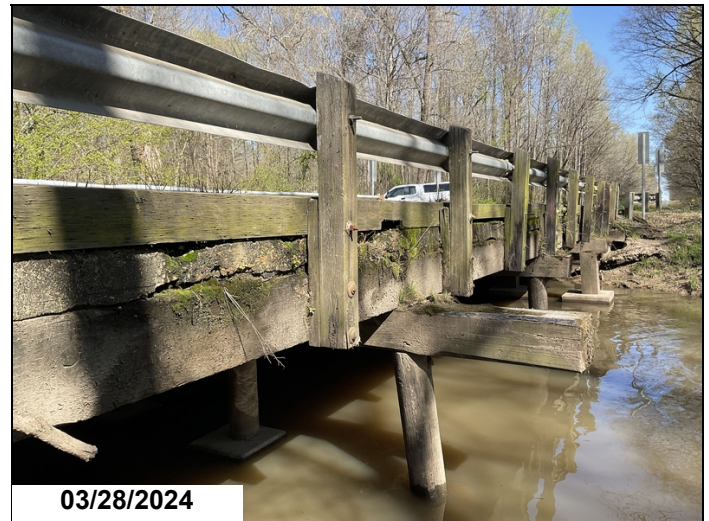
Bridge rail post are loose on both left and right sides.

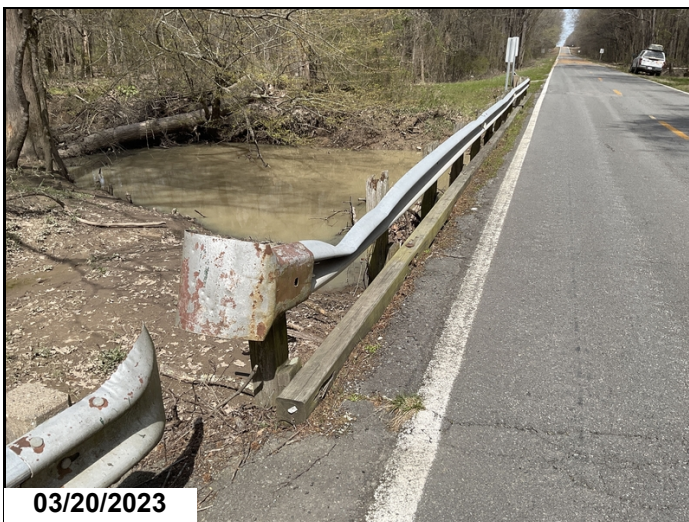
Guardrail damage at southwest end

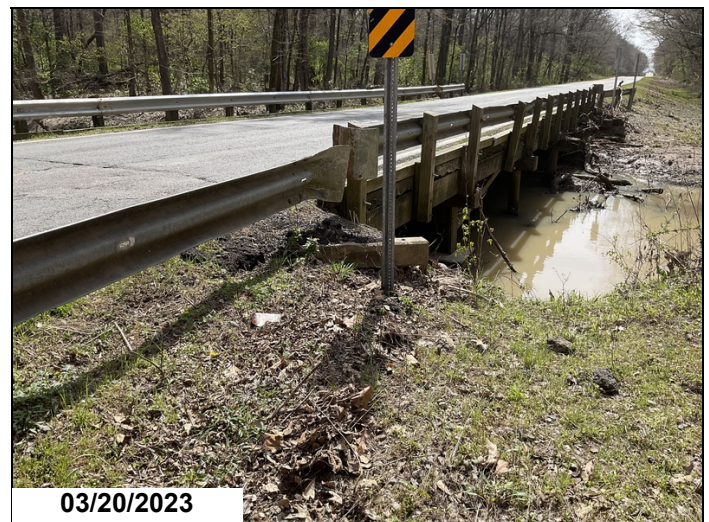
Approach guardrail post laid over due to traffic impact
